Preliminary Report: Serious Incident to M/s Alliance Air ATR 72 Aircraft VT-RKF at Bhubaneswar on 08.10.2024

6. Brief description of Serious Incident.

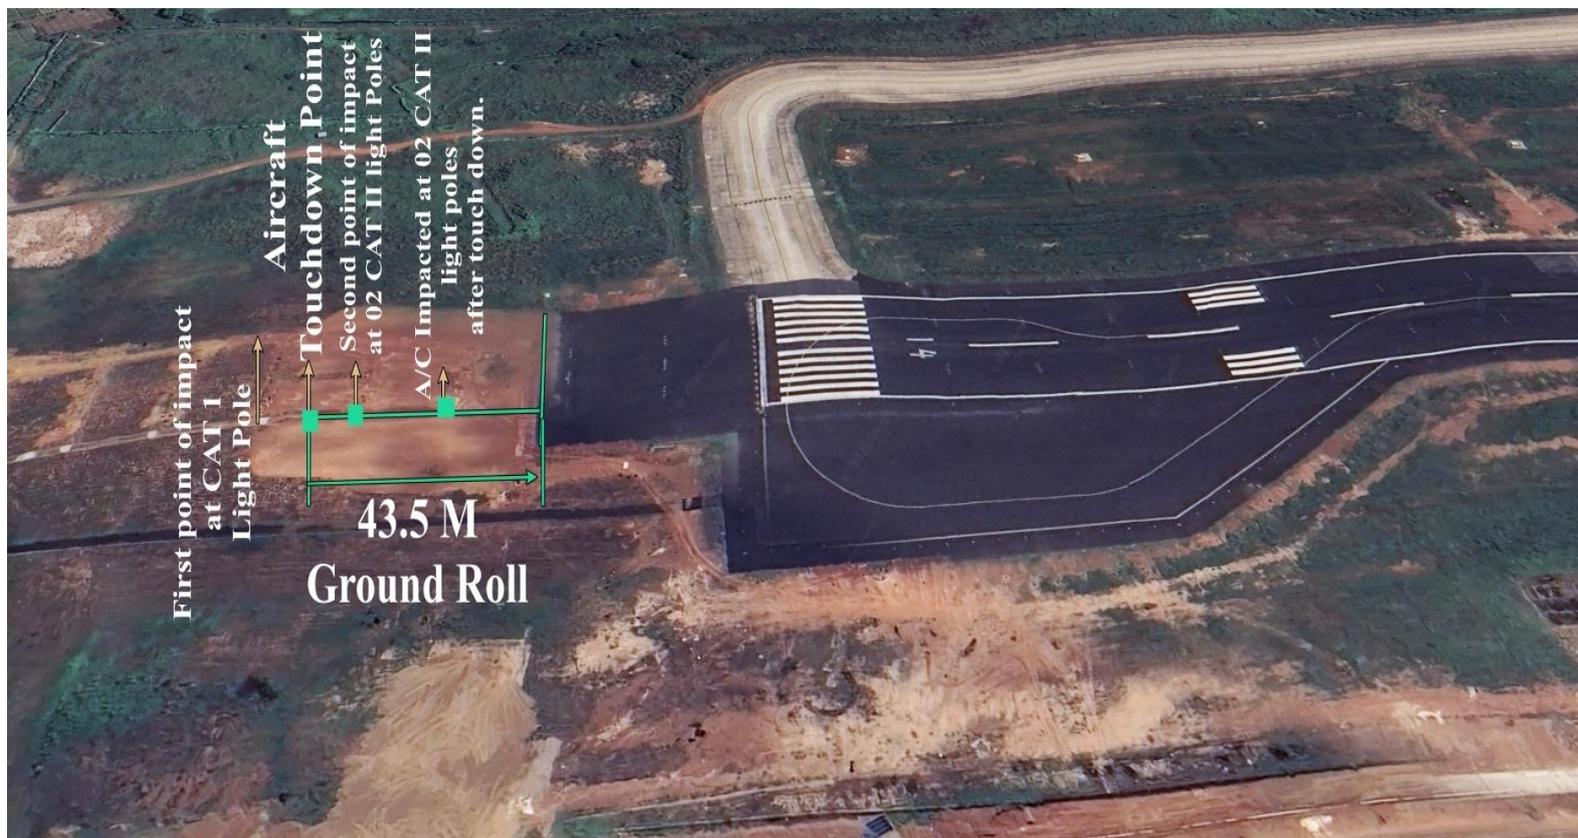
At this point, the aircraft hits one CAT I approach light and four CAT II approach lights before making its touchdown 43.5 meters short of the edge of runway 14. After landing, the aircraft cleared up to park at stand 2. Meanwhile, an outbound flight, AXB 1327 (a Boeing 737-800), which was holding at the holding point for runway 14 at taxiway J, reported FOD on the runway 14. This led to the cancellation of the outbound flight's takeoff clearance.

Figure1. Aircraft VT-RKF Touchdown point.

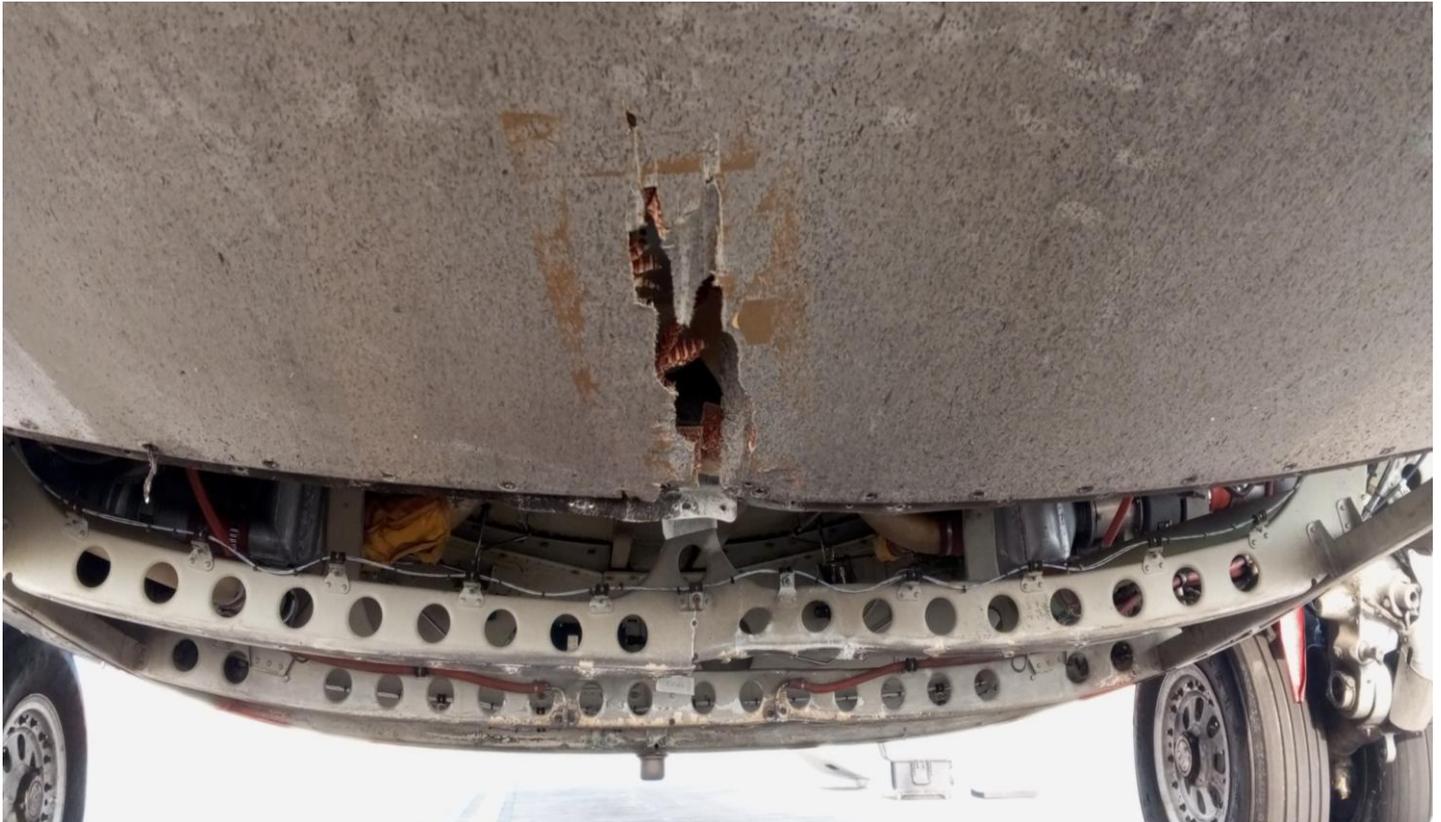
- A perforating hole was observed in the bottom skin panel between FR28D and FR29, and stringers 19L and 20L.
- The LH landing gear door, along with the folding door at its forward mounting was severely damaged.
- Two panels of the LH air-conditioning bays were found to be damaged.
- Perforation damage was observed in the honeycomb core of the LH inboard flap.
- The LH landing gear sensor cables were torn out at multiple locations on the LH landing gear.
- The electrical harnesses of 51GB & 50GB, along with the anti-skid speed sensor harness and brake temperature harness, were completely sheared.
- Belly area lower fuselage panel between FR19 & FR21 (STR 21 R) were ruptured.
- A supporting strip in the LH landing gear bay at the aft frame (FR27) was cracked.

Figure 2. Damaged Belly portion of VT-RKF
