**Final Investigation Report on
Serious Incident: Aborted Take-off on a Taxiway involving M/S Air India, Airbus, A320,
Indian, VT-EXT (AIC2592) on 05 December 2024 at Manohar International Airport, GOA
(INDIA)**

**AIRCRAFT ACCIDENT INVESTIGATION BUREAU
MINISTRY OF CIVIL AVIATION
GOVERNMENT OF INDIA**

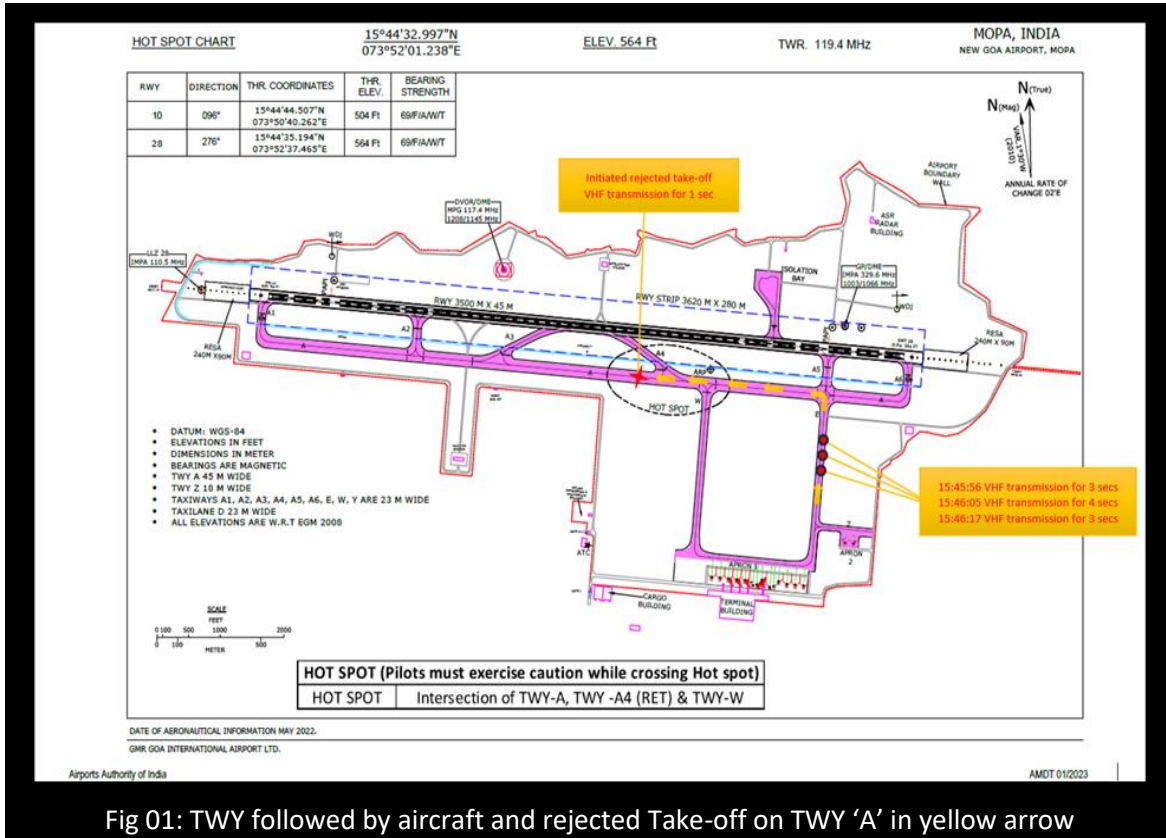
But instead, the aircraft LINED-UP on TWY 'A' which was parallel to RWY. The aircraft rolled on TWY 'A' for Take-off.

The Tower Controller confirmed with the PIC of AIC2592 whether the aircraft was on RWY28 or TWY 'A.' The PIC apologized. AIC2592 reported normal operations. (Fig 01)

Fig 01: TWY followed by aircraft and rejected Take-off on TWY 'A' in yellow arrow

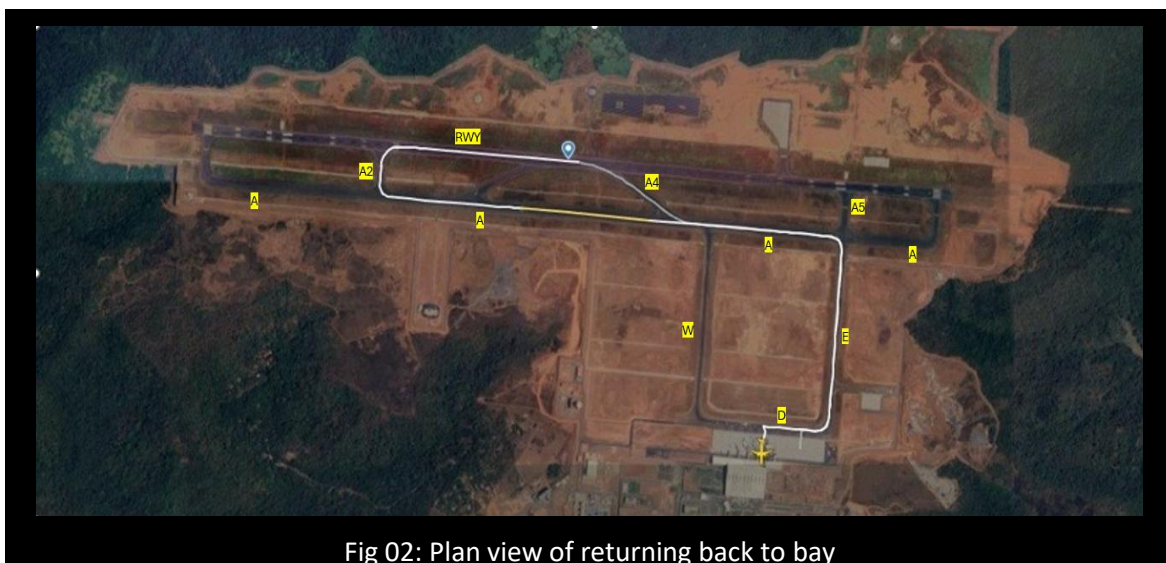
The aircraft was then instructed to taxi back to Bay '8B' via the route TWY 'A-A2-RWY28-A4-A-W-D.' A "Follow Me" vehicle was dispatched to inspect TWY 'A' which reported TWY 'A' fit for operation. (Fig 02).

Fig 02: Plan view of returning back to bay
