**FINAL INVESTIGATION REPORT ON ACCIDENT INVOLVING  
M/S ARYAN AVIATION PVT. LTD. BELL 407 HELICOPTER  
BEARING REGISTRATION VT-BKA NEAR GAURIKUND, UTTARAKHAND  
ON 15 JUNE 2025**

**GOVERNMENT OF INDIA  
MINISTRY OF CIVIL AVIATION  
AIRCRAFT ACCIDENT INVESTIGATION BUREAU**

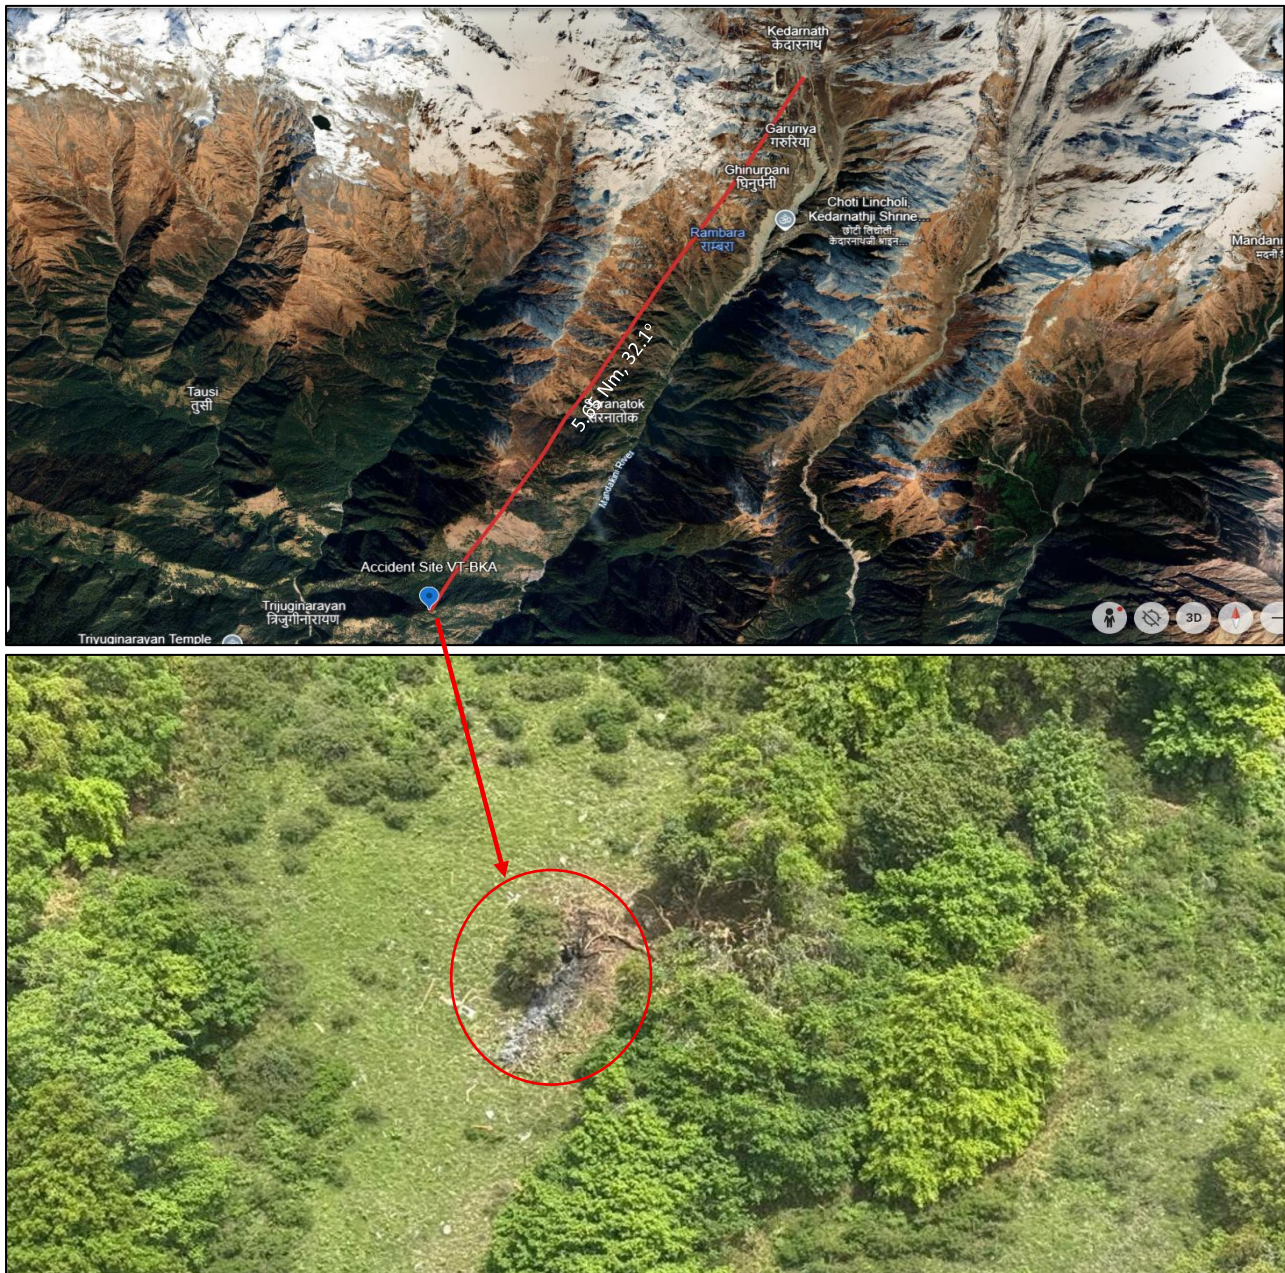
The helicopter was maintaining an altitude of approximately 9000 feet altitude (as required by the SOP) and crashed into the mountain on the right side of its flight path near the Kedarnath valley exit point. The accident site was at an ariel distance of about 5.65 Nm from the Kedarnath helipad on radial 32.1°. The co-ordinates of the accident site were 30° 38' 59.0" N, 79° 00' 35.0" E with elevation of 9051 feet. The helicopter impacted the terrain and caught fire. The wreckage parts were found scattered but were confined to the main wreckage area.

Most of the helicopter wreckage parts such as cockpit, cabin section, main rotor blades, etc were destroyed and found burnt. Some of the airframe parts such as cockpit doors, cabin doors and the tail boom were recovered from the accident site and shifted to Dehradun for further examination.

Figure 2 Aerial view of the accident site and its location in respect of Kedarnath helipad.

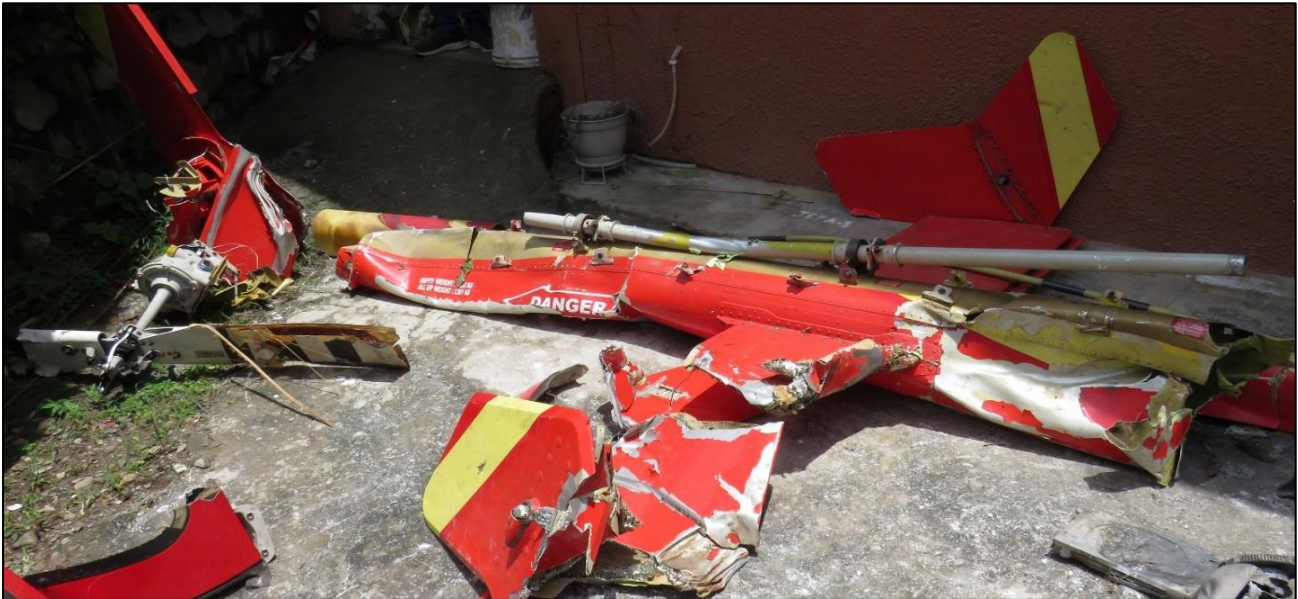
- The tail boom was the major part recovered and suffered major impact damages on its right side.
- The tail boom was found fractured at mid-point aft of the tail boom attachment and the horizontal stabilizer.
- The tail rotor gearbox support casting fractured at the tail boom joint attachment.
- The tailboom had an impact damage to the right side behind the horizontal stabilizers.
- The left stabilizer and the finlet were found intact.
- The right stabilizer had a large impact damage on its leading edge. The finlet fractured horizontally about mid-point from the bottom and was twisted/delaminated.
- The vertical fin had a large impact damage on its lower leading edge with deformation of the shape towards the right.
- The stinger was intact and no damage was found.

- The tailboom tail rotor driveshaft was mostly present with its driveshaft cover. The mid driveshaft had some impact marks and was deformed.
- The hanger bearings were rotating so was the tail rotor gearbox.
- The tail rotor gearbox chip detector didn't reveal any presence of metal and was clean.
- The oil color was normal.
- The tail rotor gearbox separated at the disc attachment (input quill) and at the gearbox support casting due to impact forces.
- The aft fuselage driveshaft separated at the oil cooler blower and was fractured on its aft end. No pre-impact anomalies were found with the portion that was assessed.

- The pilot's tail rotor control pedals separated from the airframe.
- The control tube connecting horizontally from the pedals to the 1st bellcrank fractured about 4-5 inch from the rod end connection due to overload.
- The pilot cyclic was twisted to the left and fractured at the base.
- The collective control fractured at the base and was on bare metal without the throttle control present.
- The tailboom tail rotor control tube had fractured both forward and aft at corresponding tailboom fractures location.
- The control tube had a deformation, similar to the tailboom shape to the right of the aircraft.

- The tail rotor pitch change mechanism operated normally with corresponding movement of the tail rotor.
- One tail rotor pitch link was deformed but was otherwise connected to the tail rotor.

*Figure 3 Tail Section recovered from the Accident Site*

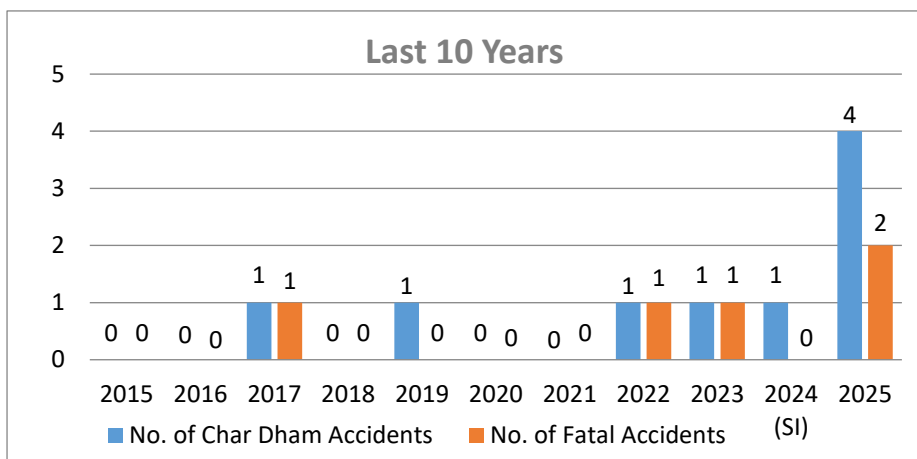
The investigation team analysed the accident data of last ten years i.e., from the year 2015 to 2025. It was observed that there has been a total of 09 occurrences including 08 Accidents and 01 Serious Incident in the Char Dham sector during this period.

Figure 4 Number of accidents in Char Dham from year 2015 to 2025

Out of these 08 accidents, 05 accidents were fatal. There was no accident in 2015 & 2016 as the Char Dham operations during that time were very limited. From the year 2017 to 2019 there were 02 accidents out of which 01 was fatal. In the year 2020 & 2021, the operations were very limited owing to COVID-19 protocols and no accidents were reported during this period. However, from the year 2022 onwards there has been atleast 01 accident/serious incident every year. The occurrence in the year 2024, was classified as serious incident. In the last year i.e. 2025 there were 04 accidents reported which is the maximum number of accidents occurred in a single year and that too within the month of May & June. Out of these 04 accidents, 02 accidents were fatal in nature.

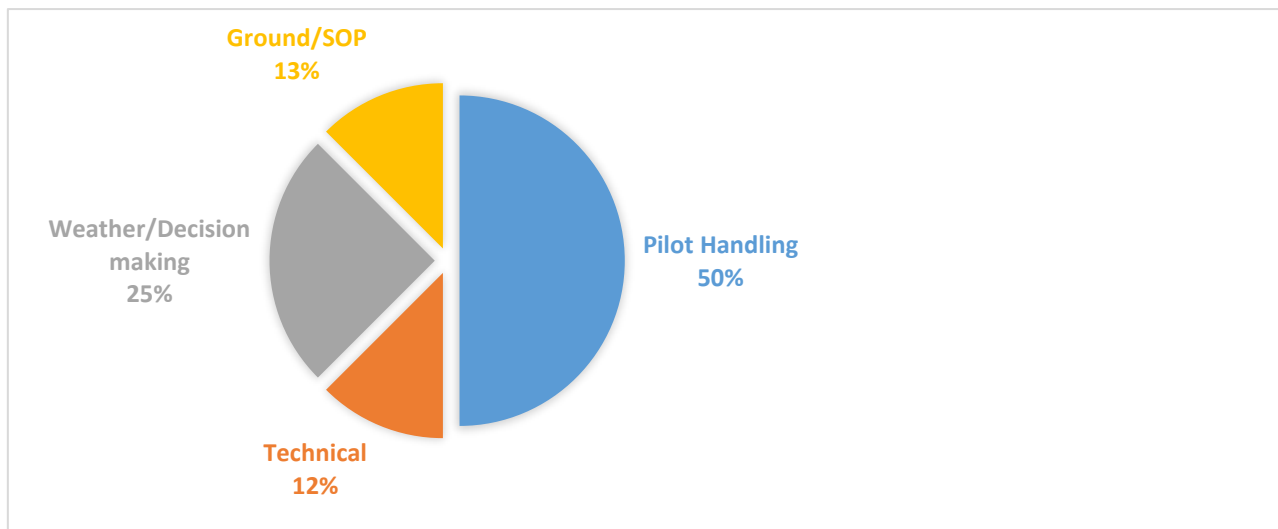
**Figure 5: Probable Cause/Contributory Factors of Char Dham accidents**

Probable cause/contributory factor(s) of these accidents were analyzed to understand the nature of these accidents. It was observed that most of these accidents occurred due to non-adherence to SOP associated with handling of the helicopter by the crew and their decision making during adverse conditions such as weather/high altitude operations. (Refer Figure 5).

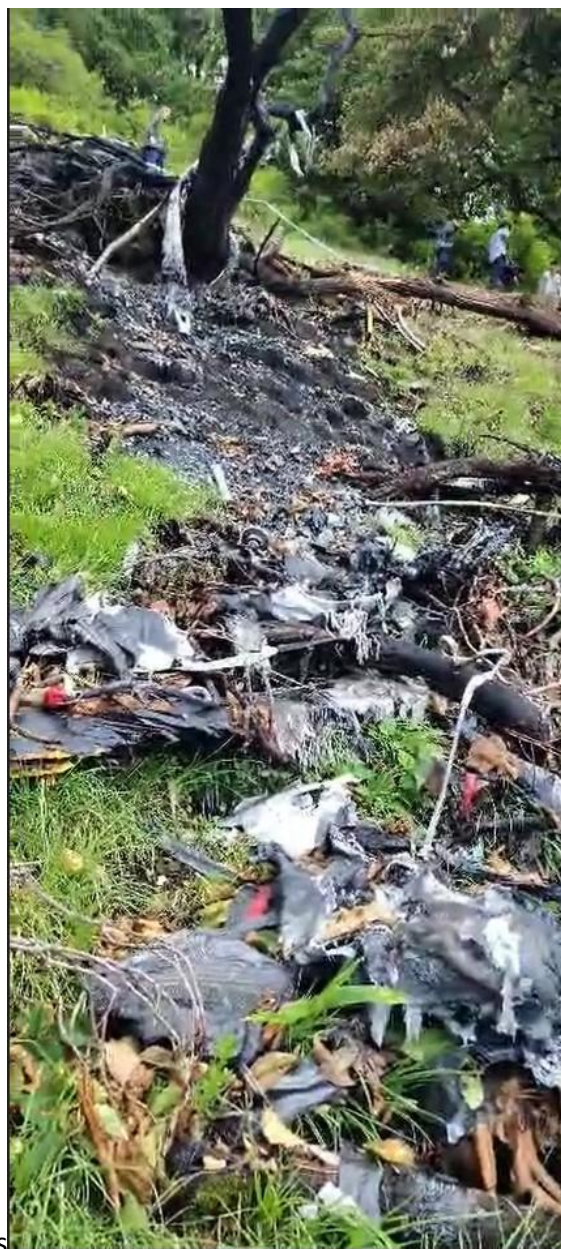
The helicopter was engulfed in fire after the accident. The accident site was at top of a hill at the middle of a jungle and was not easily accessible. Owing to difficult terrain and adverse weather, by the time the local villagers and subsequently the rescue team reached the site, the wreckage got burnt significantly before the fire could be extinguished.

Figure 6 Wreckage completely burnt

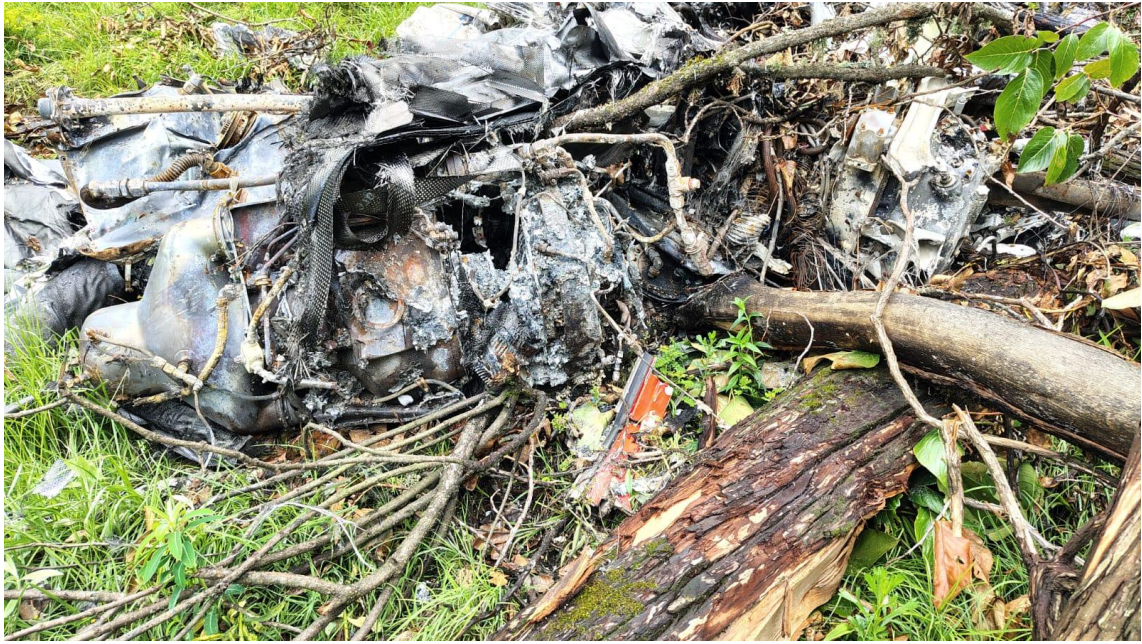
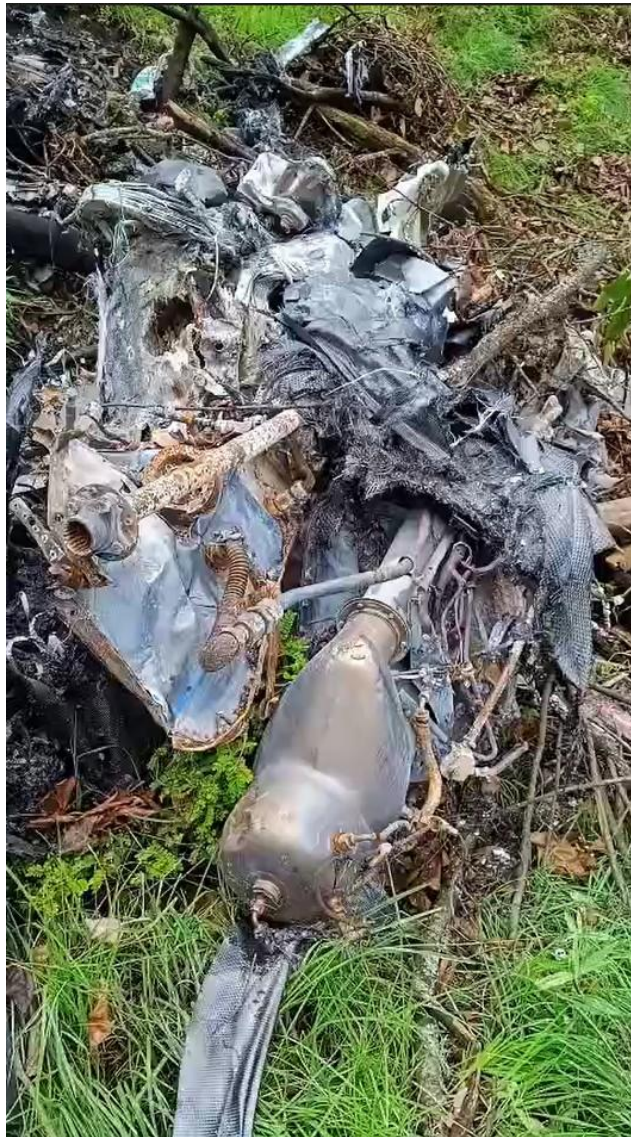
**Figure 7: Burnt Engine**

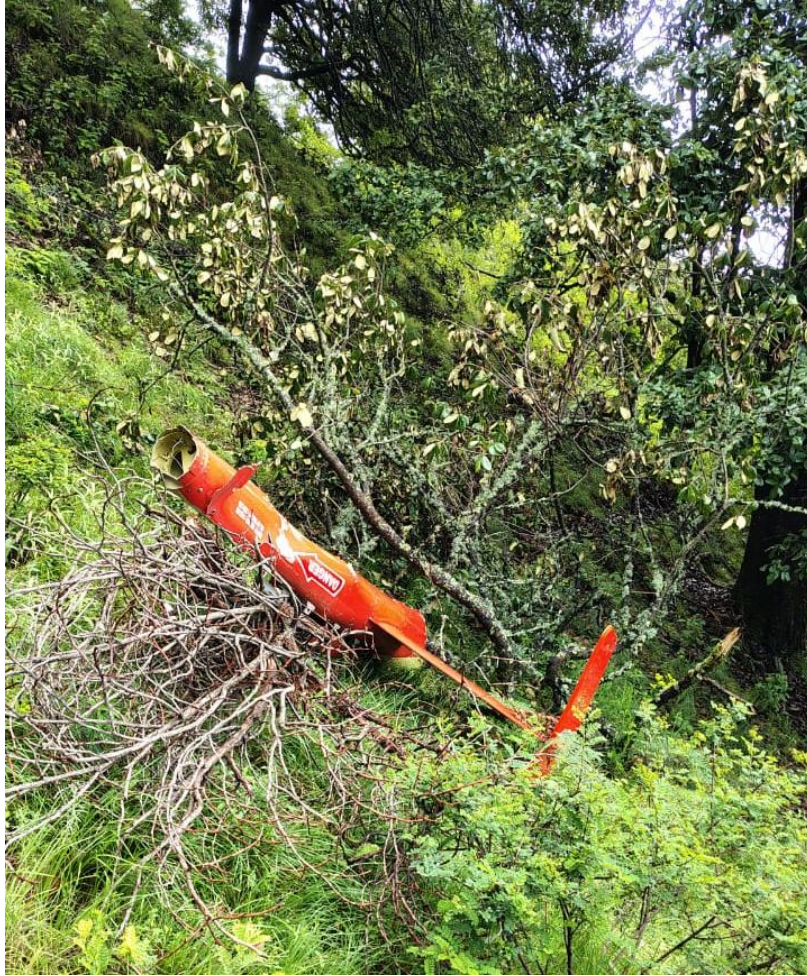
**Figure 8: Separated Tail Boom**
