**Final Investigation Report on accident involving Cessna 172S aircraft  
VT-CHP belonging to M/s Chimes Aviation Academy at Guna airport,  
Madhya Pradesh on 06 March 2024.**

**Aircraft Accident Investigation Bureau  
Ministry of Civil Aviation  
Government of India**

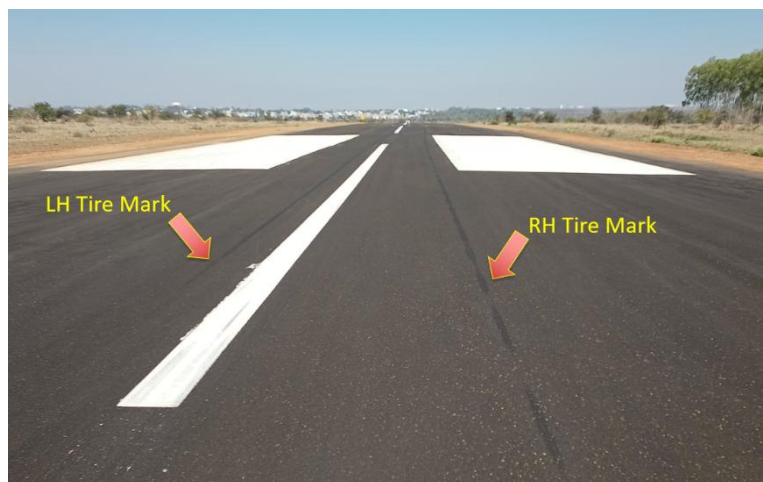
**Figure 3. Tire Marks (Start)**

Post accident, measurements of tire marks revealed following about the aircraft landing. Aircraft flared for approximately 2028 ft before touching down slightly right of the centerline. Subsequently, heavy brakes were applied for approximately 08 seconds as tire marks were prominently visible on the runway and this braking action assisted in deacceleration of aircraft speed up to 32 knots within 556 feet of runway (Refer Fig: 6). The tire marks further changed course to the left and continued onto the runway slope before they again changed their course to right near runway marking 14 (see Figures 3 and 4).

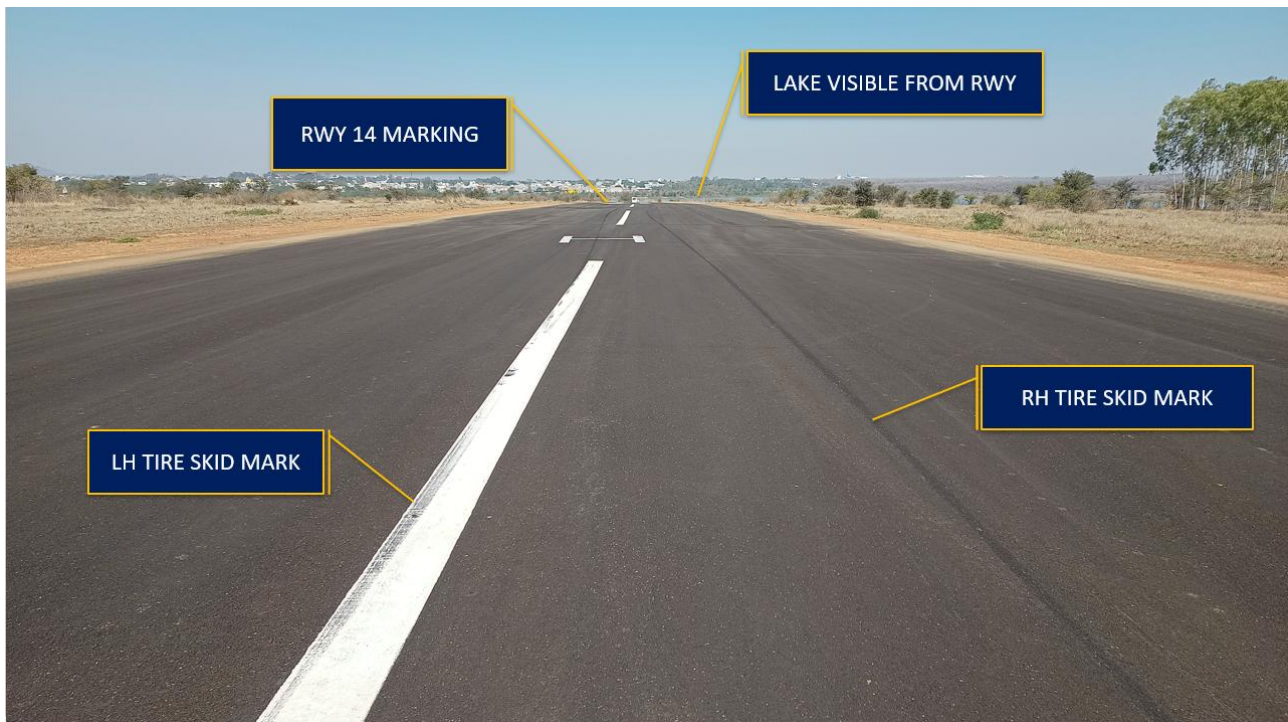
**Figure 4. Tire Skid Marks**

Main landing gear tire marks on the runway indicated that the aircraft was skidding while decelerating and appeared not to be under the full control of the student pilot. Since the aircraft did not respond as per the inputs, Student pilot anticipated aircraft would not stop on available runway and finally decided for mislanding/go around. To initiate the go around, brakes were released and throttle was moved to full power position while the flap lever position was kept same i.e., 10° setting.

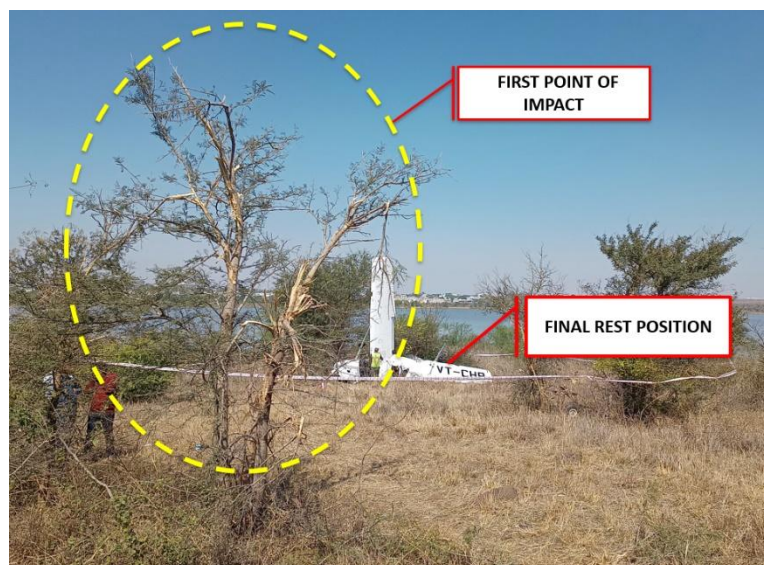
**Figure 5. First point of impact and Final Position**

Despite an increase in acceleration, the aircraft failed to achieve takeoff speed before it reached at the end of the runway. Further, no tire marks were observed on ground which was full of grass and gravel indicating that aircraft wings started generating lift and full weight did not act on ground at that point of time. Thereafter, the aircraft exited the level ground after travelling approximately 66 m (216 feet) beyond the runway end and struck a small tree situated on the steep slope.

The aircraft's left main landing gear along with left wing collided with this tree which was approximately 10 ft in height.

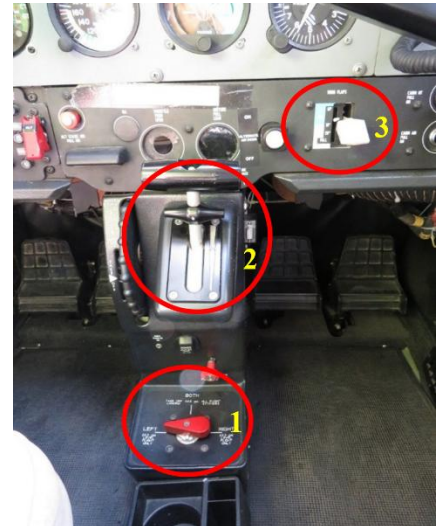
**Figure 8. Lever and Switch positions**

1. Fuel Selector valve was at Left position
2. Thrust lever was at Full Forward
3. Flap lever was at 10 degrees

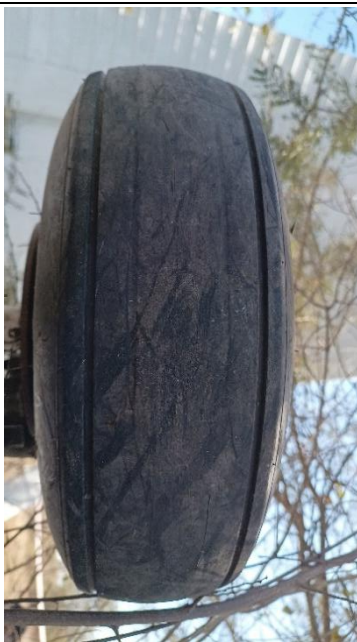
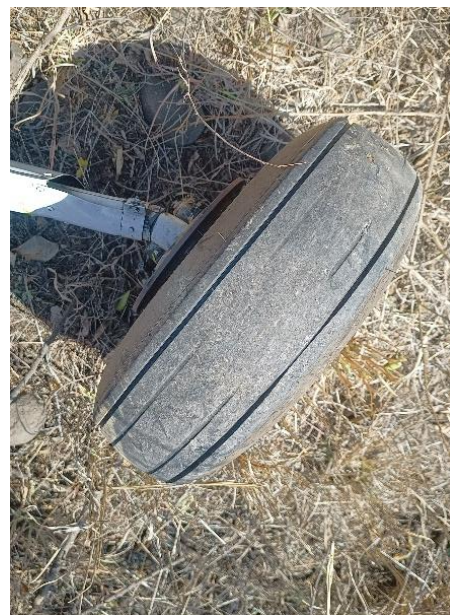
1. Pressure of both main landing tires were around 45 psi.
2. Due to impact with tree, rubbing marks were observed on the RH main Landing gear tire
3. Both main landing tires were almost “bald” as no visible grooves were present on them

However, the tire pressure of both main landing gears was around 45 psi, higher than the OEM prescribed pressure i.e 42 psi. Further, both tires were worn out beyond the permissible tread depth, which is very critical for traction. Since tyre pressure and grooves have direct relation with the aircraft traction therefore fitment of non-standard tires contributed in less effective braking action required at critical juncture.

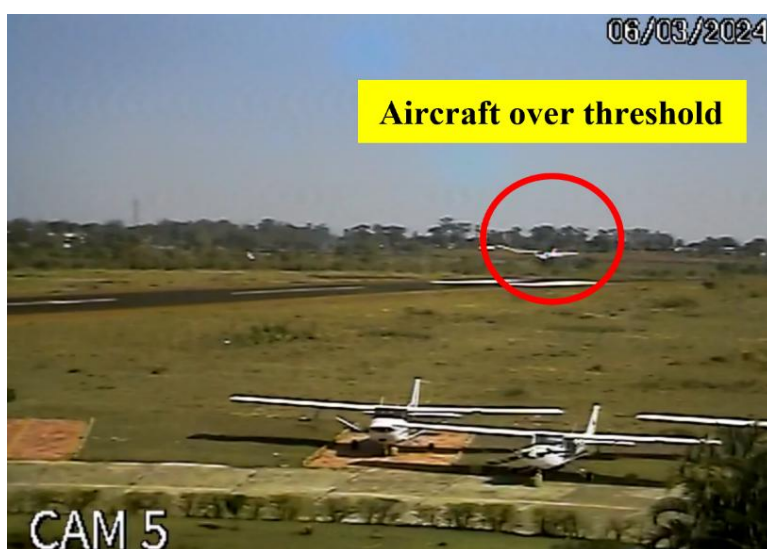
**Figure 17. Aircraft above threshold of runway 32**

Camera No. 5- This camera captures the final approach and threshold area of runway 32. Recording of the camera established that aircraft flew parallelly at a height of approximately 6 feet above the threshold area.

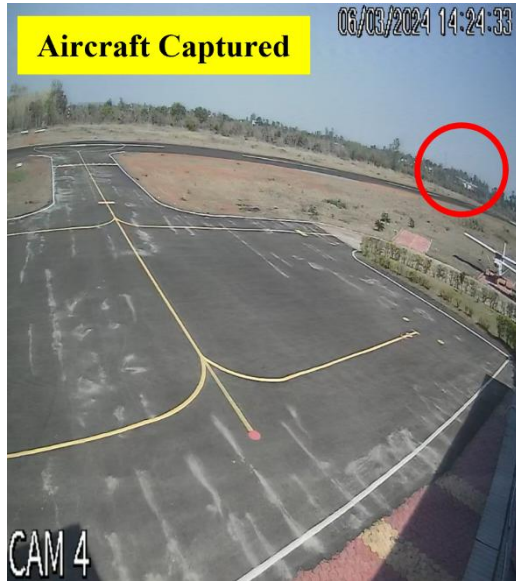
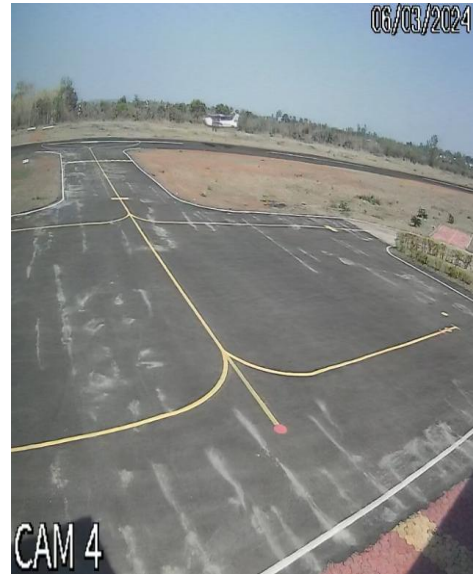
Camera No.4- It showed that aircraft was continuously floating over the runway and maintaining the same attitude and height until aircraft reached over the middle of the runway (Infront of taxiway).

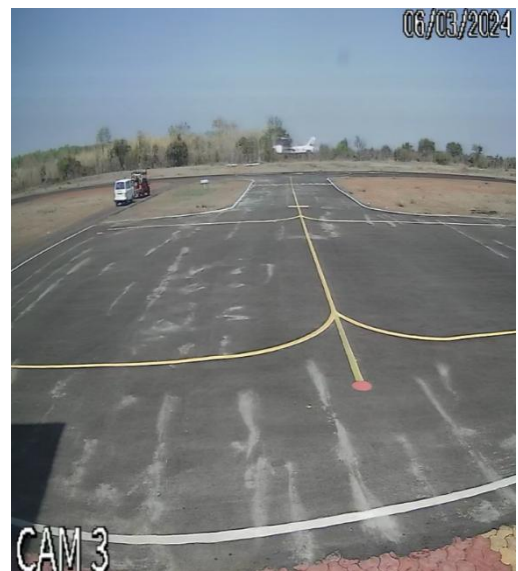
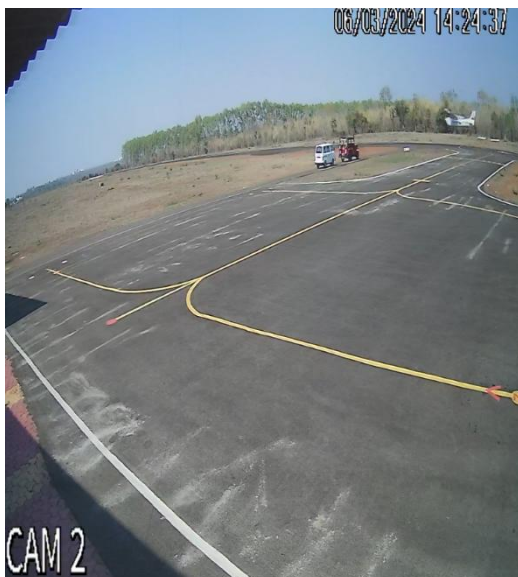
Camera No. 3- As it was facing straight towards the runway, it captured the middle section of the runway. The frame of this camera confirmed that aircraft neither lost height nor speed while floating and subsequently crossed the middle of the runway at approximately 6 feet above. Additionally, video from this camera also showed that aircraft started losing height after leaving the middle of the runway.

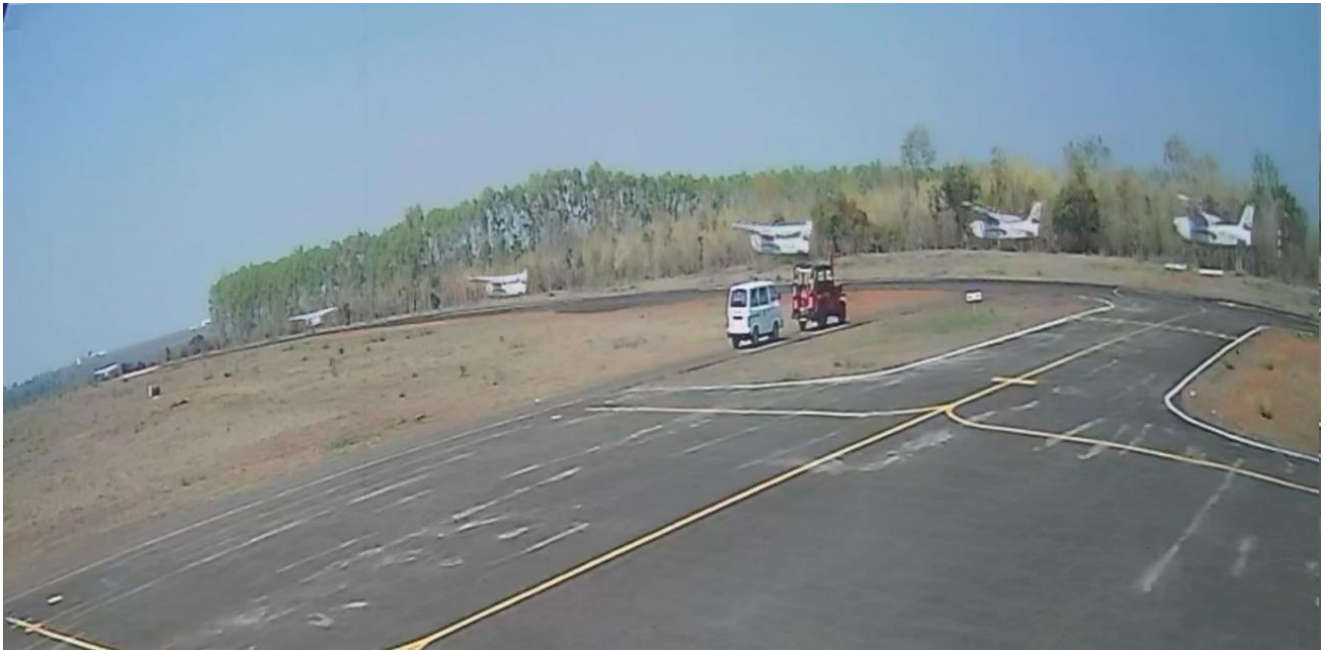
**Figure 22. Aircraft profile on downward slope**

This camera captured end of the runway and showed that aircraft started losing height, and finally landed when approximately one fourth of the runway was remaining. Aircraft appeared continuously rolling until it reached end of runway 14. Further, this camera captured the aircraft rolling until aircraft suddenly disappeared when it went below the ground level.

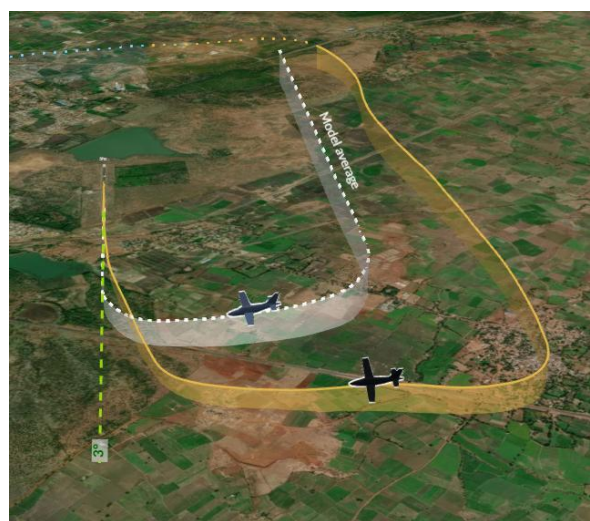
**Figure 23. Comparison of actual flight**

The normal circuit to be carried out by Cessna 172 aircraft for landing at Guna airfield was compared with the accident flight circuit. Through this comparison it can be clearly established that though the downwind leg was extended by the Student pilot, the final leg was joined by cutting the approach. And therefore, initially aircraft could not align with the final approach path. Further, as the aircraft was high on final approach, it missed the 3° glide slope. Aircraft neither followed the standard 3° glide slope nor it aligned to runway on final approach. According to the Student Pilot, to avoid high tension cables in approach path, aircraft was intentionally kept high on approach. Consequently, this resulted into higher rate of descent on final approach. Since the aircraft was neither vertically nor laterally aligned during the initial phase of final leg, this situation could have pushed the trainee towards tunnel vision effect, where his main focus was confined to two tasks. First was to bring the aircraft on correct glide slope and second was to align the aircraft with runway centerline. And due to this effect, there was a high possibility that trainee might have ignored other critical parameters.

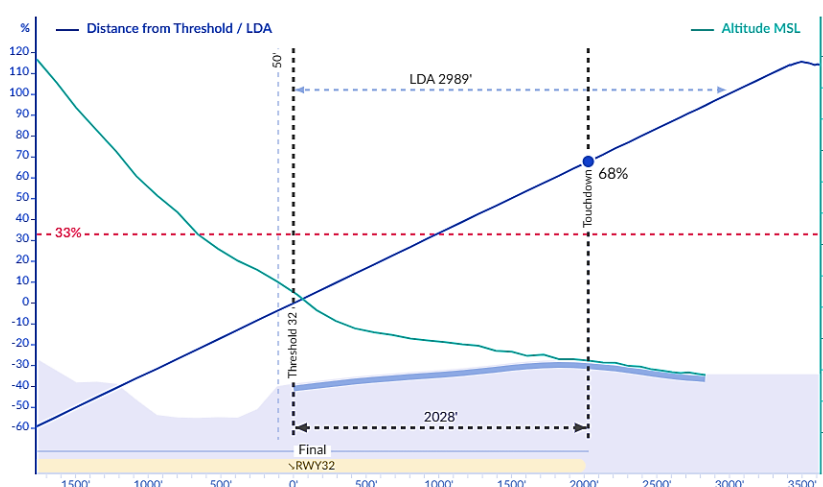
**Figure 24. Runway consumed before touchdown**

Additionally, the standard procedure defined regarding go around/miss landing was not followed by the trainee even though 1000 feet marker was missed due to long flaring of the aircraft and touch down could not be achieved till two third of the runway was consumed. In this case, aircraft had consumed about 2028 feet (68% of runway's total length) before it touchdown on the paved surface.

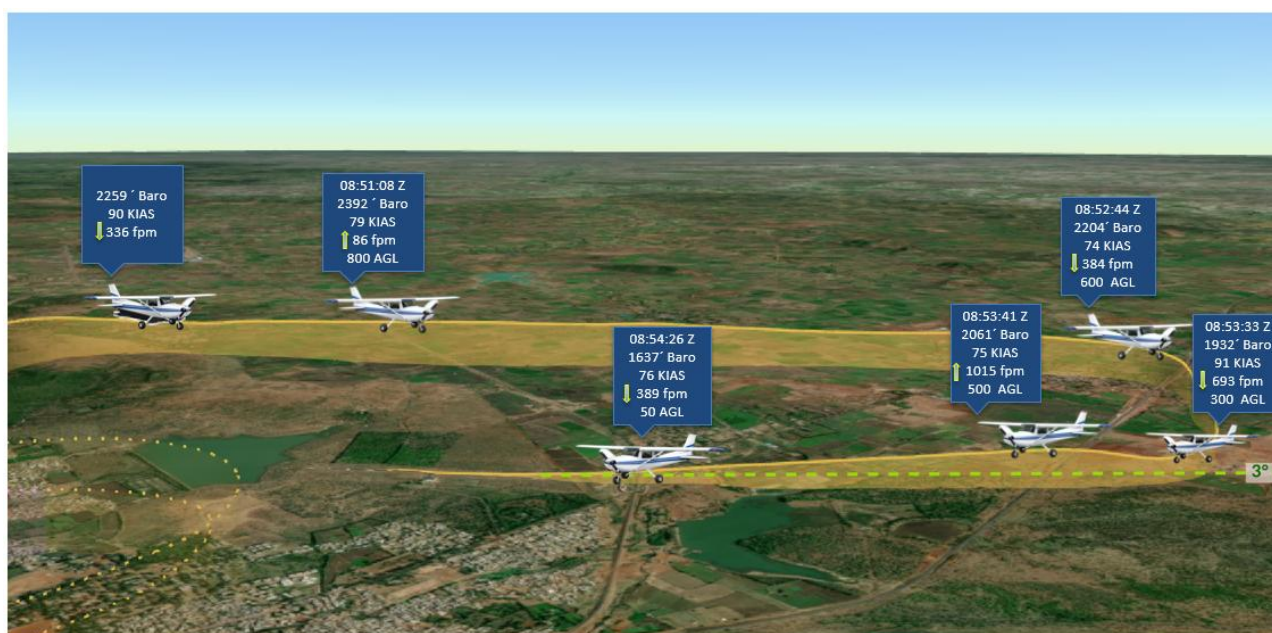
**Figure 25. Aircraft parameters at different positions**

Based on the Garmin and ECU data, performance and aircraft handling skills of student pilot was analysed and can be characterized as an unstabilized approach, poor energy management, and delayed decision-making during the go-around.
