**FINAL INVESTIGATION REPORT ON  
ACCIDENT INVOLVING M/S VSR VENTURES PVT. LTD.  
LEARJET 45XR AIRCRAFT VT-DBL AT MUMBAI ON 14 SEPTEMBER 2023**

**AIRCRAFT ACCIDENT INVESTIGATION BUREAU  
MINISTRY OF CIVIL AVIATION  
GOVERNMENT OF INDIA**

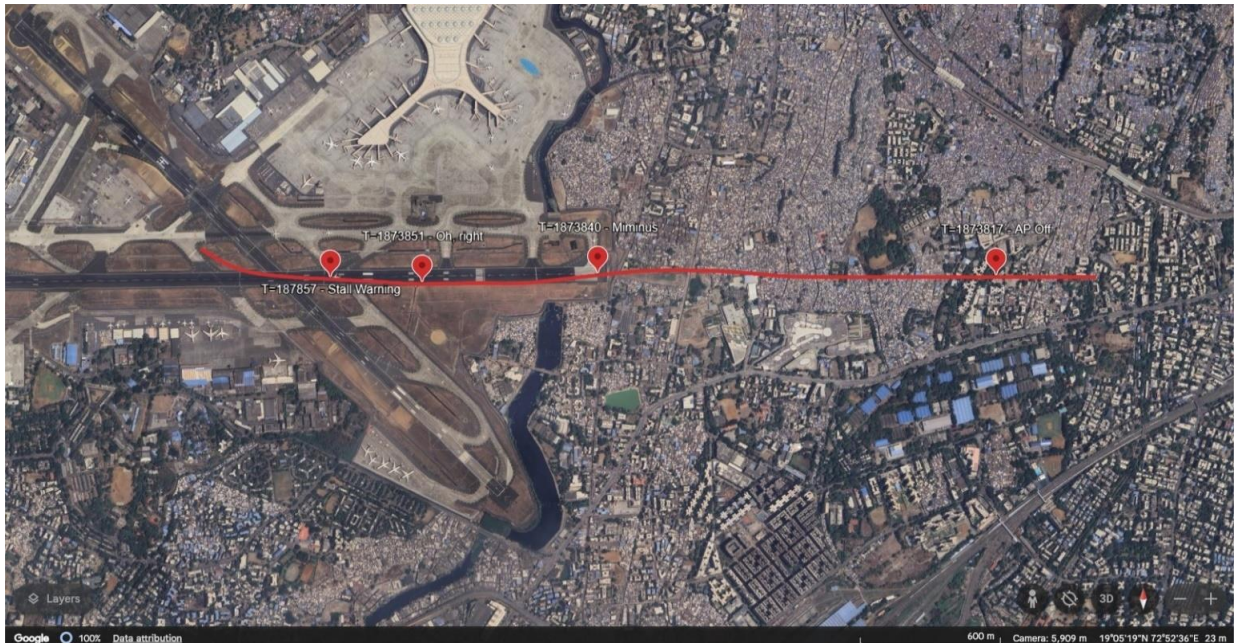
The latitude and longitude recorded by the FDR was not precise enough to describe the aircraft path with the required precision. The aircraft path was estimated using the FDR-recorded ground speed, magnetic heading, and the aircraft impact point.

**Figure 1: Aircraft Horizontal Path (1- A/P disconnect, 2- sound of MINIMUMS aural, 3 – FO calling out Right Right Right, 4 – Stall Warning)**

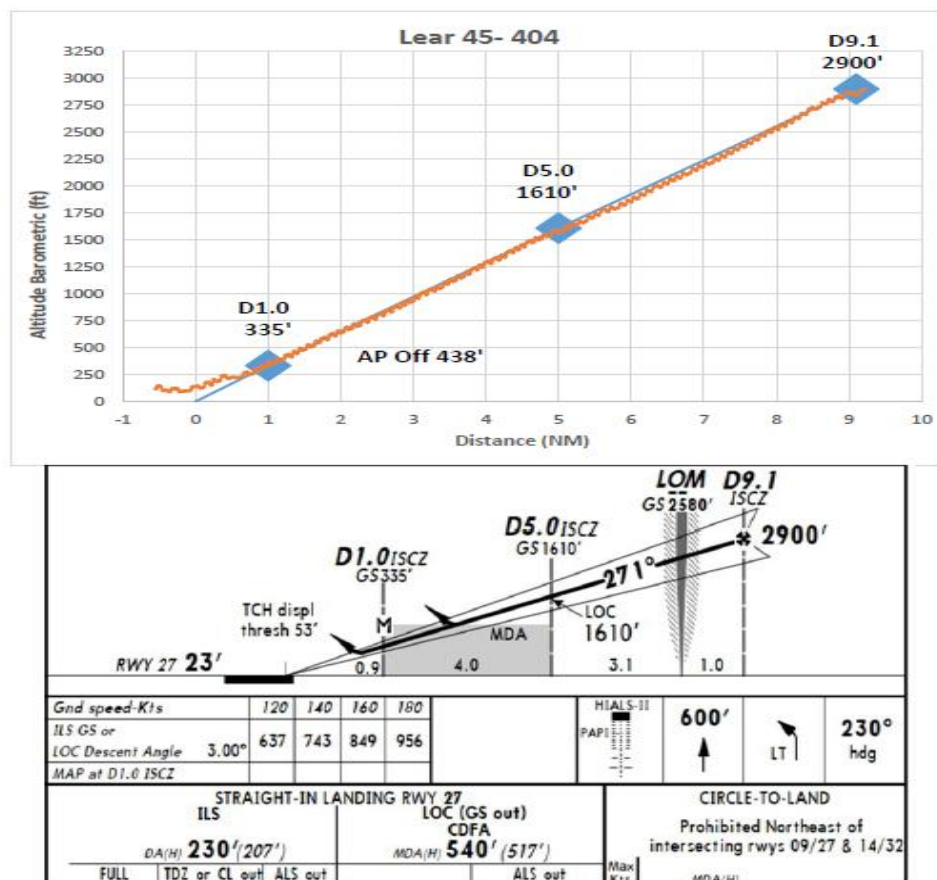
The aircraft vertical path was also estimated using the FDR recorded altitude, GS deviation, and the runway 27 ILS approach features. Figure 2 shows the estimated aircraft vertical path, along with an extract of the runway 27 ILS approach chart for reference.

**Figure 2: Aircraft vertical path (Reference Jeppesen chart)**

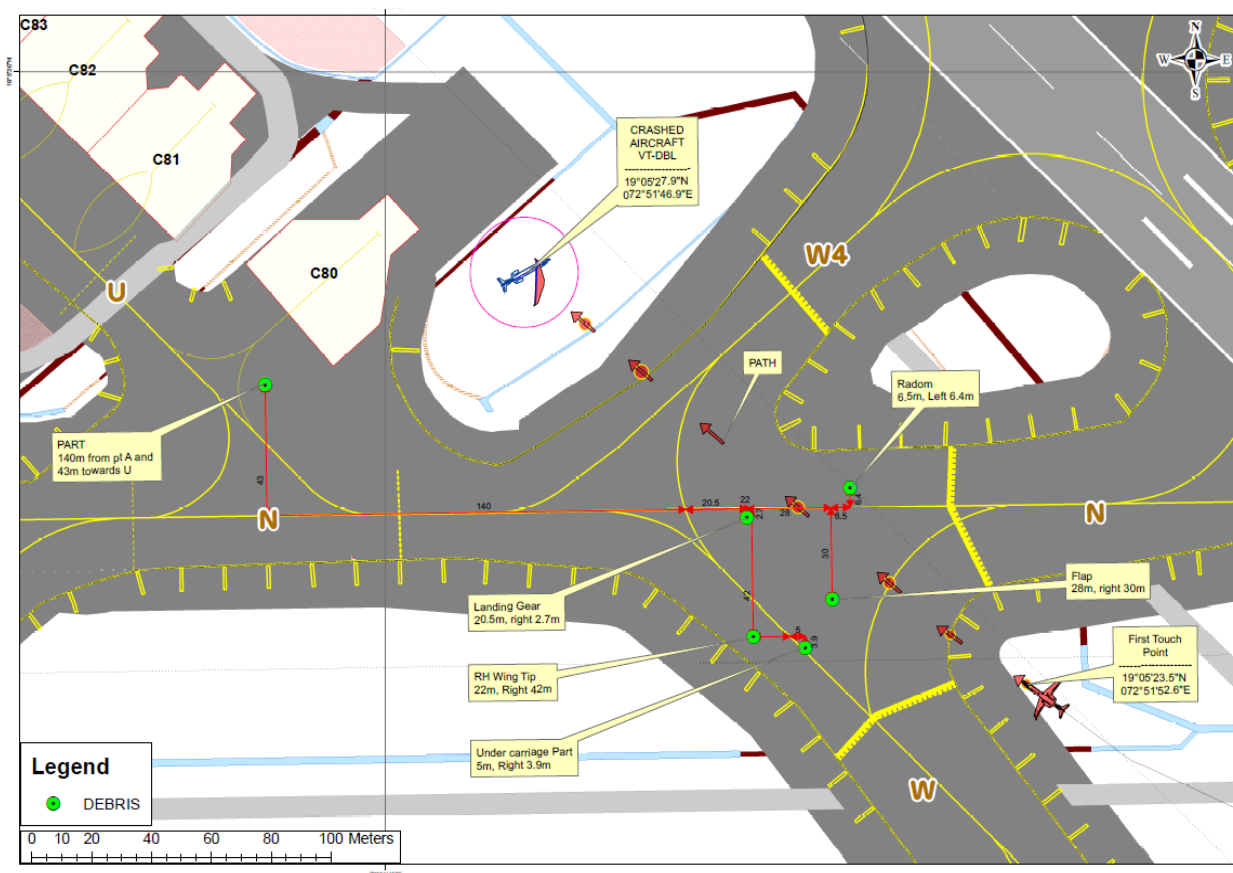
During the approach the aircraft kept on deviating towards right of runway 27. The roll angle reached upto  $53^\circ$  (right wing down) before impacting the ground at a speed of about 96 Knots. The right wing first impacted the ground followed by the fuselage. The first point of impact with ground was on an unpaved area near the intersection of Taxiway W and Taxiway N, causing the fuselage to fracture into two segments. The aircraft then skidded on the paved surface crossing taxiway N and ultimately coming to a final halt on an unpaved area close to the intersection of Taxiway U and Taxiway N, near stand C80. Broken parts of the aircraft were scattered along its skid path between first point of impact and the final resting position. The first point of impact and the wreckage scatter can be seen in figure 3 below.

Figure 3: Point of First Impact and wreckage distribution.

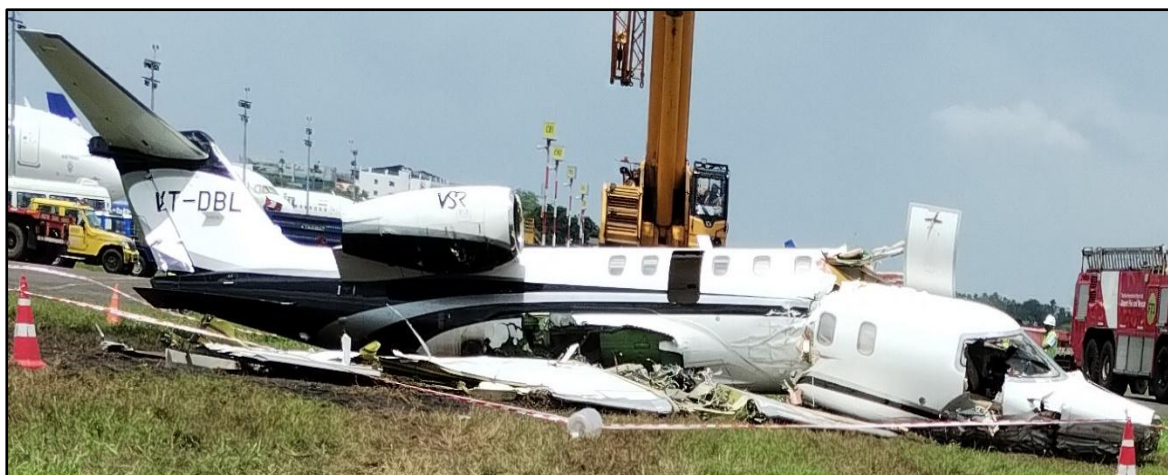
*Figure 4: Final resting position of Aircraft*

- Nose section of the aircraft sustained impact damages.
- Both the wings got separated from the fuselage structure but found beside the main wreckage area.
- The forward section of the fuselage was found fractured and separated from the central fuselage section.
- Both the nose landing gear (NLG) and main landing gear (MLG) were found broken.
- The empennage and both engines remained attached to the fuselage.
- There were scorch marks beneath the right-hand side engine.

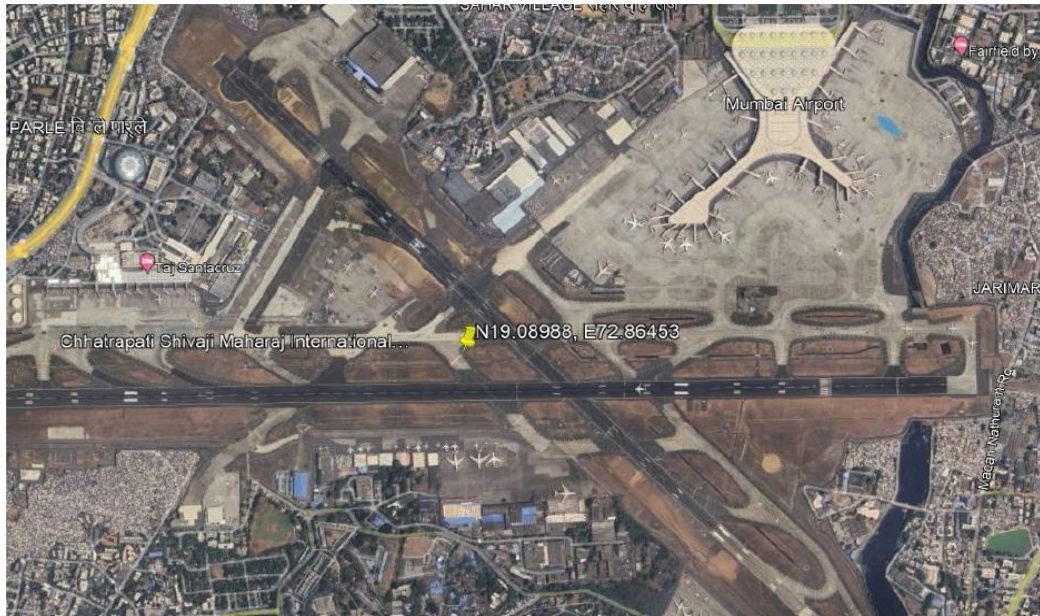
The EGPWS records 20 seconds of data prior to each caution or warning alert and 10 seconds of data after the alert. During the accident flight leg, a warning was recorded while the aircraft was at VABB Airport. The warning was a Mode 1 "Pull Up" alert, which occurs when an aircraft experiences an excessive descent rate close to terrain. The associated voice alert was "Sink Rate, Pull Up." The location where the Mode 1 "Pull Up" alert occurred, at a radio altitude of 116.8 feet, is shown below.

**Figure 5: Mode 1 Pull Up Alert**

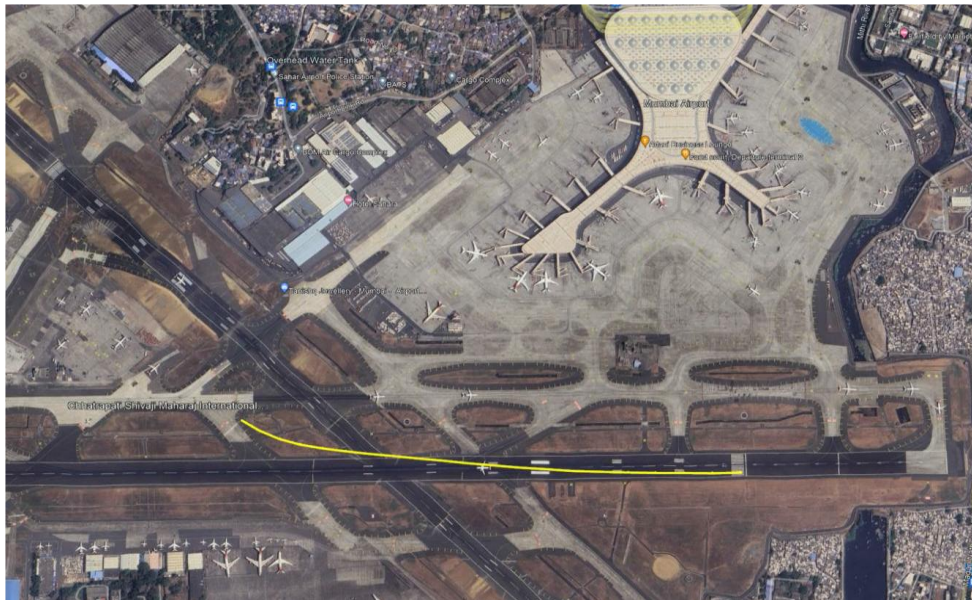
The recorded flight path from the 20 seconds of data prior to the Mode 1 alert shows the aircraft beginning to veer to the right approximately 6 seconds before the alert. The aircraft rolled from 2.1 degrees to 49.2 degrees and pitched from 9 degrees nose-up to 17 degrees nose-down. Subsequently, the Mode 1 alert was recorded. No data was recorded after this alert. The recorded flight path is shown below.

**Figure 6: Recorded Flight path for 20 Seconds Prior to Mode 1 Alert**

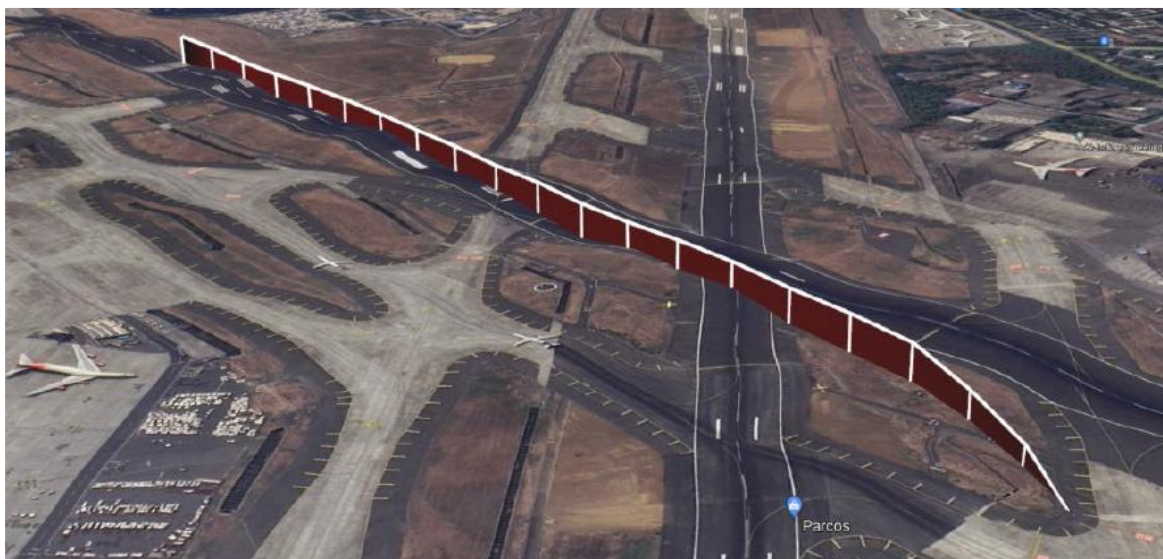
Further, the recorded elevation information from the 20 seconds of data prior to the Mode 1 alert is shown in the image below. It indicates that the aircraft crossed the runway threshold at an unusually higher height (approximately 137 feet above ground level). Based on the difference between computed airspeed and groundspeed, an estimated tailwind of 8–10 knots were present. The aircraft then pitched up and decelerated to approximately 100 knots

calibrated airspeed (CAS) before deviating beyond the right edge of the runway. Approximately 2 seconds before the Mode 1 alert, the aircraft entered a steeper descent.

*Figure 7: Aircraft Elevation Information as per EGPWS data.*

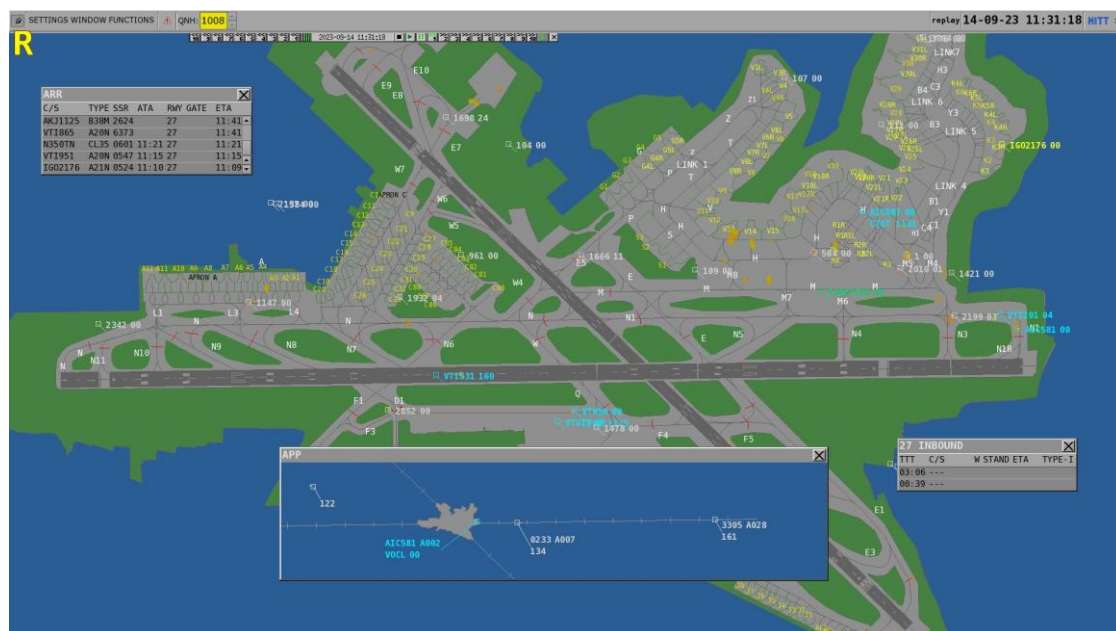
Corroboration of the A-SMGCS recording and DFDR data received from the HEAVY departure operating flight VT1531 rotated near Holding Point N6 at a ground speed of 160 kt. The rotation point of VT1531 is indicated as follows:

Figure 9: Rotating point of VT1531

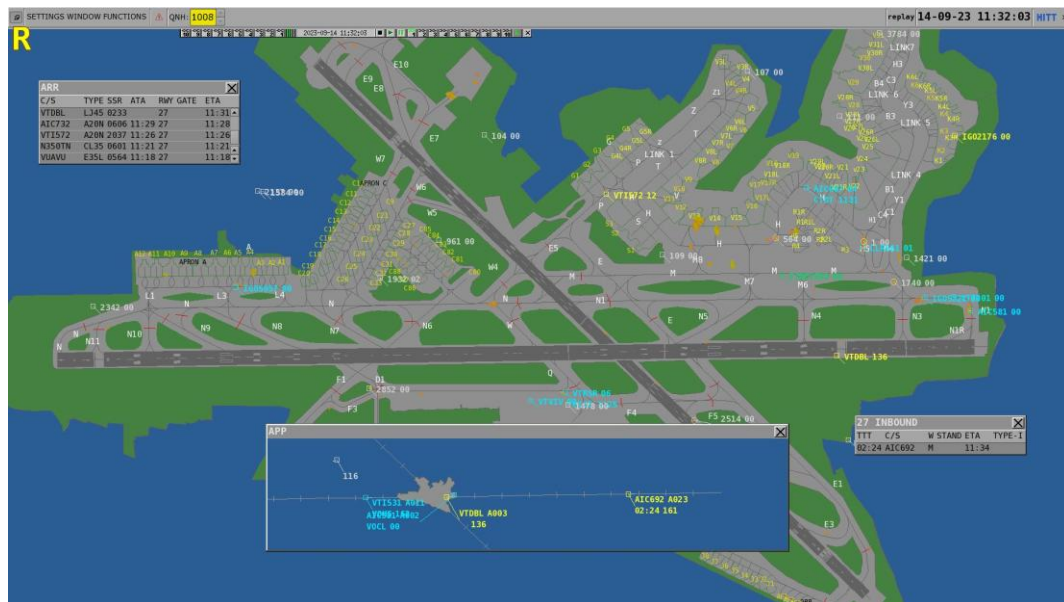
The MEDIUM category Learjet crossed the displaced runway threshold 45 seconds after the VT1531 became airborne. The threshold crossing time of VT-DBL is indicated as follows:

Figure 10: Threshold crossing time of VT-DBL

In the present case, heavy aircraft B777 operating flight VTI531 departed prior to the arrival of the aircraft VT-DBL and as per the ASMGCS recordings, the medium aircraft VT-DBL crossed the displaced threshold approximately 45 seconds after the heavy aircraft VTI531 became airborne. The ATC controller evaluated that the separation between the two aircraft was sufficient and the arriving aircraft VT-DBL will not cross the wake left by the preceding heavy aircraft at the point of its lift-off. However, the controller did not account for the prevailing weather conditions wherein there was a possibility for a go-around or a delayed landing in which case the aircraft VT-DBL could have entered into the wake zone created by the preceding heavy aircraft. Hence, it was probable that the required procedural separation was not maintained in accordance with the MATS 1 procedure.

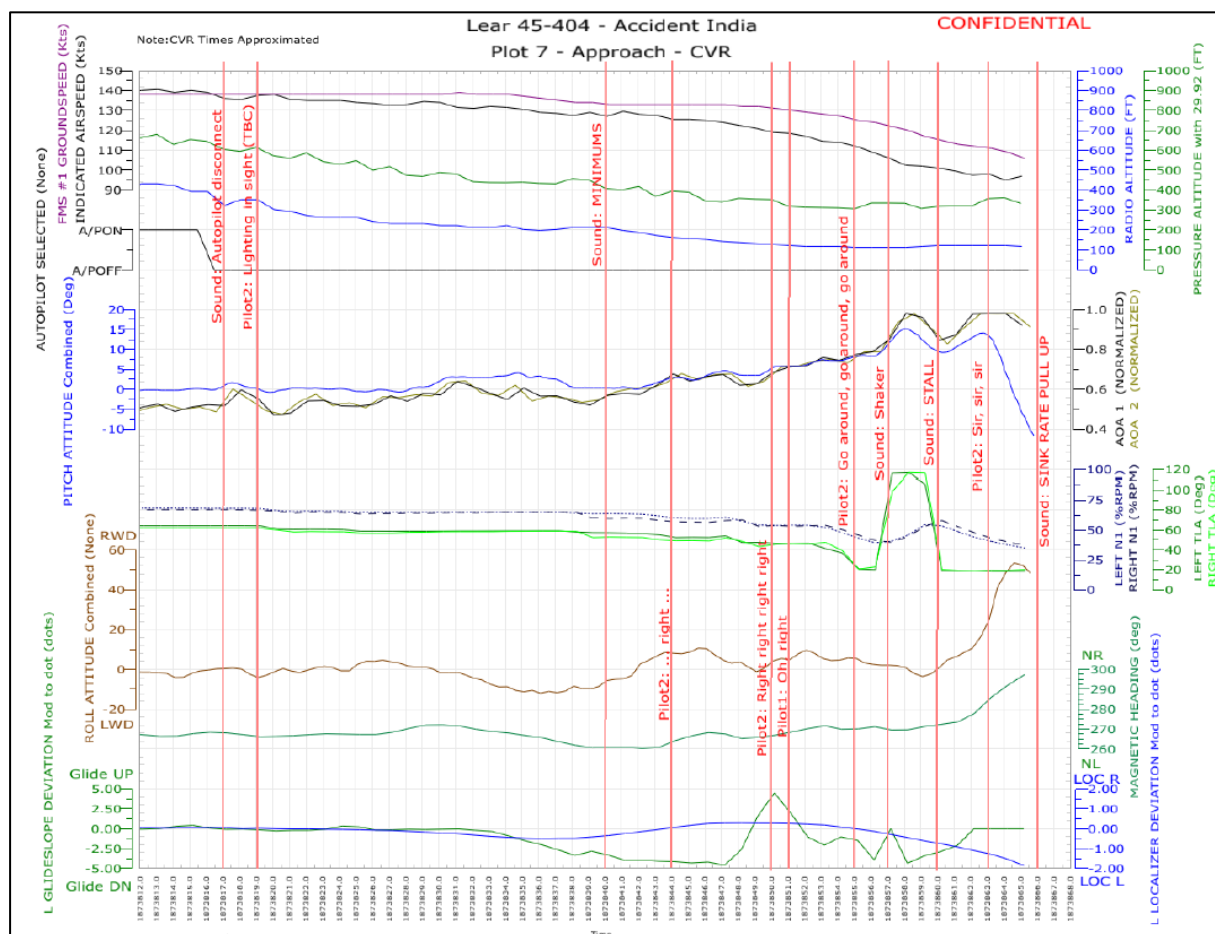
data showed tail wind component of about 8 to 10 knots which again adversely affected the approach. The co-pilot kept calling out “right right” and the PIC was following the callouts given by the co-pilot and was trying to align the aircraft with runway centreline. The aircraft thereafter started moving towards the right and when the aircraft was at 122 feet AGL, the airspeed got reduced to 118 knots i.e. below the Vref speed of 119 knots. The pitch angle was 6 degrees and normalised AoA was about 80%. As the airspeed was decaying throughout this process which eventually got reduced below Vref, no call outs for speeds were made by the PM. Thereafter, on realising that the aircraft is deviating further to the right of the runway centreline, the PM calls out for a Go Around. At this point the aircraft was at 122 feet AGL, both TLA was reduced to 21 degrees (approximately idle power), with pitch increased to 8° nose up and normalised AoA increased to 80% and speed got reduced to 111 knots.

‘Within 02 seconds, when the aircraft was at 112 feet AGL, the speed further reduced to 105 knots, and the PF in order to initiate a Go around increased the power as both TLA’s were advanced to 116 degrees (Approximately full power). However, simultaneous to this input by the PIC, stick shaker got activated. The pitch was then increased to 12 degrees (Nose up) and normalised AoA was increased to approximately 90%.

Figure 11: FDR plot depicting the approach phase with CVR synchronization.
