While aircraft was climbing, the crew observed roughness in the left engine, and subsequently loss in power accompanied by a change in engine sound. Thereafter, the crew followed the asymmetric handling procedures and tried to maintain the aircraft's heading.

While the aircraft was still in its climb phase, crew again felt roughness followed by a loss of power in the second engine. This time starboard engine showed symptoms of power loss. Thereafter, aircraft speed dropped and crew could not maintain the desired climb. Subsequently, crew had decided to perform the forced landing and eventually managed to land the aircraft within the airport premises. However, during forced landing aircraft suffered substantial damage.

The occurrence was classified as an "Accident" in accordance with the Aircraft (Investigation of Accidents and Incidents) Rules, 2017. DG, AAIB ordered an investigation into the occurrence vide order no INV: 11011/7/2022-AAIB, dated 17th May 2022 to investigate the cause(s) of the Accident.

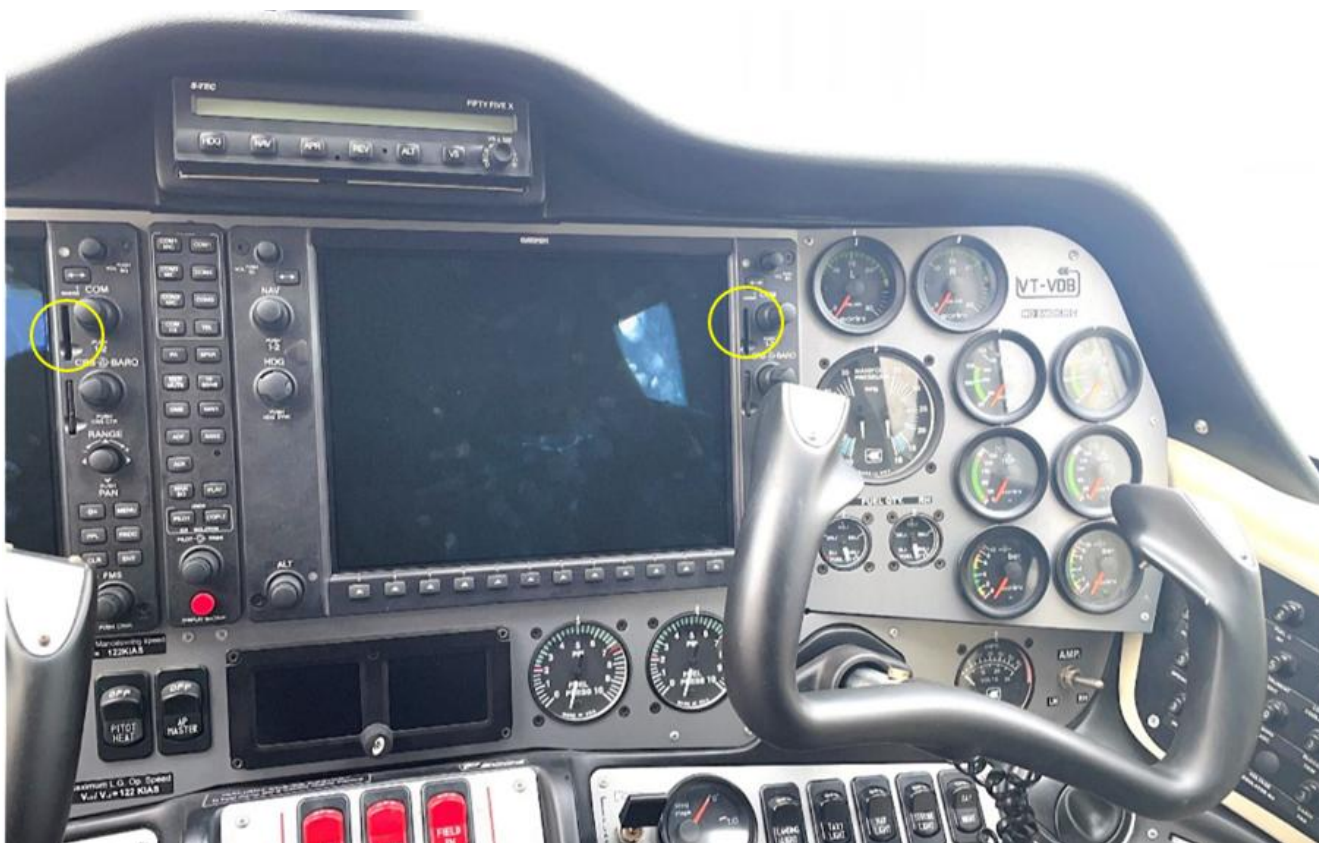
Fig 7: Aircraft’s cockpit photo post-accident (Two upper SD card slots without memory cards)

The aircraft is equipped with Garmin 950 system. On Garmin 950 system, two SD card slots are provided on each display unit for capturing aircraft parameters. The location of these slots is depicted in Figure 7.

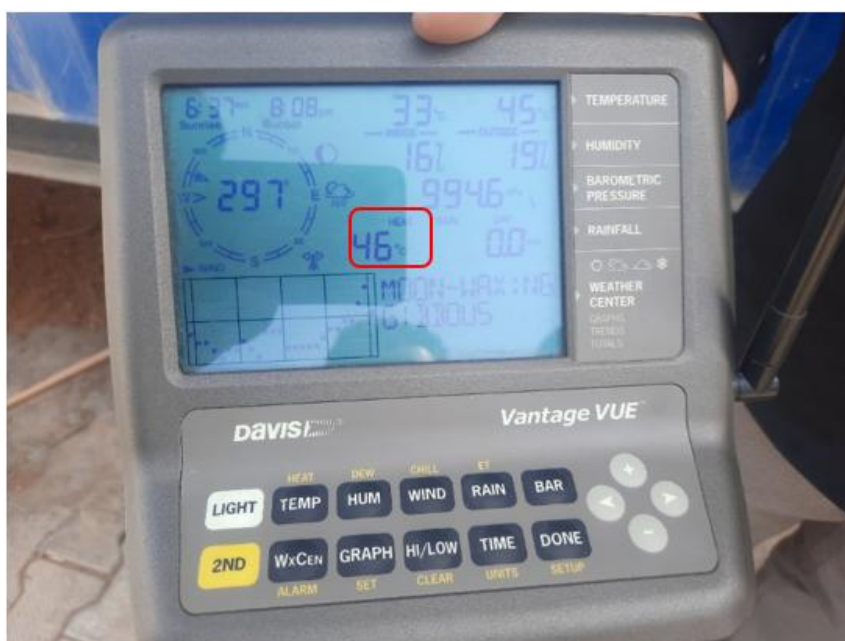
Fig 8: Ambient Temperature recorded by the Device

The weather information (METAR) recorded at Bhiwani Airport on 12 May 2022 at 0900 UTC was: wind 320 degrees 07 knot, temperature 44 °C, dew point 06 °C, QNH 995 HPa, visibility 5000m and NOSIG (no significant change). However, the ambient temperature at Bhiwani airfield was recorded 46 °C when measured on the Davis Vantage device immediately after the accident. Readings displayed on the device are shown in Fig 8.

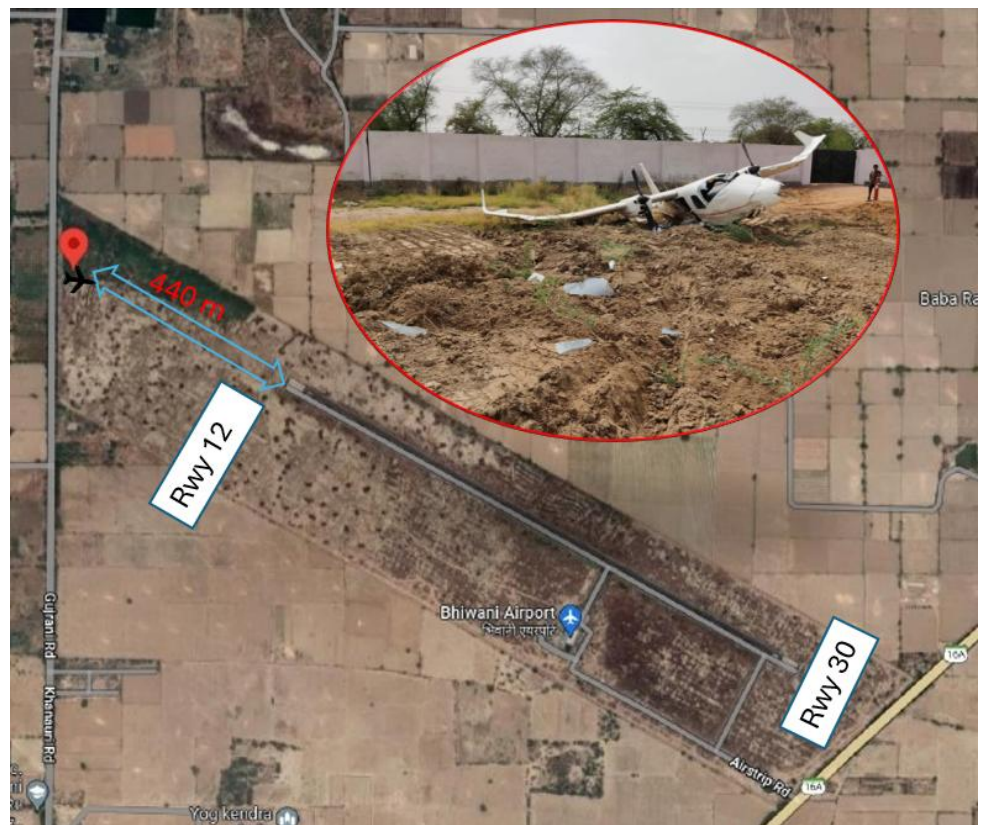
Fig 9: Aircraft wreckage final position

The aircraft wreckage was found approximately 440 meters away from the runway end and 30 meters inside the perimeter wall of the airstrip. The aircraft suffered damages beyond economical repair. Damages observed on the aircraft was found in consistence with the aircraft profile at the time of collision on ground. During forced landing, aircraft was in a right bank and nose down attitude. The nose landing gear along with right landing gear was found collapsed whereas the left landing gear was found intact. Subsequent to collision with soft ground, aircraft's left landing gear acted as a

pivot and consequently aircraft swung to 180 degrees before it settled at the final position. Since the aircraft did not accelerate after the impact, no ground marks showing forward movement was noticed at the accident site.

All major components of the aircraft were accounted for at the accident site. An examination of the wreckage revealed that both propellers were in the non-feathered position and the landing gear was extended at the time of impact.

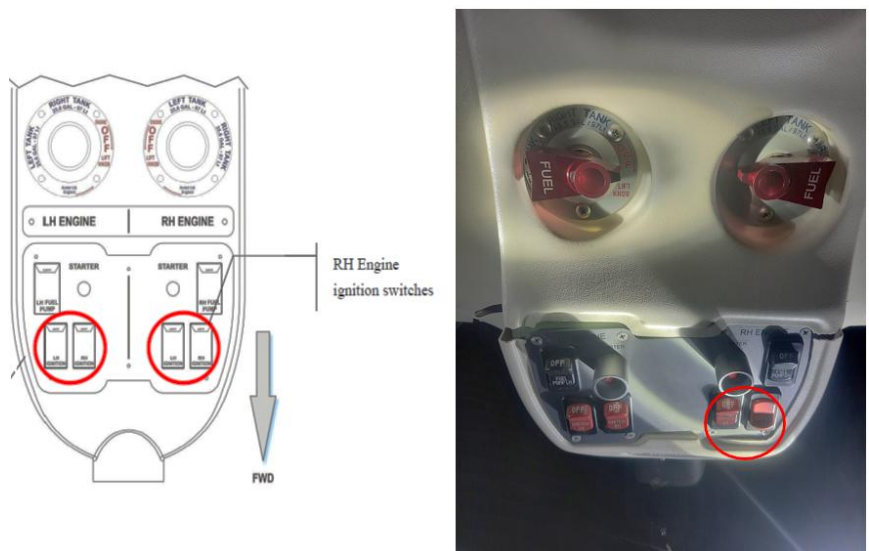
Fig 10: Positions of Switches on overhead panel

The position of different fuel switches located at overhead panel were recorded. The fuel selector knobs for both engines were at 'OFF' position. Fuel pumps of both left and right side were also at 'OFF' position. Both, left ignition switch and right ignition switch of the left engine were at 'OFF' position, however, the left ignition switch of right side was at 'OFF' position and the right ignition switch was at 'ON' position.

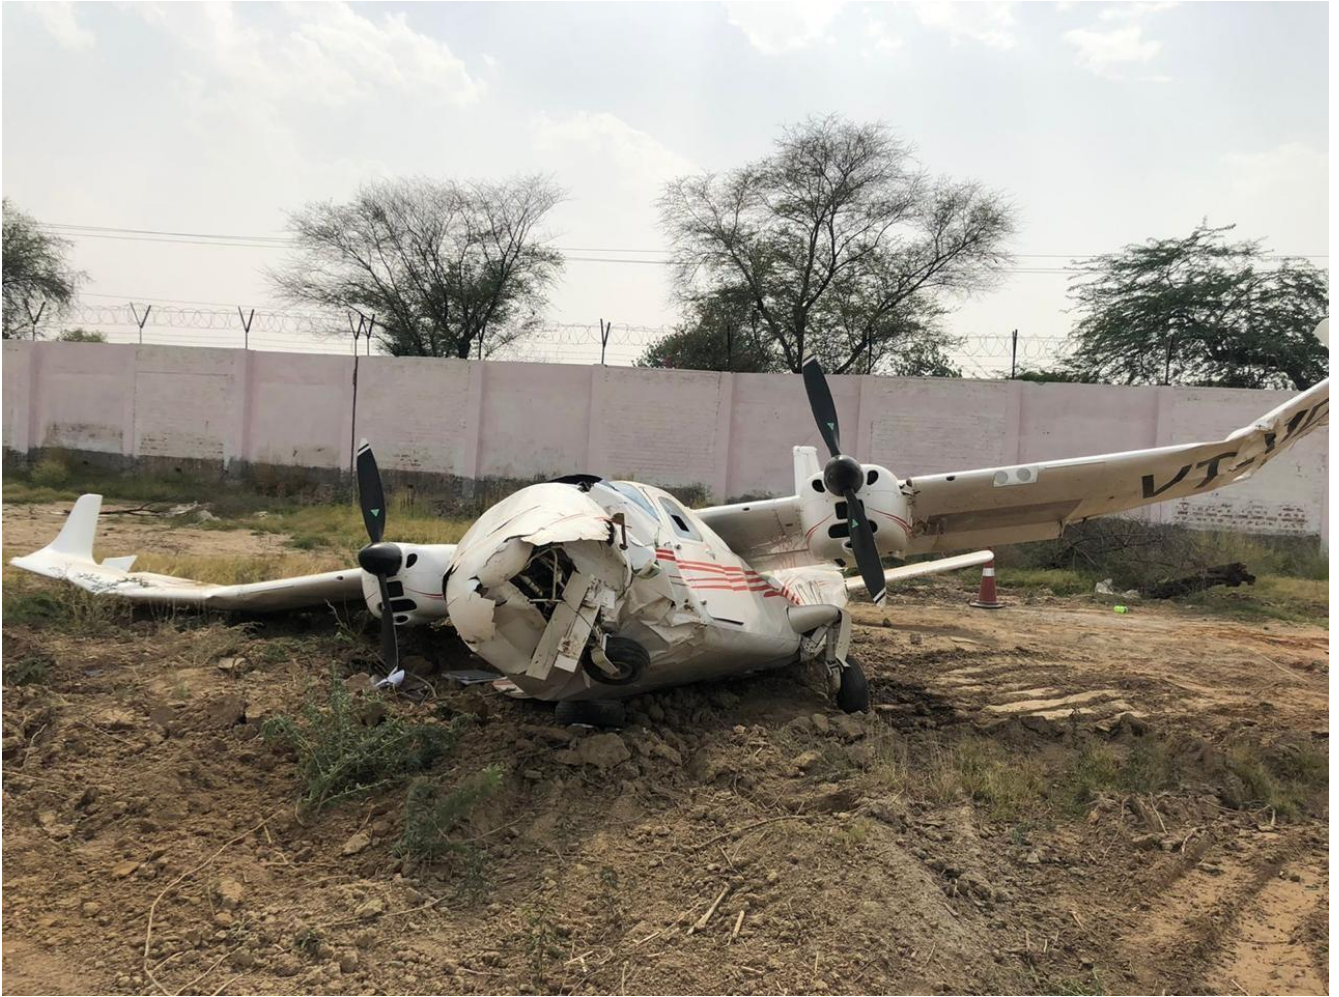
The damage observed on aircraft fuselage:

- 1) Drain pipes under fuselage (aircraft battery) broken.
- 2) Nose radome fully damaged.
- 3) LH & RH Pitot tube broken.
- 4) Multiple dents & cracks noticed in bottom skin both sides of Nose Landing Gear Wheel area.
- 5) Dent & Crack noticed on fuselage skin close to RH Pitot support tube assembly.
- 6) Outside Air Temperature probe found broken.
- 7) Heavy damage on the bottom skin and structure before of pressure bulkhead. Dent and Crack noticed on bottom fuselage.
- 8) DME, TRANSPONDER, ADF, MKR & COM 1 antenna broken.
- 9) Rear door found broken.
- 10) Wind shield fully damaged.
- 11) Instrument panel damaged.
- 12) DR Compass found displace with broken wire.
- 13) Stabilator starboard side found damaged.
- 14) Cockpit rear side fully damaged.
- 15) Damage found on vertical stabilizer.

16) Fuselage belly fully damaged

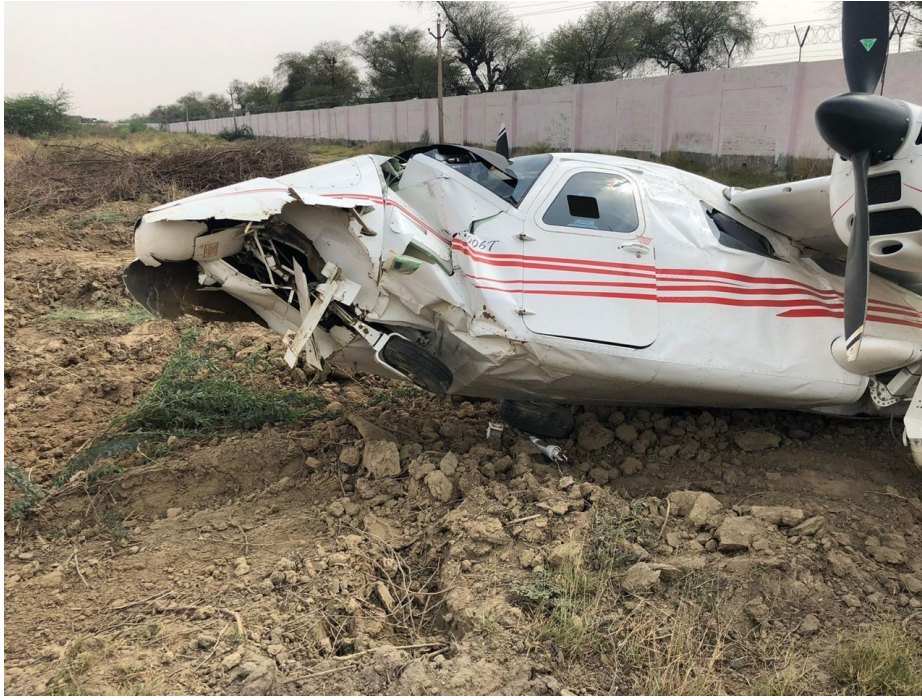
Damages observed on Engines:

A. LH ENGINE
