**Preliminary Report: Accident involving M/s Redbird Flight Training Academy Pvt. Ltd. Cessna 172 Aircraft VT-EUC near Mangalur Village, Vijayapura District, Karnataka on 08.02.2026**

## 1. General Information

## 6. Brief description of accident

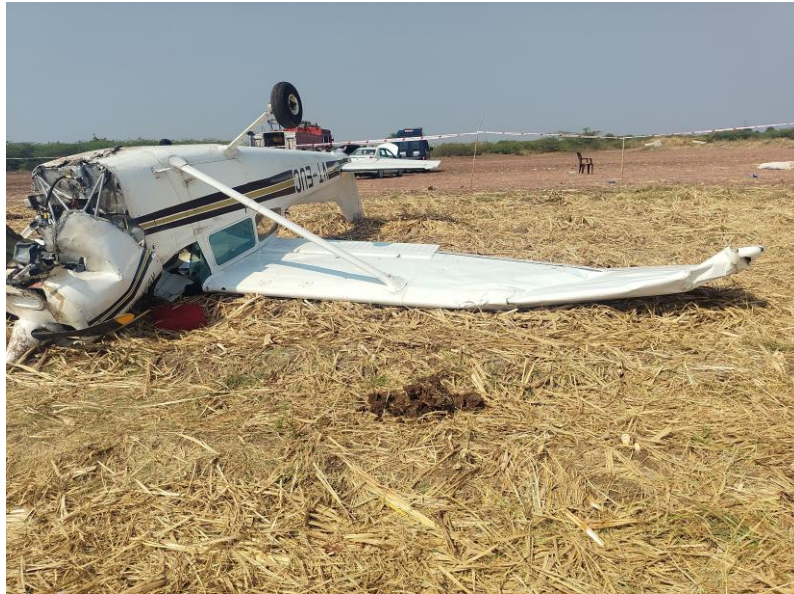
The aircraft landed in an open field which is free from tree and high-tension wires. The initial contact of the aircraft was on the Main landing gear. During the landing, the nose landing gear (NLG) was damaged and subsequently separated from the aircraft. The aircraft travelled approx. 40 m to the final resting location where it overturned and came to rest inverted, supported by the wings and the vertical stabilizer. Aircraft sustained substantial damage and following are the details:

Aircraft final resting position

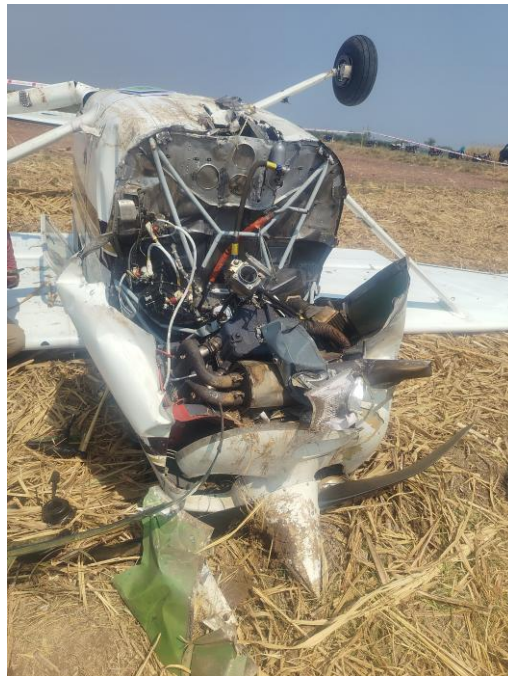
Close view of the engine

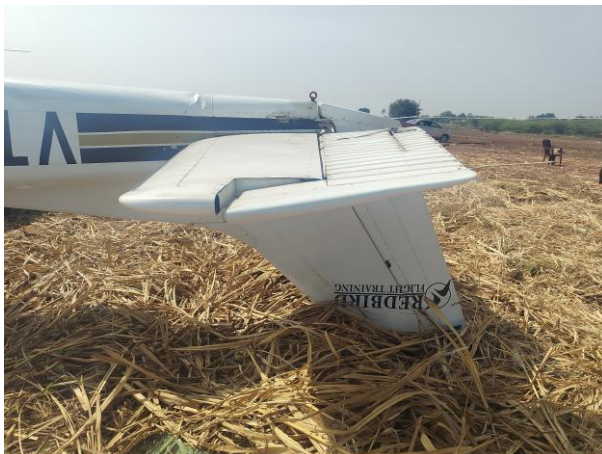
Aircraft resting on vertical stabilizer

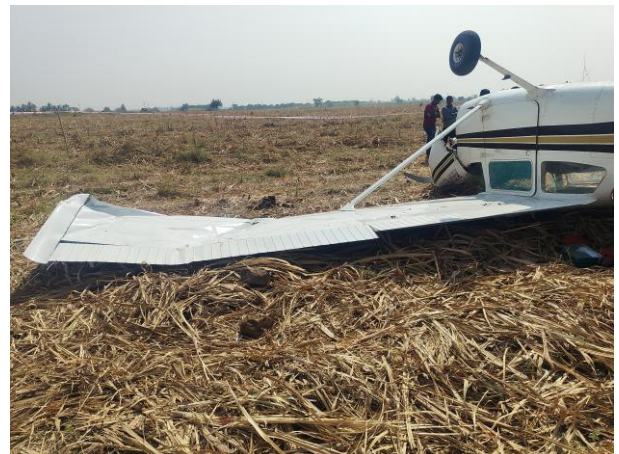
Damaged RH wing
