## Contents

**Aircraft and Serious Incident details of Airbus A-320 Aircraft VT-ATF  
on 18 May 24**

## SYNOPSIS

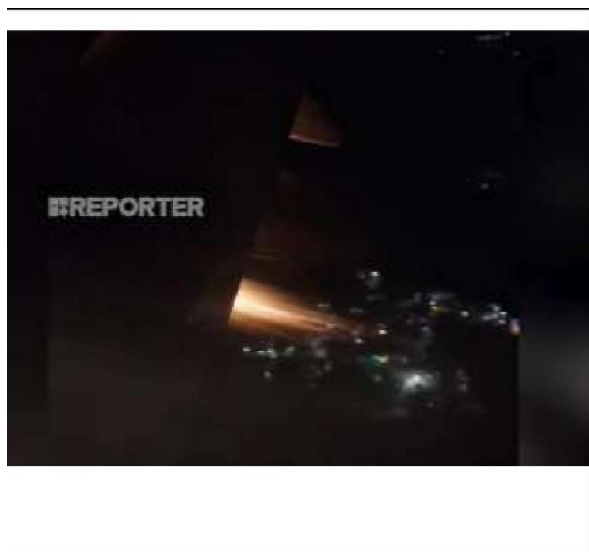
The damage started with sequence of event in air. A possible Engine fire event was reported by the Senior cabin crew. Flames were observed from the RH Engine Exhaust (Fig1&2).

**Fig 1 Flames from Engine.2 during climb**

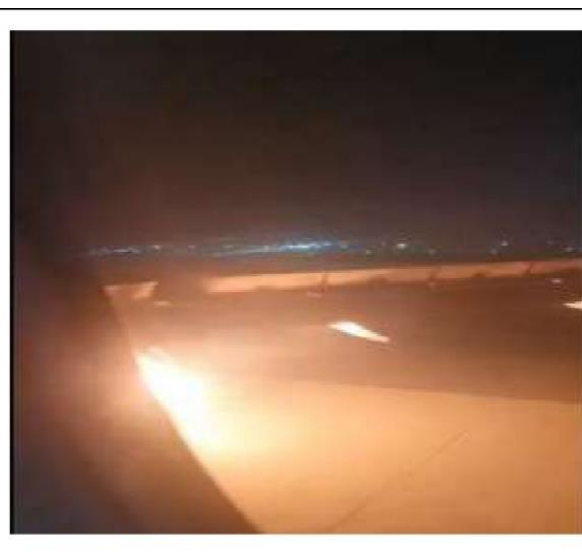
**Fig 2 Flames from Engine 2 at landing**

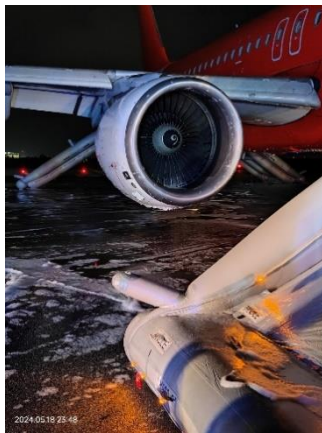
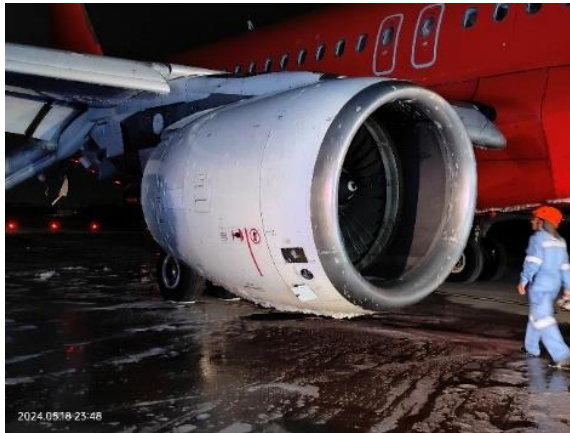
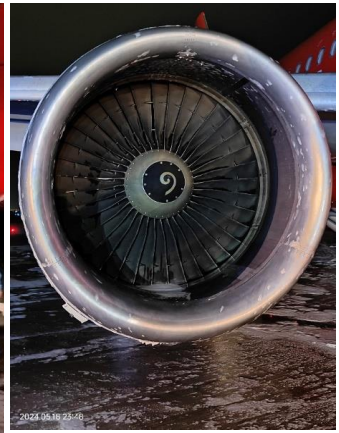
**Fig 4 Engine Inlet condition post Fire Extinguishing action by ARFF**

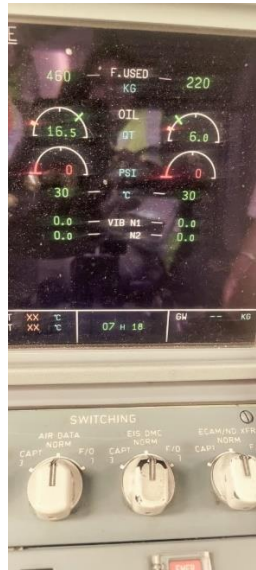
Figure 6

- ii. Engine 2 fan blades were hard to rotate
- iii. In the cockpit, on the SD page; Engine No. 2 oil quantity was observed to be 6 Quarts, whereas Engine No. 1 oil quantity observed was 16.5 quarts (Fig 6).

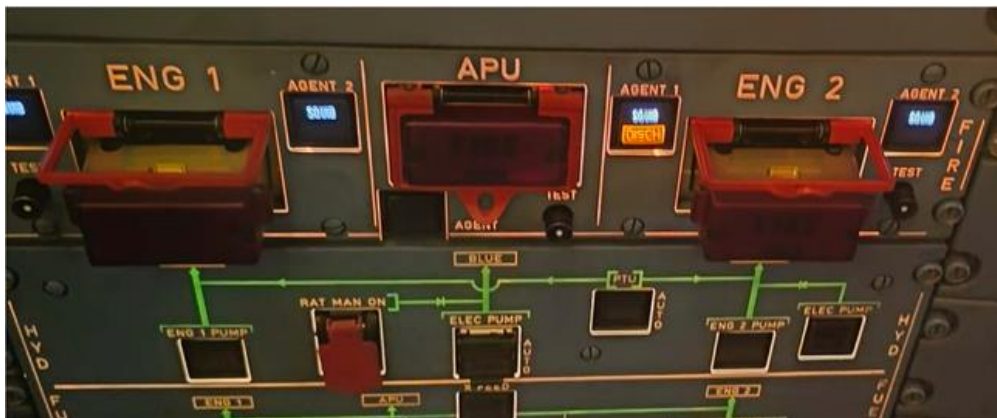
Figure 7

- iv. On overhead fire panel, Engine No. 2 fire button depressed with agent 1 discharge light on as shown in the picture below (Fig7).

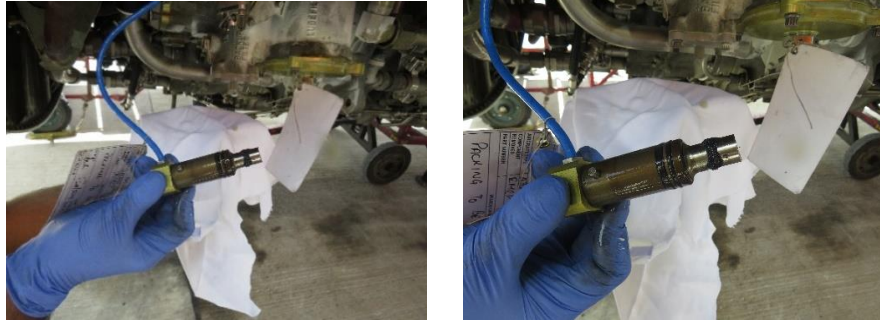
**Figure 8**

On 19.05.2024, Engine #02 fan cowl and thrust reverser cowl were opened for inspection. Externally, there were no burn marks or any damages to the Aircraft. No traces of oil, fuel and hydraulic fluid were found. Engine Magnetic Chip Detector were for checking and found abnormal contamination of magnetic debris (Fig8).

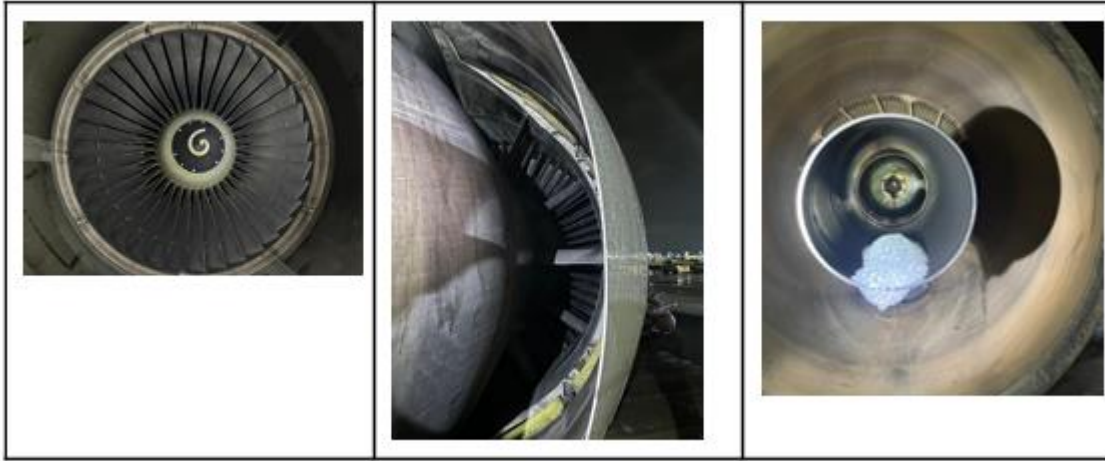
**Fig 10 Engine Inlet Conditions**

Pictures of the engine 2 taken after extinguishing the fire by the fire brigade showed no damage on the engine inlet and exhaust areas but some oil traces were observed (Fig10).

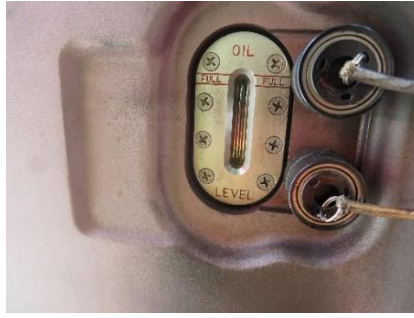
**Figure 11**

1. As per Post Flight report ENG 2 Stall warning/ Maintenance Message reported in phase 6 (climb) of flight.
2. No Visual damage observed in inlet and exhaust areas.
3. No damage on Fan cowl or T/R cowl observed.
4. Manual rotation of Fan blade carried out, found hard to rotate.
5. Oil Qty at departure was 17.5 Quarts post landing observed 7.5 Quarts (Fig11) Suspected oil Leak.

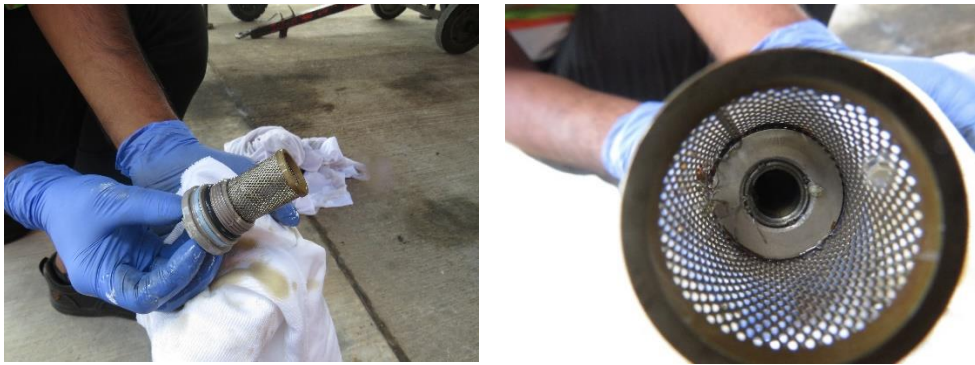
Maintenance activities carried out as per TSM TASK 73-00-00-810-866 (pertaining to Stall Checks), TSM TASK 72-00-00-810-801 (Trouble Shooting for Tail Pipe Fire) and AMM TASK 72-00-00-200-007-A (A procedure after Engine Fire or use of Fire Extinguishing Agent). Scavenge screen plugs were checked for metal/magnetic particles. Observed particles from three scavenge screen plugs (forward sump) (Fig12).

**Fig 12 Whiteish/ Greyish particles up to several centimetres long**

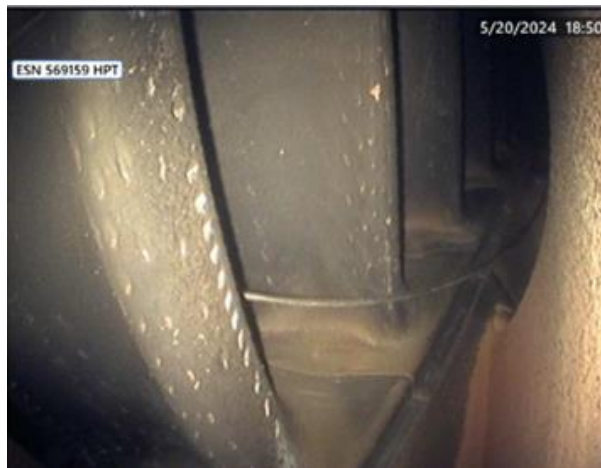
On Inspection of HPT stages as per AMM 72-52-00-290-002, it was found that aft blade retainer outer sealing ring was found disengaged from the position. All blades L/E were discolored.

**Fig 23 Boroscopic Image**

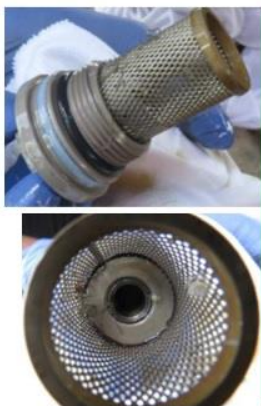
MCD (Magnetic Chip Detector) removed and checked as per AMM 79-00-00-281-002-A found chips. Scavenge screens plugs checked for particles as per AMM 79-21-10-000-007-a. Observed particles from no: 3 scavenge screen plug (Fwd sump) (Fig24,25,26,27 &28).

Screener from FWD sump

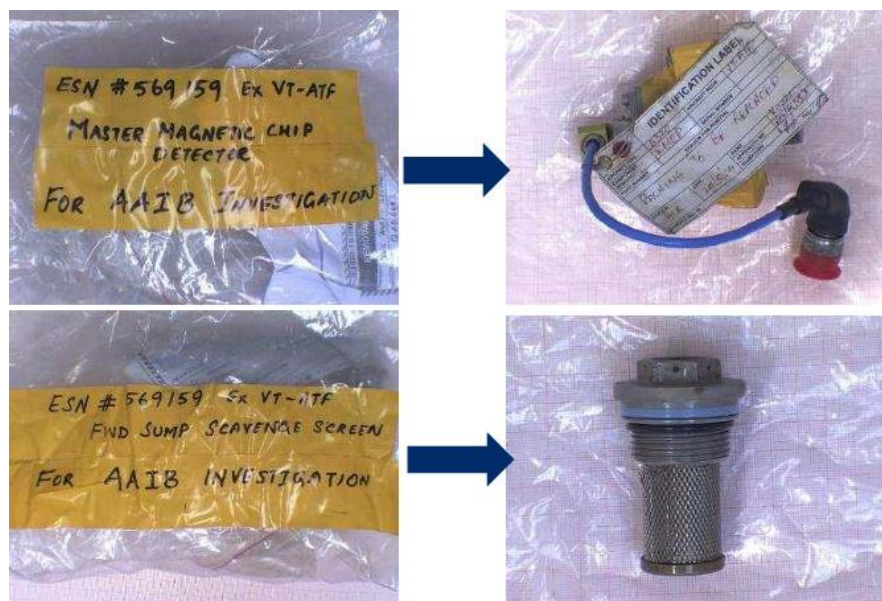
Figure 25

The debris was analyzed but could not be identified to a specific material with high confidence (Fig25).

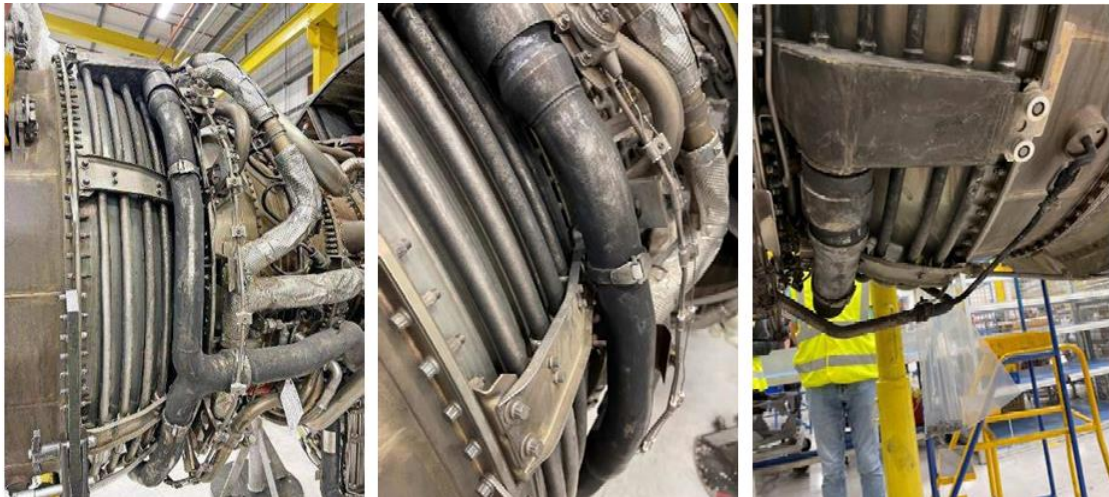
Before starting the disassembly, external visual examination was performed. Blackish deposit on LPTACC system observed (Fig30).

Fig 30 Blackish deposit on LPTACC system

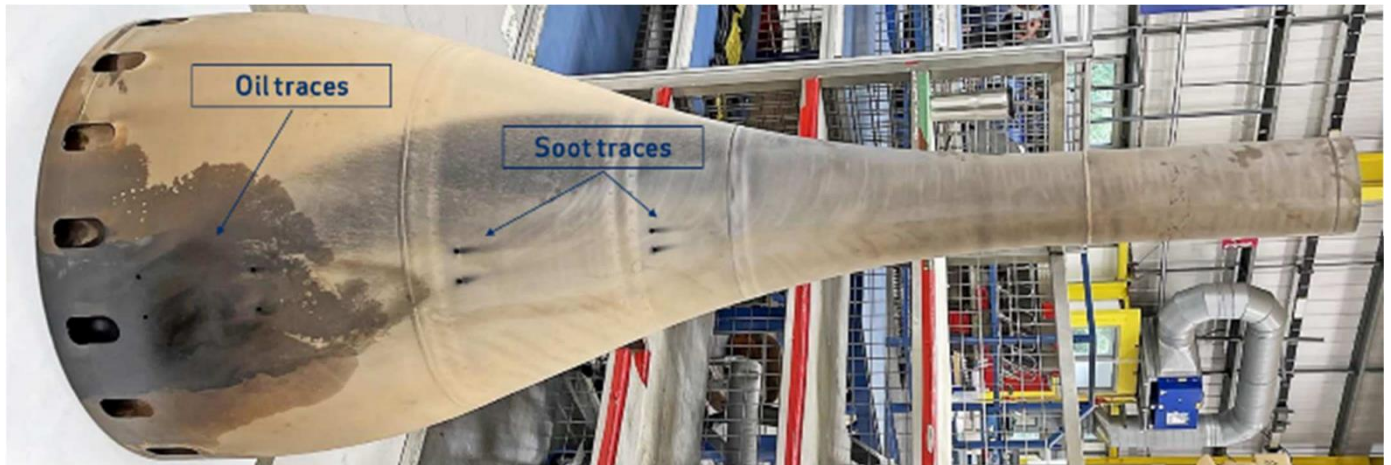
Fig 31 Oil traces and black deposit found on exhaust plug at 06:00 position.

Localized wetness area is a sign of oil leak from aft sump. #4 and #5 bearing and the lubrication system are localized in the sump area (Fig31&32).

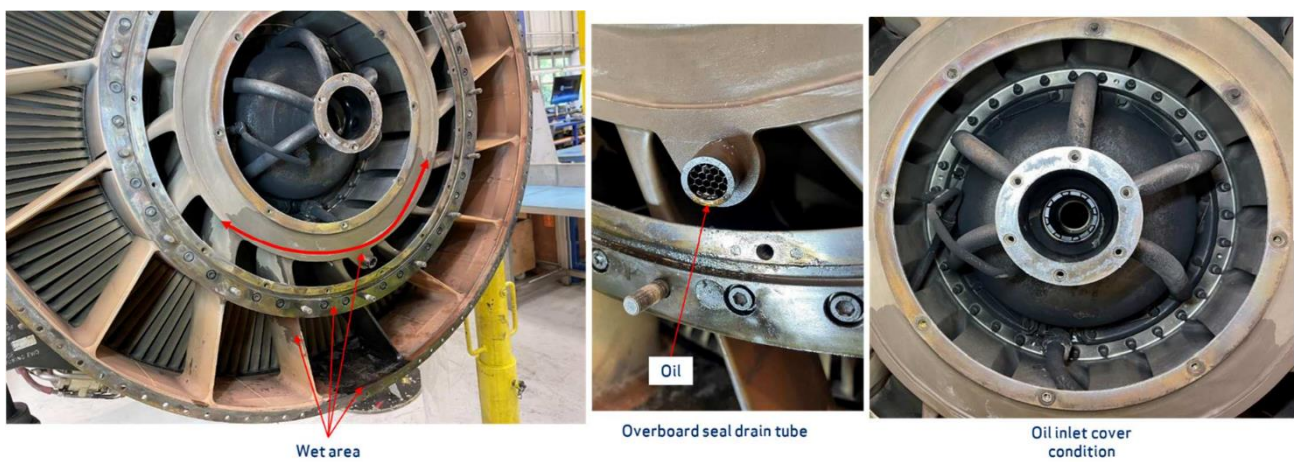
Fig 32 Wetness area on aft side of LPT observed with pollution after flange assembly removal.

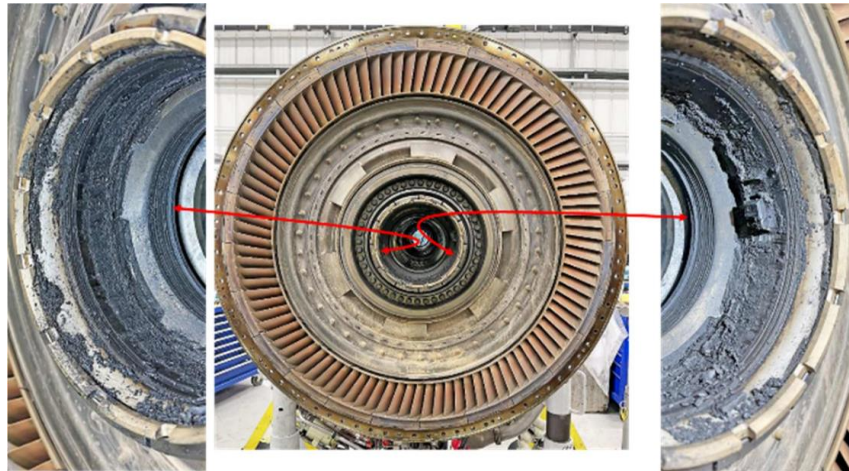
LPT major module is put at piece part and #4 bearings found broken. No traces of fire under disk cavities (Fig33).

**Fig 33 No. 4 roller bearing outer race condition: 2 rollers seized on raceway**

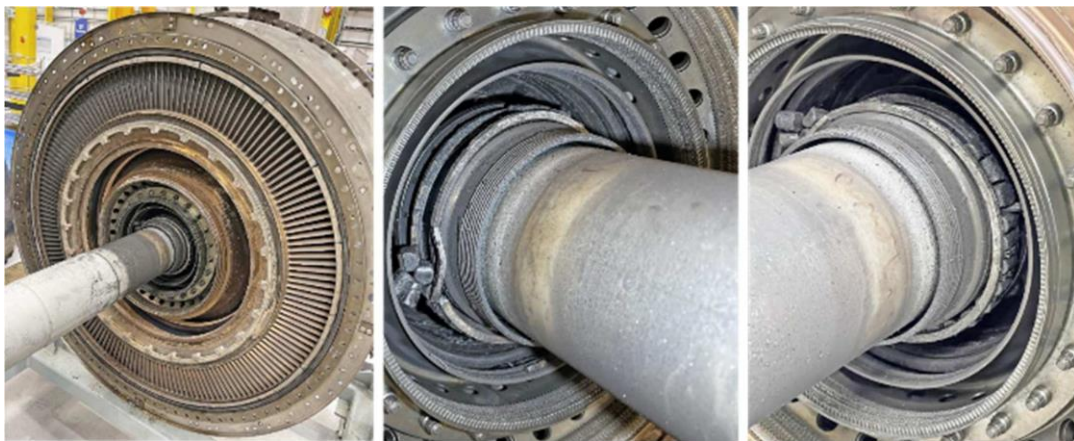
**Fig 34 No. 4 roller bearing inner ring condition: fractured cage + rollers found liberated**

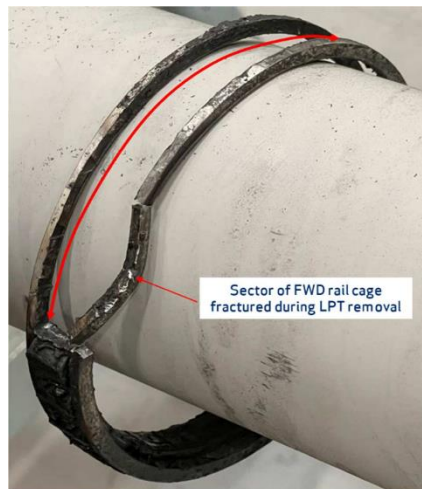
**Fig 35 Cage spacers fractured and associated rollers liberated onto a sector of ~180°**

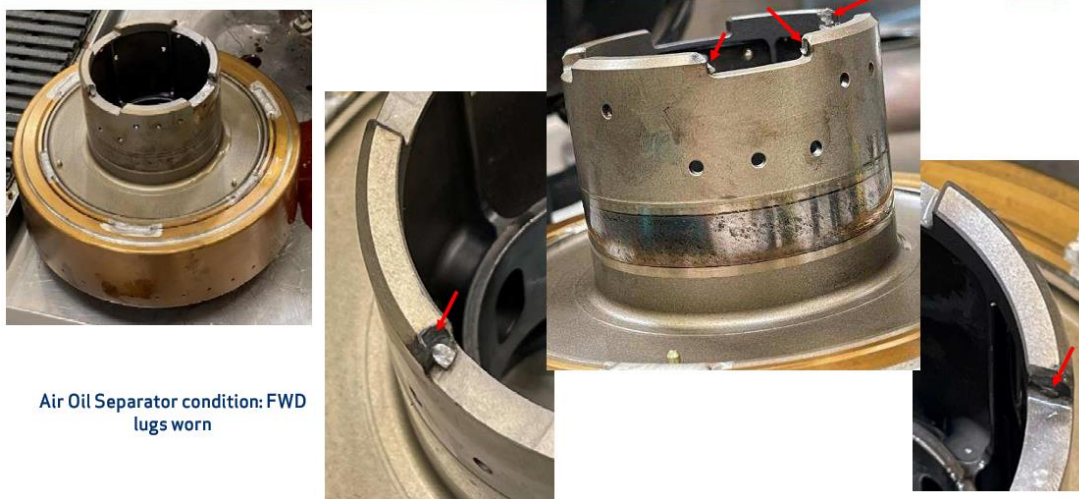
Figure 36

Air Oil Separator condition: FWD lugs worn

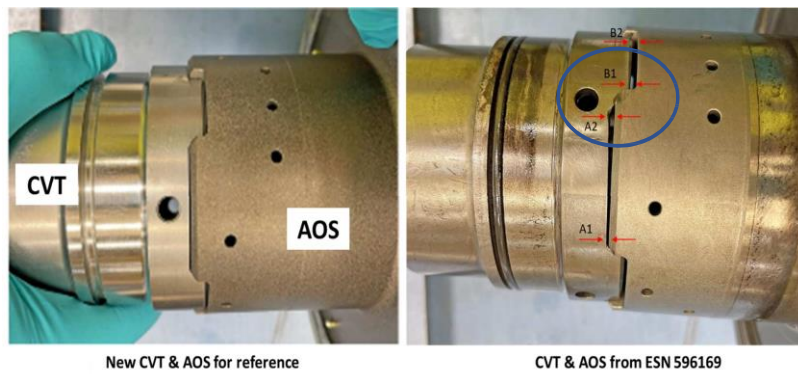
Figure 37

Axial gap is identified with no expected shape and contact between air oil separator (AOS) and Centre Vent Tube (CVT) (blue circle) (Fig37&38).

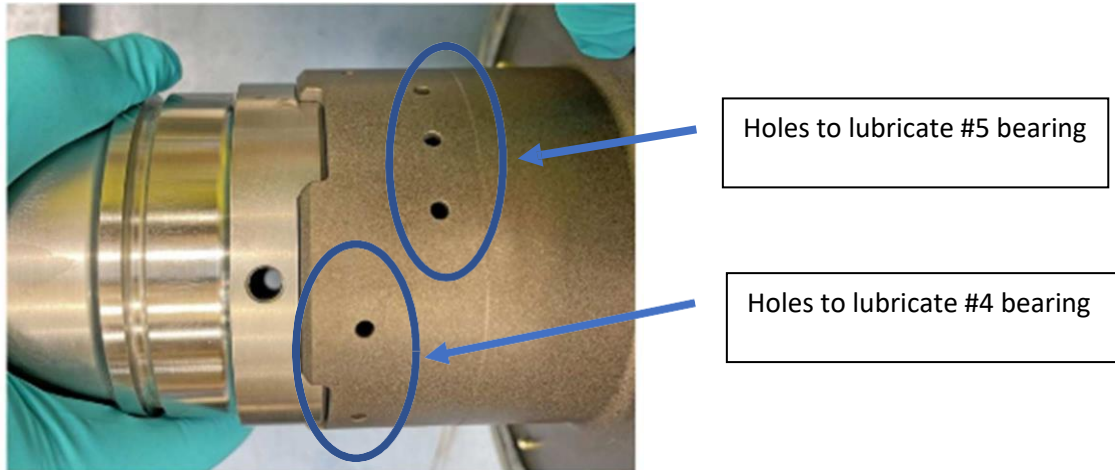
**Figure 38**

An axial gap is there due to Centre Vent Tube repair with non-conformance radius. An analysis between design intent and axial gap measured shows that there is no impact on lubrication for both bearings.

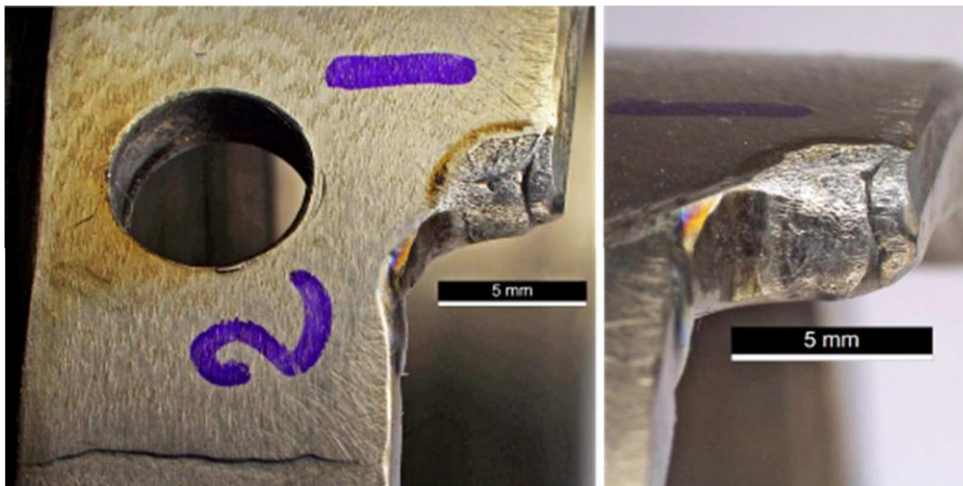
**Figure 39**

Poor geometry on CVT with heavy interference on lugs could liberate some debris through lubrication system(Fig39).

- ESM / CVT / All slots' faces can be repaired by the Task 72-55-06-300-010 Repair #010 (WELD BUILD- UP OF THE REAR SLOTS FACES IN CONTACT WITH AIR OIL SEPARATOR)
- ESM / AOS / All drive slots can be repaired by the TASK 72-55-15-300-003 repair #003 (AIR/OIL SEPARATOR AND COVER REPAIR 003 - RECONDITIONING OF DRIVE SLOTS ON THE AIR/OIL SEPARATOR)

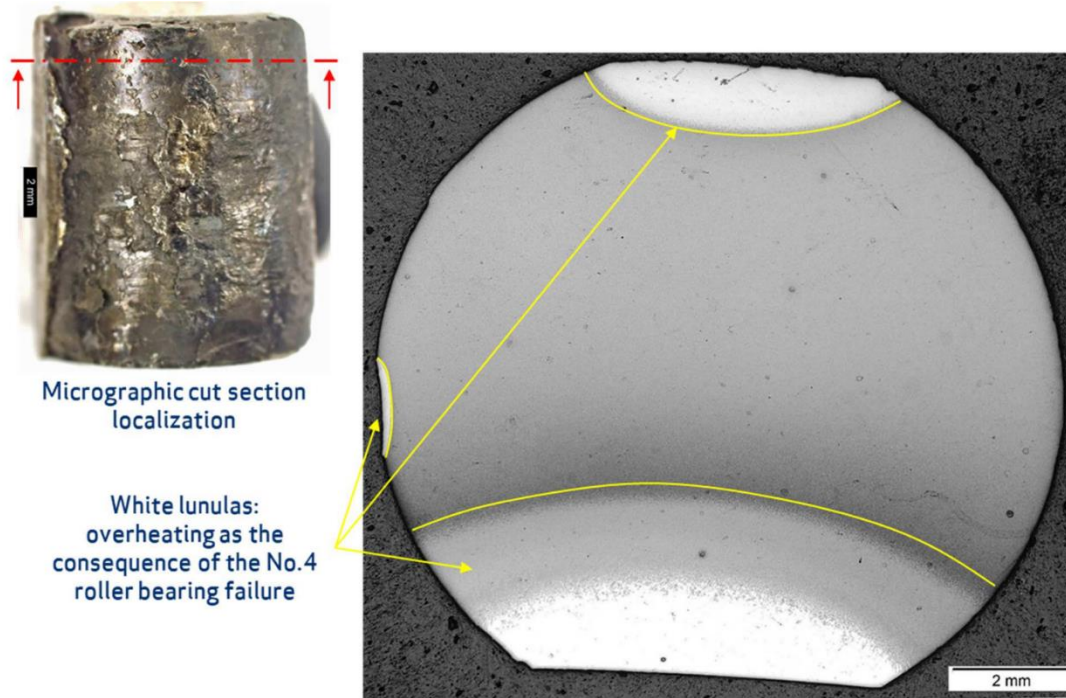
**Figure 41**

No metallurgical anomaly on rollers was found due to lack of lubrication. Local overheating was observed, following #4 bearing failure (Fig41).

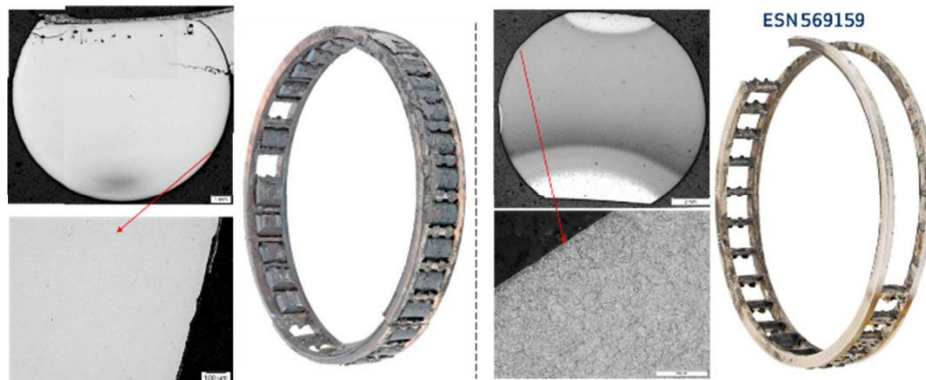
**Figure 42**

About the cage, fractures surfaces are observed with heavy damages and some rare evidences of fatigue propagation. No CVT/AOS particles have been found on the bearing (Fig42).

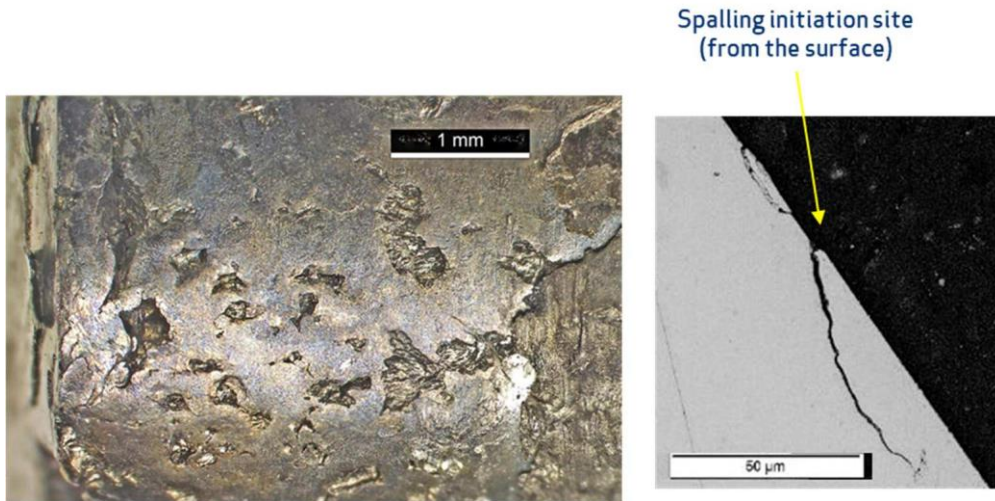
Figure 43

Micrographic cut section, performed on the roller bearing found with spalling vestiges showed that spalling initiation occurred/started from the surface (Fig43).

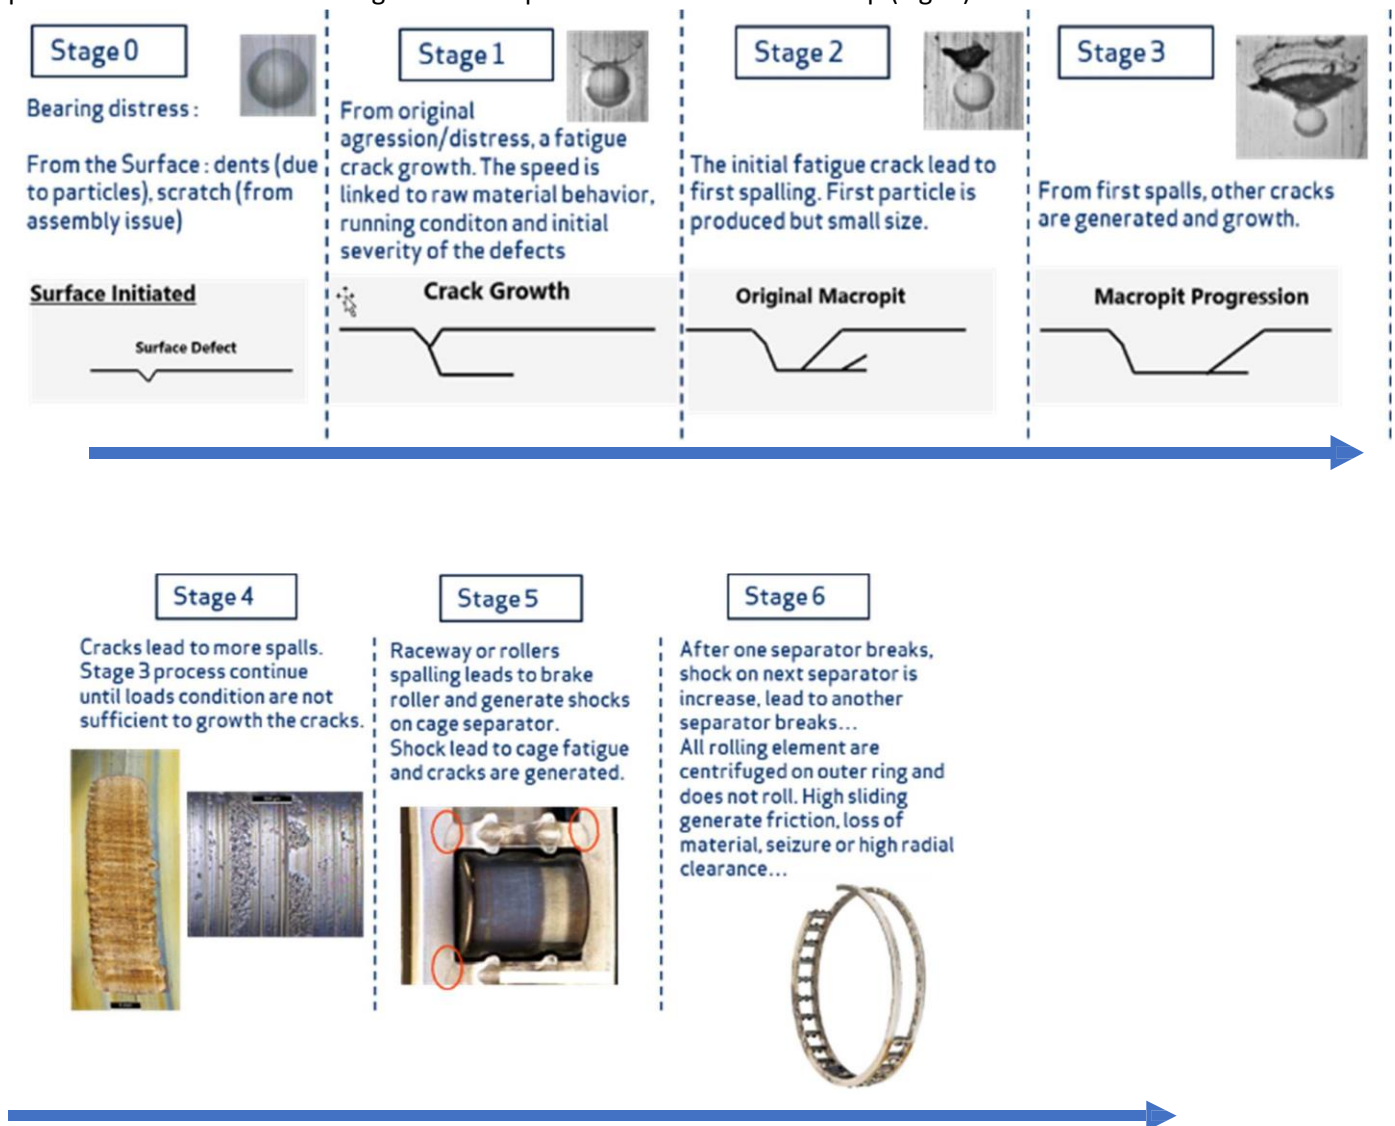
Figure 44

Based on the literature and CFM's experience, such initiation site from the surface is consistent with the presence of surface distress such as dents caused by foreign hard particles (like Alumine) or like the present case scenario particles liberated from the degradation of parts that are inside the sump (Fig44).

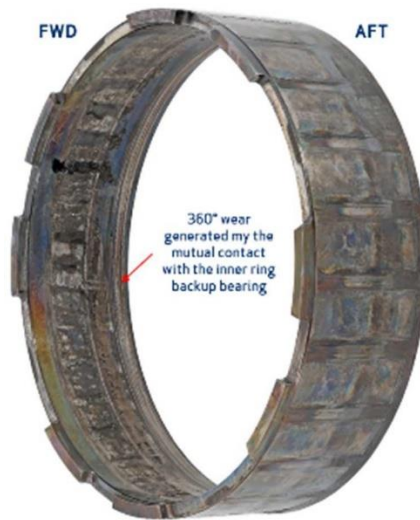
Figure 45

The outer ring raceway doesn't show sign of spalling degradation and there is absence of sectorial digging (Fig45).

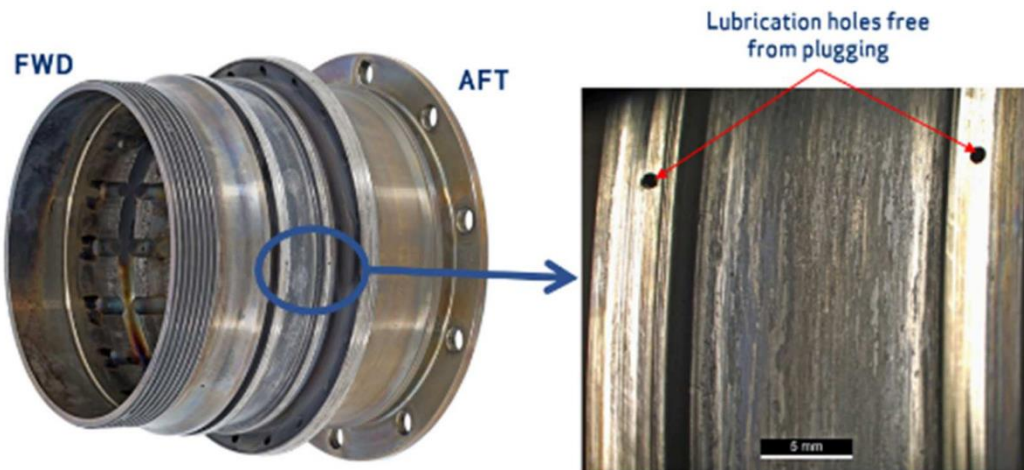
Figure 46

Heavy wear found on inner ring raceway without sign of spalling degradation (Fig46).

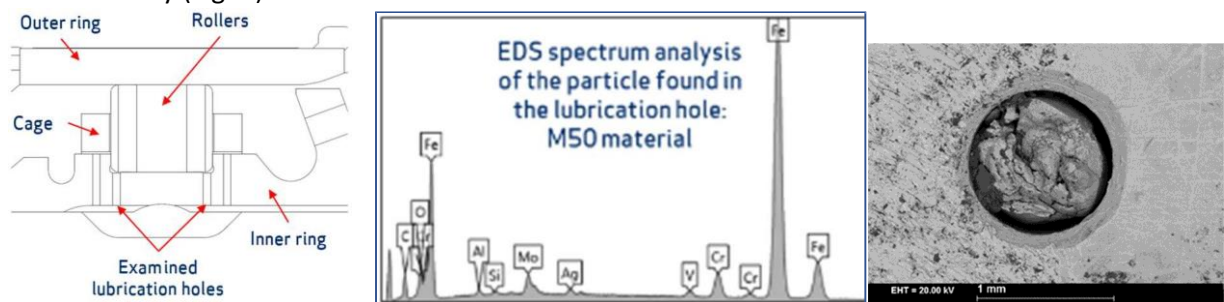
Figure 47

One lubrication hole found plugged with M50 material, consequence of #4 roller bearing distress without impact on lubrication efficiency (Fig47).

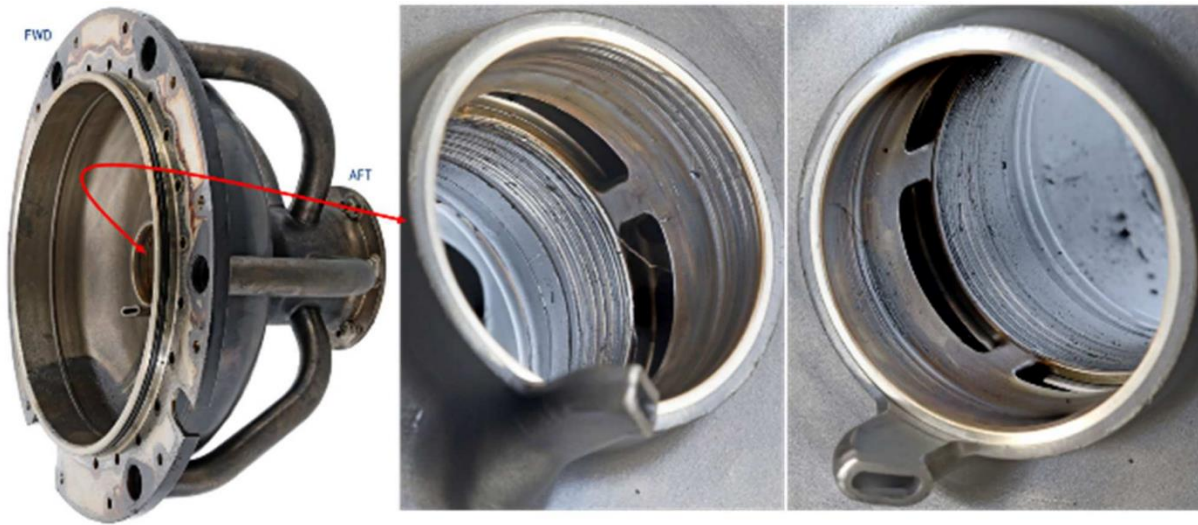
**Figure 48**

Chafing due to imbalance on oil inlet cover, representative to other damages on seal teeth leading to loss of pressurization inside sump area and oil leak (Fig48).

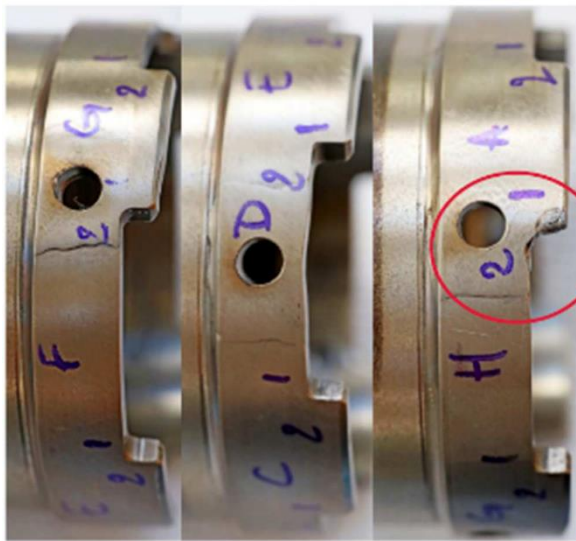
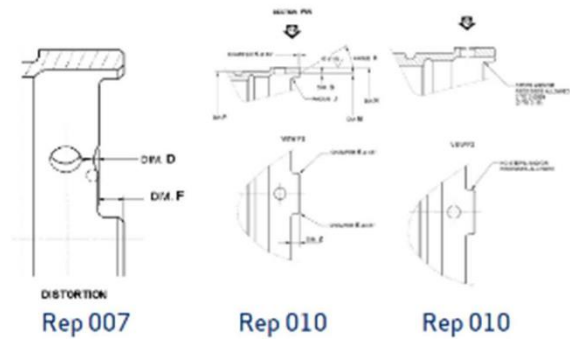
Figure 49

- R007 - Dim D Exceeded
- R007 - Dim F Exceeded
- R007 - Post Weld Yellow/Blue Colour - Exceeded
- R007 - Weld Bead - Not Smooth - Exceeded
- R010 - Radius J - Exceeded
- R010 - Dim L - Not correct along depth of Slot (See Rad J)
- R010 - No steps/recesses on slots - Exceeded
