**Final Investigation Report on Serious Incident of Airprox between A321
aircraft VT-IUO (IGO2113) and A320 Aircraft VT-ISO (IGO2206) operated
by M/s Indigo at IGI Airport, Delhi on 17.11.2023**

**AIRCRAFT ACCIDENT INVESTIGATION BUREAU
MINISTRY OF CIVIL AVIATION
GOVERNMENT OF INDIA**

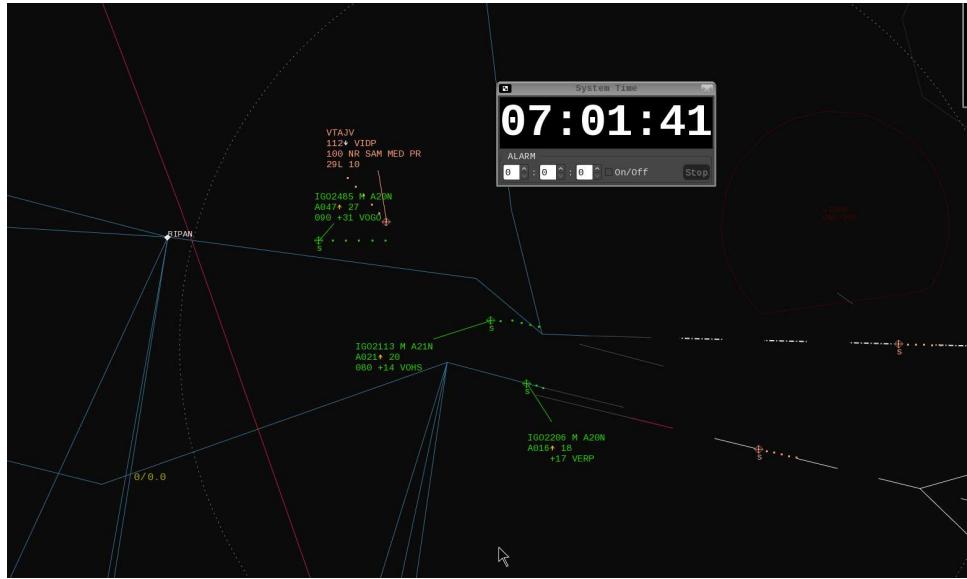
| Time HHMMSS | Unit | Transmissions |
|--|---|---|
| 070141 IGO 2113 observed turning left toward the takeoff path of RWY 29R (Refer Fig:01 of Annexure) | | |

Figure 1 IGO2113 and IGO2206 airborne, with IGO2113 turning left

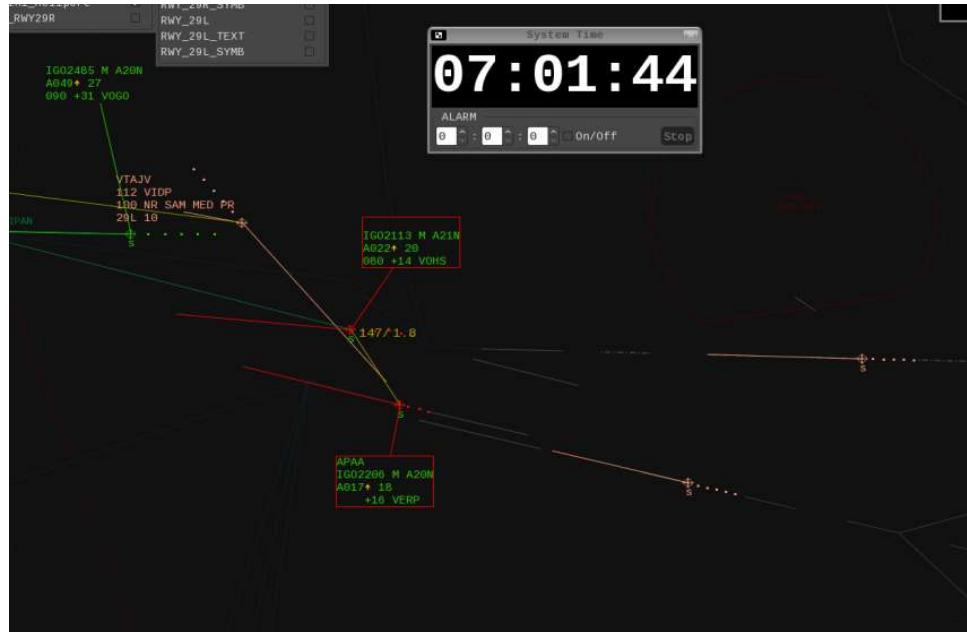
Figure 2 Generation of Current Conflict

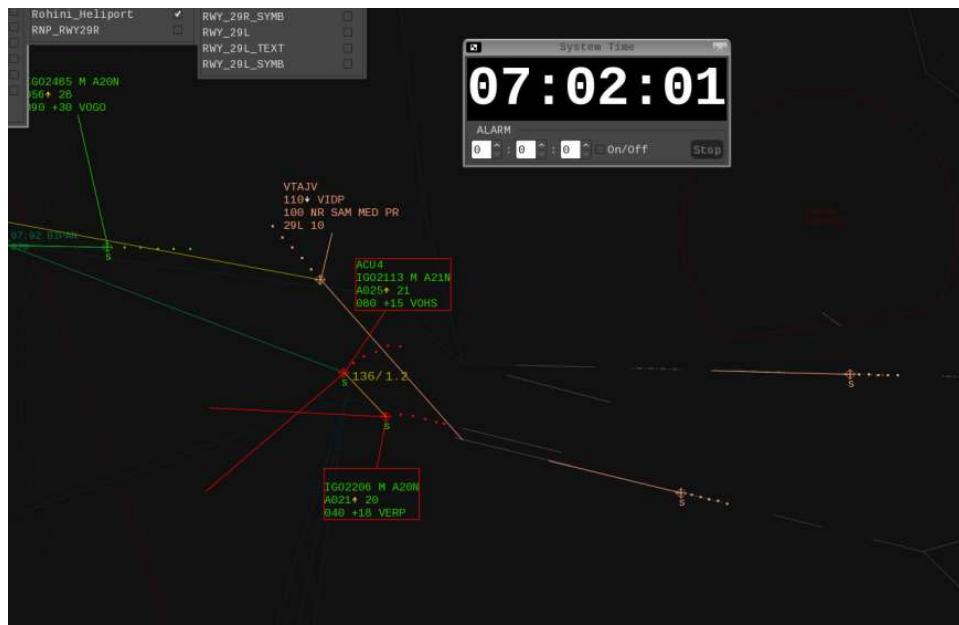
Both the Aircraft came very close and at the time of the closest vertical separation of 400 feet, lateral separation was 1.2 NM. TCAS RA maneuver was performed. There were no injuries to any of the occupants on board in either aircraft. There was no damage to the aircraft.

Figure 3 Minimum vertical separation 400 feet at lateral separation of 1.2 NM

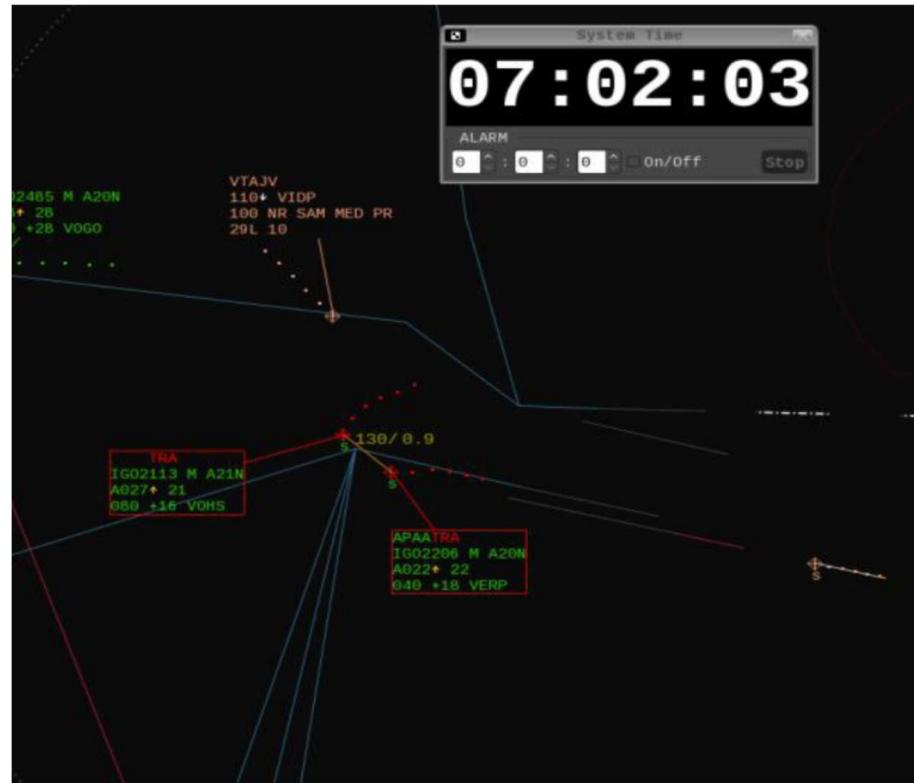
Figure 4 TRA Alert

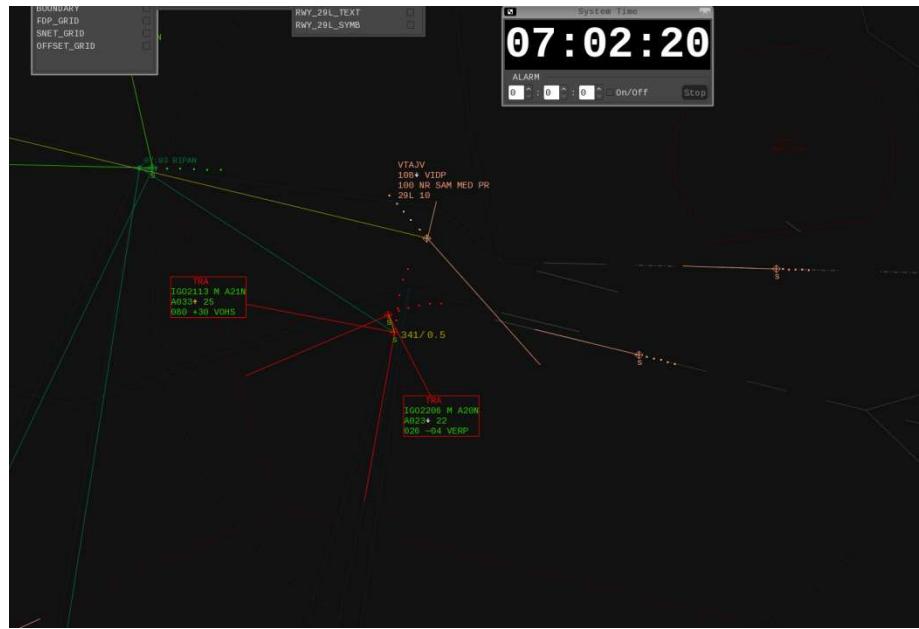
Figure 5 Vertical separation restored to 1000 feet

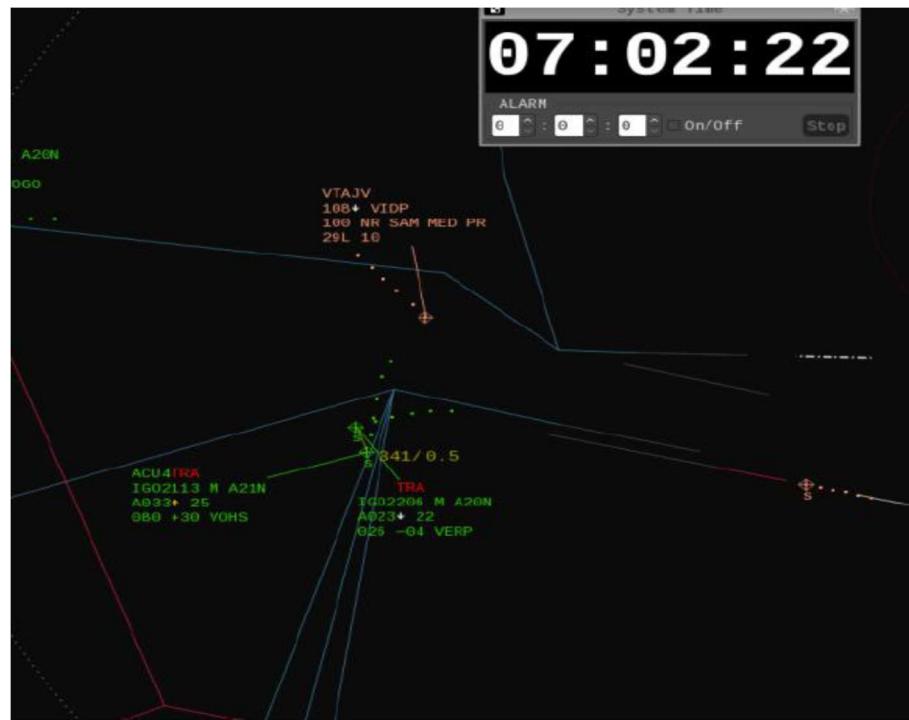
Figure 6 Disappearance of Current conflict alert

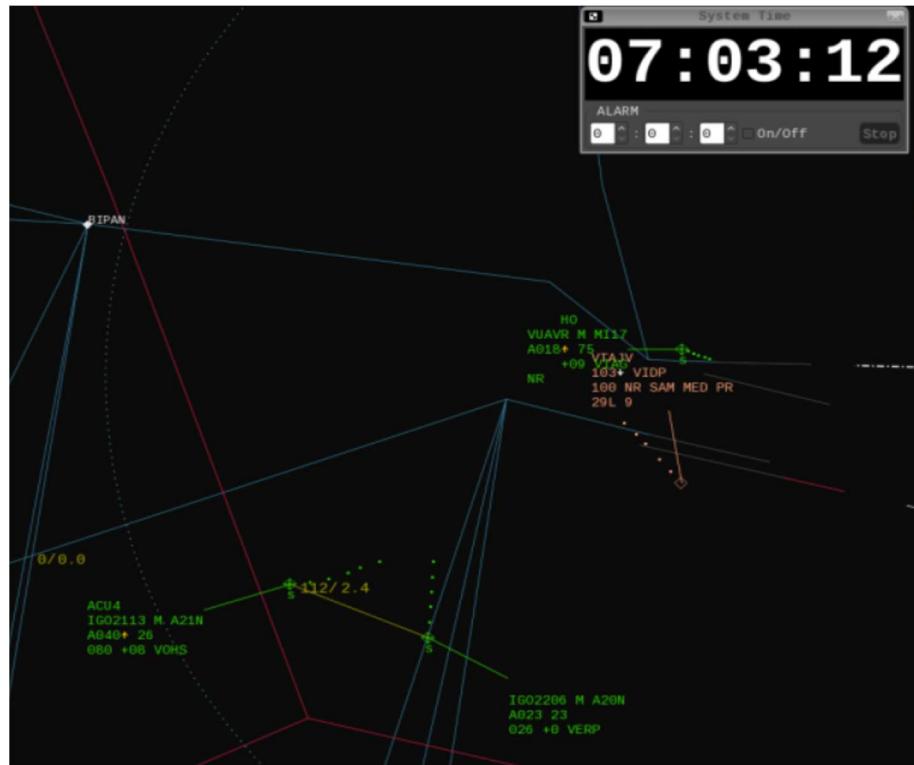
Figure 7 Disappearance of TRA Alert
