**PRELIMINARY REPORT ON  
SERIOUS INCIDENT TO M/s FLAPS AVIATION PVT. LTD.  
BEECH KING AIR C-90A AIRCRAFT, VT-SLK  
AT HISAR AIRPORT ON 14.07.2026**

**GOVERNMENT OF INDIA  
MINISTRY OF CIVIL AVIATION  
AIRCRAFT ACCIDENT INVESTIGATION BUREAU**

## Preliminary Report: Serious Incident involving M/s Flaps Aviation Pvt. Ltd. C-90A aircraft VT-SLK at Hisar airport, Haryana, India on 14<sup>th</sup> July 2026.

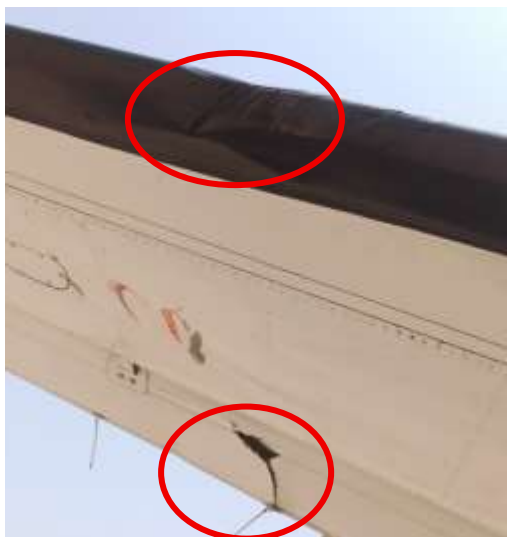
1. RH Nose L/G door hinge broken & deformation/dent in the RH door.
2. Cracks, dents & 02 punctures in skin of RH nose fuselage below RH avionics panel.
3. LH (Left Hand) engine intake lip and cowling damage, rivets shear out on side and deep depression on intake lip.
4. Damage (Metal loss) on all the blades on LH propeller leading edge. Damage (Metal loss) and bends on all the blades on LH propeller.
5. RH outer wing leading edge dent & deformed.
6. Dent on RH outer wing lower skin.
7. RH fixed aileron trim tab broken.
8. RH aileron damaged.
9. Dent on right side of Nose avionics panel and structure.
10. Dent and deformation of skin on RH forward lower cowling.
11. Dent on nose in front of condenser intake.
12. RH Front lower cowling.
13. Nose wheel with multiple cuts.
14. Cuts on RH main wheel.
15. Nose landing gear RH trunnion bolt blank panel and adjacent skin damaged.

**FIG 1: Damage to RH Wing and Aileron**

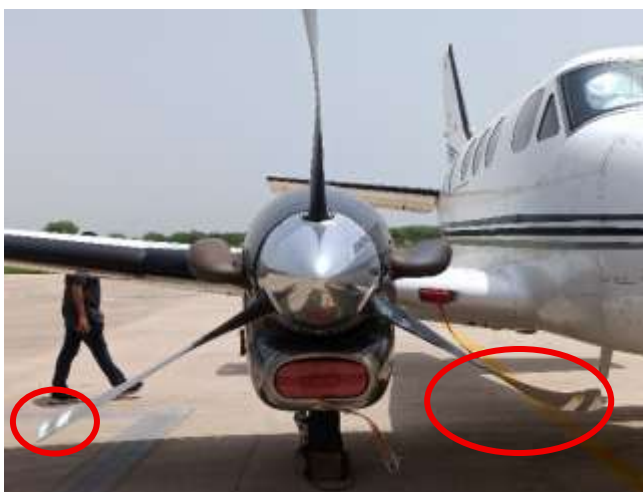
**FIG 2: Damage to RH Propeller**

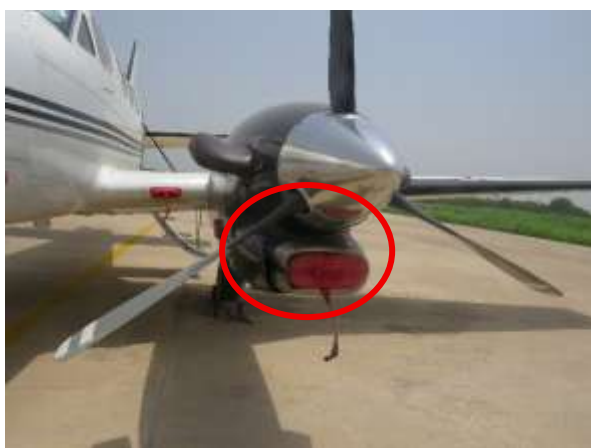
**FIG 3: Damage to LH engine intake and propeller**

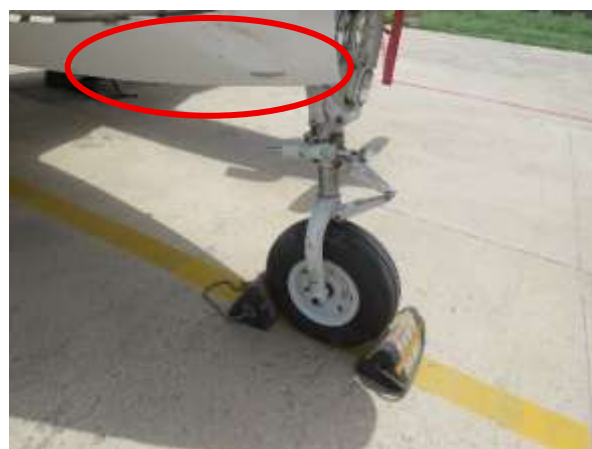
**FIG 4: Damage to Nose L/G**

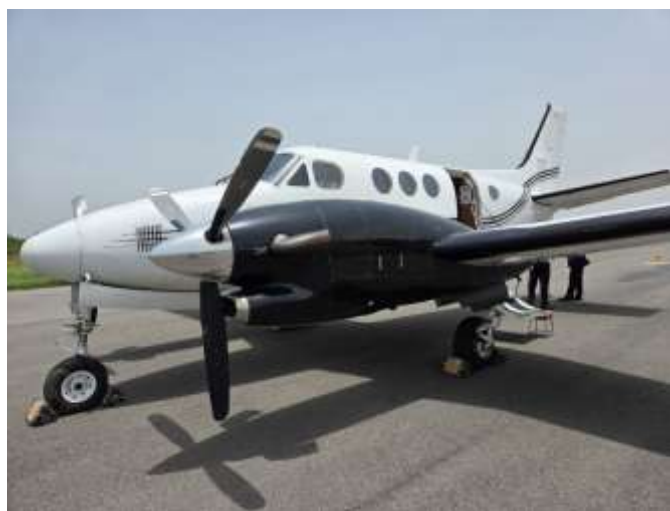
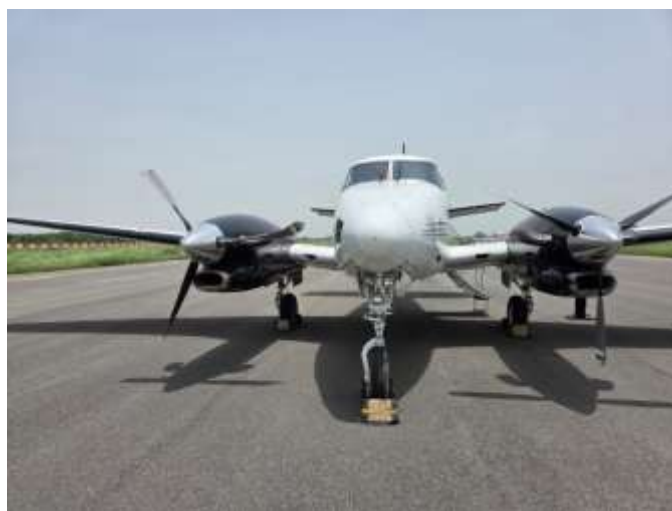
**Final Position of the aircraft**

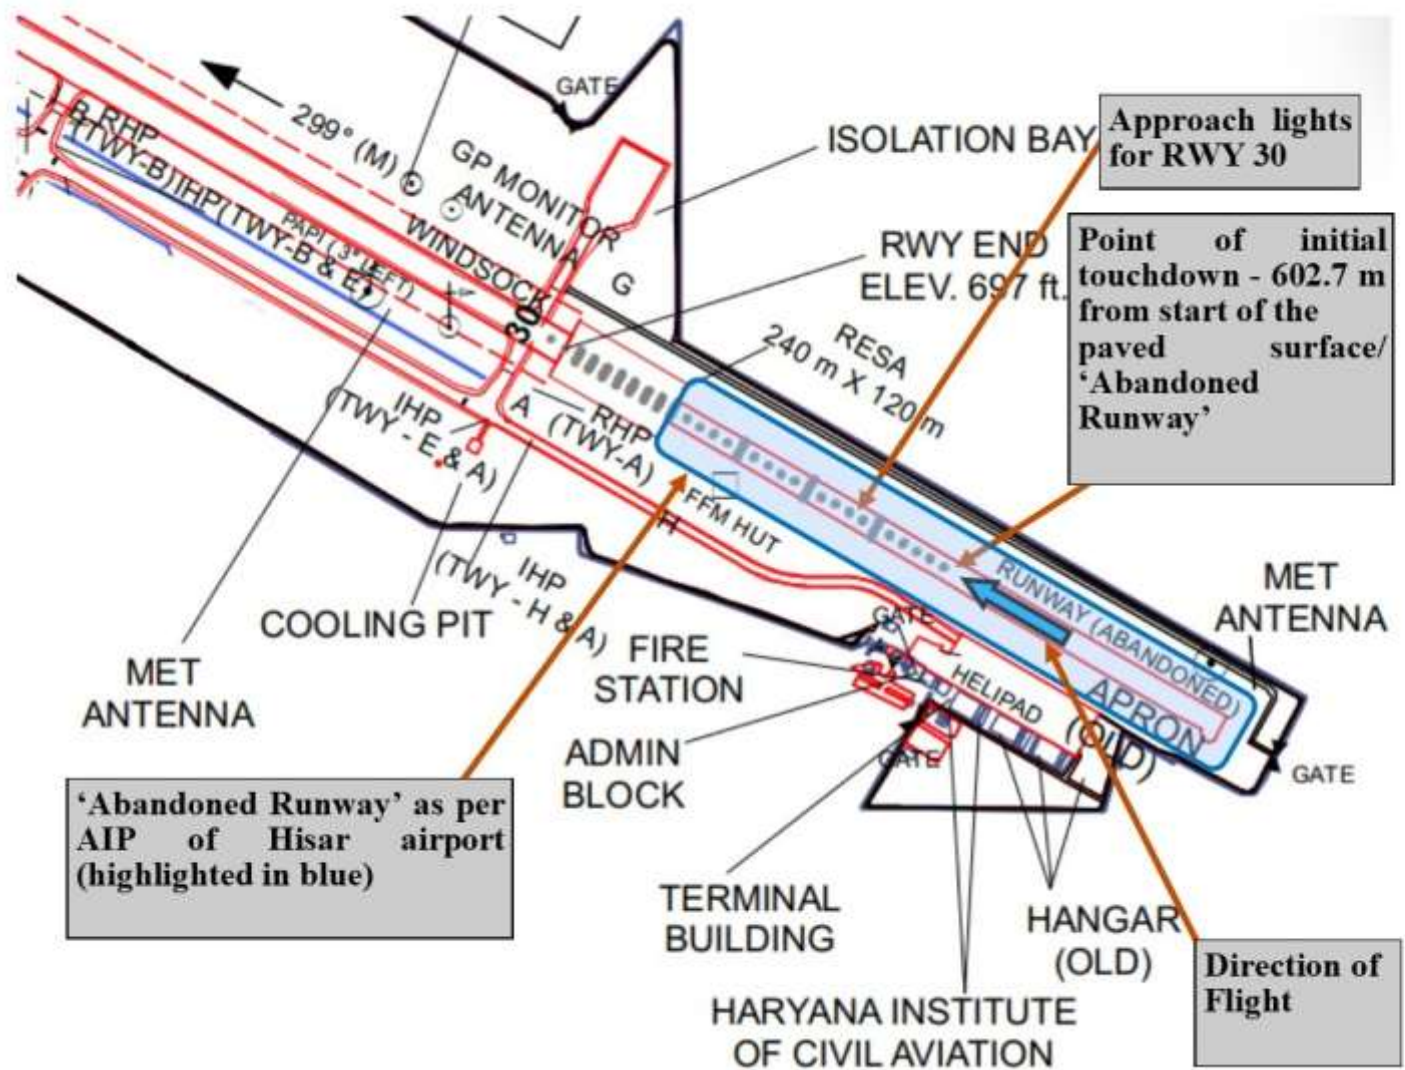
There is an old abandoned runway in the approach path (in-line) with RWY30 - which is declared as 'Abandoned Runway' on the 'Aerodrome Chart' available in the published eAIP India [FIG 7].

**FIG 7: Runway (abandoned) portion (marked in blue) - Aerodrome Chart of Hisar-VIHR (as in published in eAIP India)**

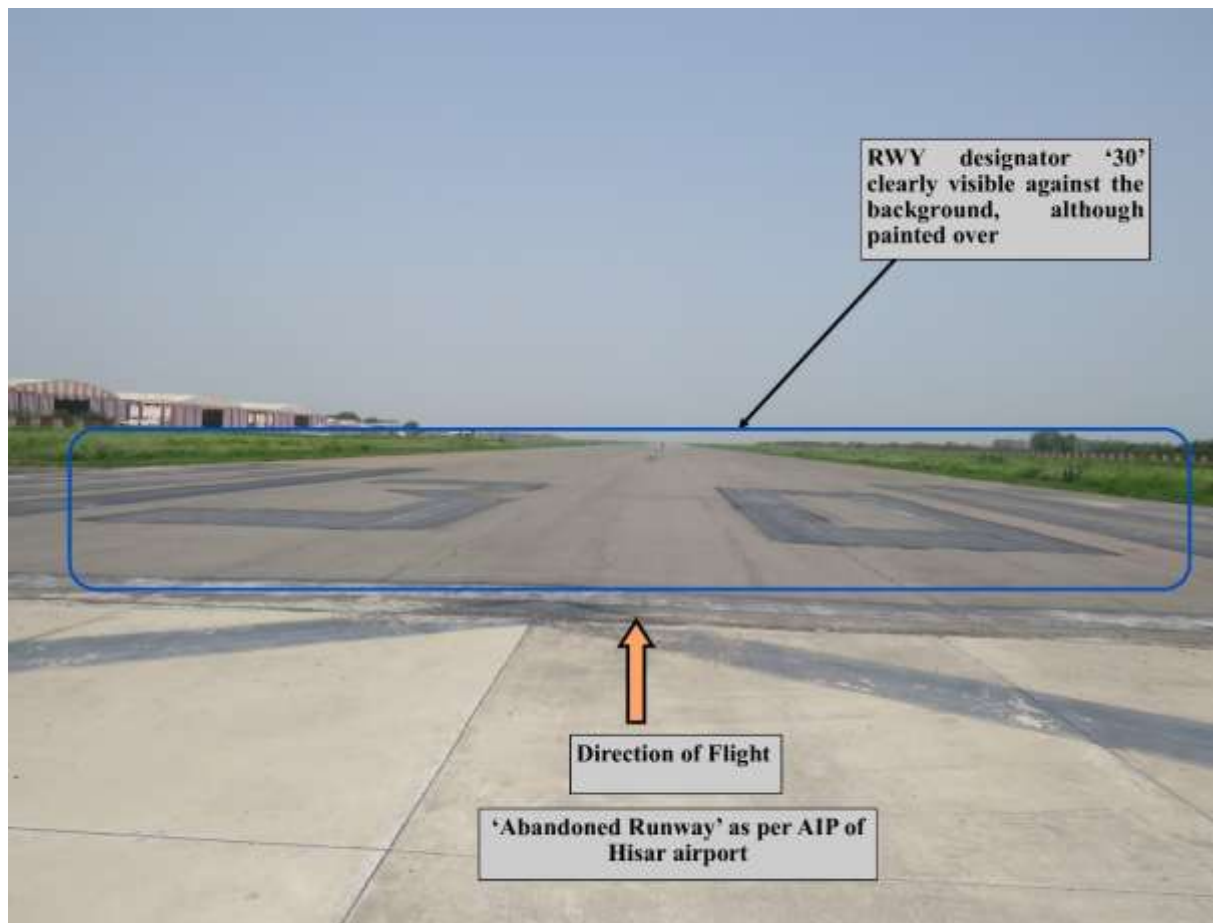
- 'Abandoned Runway' markings still stand out in contrast against the pavement, though the markings have been painted black.
- RWY designator marking for RWY30 has been painted over with black paint which is still readable as 30, along with the threshold markings and Chevron marking ahead of the runway and the runway centre line marking [FIG 8].

**FIG 8: 'Abandoned Runway' portion ahead of RWY30**

- a) AAI-Hisar (Aerodrome License holder) to obliterate/ remove the RWY markings on the abandoned runway at Hisar airport, in a manner that it prevents visibility of markings on the abandoned runway.
- b) AAI-Hisar (Aerodrome License holder) to ensure that, closed runway markings are placed at each end extremity of the runway as per DGCA regulations.
- c) AAI may consider to include a 'caution' in the relevant charts of Hisar airport regarding the existence of pavement- 'abandoned runway' in the approach path (in-line) with RWY30.

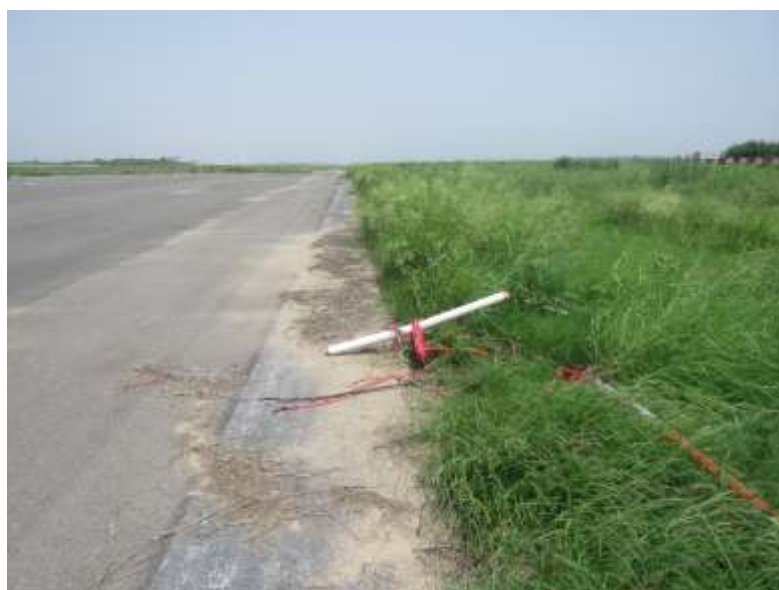
- c) 11 Approach Lights (installed on pavement of the abandoned runway) were damaged.
- d) The Far Field Monitoring Antenna (FFM) and its supporting cables installed on the paved surface (abandoned runway) at 1054.1m from beginning of the abandoned runway, was damaged/ uprooted upon impact with the aircraft. The FFM antenna was recovered on the RH side/ shoulder area of the abandoned runway at approx. 60m from its installed location [FIG 9].

**FIG 9: Location of Far Field Monitoring Antenna after the incident**

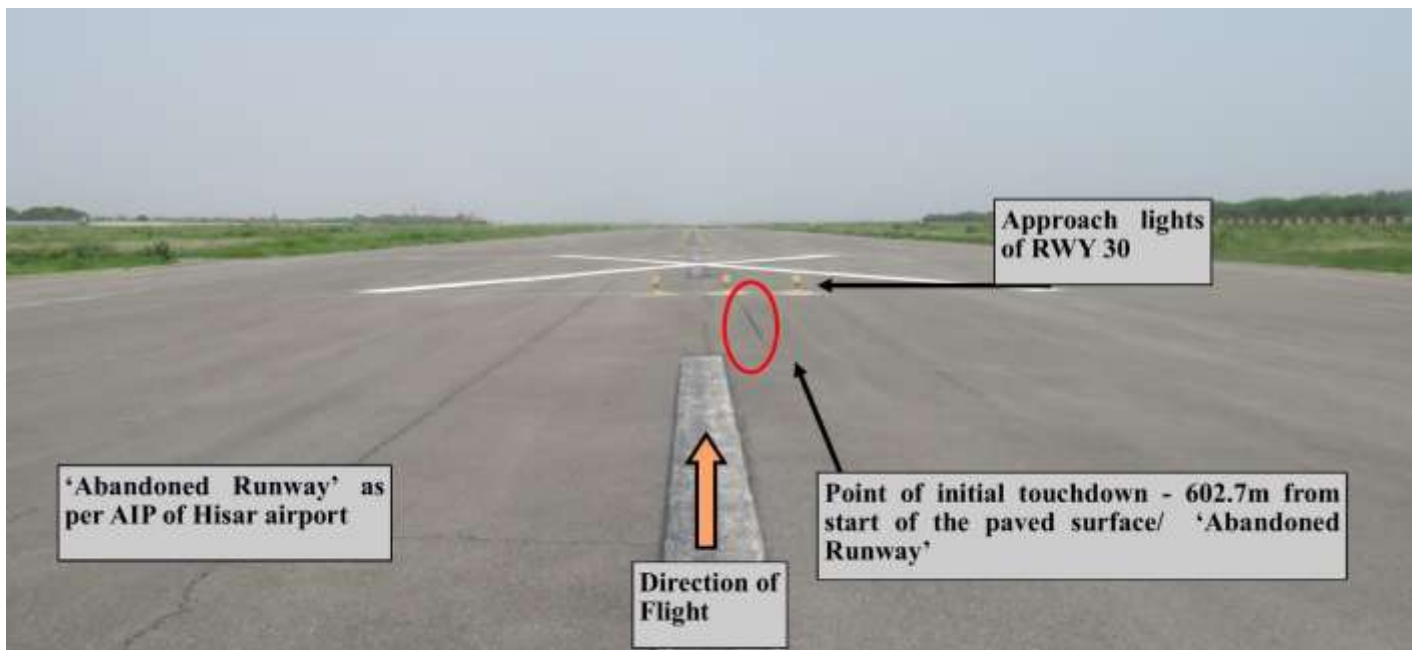
- a) The aircraft touched down at 602.7m (near the start of the installed approach light system) from the beginning of the paved surface of the abandoned runway [FIG 10].
- b) The First closed runway marking 'X' was located at a distance of 315m from the beginning of the pavement/ abandoned runway.

**FIG 10: Point of touchdown**

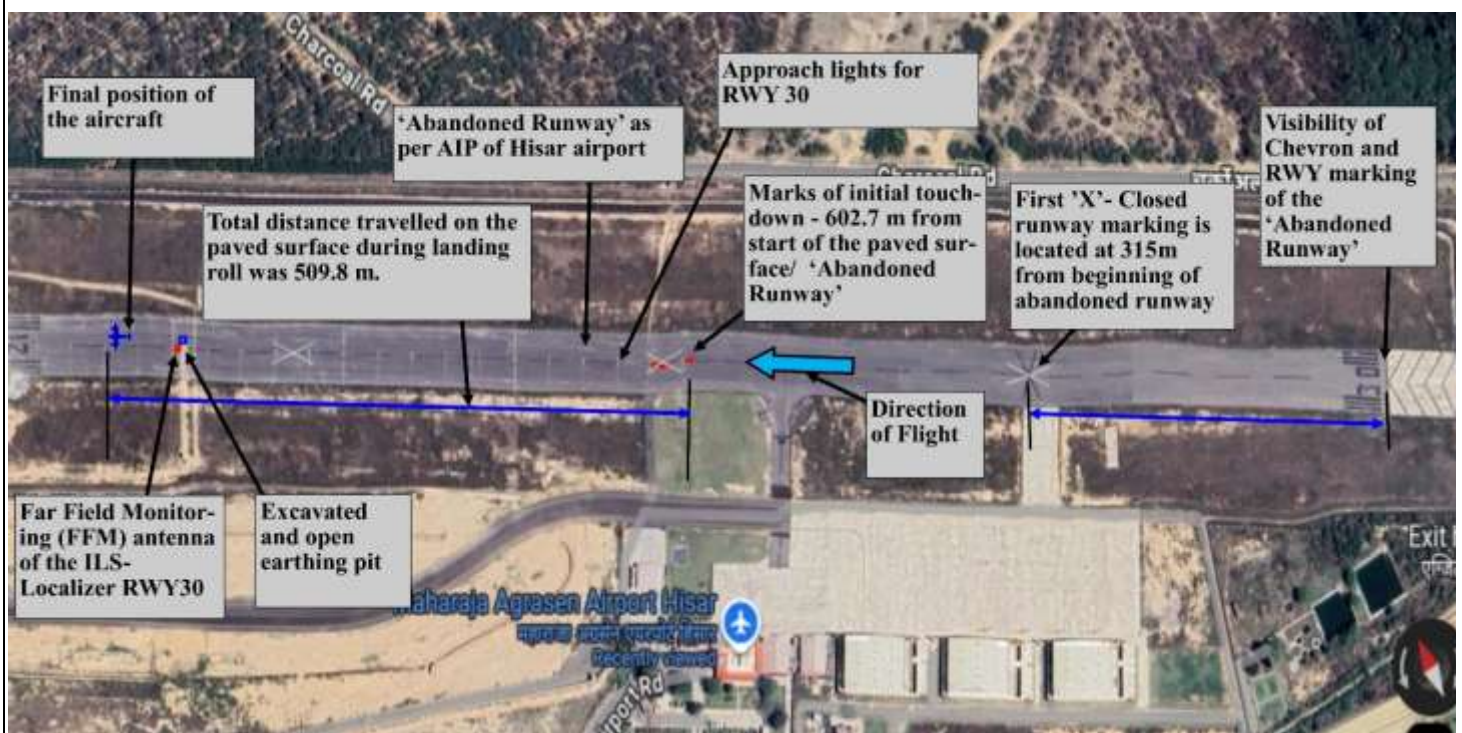
- c) The aircraft came to rest after a ground roll of 509.8m on the paved surface (abandoned runway).
- d) The aircraft made contact with the FFM antenna and approach light during the landing roll and damage is detailed in section 2.1 above.

**FIG 11: Incident site of aircraft on 'Abandoned RWY' – marked on Google maps (not to scale)**
