**Final Investigation Report on Serious Incident of Runway Undershoot involving  
M/s Alliance Aircraft VT-RKF on 08.10.2024 at Bhubaneswar Airport**

**Aircraft Accident Investigation Bureau  
Government of India  
Ministry of Civil Aviation**

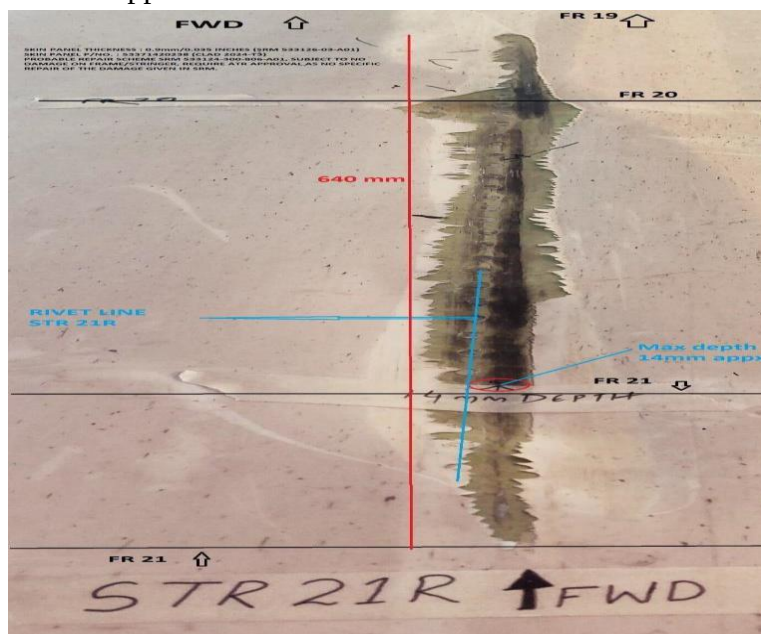
Damage was observed on the lower fuselage belly panel located between Frame 19 and Frame 21, along Stringer 21R (STR 21R) due to the Aircraft hit the ILS light pole. The affected area forms the bottom skin of the fuselage and is subject to cabin pressurization and bending loads. The damage extends within the belly/fairing region and involves adjacent structural members including Rib 23C, Rib 23D, Rib 27, and Rib 28A, which serve as transverse supports.

**Figure1. Damage observed at Aircraft Belly.**

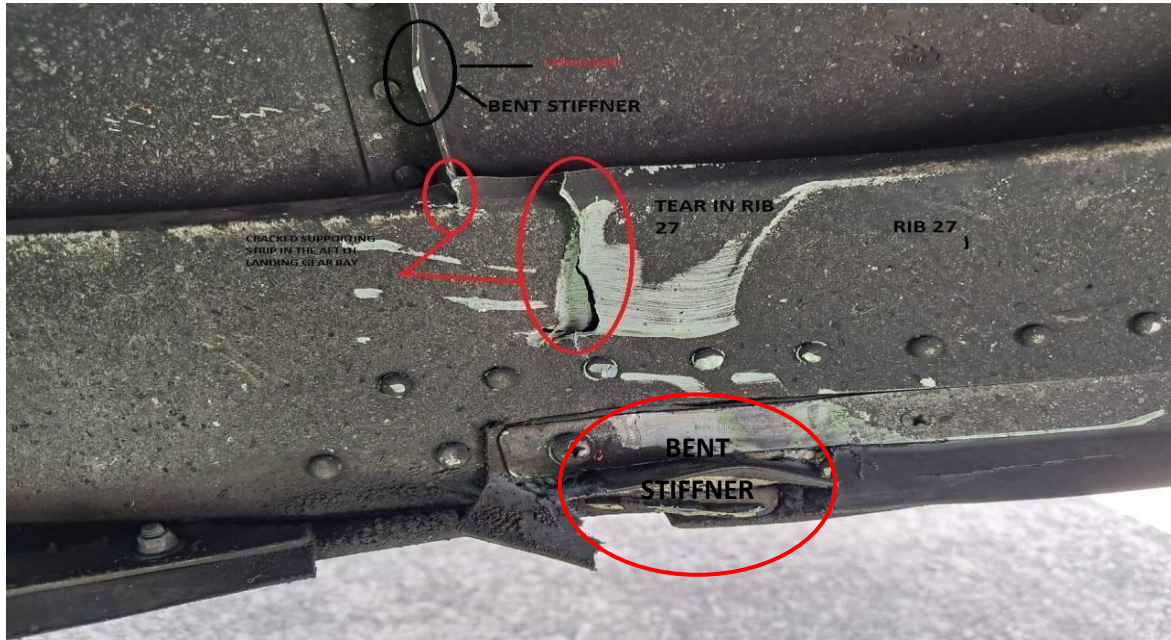
Damage was observed in the LH landing gear bay structure in the vicinity of Rib 27 after impact with the small electric Concrete tank. A vertical tear is present in Rib 27 web, with the crack extending through the rib material and showing local deformation around the torn area. The tear appears to initiate near the rib flange and propagates downward toward the fastener row. The supporting strip adjacent to Rib 27 is also found cracked in the aft LH landing gear bay area. In addition, a nearby stiffener is observed bent with local

deformation at the attachment location and bottom stiffener. Surface scraping and paint removal are visible around the damaged zone, indicating impact contact. The damage affects Rib 27, the supporting strip, and adjacent stiffener, which may influence local load transfer in the LH landing gear bay structure.

**Figure2. Damage observed at LH landing gear bay structure.**

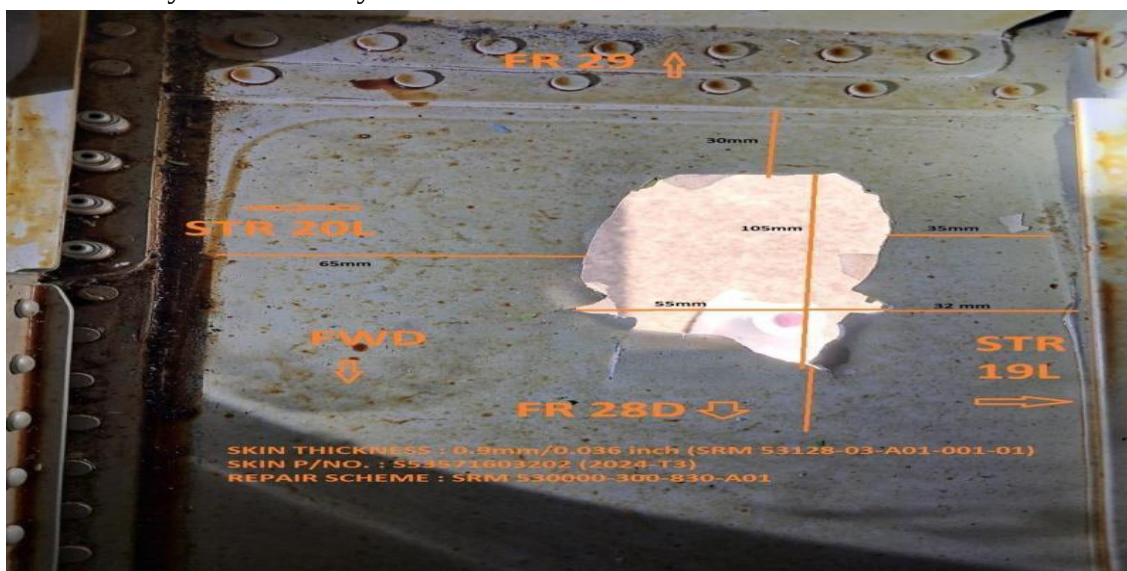
During approach the Aircraft initially impacted ILS light pole and damage the ILS pole, due to this sharp impact with the Aircraft belly and ILS Pole, A puncture hole was formed in the lower fuselage skin panel located between Stringer 19L and Stringer 20L, in the bay bounded by Frame 28D (forward) and Frame 29 (aft). The damage is an irregular tear-out in the skin with an approximate maximum vertical length of 105 mm and a width of about 55 mm at the lower section. The hole is positioned approximately 30 mm forward of FR29 and about 32–35 mm from STR19L, and approximately 65 mm from STR20L. The affected skin thickness is 0.9 mm, and the puncture fully penetrates the panel. The damage is within the lower belly skin area, which is subject to pressurization and fuselage bending loads.

The surrounding structure, including FR28D, FR29, STR19L, and STR20L, appears in close proximity to the damaged zone and may be affected by load redistribution.

**Figure 3. A puncture hole was formed in the lower fuselage skin panel**

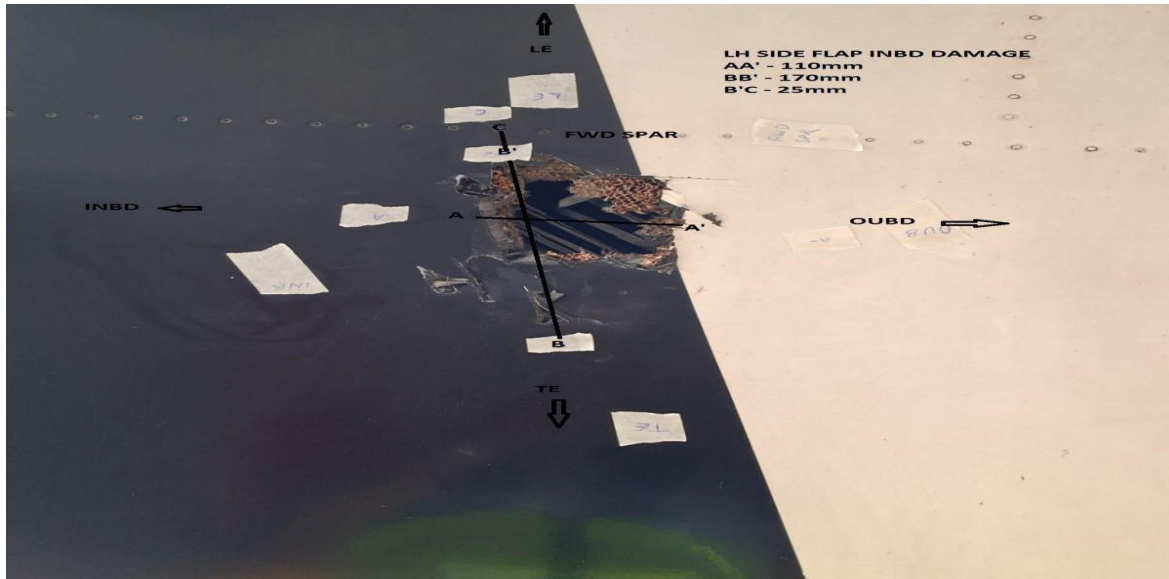
Damage in the form of a penetration hole was observed on the LH inboard flap, located forward of the front spar between Rib 8 and Rib 9. The damage extends through the outer skin and into the core honeycomb area. The affected region is part of the flap sandwich structure, and the penetration may compromise local skin-to-core bonding and structural stiffness. This damaged has confirmed the aircraft has landed before runway on unpaved land, The damage is confined to the area between Rib 8 and Rib 9 and forward of the spar, with potential impact on load transfer and aerodynamic surface contour. A detailed inspection was carried out after the occurrence of the surrounding skin, core material, spar, and adjacent ribs to determine the extent of disbond, core crush, moisture ingress, or additional hidden damage.

**Figure 4. Penetration hole was observed on the LH inboard flap.**

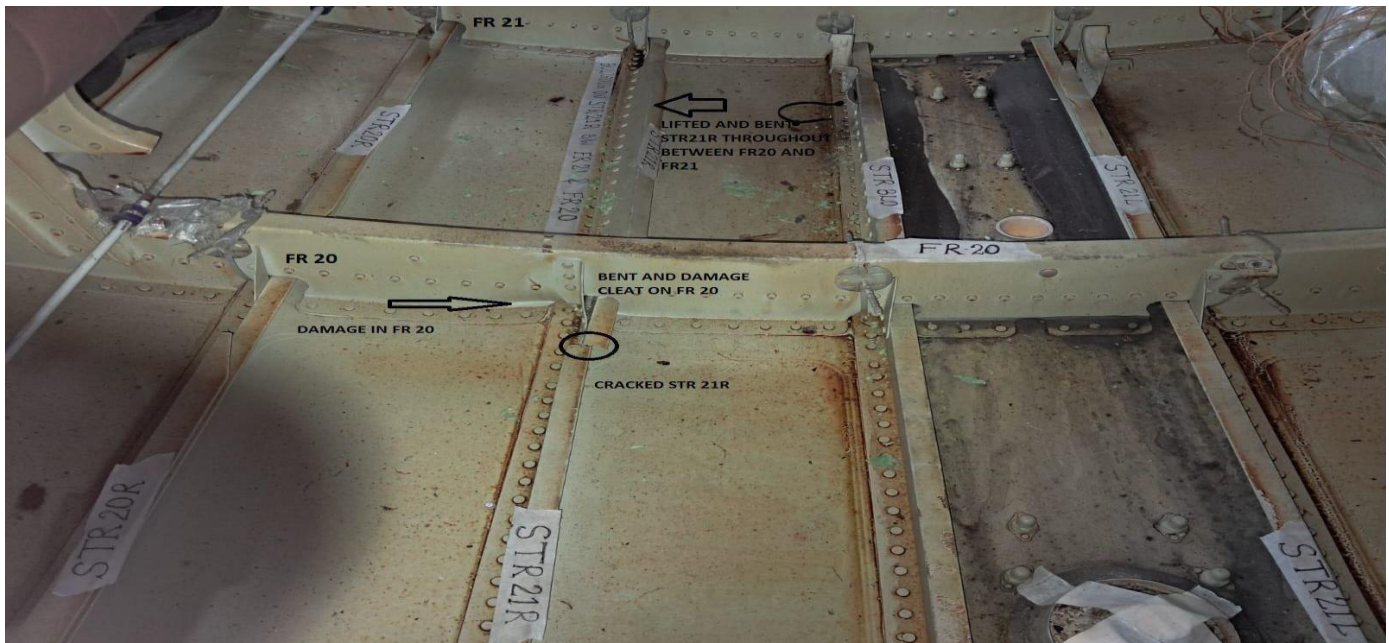
Damage was observed in the lower fuselage structure in the vicinity of Frame 20 (FR20), extending between FR19 and FR21. Stringer 21R is cracked between FR19 and FR20, adjacent to FR20, with separation noted at the frame-stringer junction. The crack initiates near the fastener row and the stringer shows local lifting in the affected area. Further deformation of STR21R is observed within the FR20–FR21 bay. Stringer 20R between FR20 and FR21 is deformed and bent. The stringer is also locally loose in the same region. A missing rivet is observed at the skin-to-stringer attachment level. Frame 20 is locally deformed at the STR21R cleat attachment location. The cleat attached to FR20 is bent and damaged. The associated bracket is also found deformed. Local deformation is visible on the FR20 web and flange. The damage affects load transfer at the frame-stringer interface. The surrounding skin in the area may be subjected to load redistribution. The damage is confined to the FR19–FR21 bay.

**Figure 5. Damage was observed in the lower fuselage structure.**

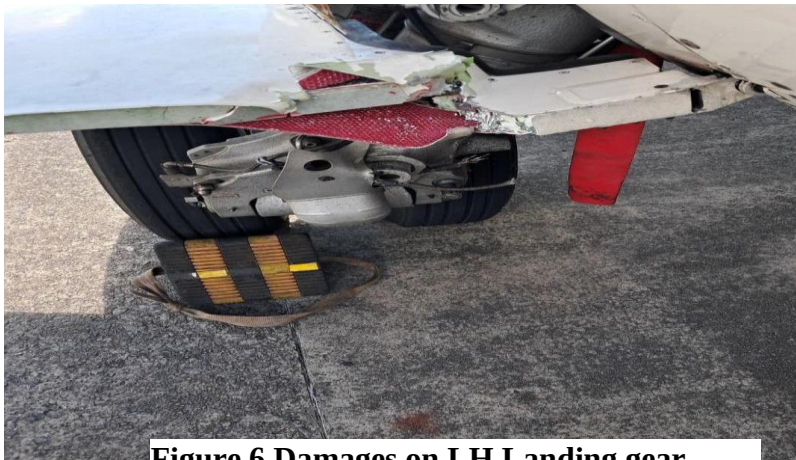
**Figure 6. Damages on LH Landing gear**

Damage was observed on the LH landing gear (L/G) door assembly affecting both the fixed and folding panels. The outer skin is torn and peeled back, exposing the internal honeycomb core with visible core crush and skin-to-core separation. The damage extends along the door edge near the hinge/attachment area, with local deformation and fractured sandwich structure evident. Panel edges are bent, affecting the aerodynamic contour and stiffness of the LH L/G door. Nearby cables routed in the LH L/G door area are also found damaged, showing signs of abrasion and possible severing. In addition, the baffle plate covering the weight-on-wheels (WOW) sensors of the LH landing gear leg assembly is found deformed.

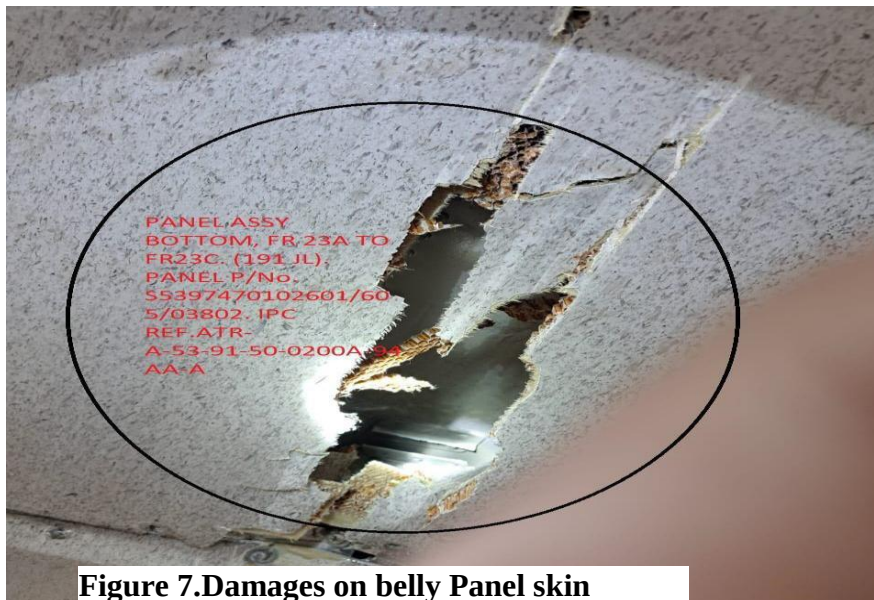
**Figure 7. Damages on belly Panel skin**

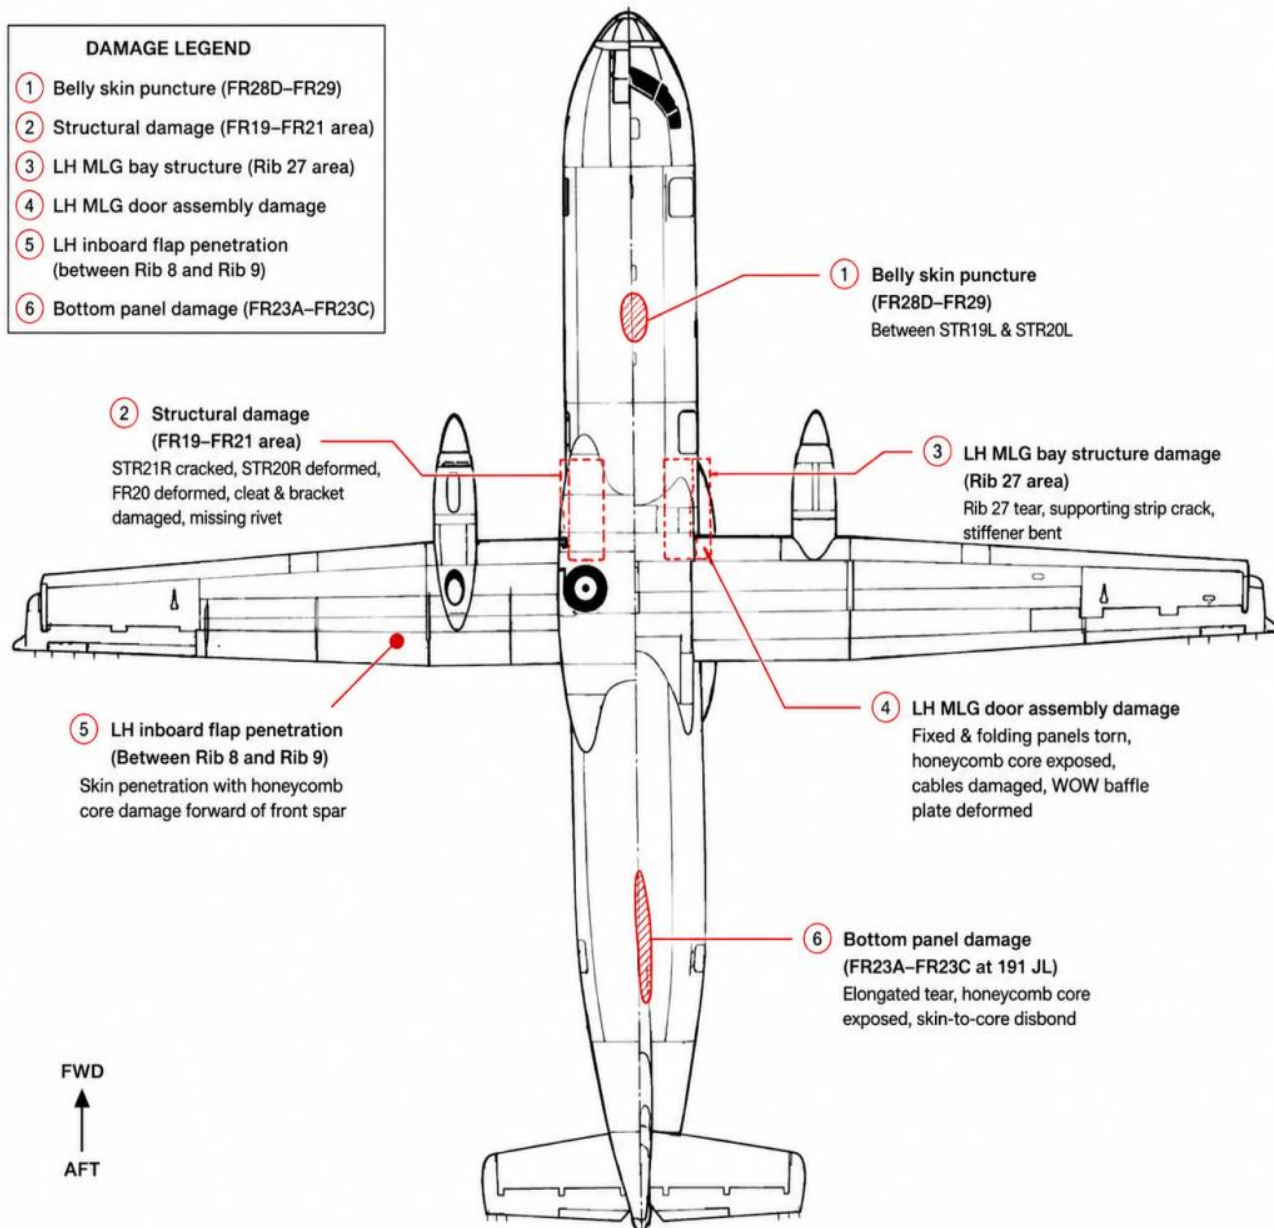
Damage was observed on the bottom panel assembly located between FR23A and FR23C at 191 JL. The panel skin is torn with an elongated penetration, exposing the internal honeycomb core. The damage extends longitudinally along the panel with fractured skin edges and crushed core

material visible. Local skin-to-core disbond is evident around the tear, with irregular edges indicating impact-related failure. The penetration appears to pass completely through the sandwich panel thickness. The surrounding panel area shows additional cracking and de-lamination adjacent to the primary tear. The damage may affect local stiffness and load distribution of the bottom panel assembly. Internal structure beneath the panel is visible through the opening, indicating full-thickness penetration.

**Figure 8. Aircraft Damages from Bottom view**

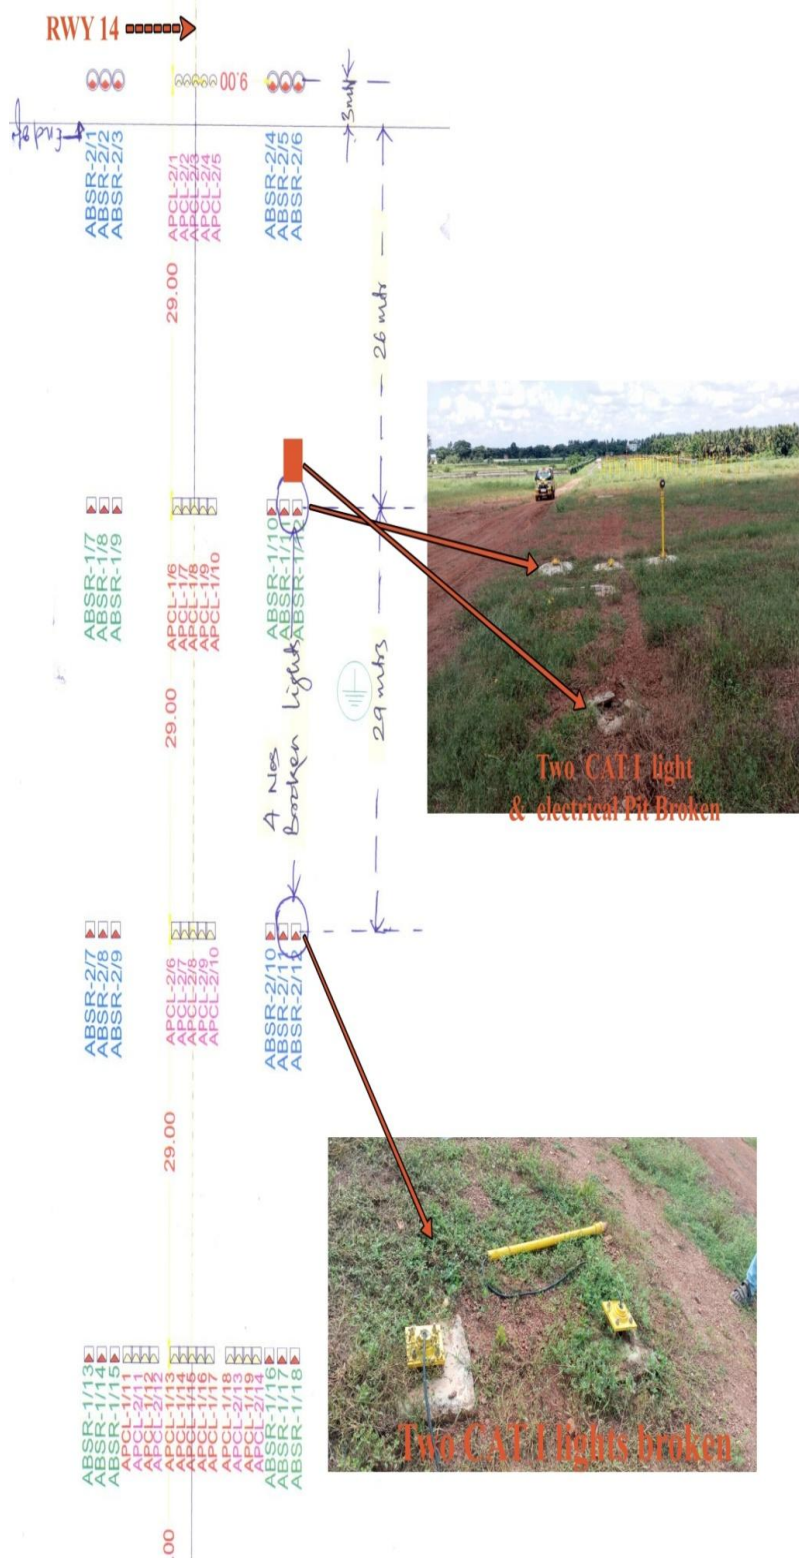
Four CAT I ILS approach lights have been confirmed as damaged due to the incident. The damage affects both the light fixtures and their supporting structures. Electrical cables connected to the system have been disturbed and are partially exposed. Additionally, one electrical pit has been identified as broken and displaced from its original location.

Several components are misaligned and are no longer in a serviceable condition. This includes signs of possible deformation or misalignment in the gear assembly. Overall, both the ground infrastructure and the aircraft structure were affected by the event.

Figure 9.Damages on ILS CAT I& CAT II lights.

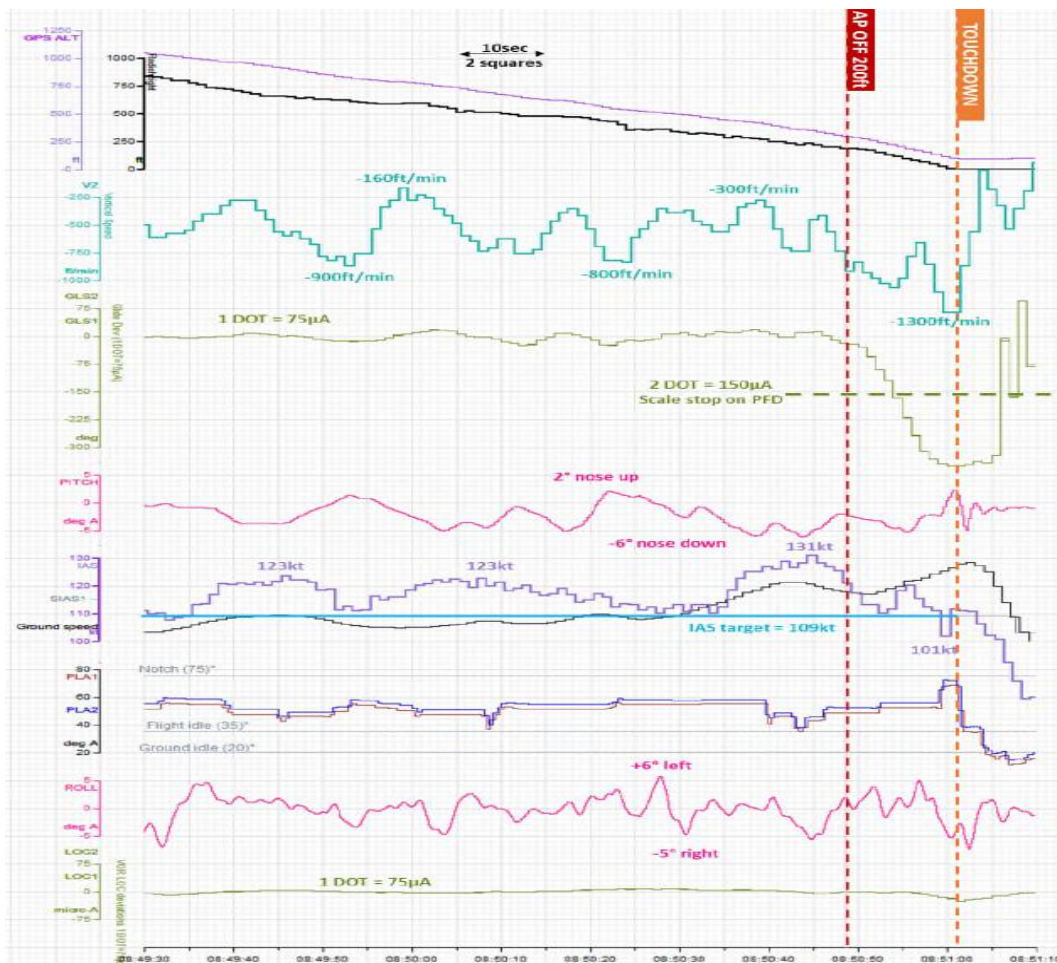
The DFDR data reveals that, at approximately 200 ft RA, while the AP was engaged, a nose-down input began to be recorded on the CM1 side, eventually reaching 11 daN. The data also shows the progression of the control inputs leading to the disengaged of the AP and YD. It should be noted that the AP/YD parameter is sampled at a rate of 1 second; therefore, the recorded disconnection may appear slightly later than the actual event, which most likely occurred when the control effort reached 10 daN.

Based on the GPS position the aircraft touched down at ~100m before the runway threshold.

- The maximum lateral deviation was reached at touchdown also and was recorded at 16m (1/3 DOT).
- The IAS was 111kt and the ground speed was 126kt.
- The pitch angle was at +2° nose up and the roll angle was -5° left.
- The load factor reached 1.7G

**Figure 13.DFDR analysis of the occurrence Aircraft**

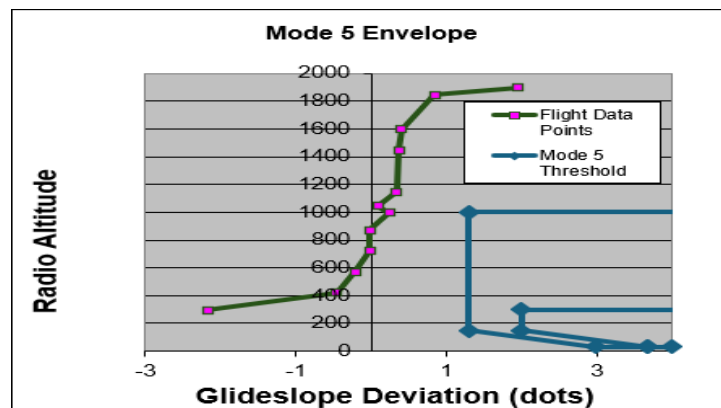
**Figure15. Actual Mode 5 Envelope VS Altitude**

The graph demonstrates that the aircraft progressively deviated below the glideslope as the radio altitude decreased, eventually entering the Mode 5A and Mode 5B warning regions associated with excessive glideslope deviation. The plotted flight points show that the deviation increased significantly during the final stages of approach, particularly below 300 feet Radio Altitude, indicating an unstable approach profile. Analysis of the slope between the 1.3 dot / 150 feet point and the 2.98 dot / 30 feet point shows a calculated descent gradient of approximately -71 feet per dot. Based on this slope projection, when the glideslope deviation increased from 1.3 dots to 2 dots, the aircraft would be approximately 50 feet lower, resulting in an altitude difference consistent with the reported 100 feet deviation observed during the occurrence.

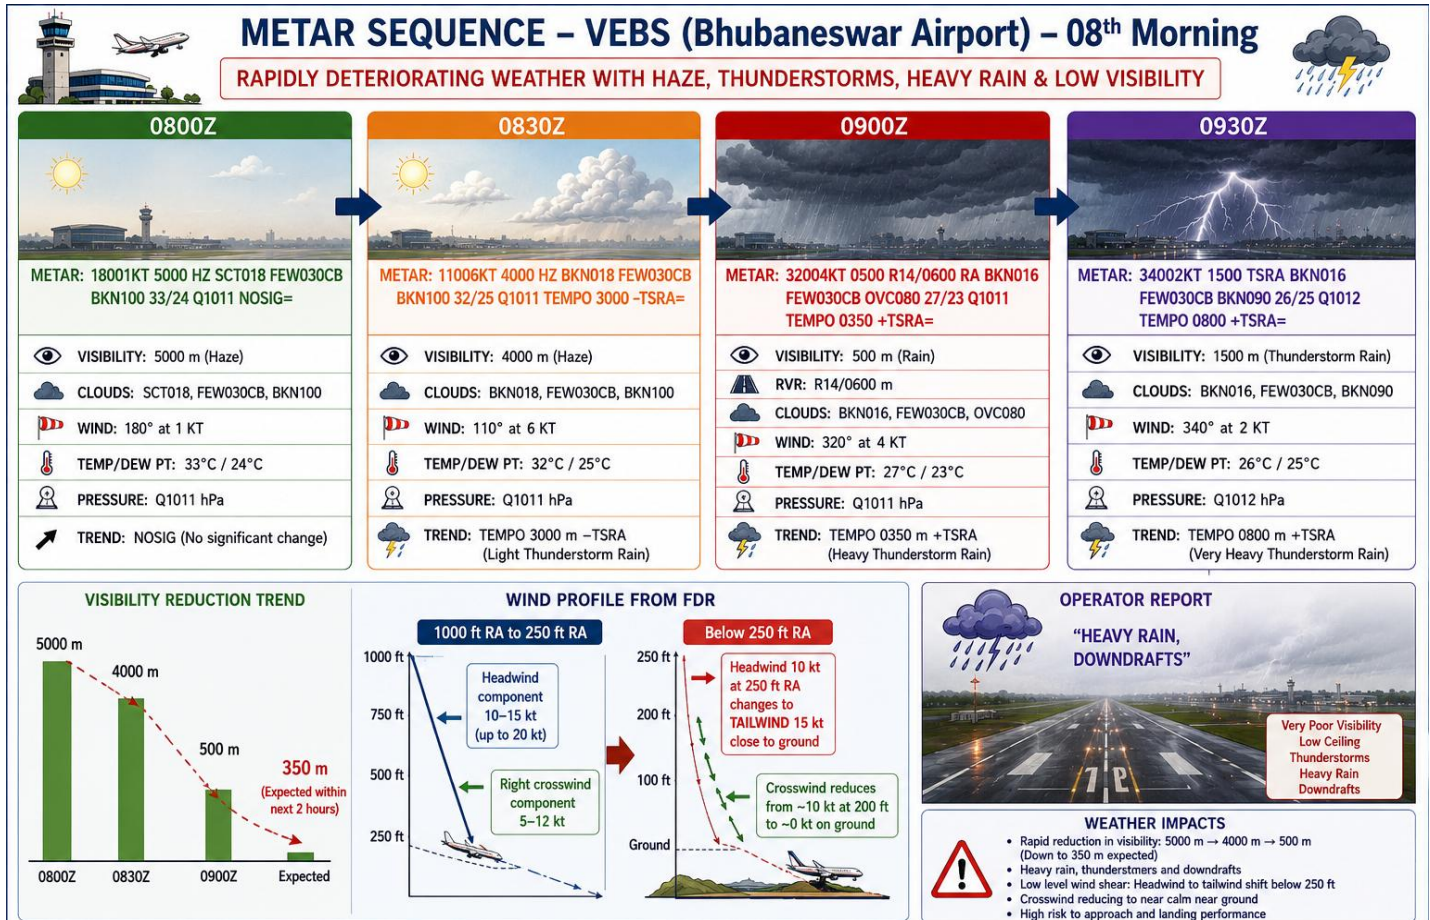
Simultaneously, the crosswind component decreased from around 10 knots at 200 ft to nearly zero at ground level. This sudden change in wind characteristics had a critical aerodynamic impact on the aircraft. The loss of headwind resulted in a reduction of relative airflow over the wings, thereby decreasing lift and increasing the aircraft's sink rate. The transition to tailwind further increased ground speed and reduced the effectiveness of lift generation. The diminishing crosswind also altered lateral aerodynamic forces, potentially affecting directional control. Such rapid changes in wind speed and direction at low altitude are

particularly hazardous because they occur during the final phase of flight, where there is minimal time and altitude available for corrective action.

Figure 20.VEBS METAR Sequence at time of occurrence.

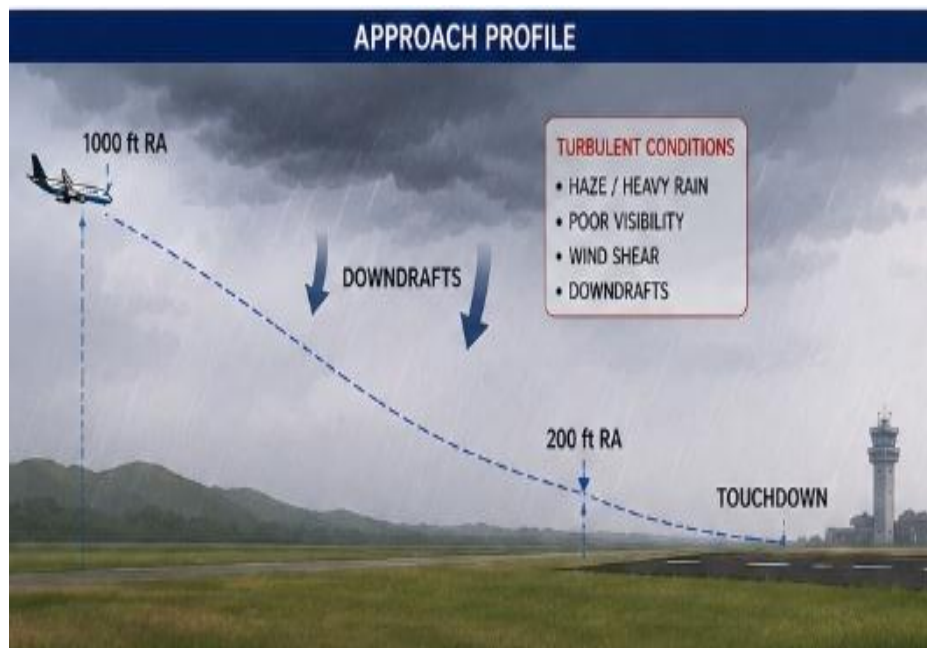
Figure 21.VT-RKF Approach profile from 1000 ft.

The rapid transition from headwind to tailwind would have caused a sudden loss of aircraft performance and lift during the critical landing phase. Combined with heavy rainfall, poor visibility, cumulonimbus clouds, and intense downdrafts, the meteorological environment was extremely unfavorable for safe flight operations. Overall, the sequence of METAR reports together with the operator's weather observations and recorded wind data clearly demonstrate the presence of severe convective weather, heavy precipitation, deteriorating visibility, and low-level wind shear conditions over Bhubaneswar airport during the observation period.

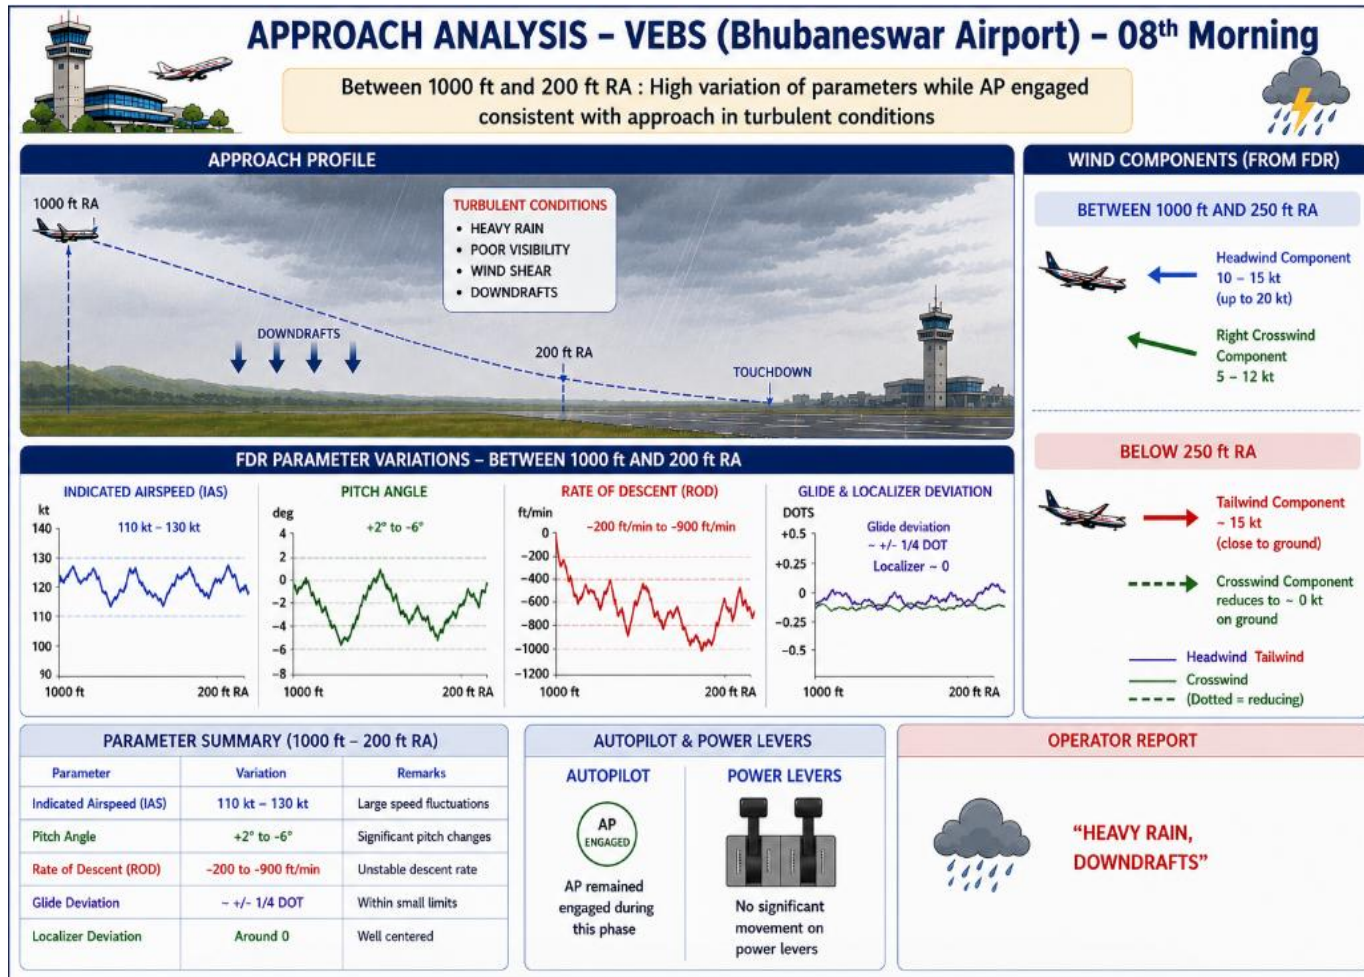
During the final stage of the approach, at approximately 200 feet radio altitude, a significant nose-down control effort started to be recorded from the Commander 1 (CM1) side while the autopilot remained engaged. The recorded nose-down force progressively increased and reached approximately 11 daN, indicating a strong forward input on the control column. Analysis of the flight data shows that the autopilot and yaw damper systems were still engaged during the initial phase of this control input. Due to the one-second sampling rate limitation of the autopilot and yaw damper parameters, the recorded disconnection times may not exactly represent the precise moment of disengagement. It is therefore highly probable that the autopilot disengaged when the control column force reached approximately 10 daN. Simultaneously, an effort was also detected on the rudder pedals while both the autopilot and yaw damper were still active. This rudder pedal input caused the automatic rudder trim system to react in opposition to the applied force. As a consequence, the rudder trim progressively moved toward the nose-right direction

in order to counterbalance the rudder pedal pressure. The rudder trim value eventually reached approximately 7 degrees nose-right, corresponding to nearly one dot of trim indication. Shortly afterward, the yaw damper system was re-engaged and then disengaged again approximately two seconds later, most likely through manual activation of the yaw damper push button.

**Figure22. VT-RFK Approach analysis from 1000ft to landing.**

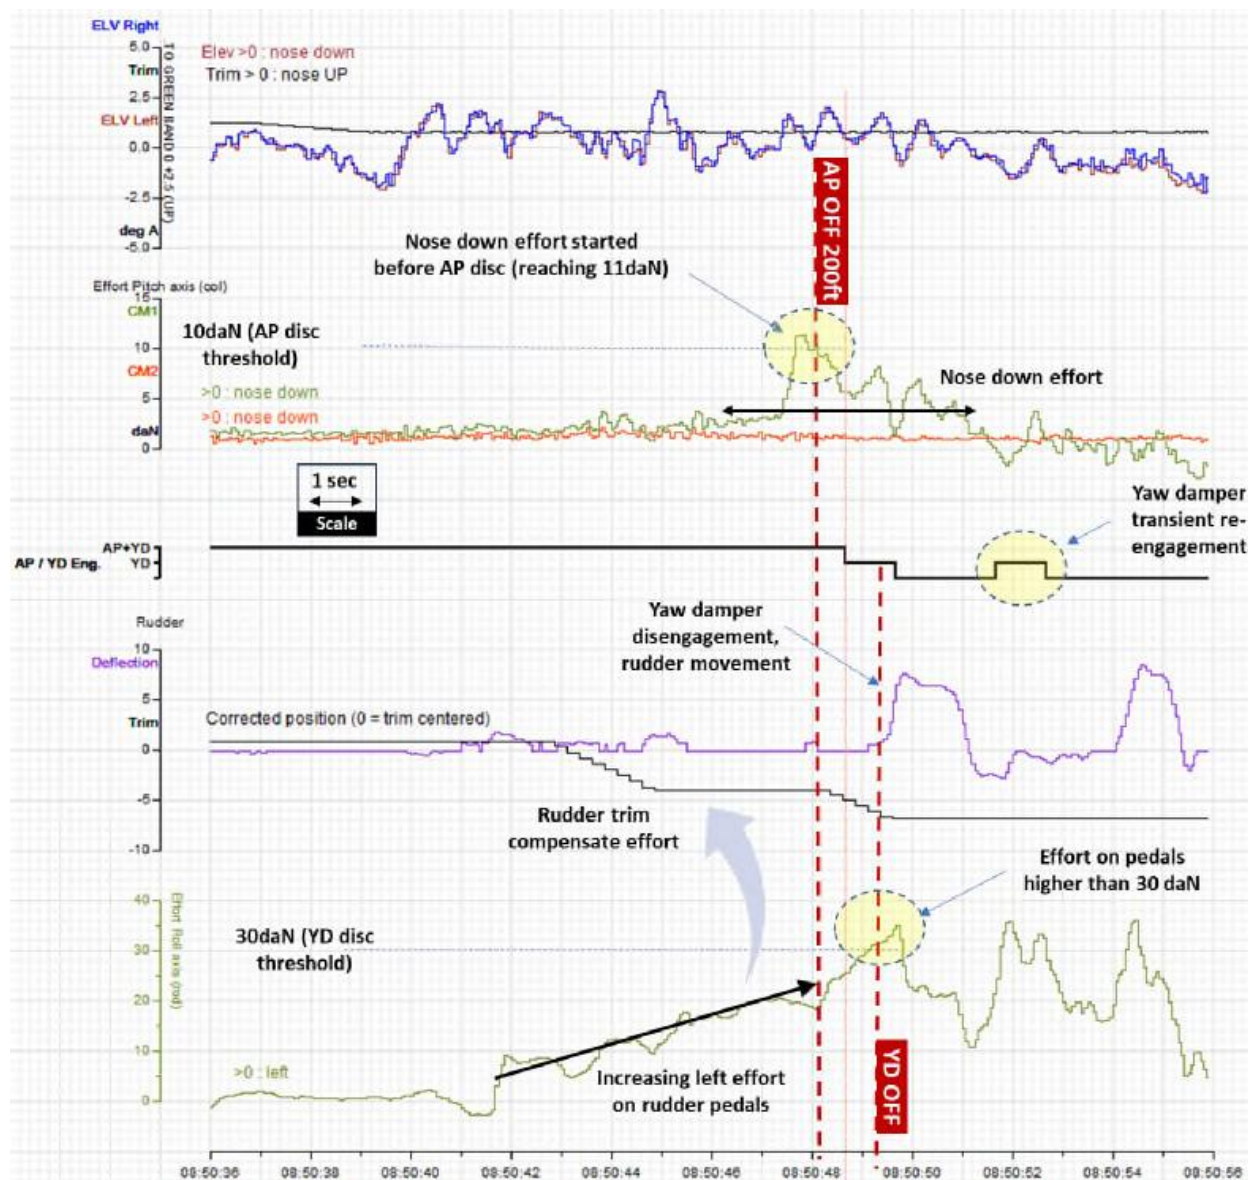
These repeated yaw damper engagement changes indicate a rapidly evolving flight control situation during the critical final phase of approach. As soon as the autopilot disengaged, the aircraft response became directly influenced by the previously applied nose-down control input. The pitch attitude rapidly changed from approximately 2 degrees nose-down to nearly 5 degrees nose-down within a period of only six seconds. This pitch decreases significantly altered the aircraft flight path and contributed to a rapid increase in descent rate. During the same time interval, the vertical speed increased from approximately 600 feet per minute descent to nearly 1000 feet per minute descent when the aircraft was around 100 feet radio altitude. Such a rapid increase in descent rate during low altitude flight represented a critical degradation of approach stability. Concurrently, meteorological conditions in the runway environment were deteriorating due to significant low-level wind variations associated with convective weather activity. As indicated by the weather analysis, the wind component transitioned from a headwind of approximately 10 knots at 250 feet radio altitude into a tailwind of approximately 15 knots close to the ground. This sudden wind reversal is characteristic of low-level wind shear and possible microburst activity generated

by thunderstorm downdrafts. The rapid change from headwind to tailwind would have caused an abrupt loss of aircraft energy and lift, further aggravating the increasing descent rate and nose-down flight path.

**Figure 23. Trim and efforts during AP/YD disengagement**

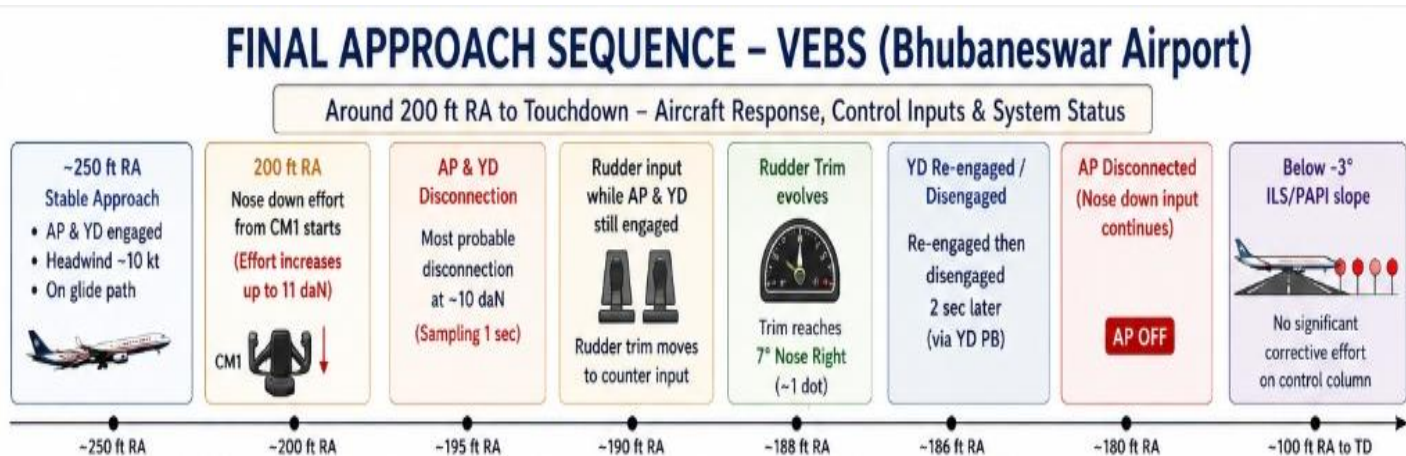
The combination of the nose-down control input, autopilot disengaged, and deteriorating wind conditions significantly affected the aircraft's vertical profile. As the descent continued, the aircraft deviated below the nominal 3-degree ILS and PAPI approach slope. Flight data analysis indicates that no significant corrective control column efforts were subsequently recorded to recover the flight path deviation. This absence of strong corrective pitch input suggests that the aircraft remained in a continued descent below the stabilized approach profile. The Precision Approach Path Indicator (PAPI), located approximately 270 meters beyond the runway threshold, provides a visual glide path corresponding closely to the Instrument Landing System glide slope. Since both the PAPI and ILS define essentially the same 3-degree approach path, the aircraft deviation below the glide slope confirms that the aircraft was descending beneath the safe visual and instrument guidance profile during the final moments of the approach.

The combination of unstable atmospheric conditions, strong control inputs, autopilot disengagement, changing wind components, and increasing descent rate created a highly critical flight situation at very low altitude. Overall, the recorded flight data indicate that the aircraft encountered severe operational difficulties associated with turbulent weather, low-level wind shear, and destabilized flight path conditions during the final approach segment.

**Figure 24. Sequence of Final approach**

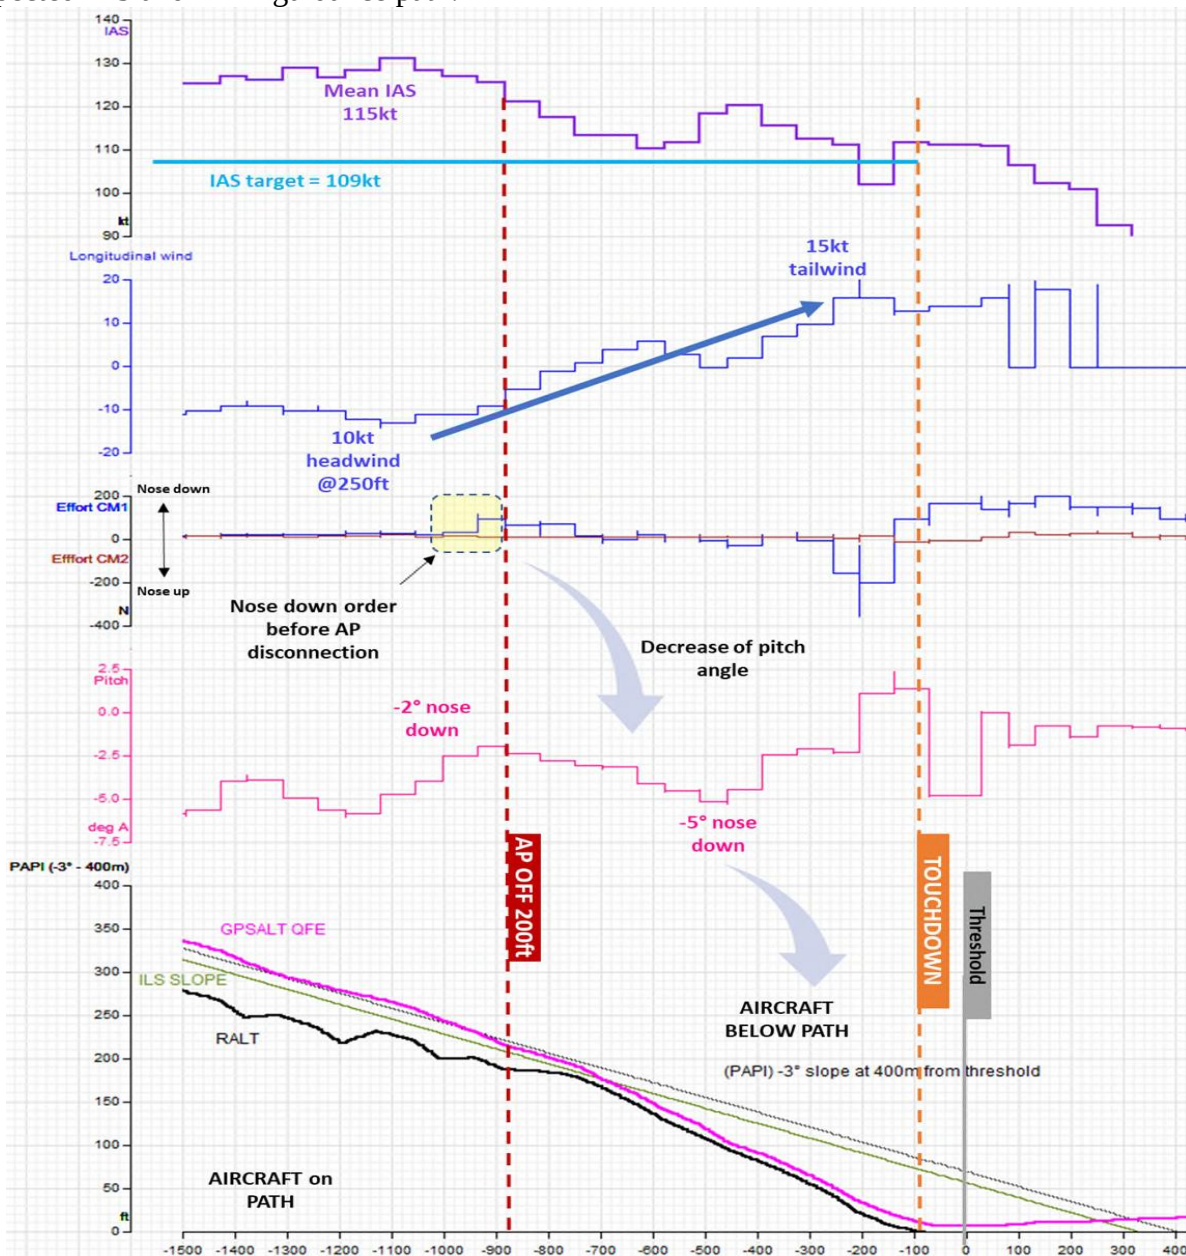
At approximately 100 feet radio altitude, the glide slope deviation reached minus 2 dots, corresponding to the lower scale stop indication on the Primary Flight Display. This indicated that the aircraft had significantly deviated below the normal ILS glide path. The deviation below the expected vertical profile confirmed that the aircraft was no longer maintaining a stabilized approach condition. On the lateral axis, the aircraft also began to drift progressively toward the right side of the runway centerline. Flight data showed that the localizer deviation increased and reached approximately one quarter dot to the right. Although the lateral deviation remained relatively limited, it demonstrated the beginning of directional instability during the final approach segment. One of the contributing factors to this lateral behavior was the rudder trim position. At the time of the autopilot disengage the rudder trim remained positioned at approximately 7 degrees nose-right and was not re-centered afterward. This trim position had initially been generated automatically to compensate for rudder pedal inputs while the autopilot and yaw damper were still engaged. Since the trim remained displaced after autopilot disengagement, the aircraft required greater pilot effort to apply left rudder input compared with right rudder input. Consequently, directional corrections toward the left side became more difficult during the critical low-altitude phase of flight. At the same time, the prevailing crosswind component was from the right side and remained below approximately 5 knots near the ground.

Although the crosswind magnitude was relatively weak, its direction combined with the existing rudder trim condition may have further influenced the aircraft tendency to drift to the right. The analysis of the rudder trim parameter also required correction due to the recording reference system. The recorded rudder trim value corresponds to minus 3 degrees when the trim is physically centered. For analysis purposes, a manual offset of plus 3 degrees was therefore applied in order to obtain a more accurate representation of the actual trim position. After applying this correction, the rudder trim displacement was determined to have reached approximately 7 degrees nose-right during the final approach phase. Flight data further indicated that the maximum recorded rudder trim values ranged between plus 13 degrees and minus 19 degrees, corresponding to approximately plus or minus 16 degrees of actual rudder trim displacement capability. These values demonstrate the significant authority available within the rudder trim system and highlight the importance of trim centering during critical flight phases. Overall, the combination of the nose-down input, low-level wind reversal, uncorrected glide path deviation, residual rudder trim

displacement, and increasing lateral deviation contributed to a destabilized final approach condition below the expected ILS and PAPI guidance path.

Figure 25. Trajectory and parameter around the AP disengaged

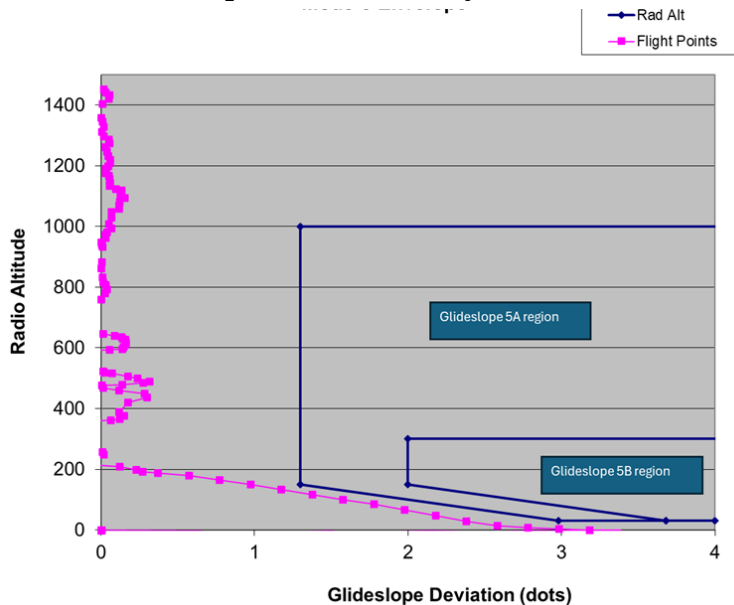
This analysis supports the conclusion that the aircraft descended substantially below the intended glide path during the final approach phase which is MUST NOT ALERT region. The analysis also highlights the effect of the glideslope rate limiting filter incorporated within the system. Flight testing conducted by ACSS revealed that several parameters, including ILS glideslope signals, are susceptible to noise, fluctuations, and momentary signal disturbances. To prevent nuisance warnings and false alerts caused by these signal irregularities. The non-alerting is acceptable via the TAWS regulations and filtering mechanisms are applied to smooth the glideslope operation.

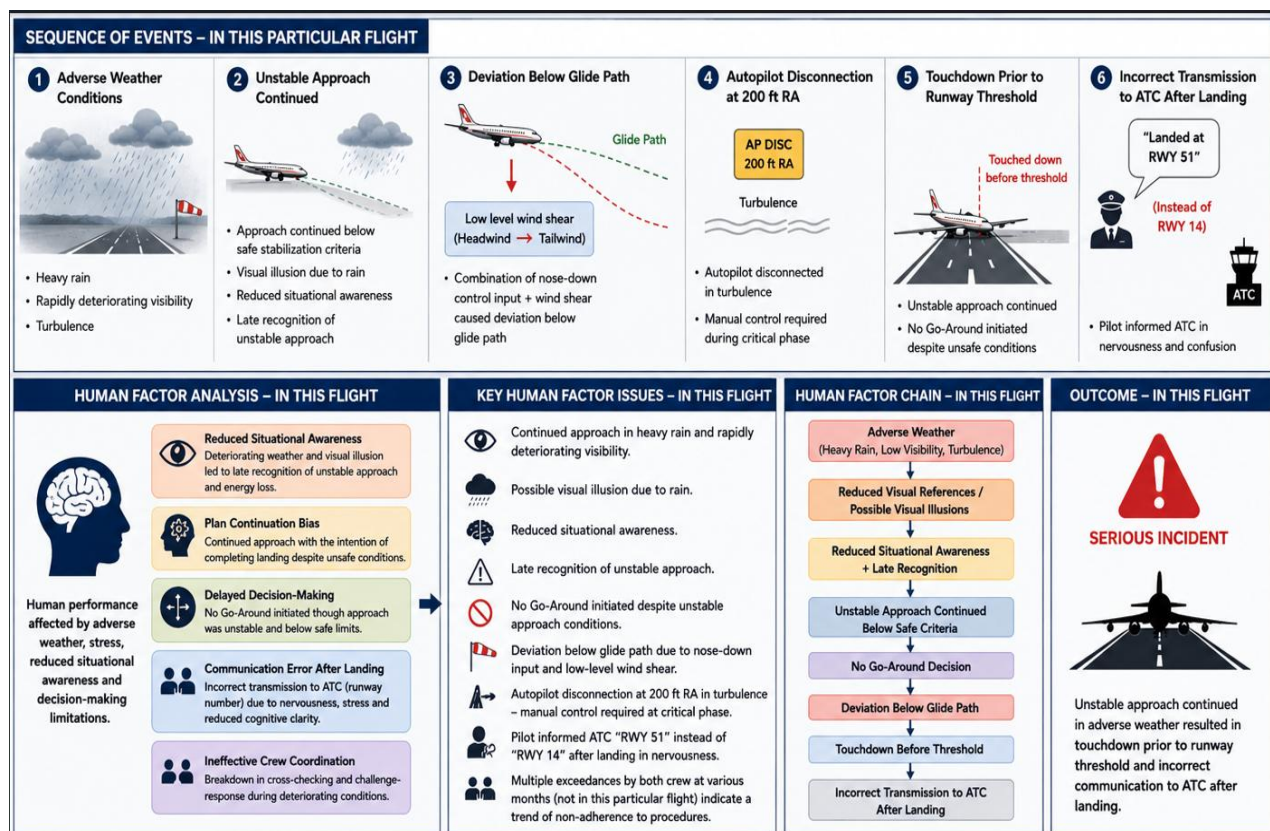
This Runway undershoot occurrence highlights important human factor issues related to pilot decision-making, situational awareness, and handling of the aircraft during bad weather conditions. The flight crew continued the approach and landing in heavy rain and rapidly reducing visibility, which increased the risk during the final phase of flight at 500 ft RA. Heavy rain can create visual illusions and reduce outside visibility, making it difficult for pilots to correctly judge the aircraft's position, height, runway alignment, and descent rate. Due to the worsening weather conditions, the crew's situational awareness may have reduced, and the unstable approach may not have been identified at the proper time. Even though the approach conditions became unsafe, no Go-Around was initiated. Failure to carry out a timely Go-Around indicates a lapse in judgment and decision-making by the crew as per the operator's Operation Manual. The organization operational manual strictly advised the pilots may not continue the approach with the intention of completing the landing despite worsening weather conditions and plan for Go around. However, the crew continued the approach to land which is a common human factor known as "plan continuation bias." The rapidly changing weather and high cockpit workload may also have affected the crew's ability to properly monitor the aircraft and respond quickly.

**Figure 26. Human Factors Analysis of VT-RKF Runway overshoots occurrence.**

The continuation of the approach without initiating a Go-Around indicates a critical lapse in operational judgment and decision-making. Failure to execute a timely Go-Around despite deteriorating weather, possible energy loss, and unstable approach indications suggests reduced threat perception and delayed cognitive response under high workload conditions, also there was shortcoming in Crew Resource
