**Final Investigation Report on Serious Incident: Airprox
Between
Turkish Airlines, Airbus, A330-223F, Türkiye, TC-JOO
and
Flydubai, Boeing, B737 MAX 8, United Arab Emirates, A6-FKR
On
30 August 2025 in Mumbai FIR (INDIA)**

**AIRCRAFT ACCIDENT INVESTIGATION BUREAU
MINISTRY OF CIVIL AVIATION
GOVERNMENT OF INDIA**

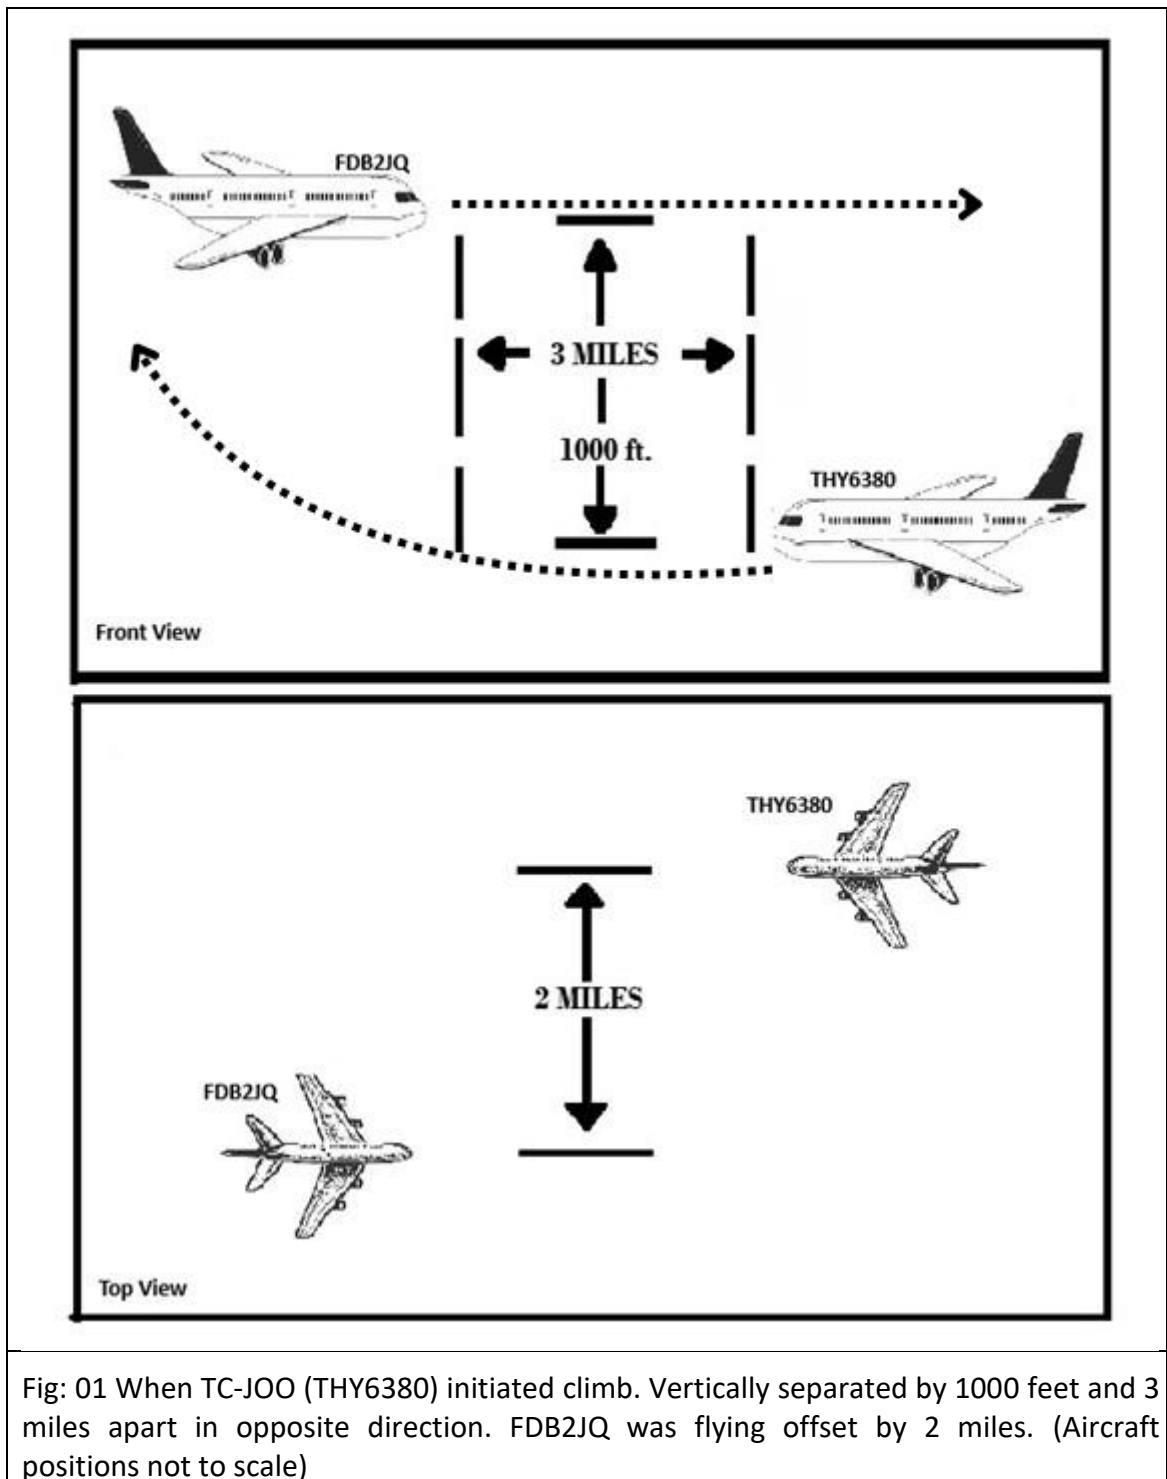
At this time the opposite direction traffic FDB2JQ was 3 miles ahead and 2 miles offset

towards right of THY6380 in the opposite direction and 1000 feet above as shown in Fig:01.

Fig: 01 When TC-JOO (THY6380) initiated climb. Vertically separated by 1000 feet and 3 miles apart in opposite direction. FDB2JQ was flying offset by 2 miles. (Aircraft positions not to scale)

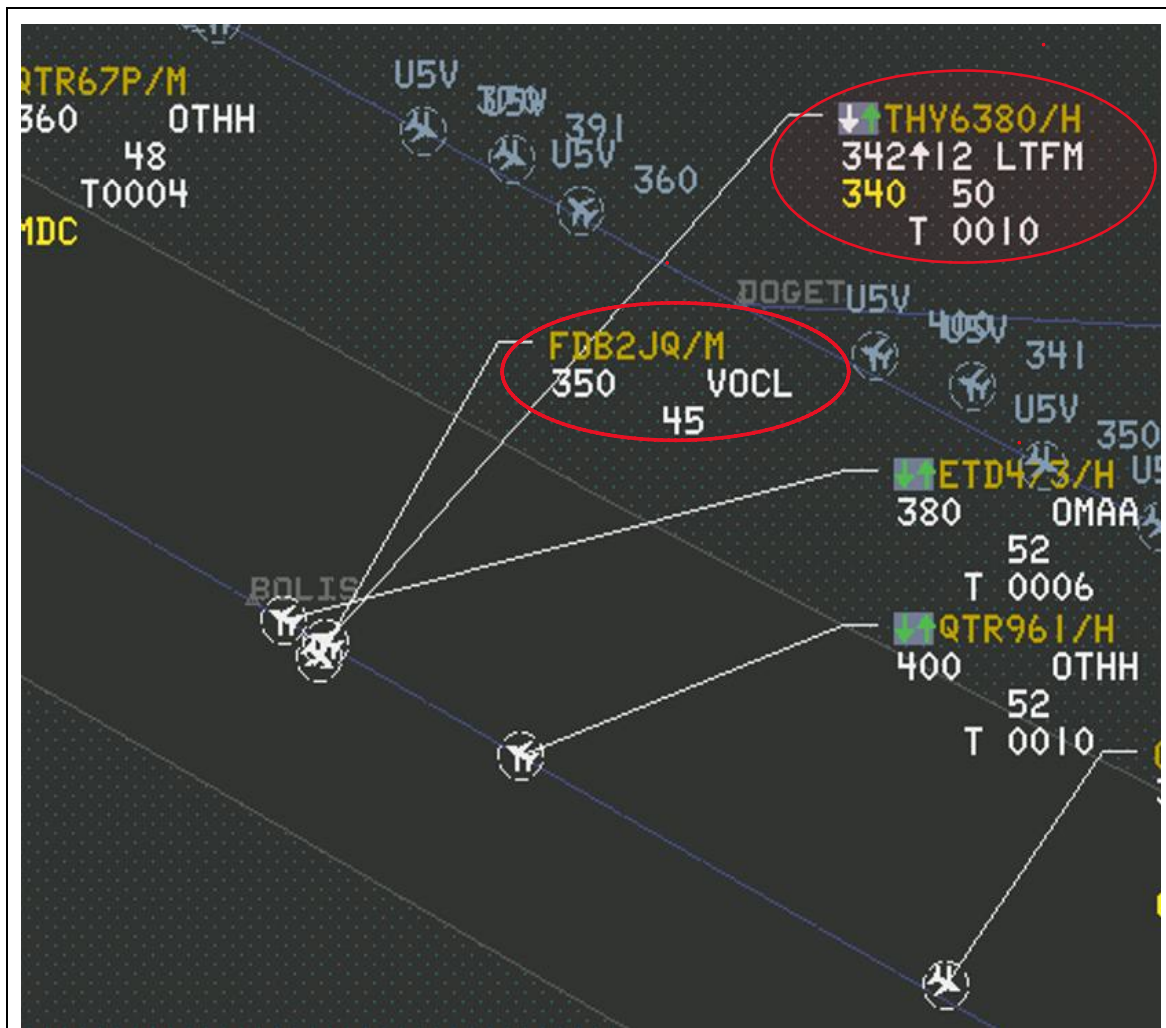
Fig: 02 Position of THY6380 passing FL342 in climbing phase and FDB2JQ at FL350 (Screenshot of Controller work Position in OCC, by Mumbai ATC)

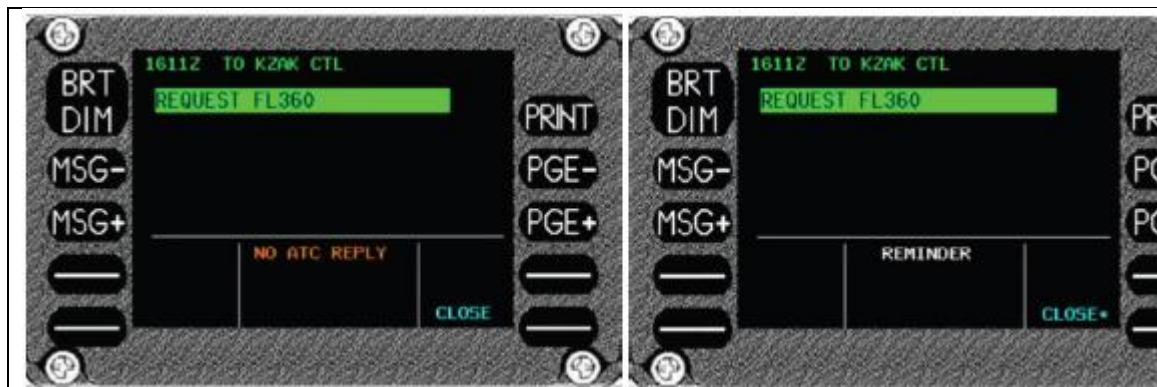
At 23:46:06, in absence of an ATC uplink message with a MRN, the onboard ATC datalink system displayed a reminder message on the DCDU associated with the visual cockpit ATC MSG pb light. The PB lights are the attention getters for the flight crew to have a look at the ECAM pages to deal with different kind of messages with ATC that are not only clearances but also report request, negotiation, information or reminder messages.

Fig 06A: Example of the reminder messages displayed on the DCDU

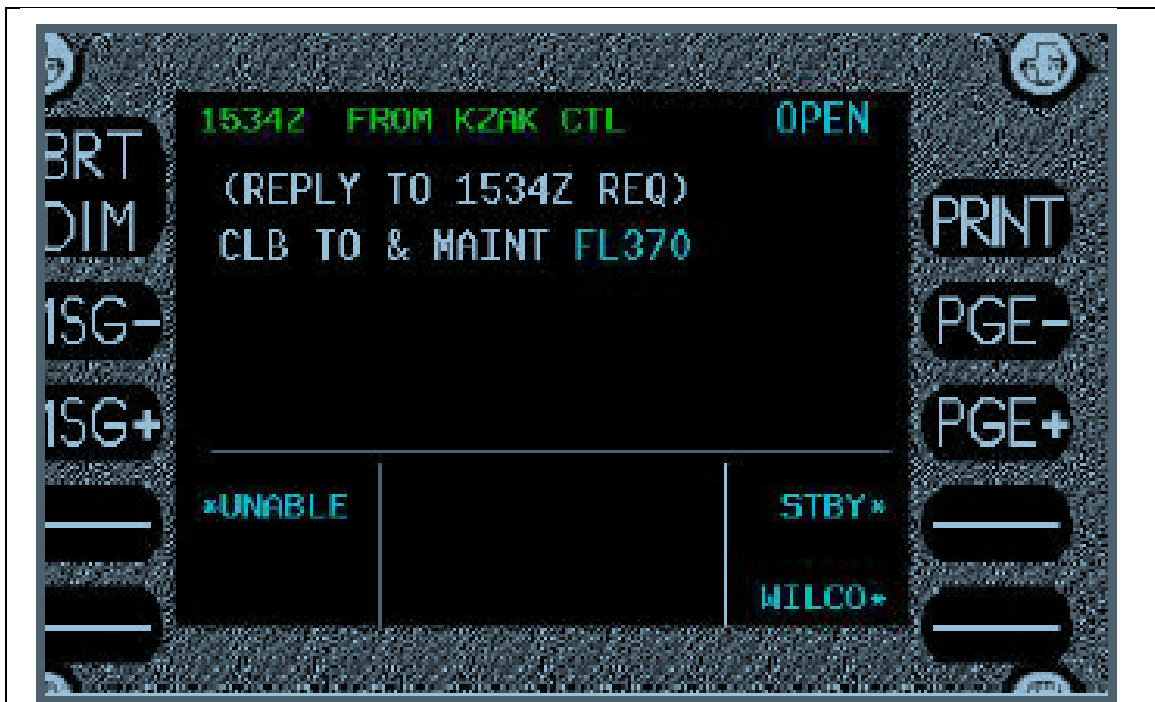
Fig 06B: Example of the reception of the ATC clearance to FL370 to a downlink request sent at 1534Z and linked with MRN.
