**FINAL INVESTIGATION REPORT ON
SERIOUS INCIDENT INVOLVING
M/s AIR ARABIA A320 AIRCRAFT A6-AOT
WHILE OPERATING SECTOR CHITTAGONG- ABU DHABI ON 6 JUNE 2022**

**GOVERNMENT OF INDIA
MINISTRY OF CIVIL AVIATION
AIRCRAFT ACCIDENT INVESTIGATION BUREAU**

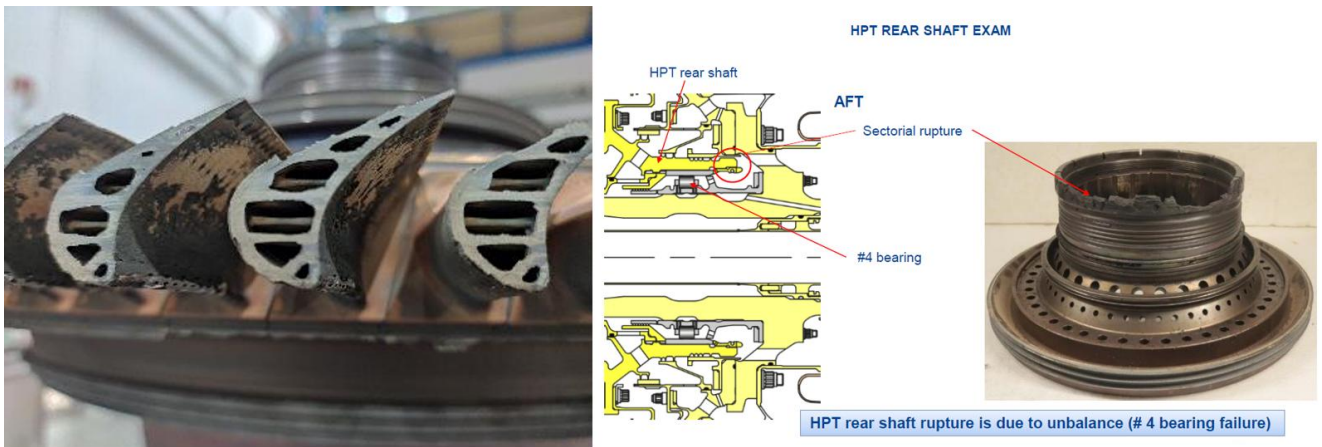
Figure 6

1. HPT Blades were found with heavy rubbing and the HPT rear shaft was damaged.

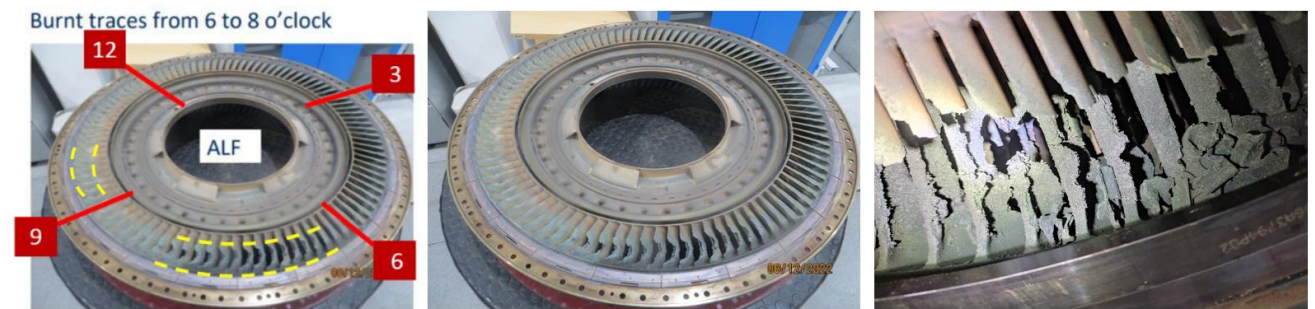
Figure 7

2. LPT nozzle guide vanes were observed with distress signs. Vanes from 6 to 8 o'clock position were severely burnt. LPT 2 Nozzle guide vanes were fully burnt.

The correlation of damages on LPT stator vanes with Fuel Nozzle's flow distribution or observations on Combustion Chamber does not indicate any significant linking. The distress and damages were likely caused due to excessive fuel flow during engine roll back.

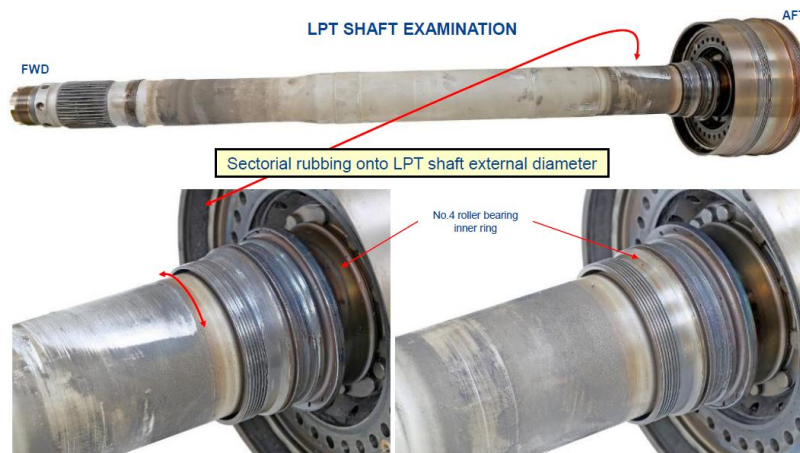
Figure 8

3. Rubbing marks were found on LPT shaft.

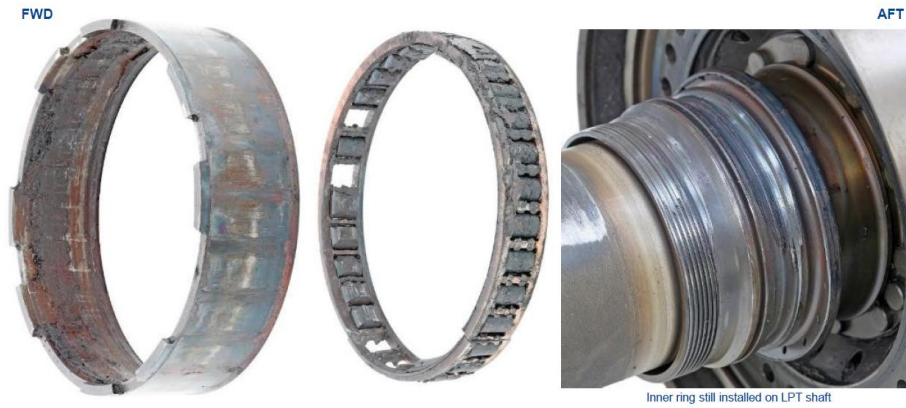
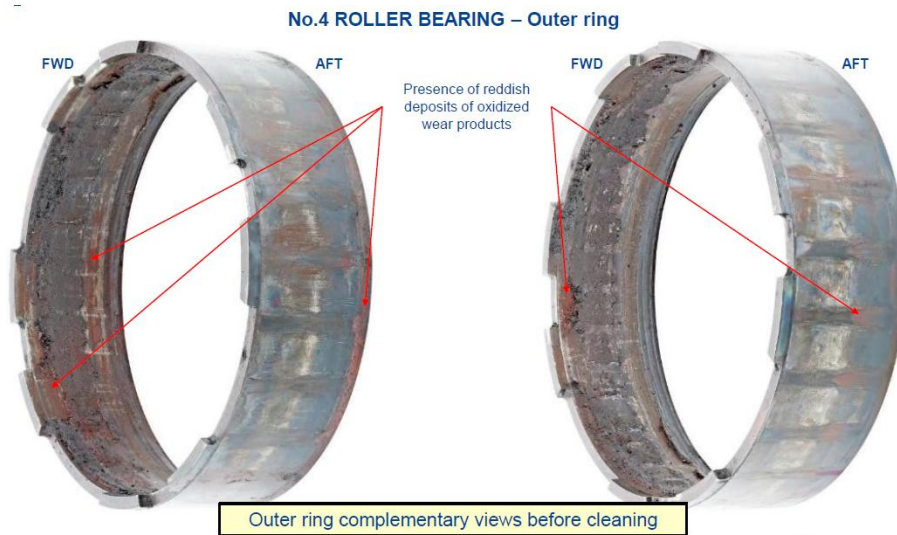
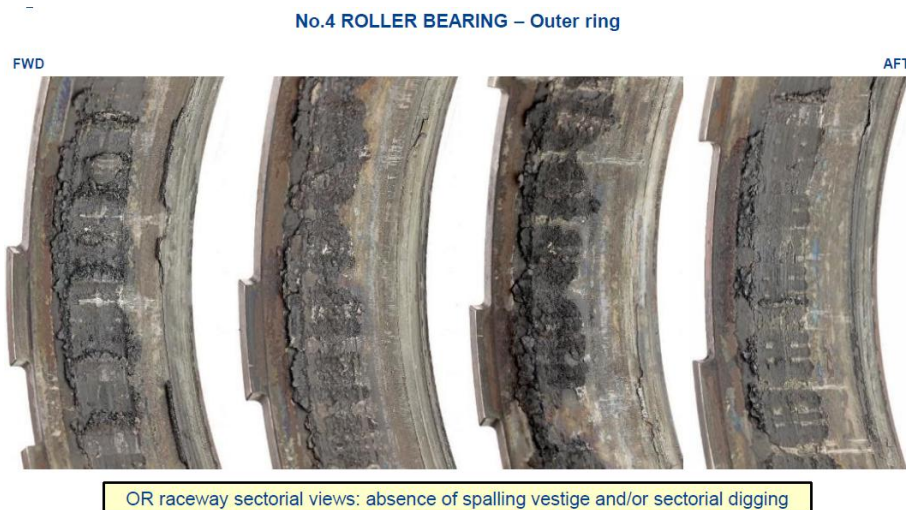
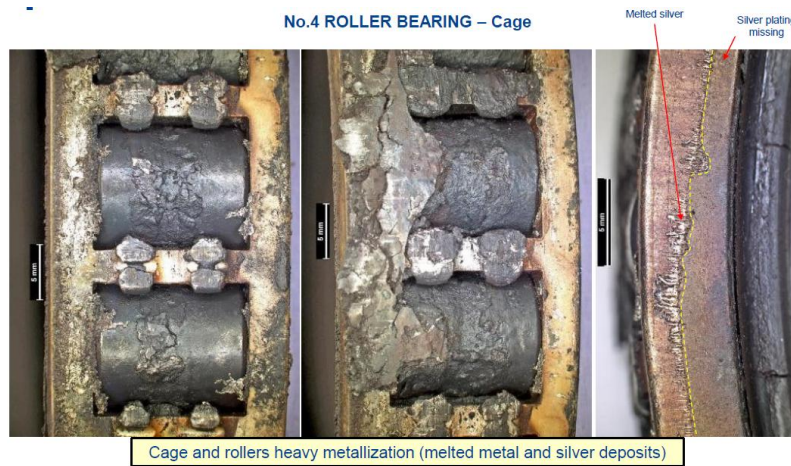
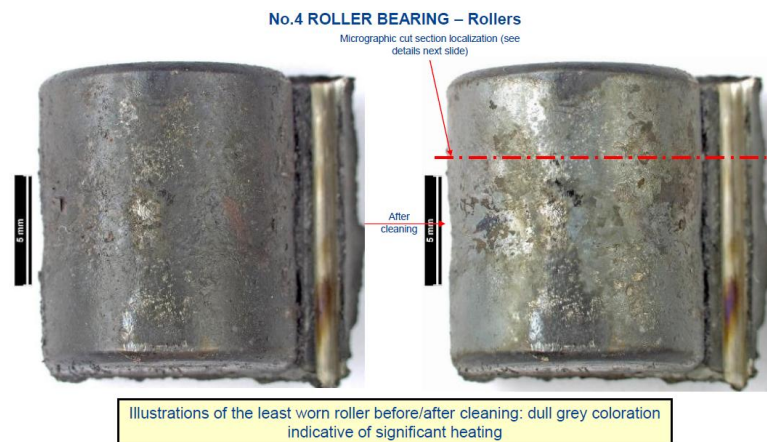
4. LPT #4 bearing was found damaged. No. 4 roller bearing was subjected to detailed examination. The failure was characterized by the heavy metallization of the inner and outer ring tracks, rolling elements and cage with the presence of melted deposits of metal and silver, a dull grey aspect of the rollers as well as an important diameter reduction for some of the rollers and the absence of prior fatigue cracking-rupture of the cage spacers which allow to rule out a degradation mode by primary spalling of the track(s) and/or the rollers.

On micrographic cut section, performed through the least damaged roller, a microstructural aspect (both on surface and in the core) corresponding to a totally overheated material condition – overheated aspect also consistent with the measured hardness: ~70 HRC measured for a BP prescription between 60 and 64 HRC.

Those findings, in relation to the relatively long time accumulated by this bearing before failure (19613h/6224cy) suggest a lubrication deficiency issue also supported by the presence, on the outer raceway and rollers, of reddish deposits of oxidized wear products.

The engine #1 IFSD resulted from total failure of No. 4 roller bearing during the flight. The strip examination and further analysis carried out on different components of involved engine suggests that due to lack of lubrication resulting into less heat dissipation led to failure of No. 4 roller bearing. This is established based on finding of heavy metallization of the inner and outer rings tracks, rolling elements and cage with the presence of melted deposits of metal and silver. Further, some of the roller's diameter reduced and no prior fatigue cracking-rupture of the cage spacers was observed ruling out a degradation mode by primary spalling of the track(s) and/or the rollers. The micrographic examination of the least worn roller, both on surface and core, indicated overheating condition of the rollers despite showing hardness within BP limits.

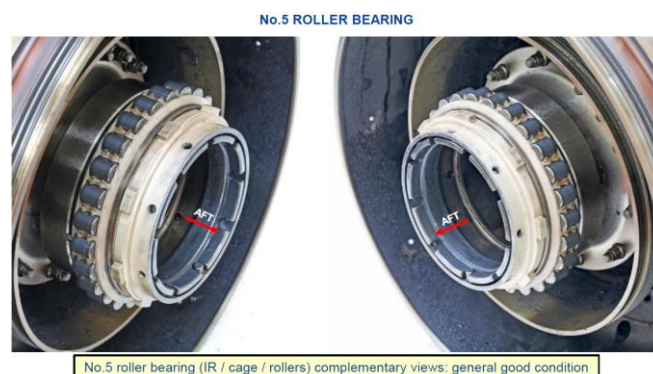
Figure 14

5. #5 Roller bearing were in general good condition. However, traces of coked oil particles and particles made of ZxWC10 (No.4 roller bearing) and Inco 718 were present on the rollers.

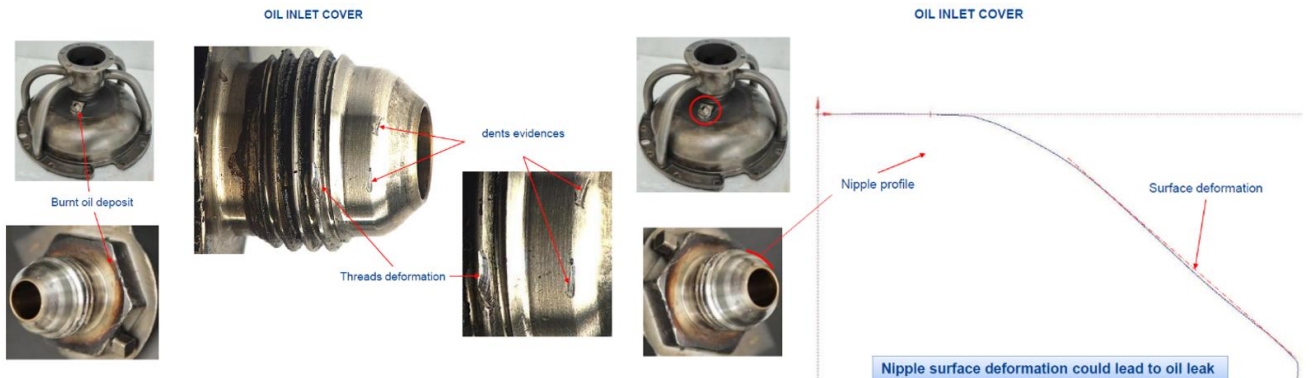
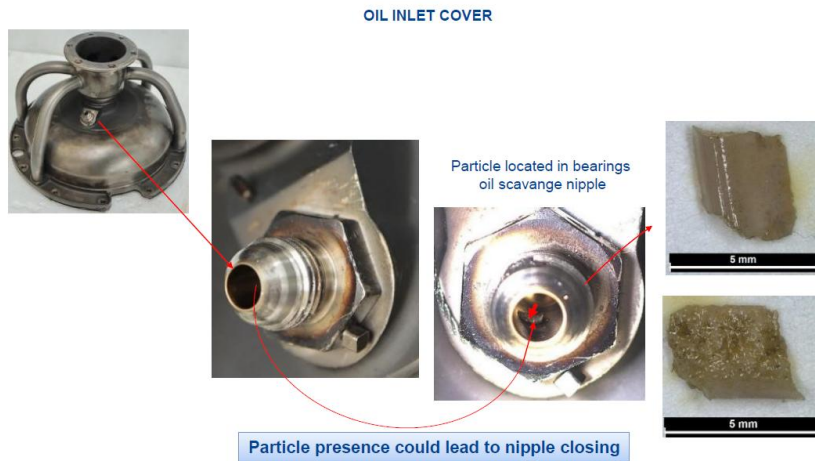
6. Oil scavenge nipple Air/Oil inlet cover had deformation, dents, thread damage which could cause oil leak. Burnt oil deposit were observed on the nipple. Particle matter was found in the bearing of oil scavenge nipple.

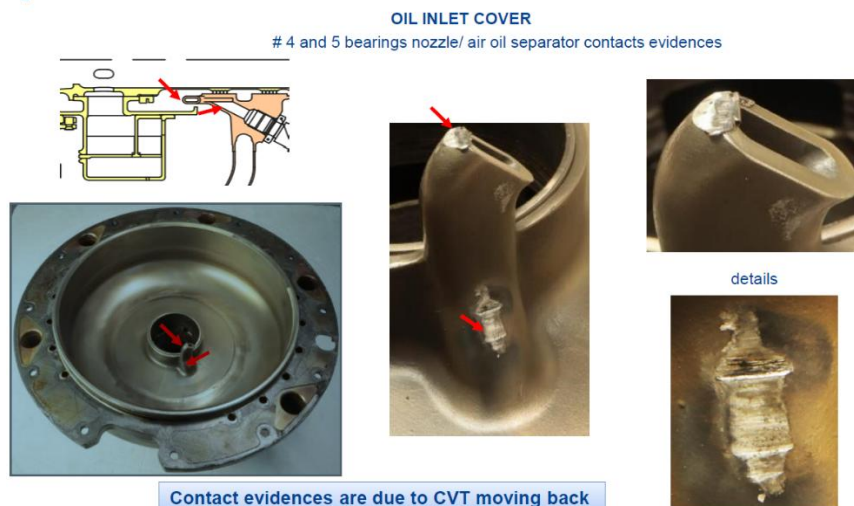
Figure 17

7. Center Vent Tube (CVT) was displaced until the Air Oil Separator came into abutment with the oil inlet cover. Contact between Air/oil Separator and Oil Inlet cover caused imprints of CVT seals and wear.

AIR OIL SEPARTOR/ OIL INLET COVER CONTACT EVIDENCES

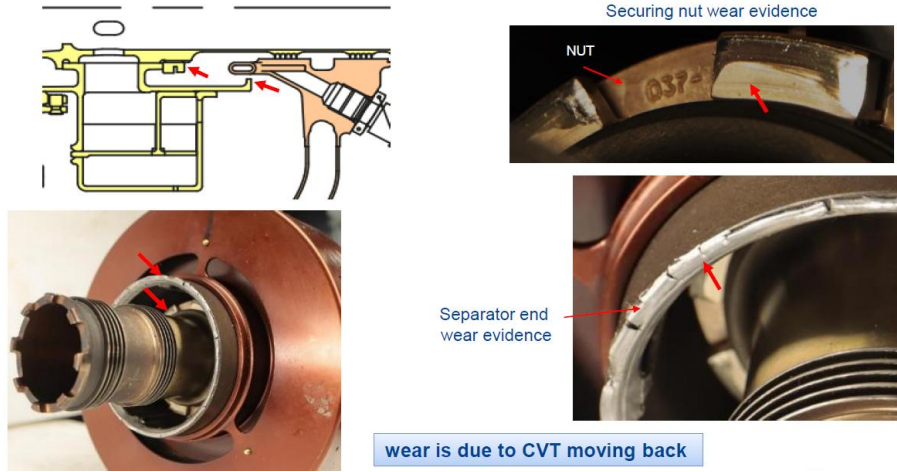
Figure 18

CENTER VENT TUBE EXAM

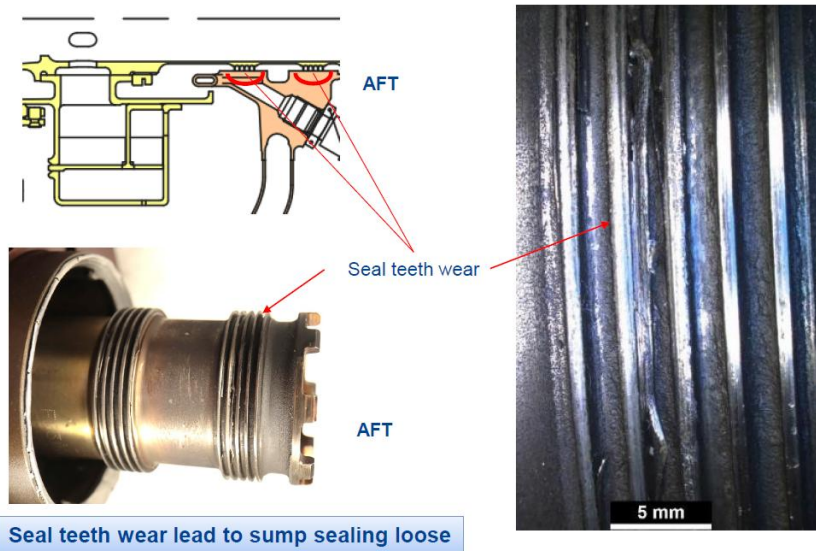
Figure 19

CENTER VENT TUBE EXAM

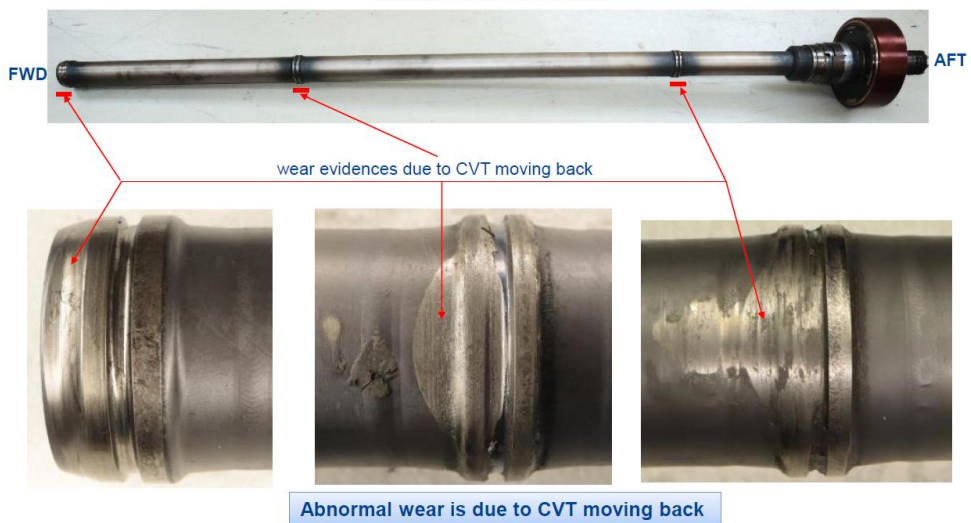
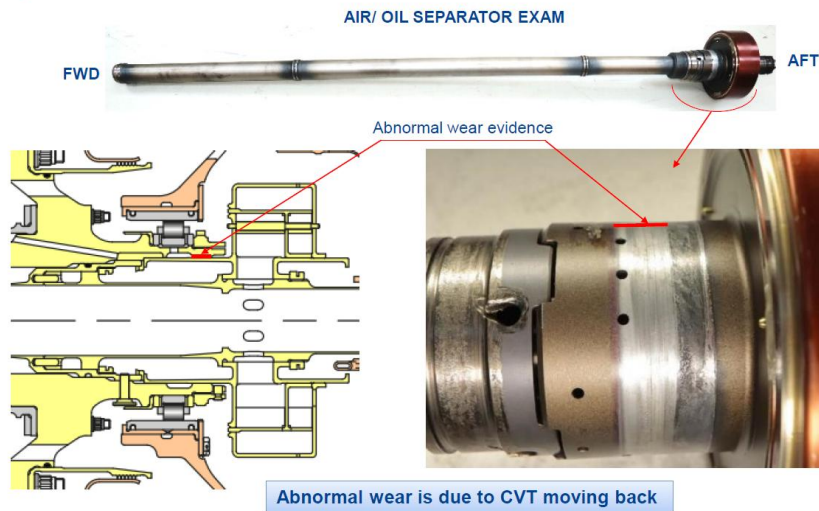
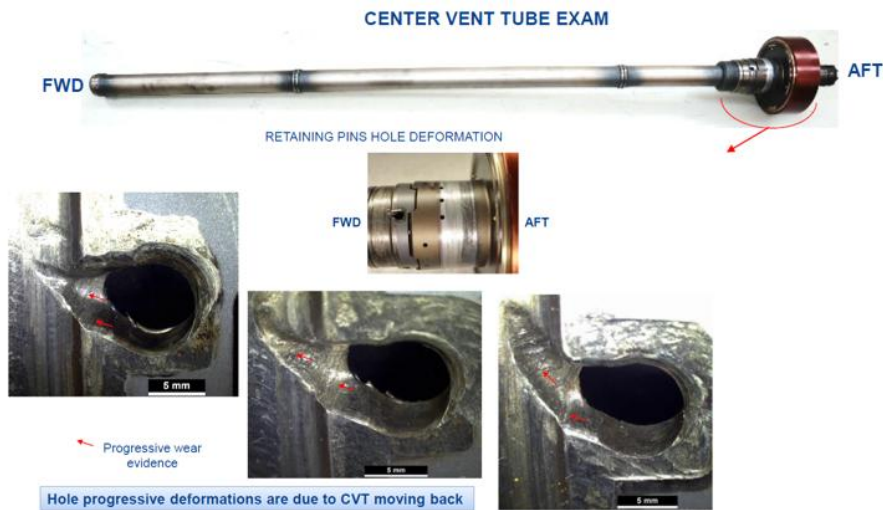
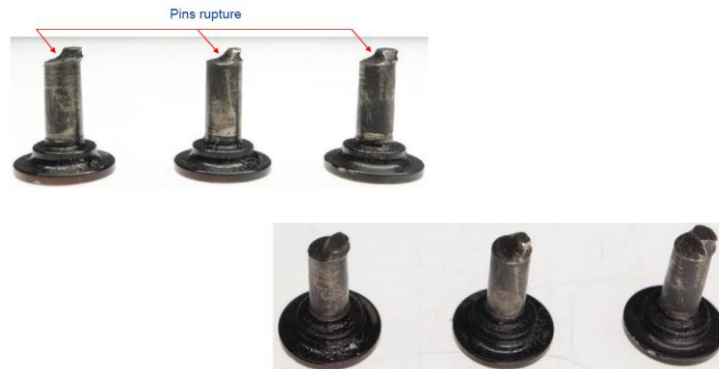
This progressive move back is also characterized by 3 retaining pins damaged but in place in the LPT shaft and escaping CVT holes which are also deformed and worn. Wear evidences on the CVT center zones confirms some operation time in the retracted position.

As per the OEM's report, CVT move back is at the origin of failure sequence, and stall occurred after #4 bearing failure. Axial movement of CVT and condition of CVT retaining holes and pins cannot be inspected in line maintenance but can only be inspected during shop maintenance.

The Center Vent Tube (CVT) got displaced during the flight. This move back of CVT is characterized by 3 retaining pins damaged but found in place in the LPT shaft. CVT pin holes were also found deformed and worn. OEM has also observed some wear evidences on the CVT center zones which confirms some operation time in the retracted position. The dislocation of CVT from its installed position also led to a loss of lubrication of the No.4 bearing inner race.

As per the OEM, the elongation of pin holes can be caused by operational loads (centrifugal loads, vibrations, thermal stresses, etc). Excessive elongation can allow a pin to move outside of the hole of the CVT tube. In that case, CVT is no longer retained axially and can generate damage to the pin. Axial movement of CVT and condition of CVT retaining holes and pins, however, cannot be inspected in line maintenance but can only be inspected during shop maintenance.

Post-event maintenance followed the Trouble shooting Manual (TSM) and the Oil inlet cover was replaced on each occasion. The TSM task for Engine tailpipe fire however, did not have requirement to check CVT position to detect absence of axial movement. The axial movement of CVT can block oil path to #4 bearing if left unchecked.

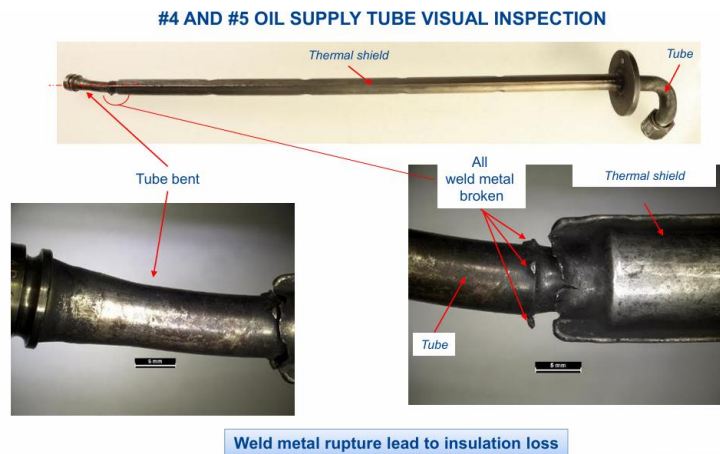
Figure 24

8. Damages and wear were observed on the #4 and 5 Oil Supply Tubes. Weld metal on the tube thermal shield had ruptured.

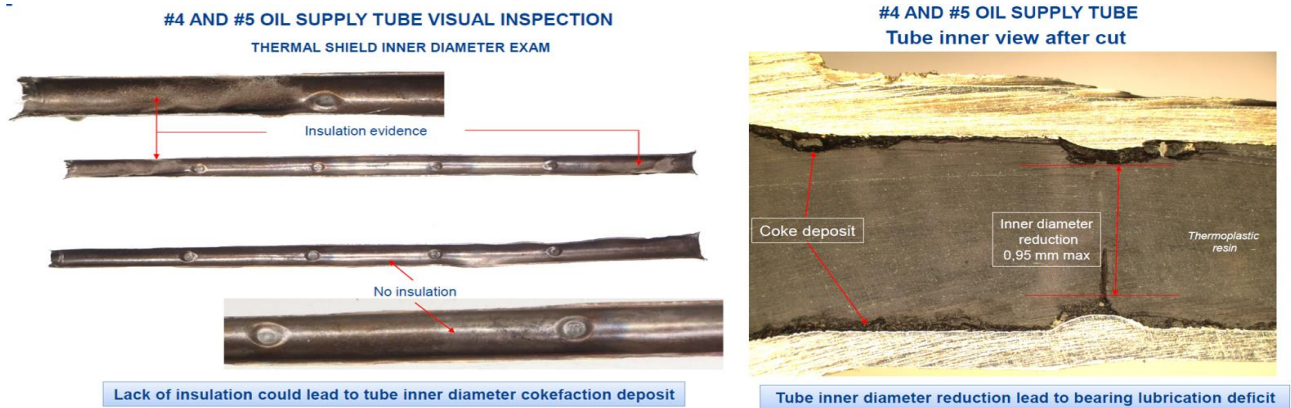
Figure 25

There was loss of Thermal insulation.

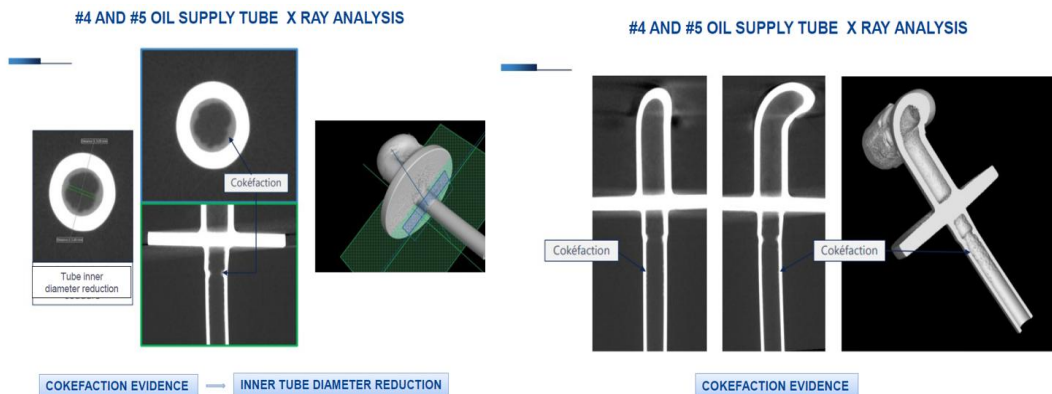
Figure 26

Loss of thermal shield caused cokefaction, leading to coke deposit on inner tube surface. This caused reduction in inner tube diameter. As per the information available from OEM, the engine design allows a 30% reduction without degradation of bearings, therefore, the impact of this section reduction on the oil flow inside the tube and consequently on the lubrication of bearing #4 was determined as marginal.

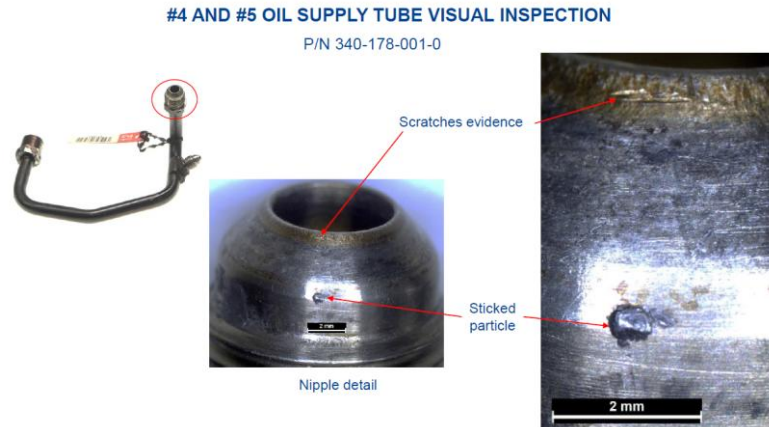
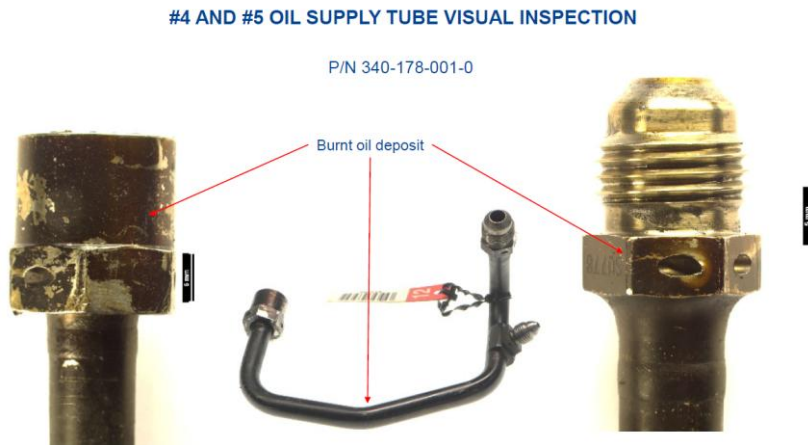
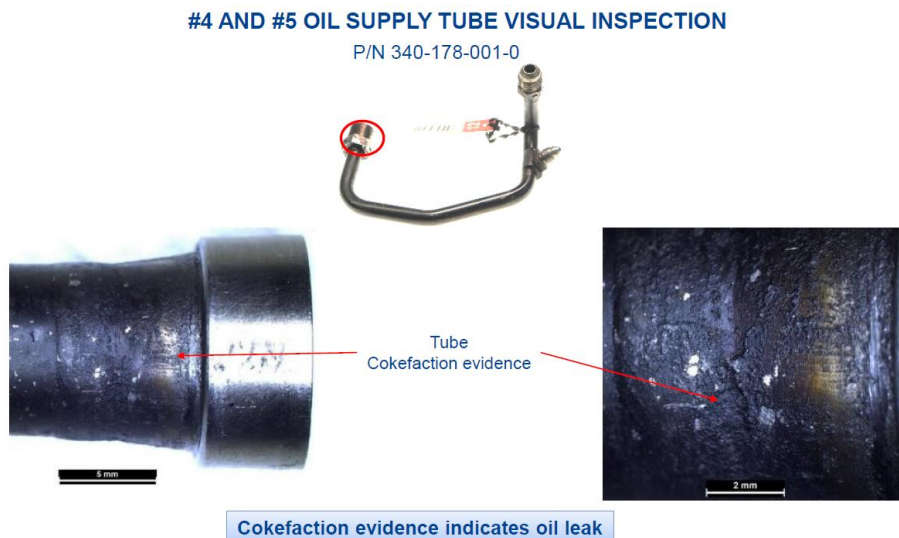
9. Nipple deformations were observed on #4 and #5 Oil Supply pipeline along with scratch evidence on the nipple. These abnormality could cause oil leak which was evident from burnt oil deposit and cokefaction.

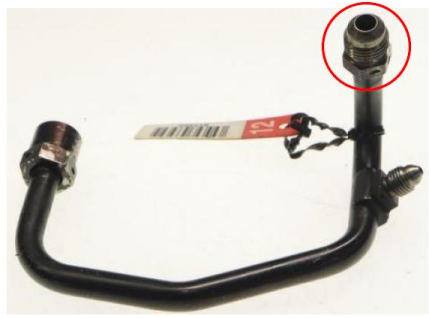
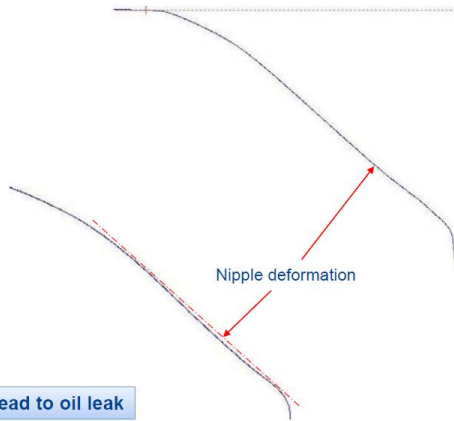
Figure 30

Nipple deformation could lead to oil leak

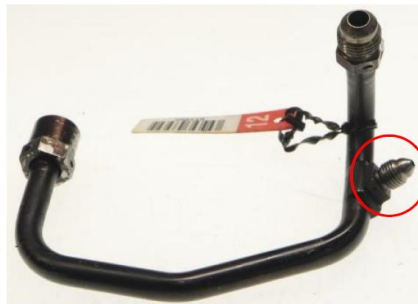
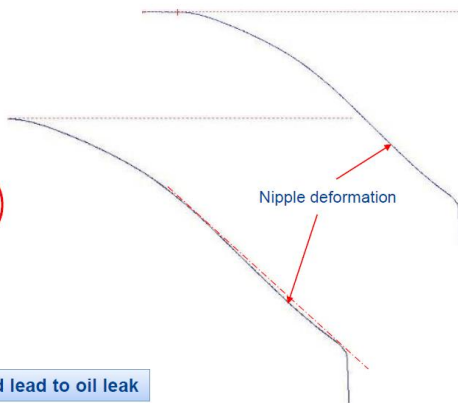
Figure 31

Nipple deformation could lead to oil leak

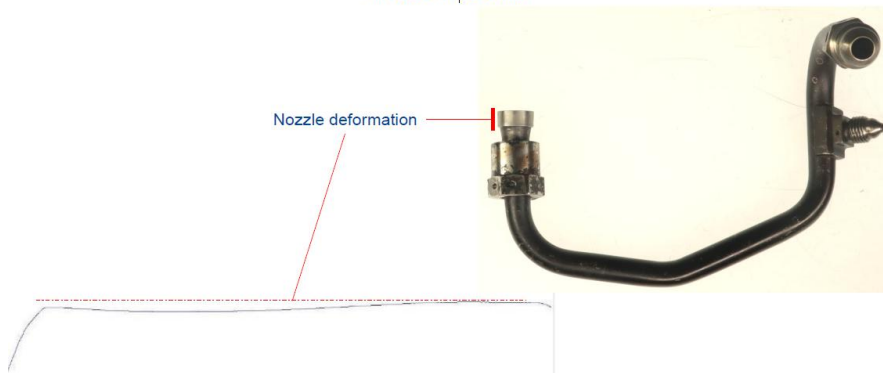
Figure 32

Nozzle deformation could lead to oil leak
