Government of India
Ministry of Civil Aviation
Aircraft Accident Investigation Bureau

Preliminary Report: Serious Incident involving M/s Swiss International Air Line Airbus A330-343 aircraft, bearing registration HB-JHK at Delhi, India on 26 April 2026 (Indian Standard Time).

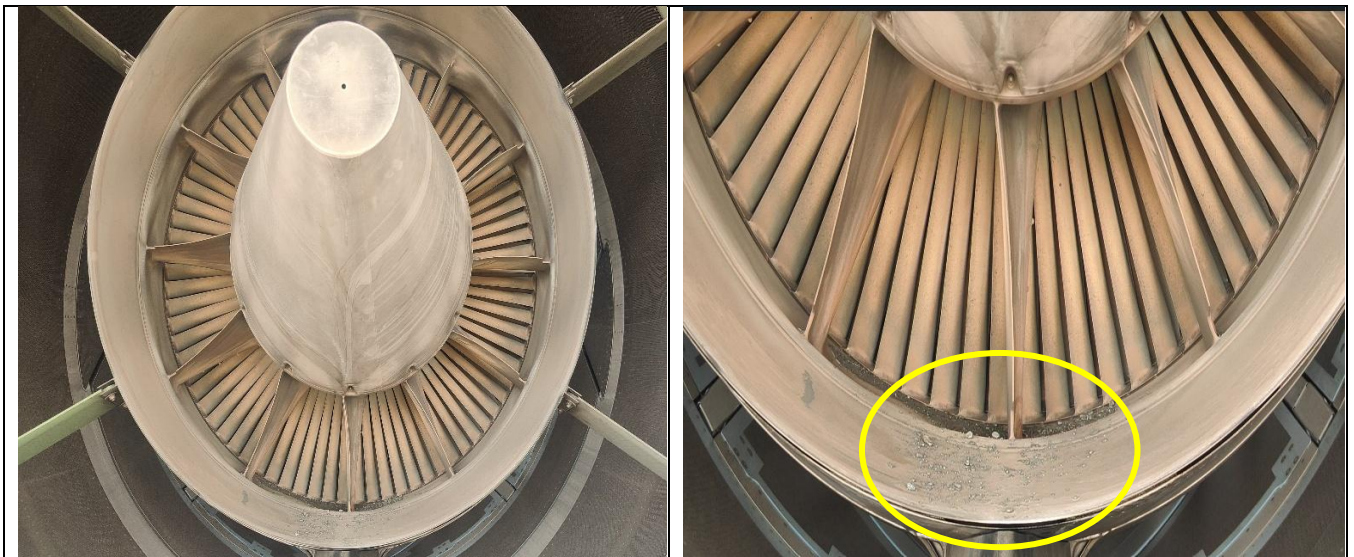
- Small Metal particles/debris were observed at the exhaust section/ CNA of engine # 1. See Figure 1 below.

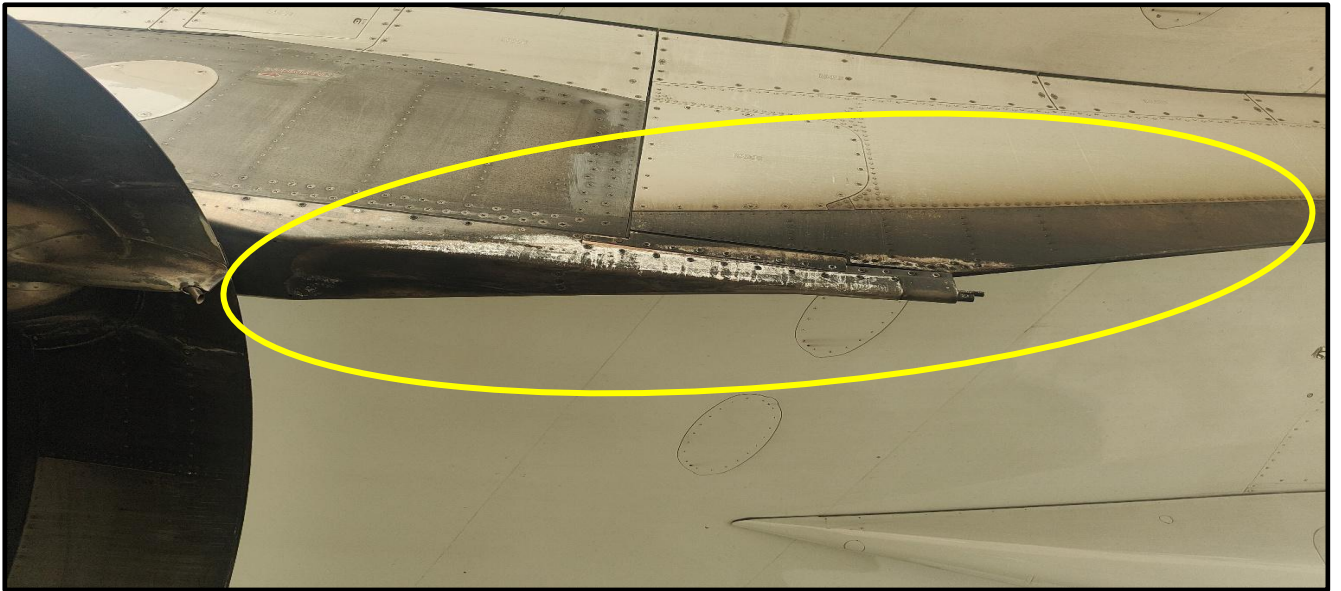
- Soot/burn marks were observed on the engine pylon structure just behind the exhaust section. See Figure 2 below.

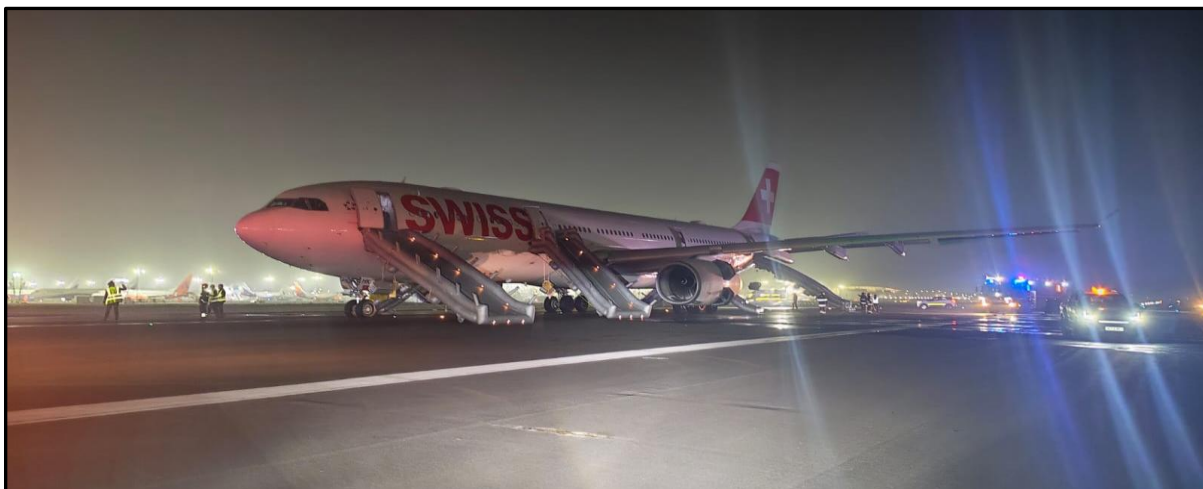
Thereafter, emergency evacuation of passengers was carried out on runway itself. All the 07 slides (except one) were used for evacuating the passengers. At 0150 IST, FM jeep informed that the fire is extinguished totally and the passengers are on ground. During the process of emergency evacuation four passengers were reported to have received injuries. They were immediately taken for medical treatment.

Figure 3: The aircraft on runway with emergency slides deployed.

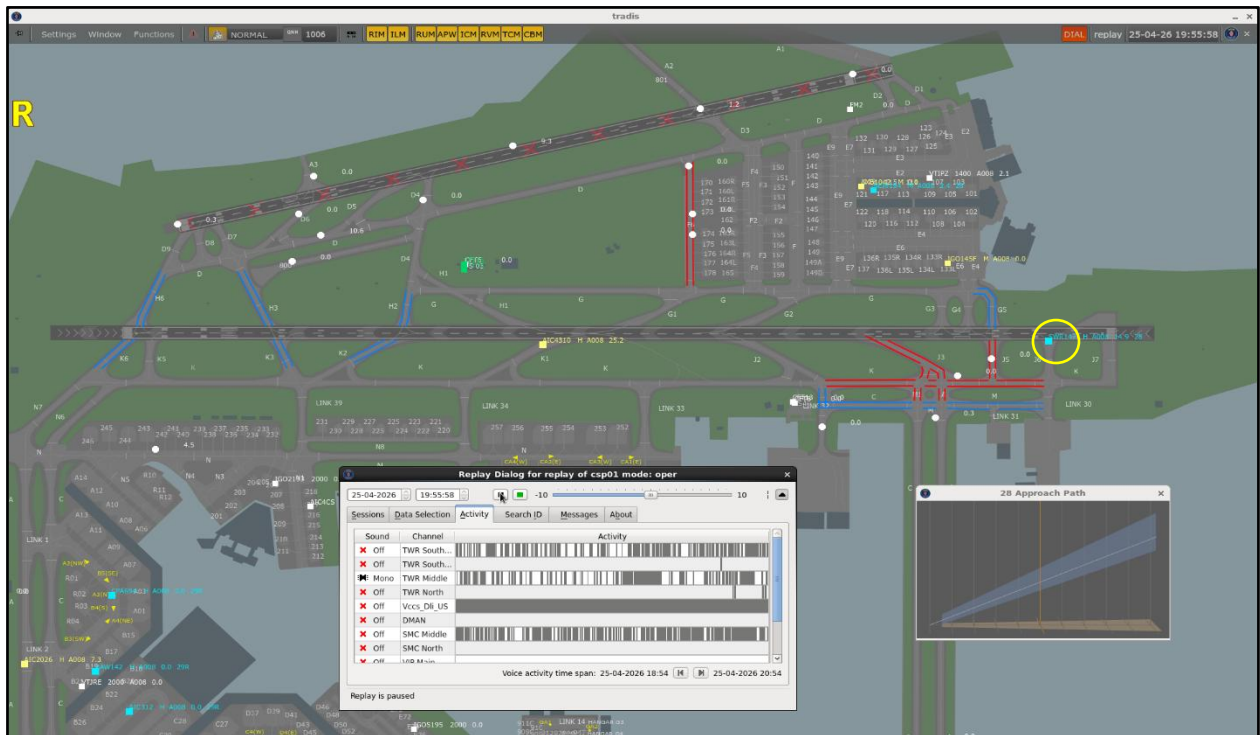
1. Aircraft at Holding point J6, RWY 28.

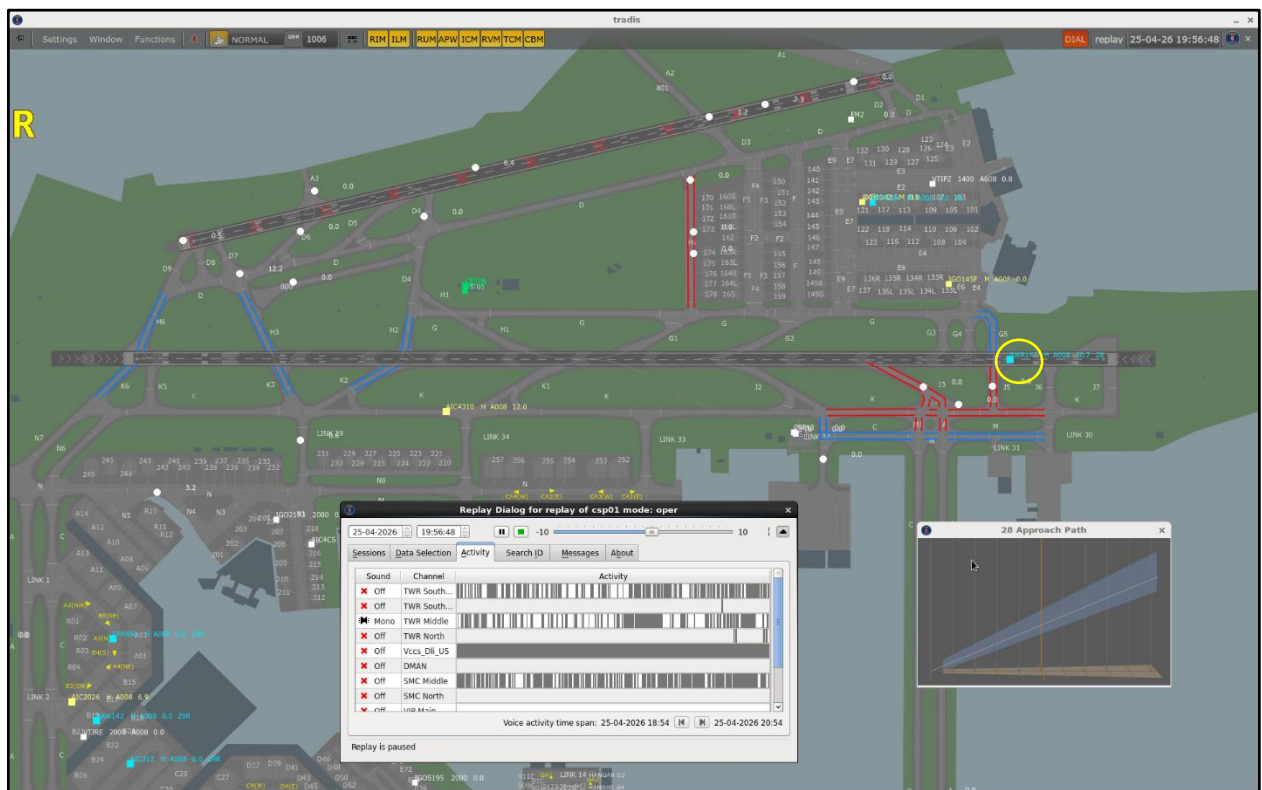
2. Aircraft Commenced roll.

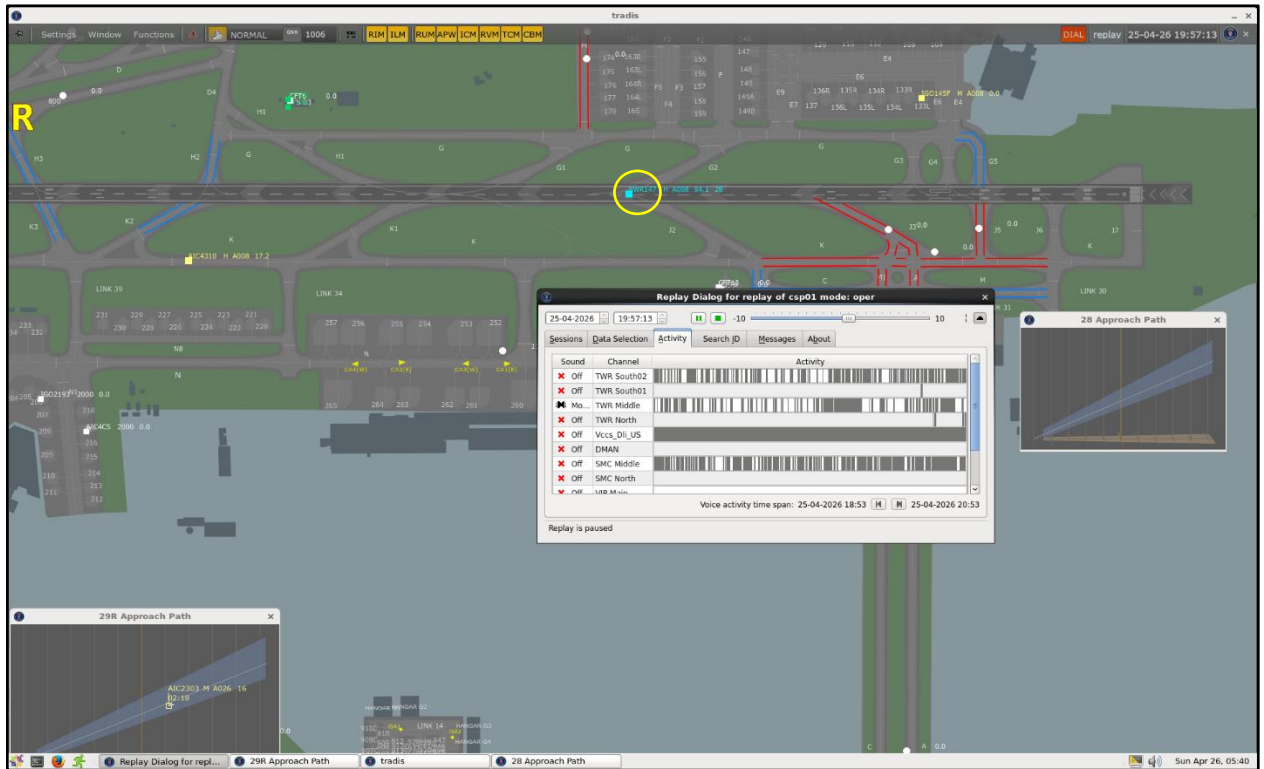
3. Aircraft Abandoned Take-off.

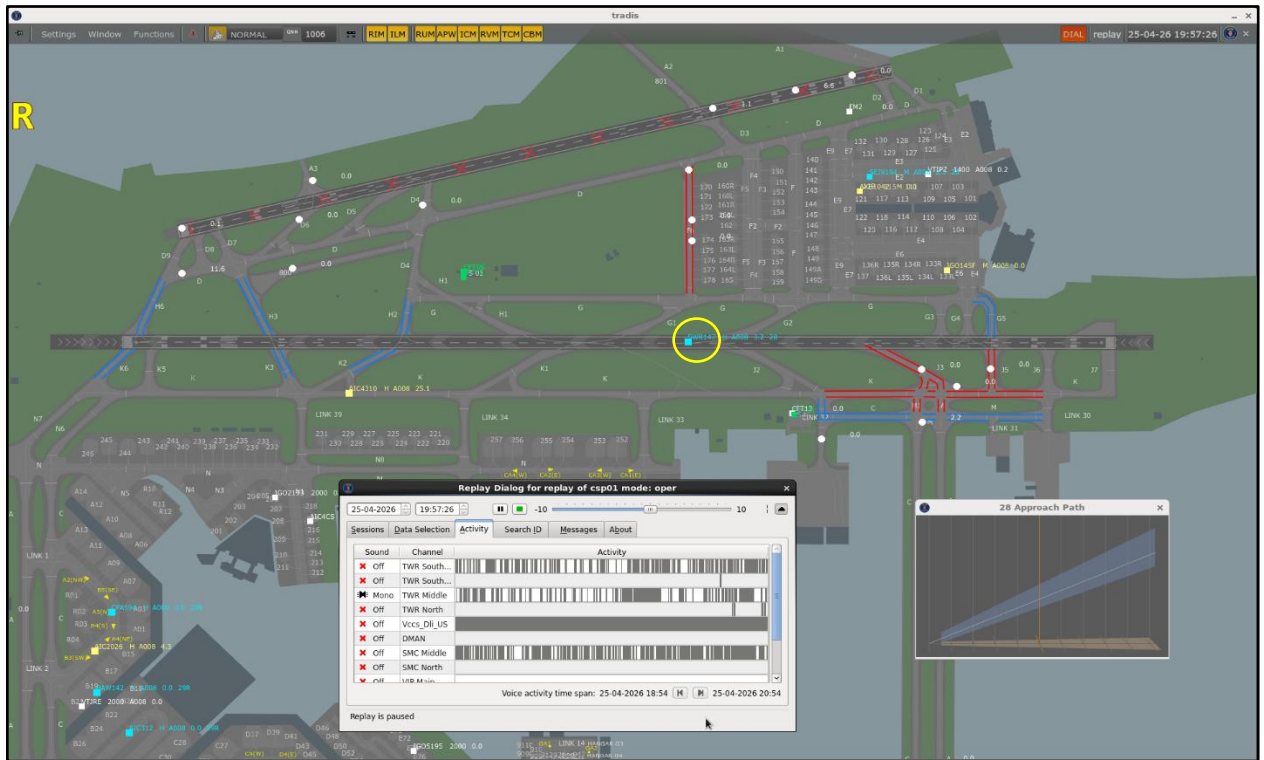
4. Aircraft Stopped on RWY 28 between taxiway G2 & G1.

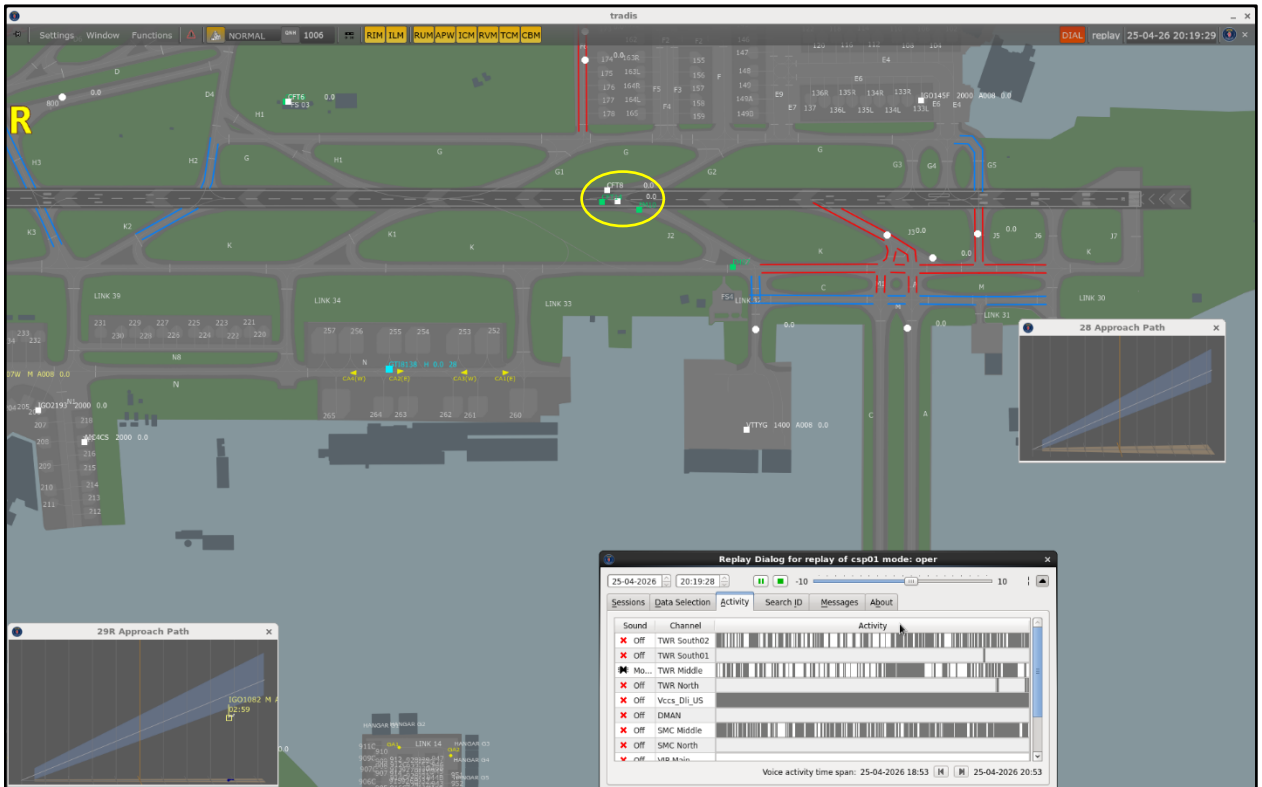
5. Passengers evacuated with CFT & FM Jeep on runway.

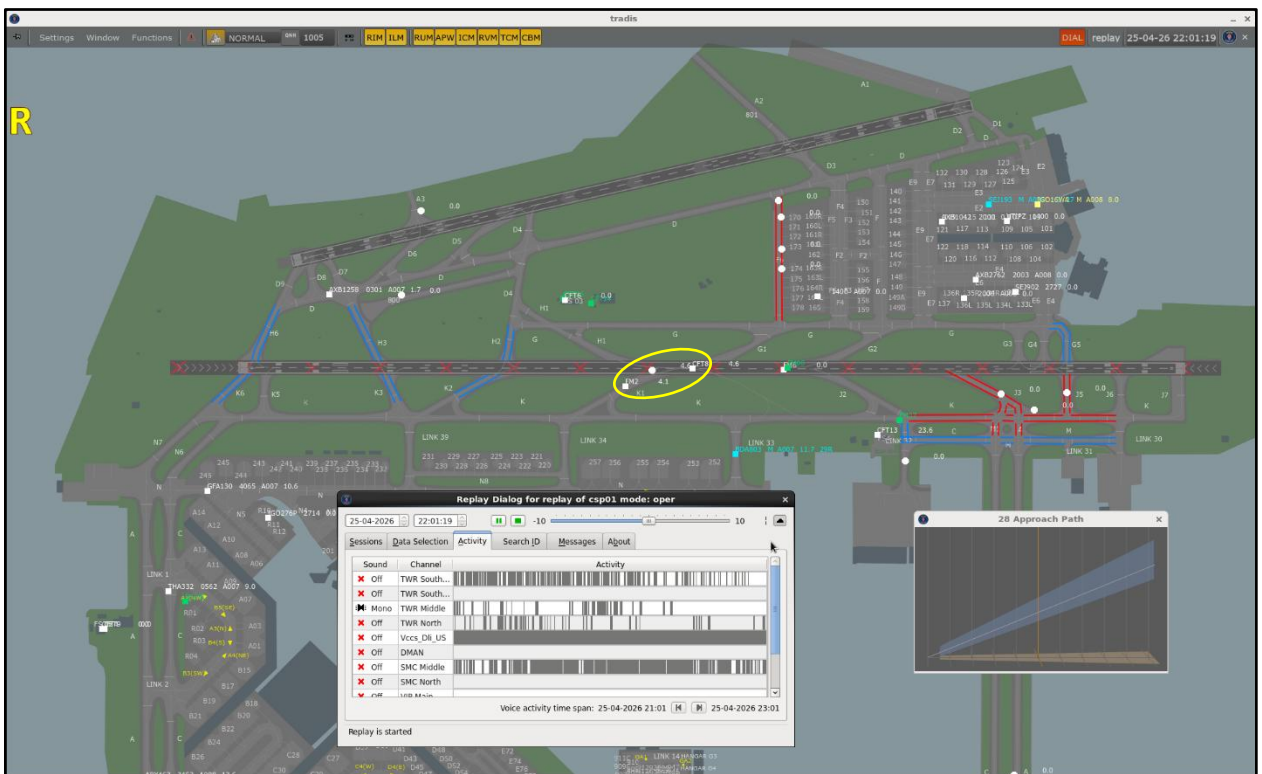
6. The aircraft Vacating Runway.

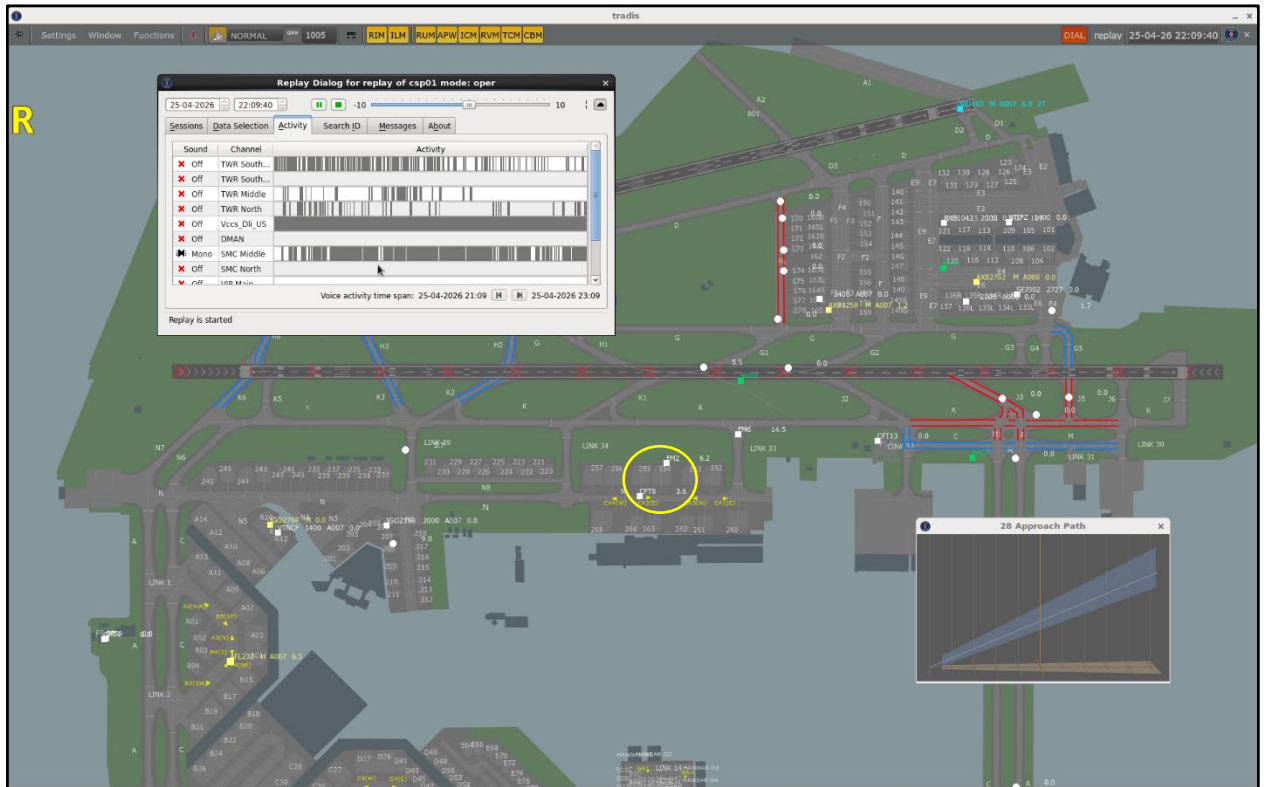
7. Aircraft Parked at Bay 254 accompanied by FM Jeep & CFT.
