Final Investigation Report
on
Serious Incident involving M/s InterGlobe Aviation Limited,
Airbus A320 Aircraft, VT-IFM on 28 October 2022

Government Of India
Ministry of Civil Aviation
Aircraft Accident Investigation Bureau

On 28 October 2022, M/s InterGlobe Aviation Limited's A320 aircraft, bearing registration VT-IFM, while operating a scheduled flight (6E-2131), Delhi to Bengaluru was involved in an engine failure occurrence.

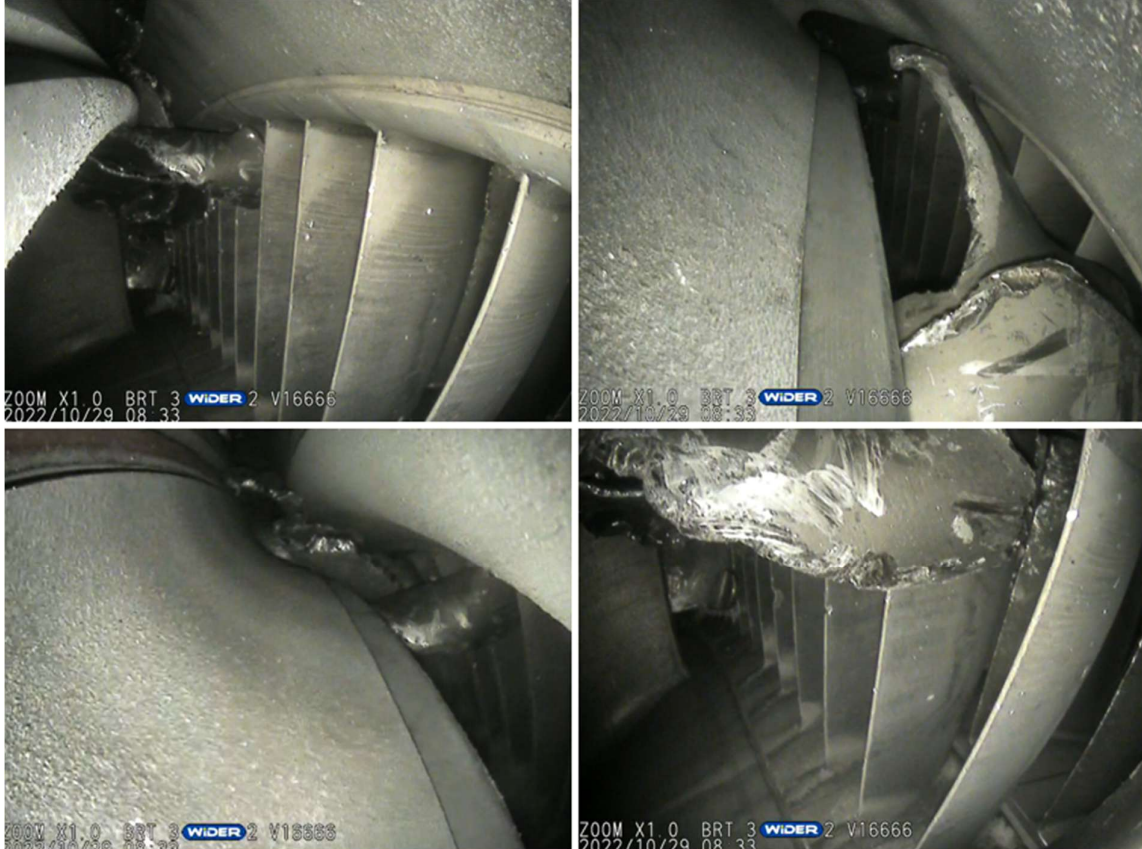
Figure 1: Damaged LPC 2.5

(a) Severe damages were observed in (Low Pressures Compressor) LPC 2.5 stage.

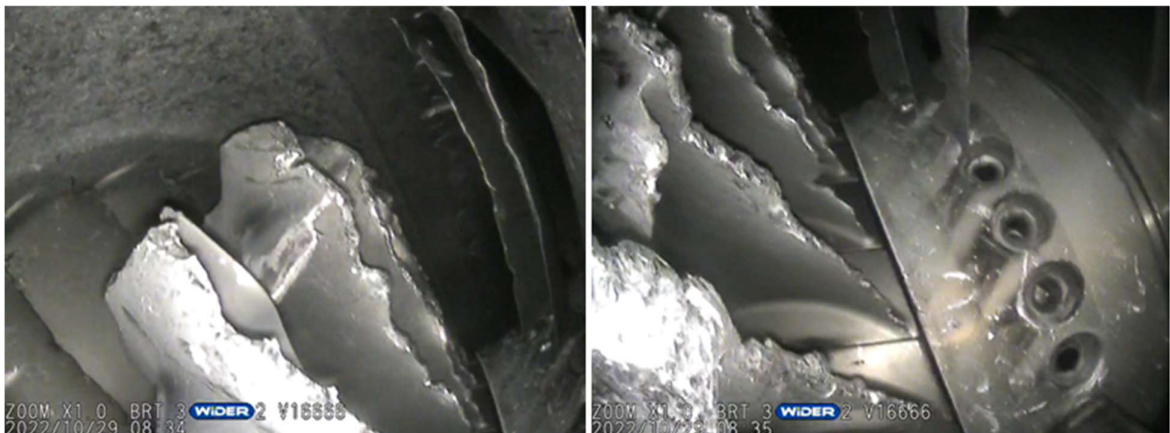
Figure 2: Damaged HPC 3rd Stage

(b) Severe damages were observed in the (High Pressures Compressor) HPC 3 stage.

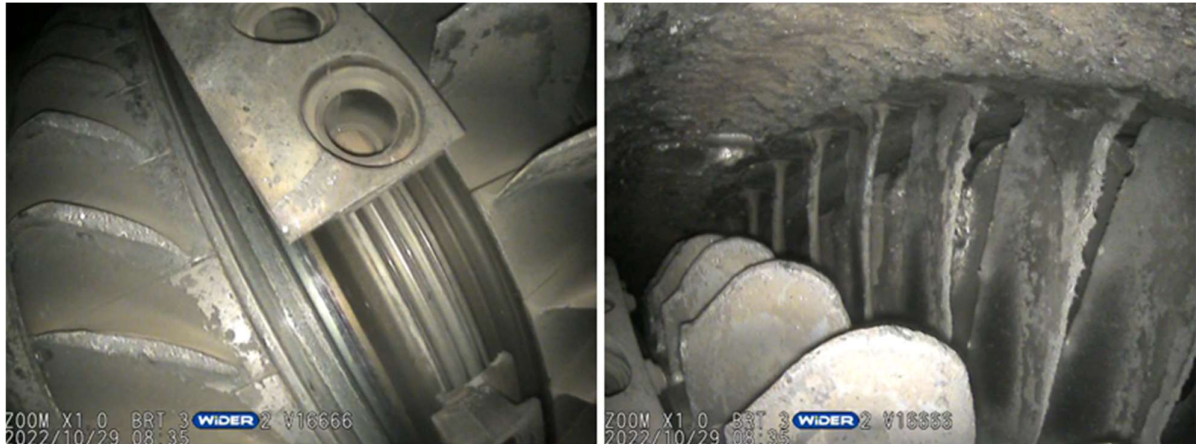
Figure 3: Damaged HPC 6th Stage

(c) Severe damages were observed in the (High Pressures Compressor) HPC 6 stage.

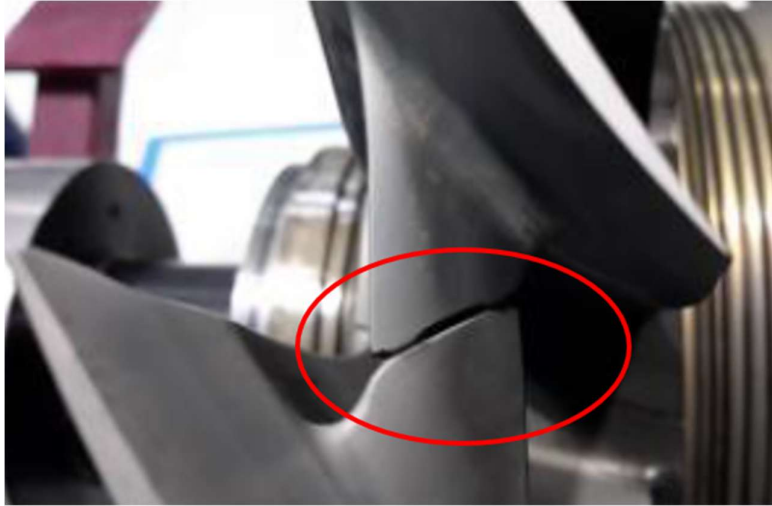
Figure 11: Extensive clapper wear

- a) Minor airfoil nicks/dents observed
- b) No airfoil FOD observed
- c) Minor blade leading edge erosion observed
- d) No blade tip curl observed
- e) **Extensive clapper wear observed**

- f) No blade tip rub observed
- g) Installed blade set passed porcupine check for clapper wear
Actual Clearance: 0.308"
Engine Manual Limit: 0.140"
- h) No significant blade root galling observed

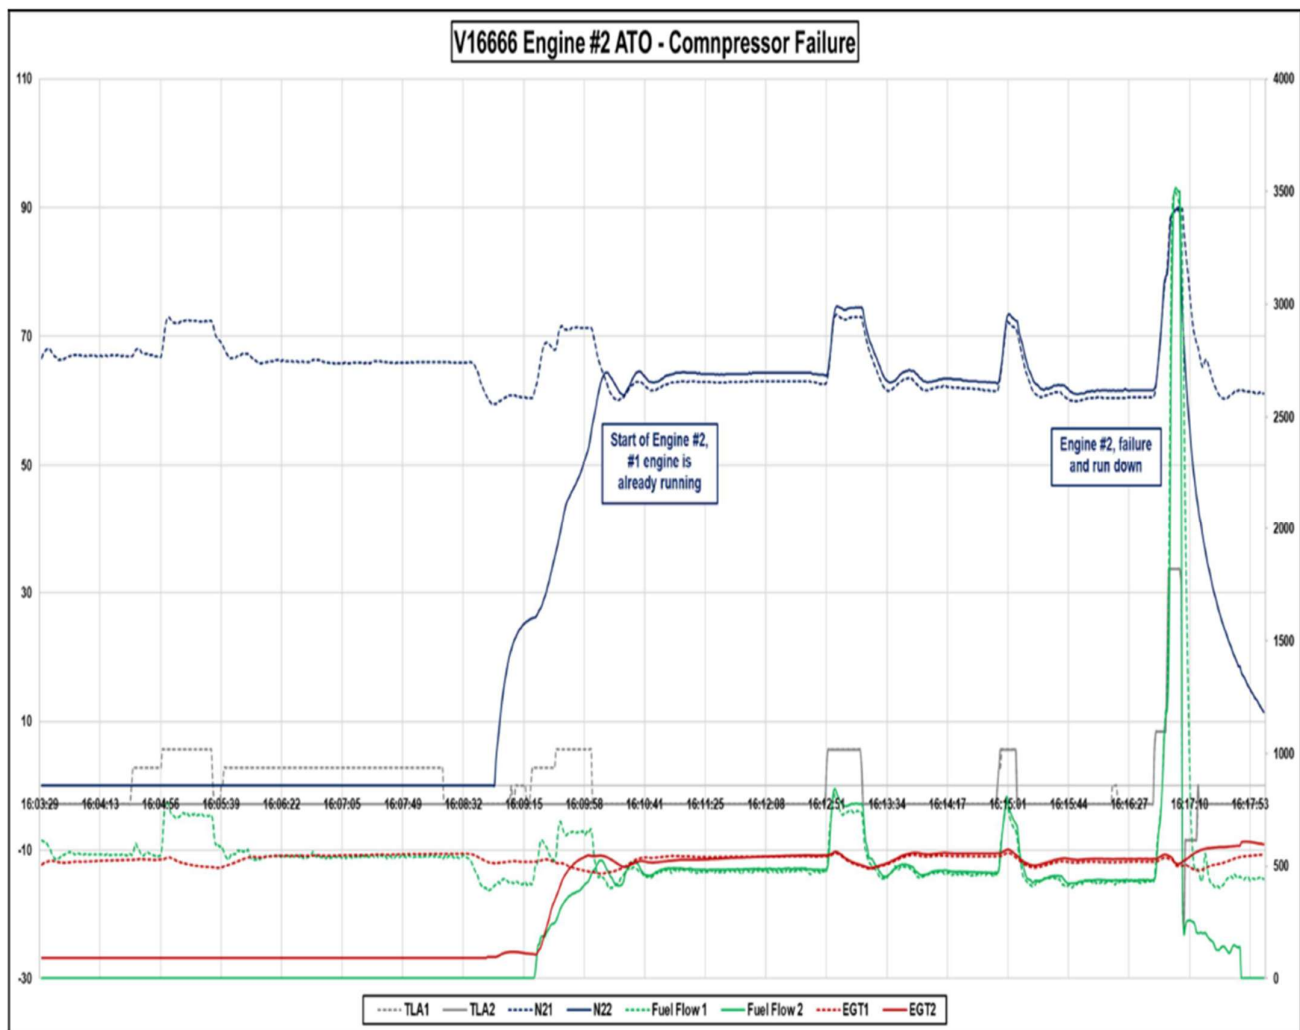
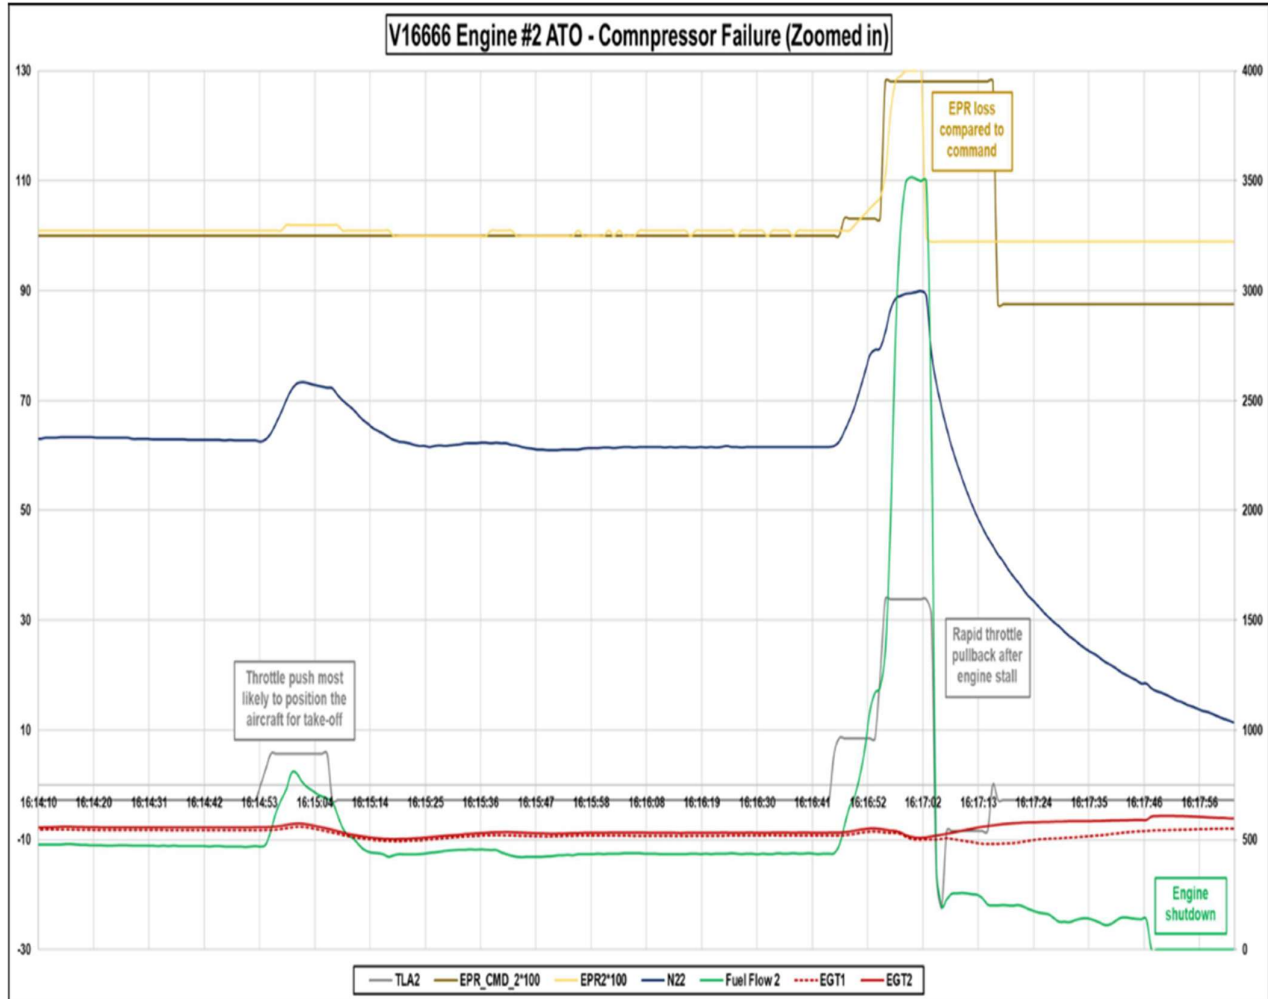
In Graph 1, the engine no. 2 starts up point is shown as thick gray lines. The High spool speed N22 of engine no. 2, shown as thick Navy-Blue line rises more than 60% before it got almost stabilized at around 65%. It also depicts the engine no. 2 failure point and run down.

In Graph 2, plot near the engine no. 2 failure event is enlarged to give more clarity. Few crucial engine no. 2 parameters were also added such as EPR shown as thick yellow line, EPR CMD shown as thick brown line. Enlarged plots gives more precision about the changes occurred in some significant engine parameters such as N22, Fuel, EPR and EPR CMD.

During the investigation DFDR data was shared with the OEM for comments. The OEM has provided a brief DFDR analysis (with above two graphs). As per OEM’s DFDR analysis “**No Significant observations (engine parameters) were seen prior to the event**”. It is also stated that “**There are no engine parameters identified as precursors to the event**”.

The analysis of DFDR also revealed that the throttles were pushed forward to initiate the take-off at 16:16:45 UTC. The engine no. 2 (V16666) event occurred at 16:17:03 UTC, The Flight crew immediately pulled back the throttles for rejecting the take-off at 16:17:05 UTC. During the event, loss of EPR against the CMD EPR noticed on the engine no. 02, followed by a sharp decrease in the Fuel Flow and N22. The loss of EPR against the CMD EPR, followed by decrease in Fuel Flow and N22 indicates engine no. 2 failure.

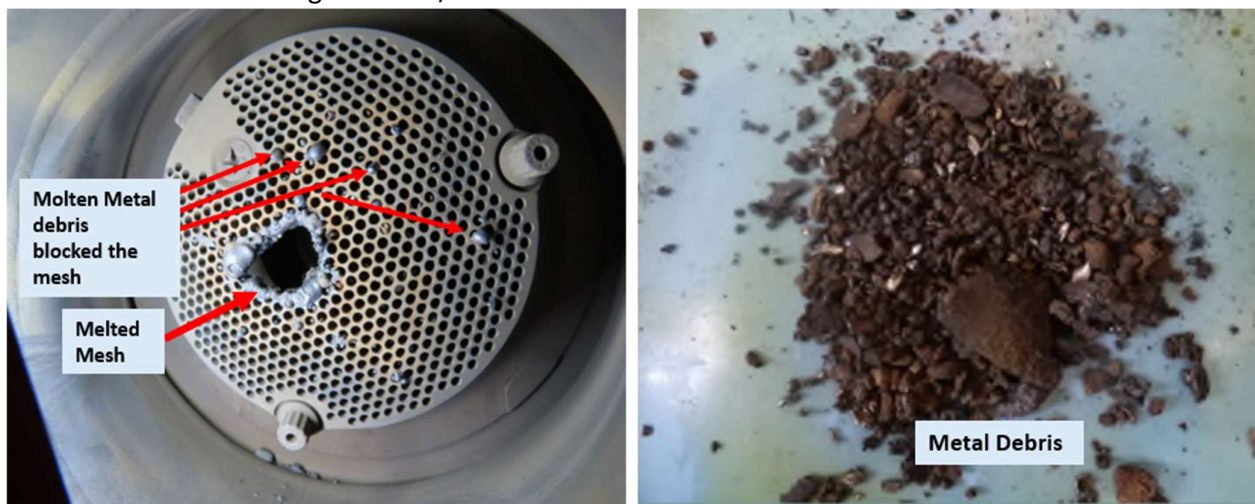
Figure 15: Bleed Valve 7B

- a) FEGV (Fan Exit Guide Vanes) two panels removed –no notable/visual damage observed.
- b) **Bleed Valves:** All valves were found packed with heavy debris. 7B Bleed Valve was found burnt through silencer/diffuser.

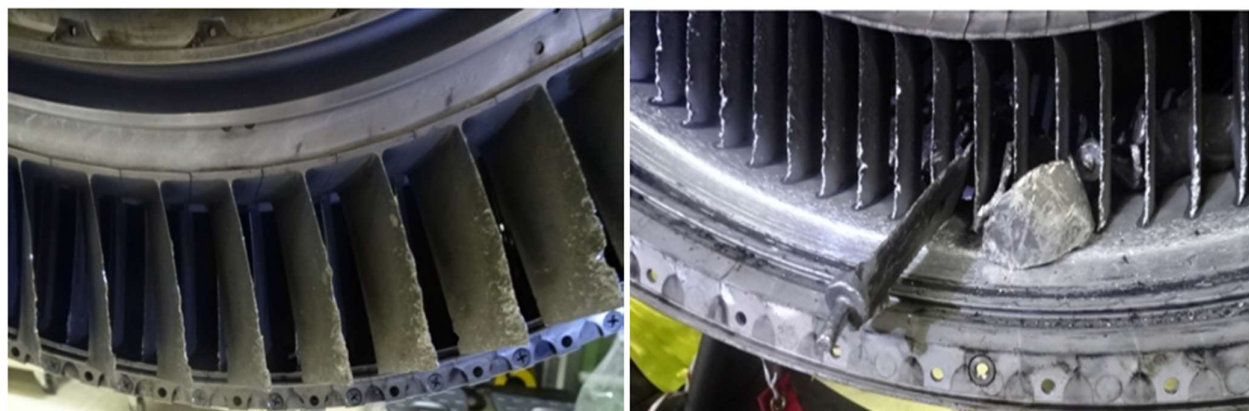
Figure 16: Damages in LPC 2.5 Blade (LH) and in LPC 2.5 vanes (RH)

- c) **LPC:** Heavy damage was observed to 2.5 blades and 2.3 vanes from VIGVs. Large amount of metal debris was found in 2.5 bleed and in 2.5 bleed path.

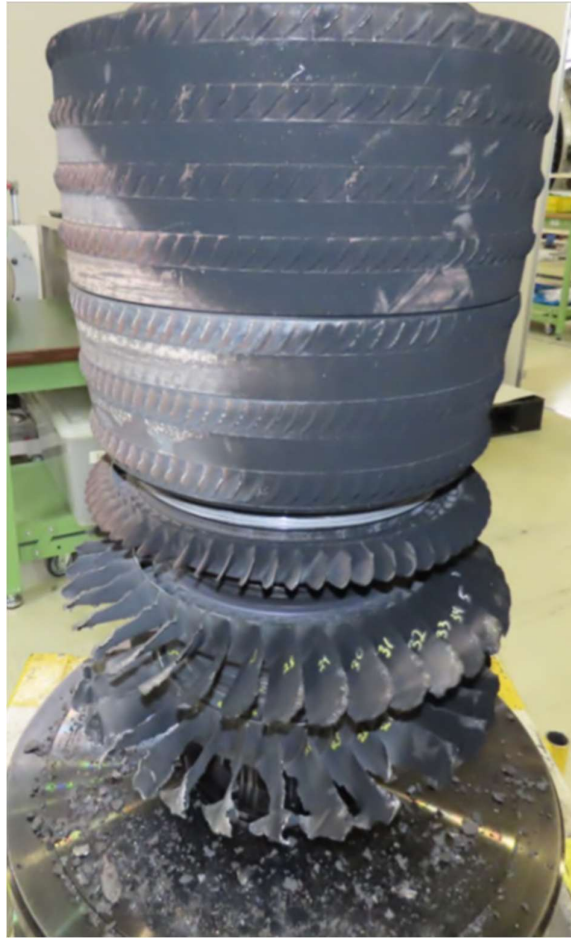
Figure 17: Damaged HPC all Stages

d) **HPC:** Substantial damage observed in the HPC

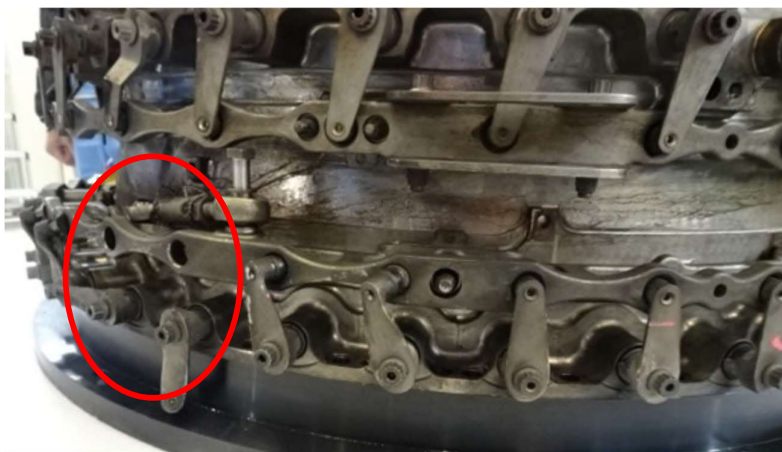
Figure 18: Deformed Lever arms of VIGV

- i. VIGV levers were found bent and several lever bushings were found broken and missing. VIGV many levers were found disengaged from the unison rings. Majority of the VIGV were found missing and debris in the 2.5 bleed and LPC.

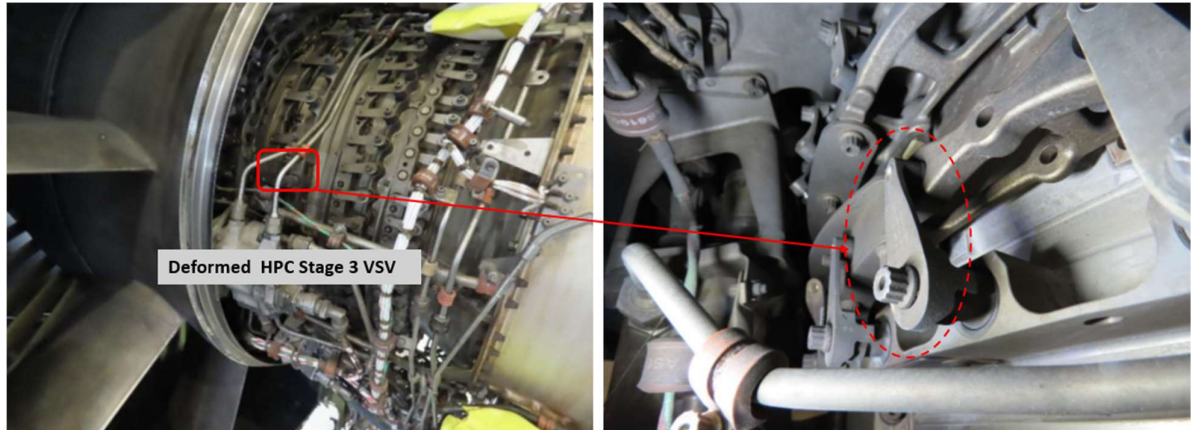
Figure 19: Damaged HPC 3rd Stage VSV

- ii. VSV HPC 3rd stage levers were found bent with many lever bushings broken and missing and disengaged from unison ring.

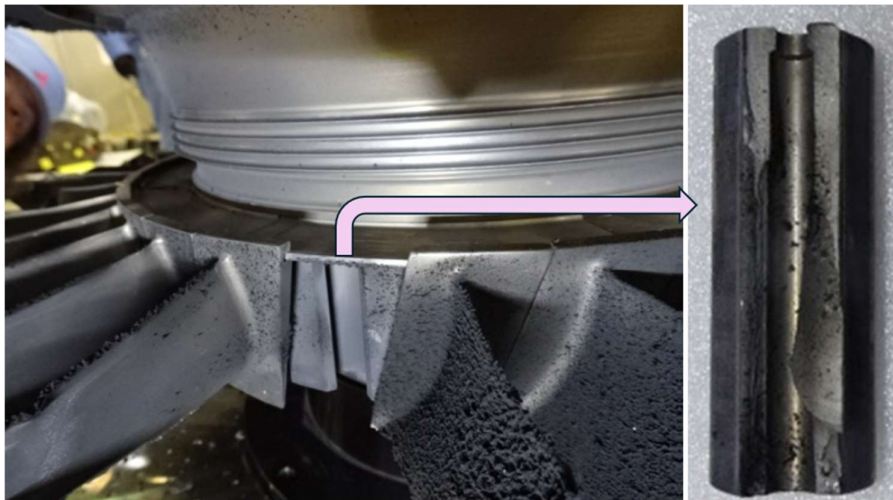
Figure 20: Damage HPC 3rd Stage

- iii. One HPC 3rd stage blade was found with below platform fracture (#1). Both pieces recovered. Five HPC 3rd stage blade fracture above platform. Only 11 VIGV were found whereas, all others were missing. All HPC vanes were found damaged.
- iv. Majority of the VIGV were missing and their debris was in the 2.5 bleed and LPC.
- v. HPC rear case seems to be deformed.
- vi. All blades' platforms of HPC 4-12 stage were found.
- vii. Starting around HPC 5th stage thermal damage can be observed.
- viii. In HPC 5-11 Stage, vanes were found with no airfoils remain.
- ix. In HPC 3rd stage, 1 lock plate was found missing.
- x. Possibly One retaining plate found in gas path.

- xi. In HPC 3rd stage, blade tips missing above platform damage nicks, dents, tears.
- xii. In HPC 3rd stage, leading edge and trailing edge damaged (nicks, dent, tears)
- xiii. In HPC 3rd stage, all clappers damaged. Clappers cracked, broken, missing material. Clapper contact wear.

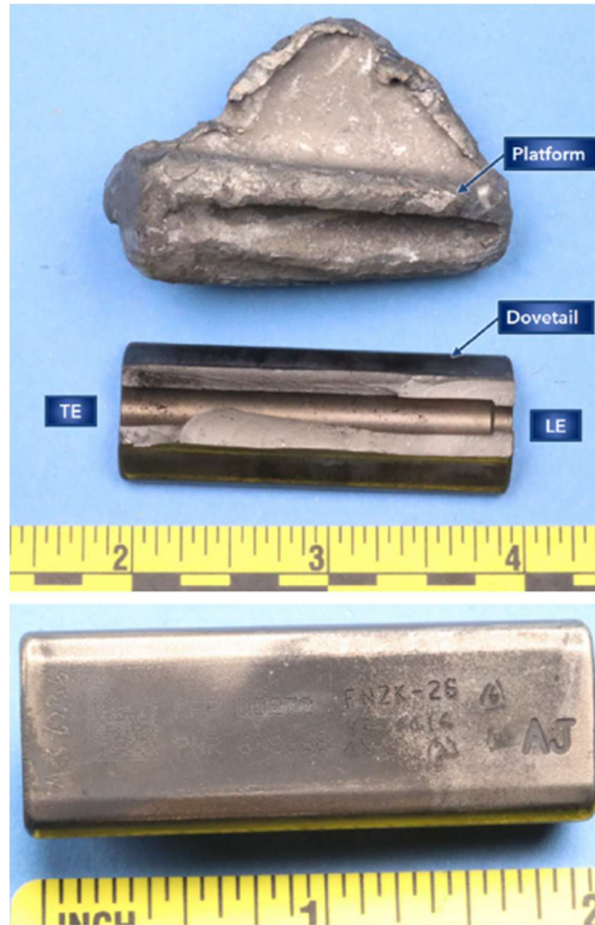
- a) HPC 3rd stage blades had been labeled from 1 to 31 in a clockwise direction as viewed forward looking aft. Blade 1 shown in figure 21 was fractured in the blade root below the platform. The dovetail piece of the blade was recovered from its respective disk slot, and

Figure 21: Blade no. 1 showing the dovetail piece and mating piece with the platform and airfoil root (upper image) and the root end face of the dovetail (lower image).

a battered mating piece shown in below figure 21 was recovered during the engine teardown. The root end face markings for blade 1 are shown in the lower image in figure 21. The blade was marked with part number 6A8688 and manufacturer code D0272. The blade was also marked with repair codes VRS 6236 and VRS 6616, indicating the clapper coating was replaced and damaged or worn clapper abutment faces were repaired by welding, respectively. Triangle repair codes 1, 2, 4, and 6 indicate vibro polishing to restore the surface finish, glass/ceramic bead peening the airfoil to restore peened surface condition, restoration of dry film lubricant on the dovetail, and shot peening the root to restore fatigue strength, respectively. Additional alphanumeric markings included FNZK-26 and AJ.

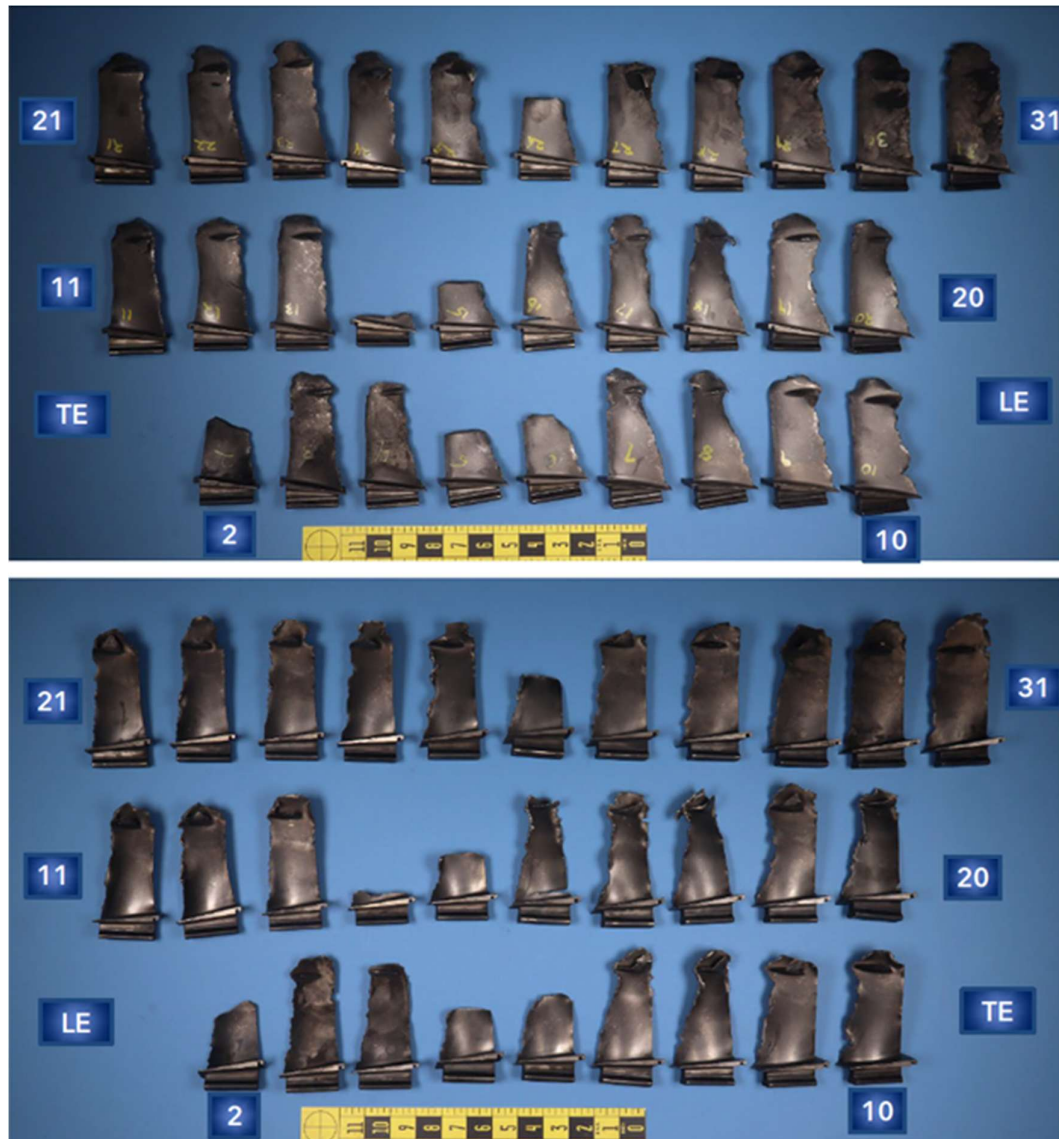
- b) The remaining blades labeled 2 through 31 as shown in figure 22 were damaged in the airfoil region above the platform. Blade 14 was fractured through the chord just above the platform, and blades 2, 5, 6, 15, and 26 were fractured near midspan.

Figure 22: concave side (upper image) and convex side (lower image) of the HPC 3rd stage blades 2-31 positioned consecutively. LE- Leading edges and TE- trailing edges.

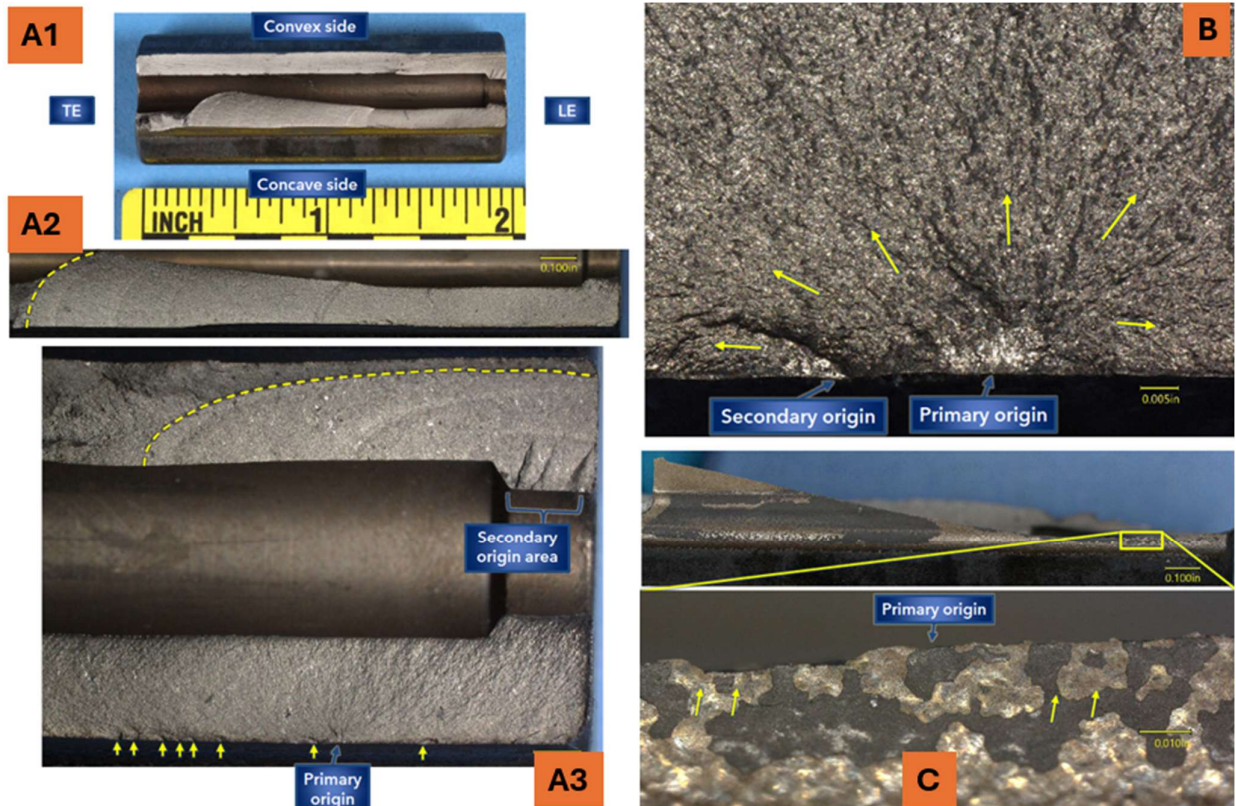
- c) The fracture surface for blade 1 had scattered black deposits on the surface in the as-received condition shown in figure 1. The deposits were cleaned. Views of the fracture surface on blade 1 after cleaning are shown in figure 23 (A1). The fracture intersected a cylindrical cavity extending longitudinally through the blade root. Portions of the fracture surface on each side of the cavity had relatively smooth features with curving crack arrest lines, **features consistent with fatigue**. The fatigue region on the concave side of the dovetail is shown in the middle image in figure 23 (A2), and the fatigue region on the convex side is shown in the lower image in figure 23 (A3). The fatigue region extended along approximately $\frac{3}{4}$ of the concave side and $\frac{1}{4}$ of the convex side to the respective boundaries indicated with dashed lines in figure 23 (A2&A3). On the concave side, the

fatigue features emanated from a primary origin located at the convex side surface approximately 0.266 inch away from the leading edge. Multiple secondary origins were also observed along the surface at location indicated with unlabeled arrows in the lower image in figure 23 (A3). On the convex side, multiple origins were located at the interior cavity surface near the leading edge. The location of the origins and fractographic features on the convex side were consistent with secondary fatigue crack initiation following cracking on the concave side.

Figure 23: A1- Fracture surface of blade 1 (upper image, A2- closer views of the fatigue region on the concave side (middle image) and A3-origin areas at the leading end of the dovetail (lower image). B- the primary origin area on the blade 1 fracture surface. C- Surface adjacent to the primary origin area showing a peened surface finish

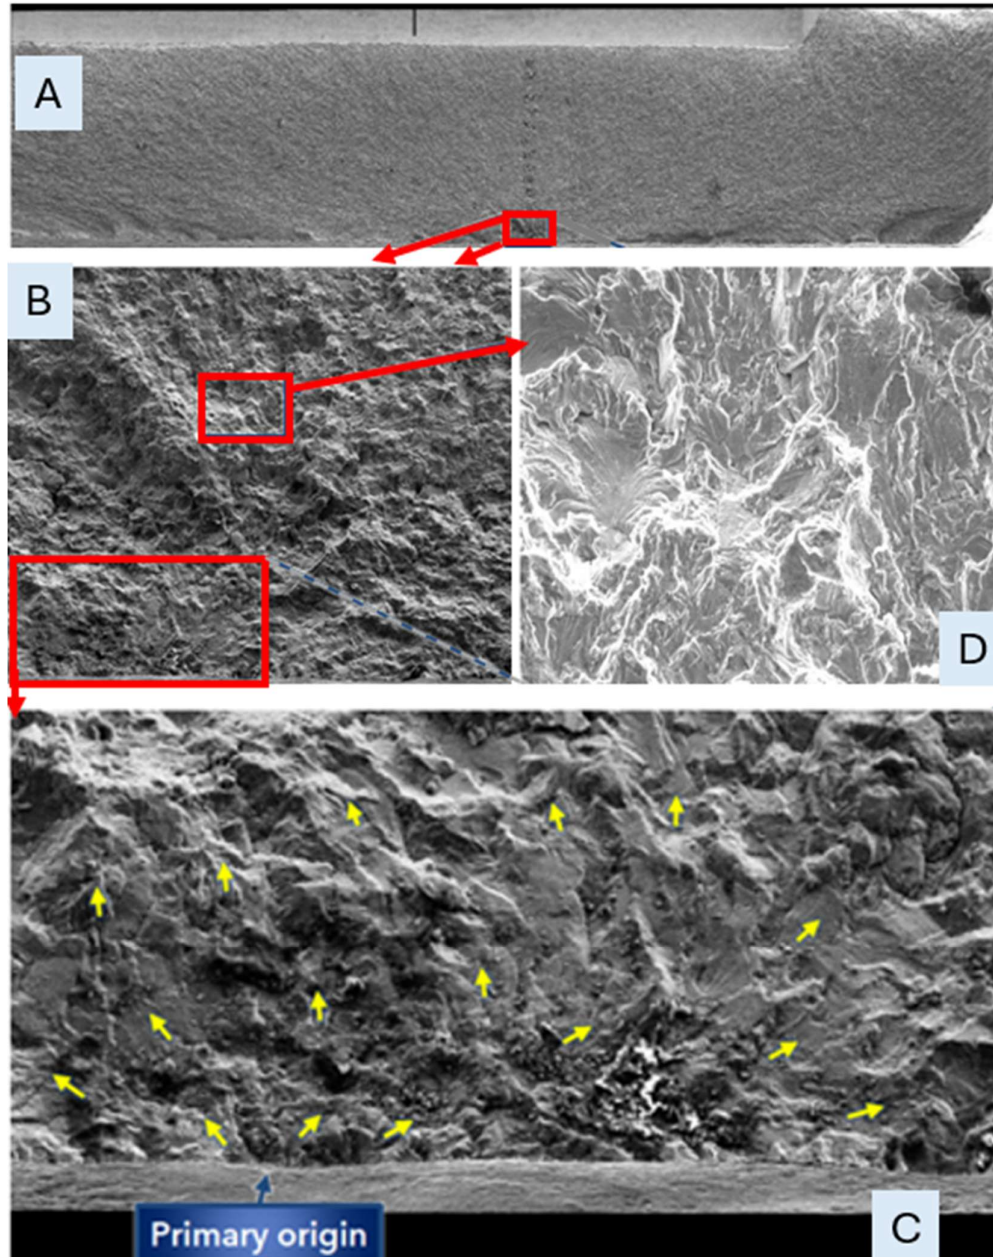
- f) Next, the fracture surface was examined using a scanning electron microscope (SEM). A montage of images stitched together to present an overall view of the leading end of the fracture surface on the convex side of the dovetail is shown in the upper image in figure 24 A. Rectangular areas that appear darker in the montage represent areas where more detailed images of fracture features were obtained, such as those shown in the lower images in figure 24(B) and in figures 24 (D) and 25.

Figure 24: A & B -Montage SEM images of the fatigue region on the blade 1 concave-side fracture surface showing the leading end. C- closer views of the primary origin area. D- SEM image of fatigue fracture features.

- g) Closer views of the primary origin area are shown in the middle and lower images in figure 24 (B&C). The origin area was partly obscured with nonconductive surface

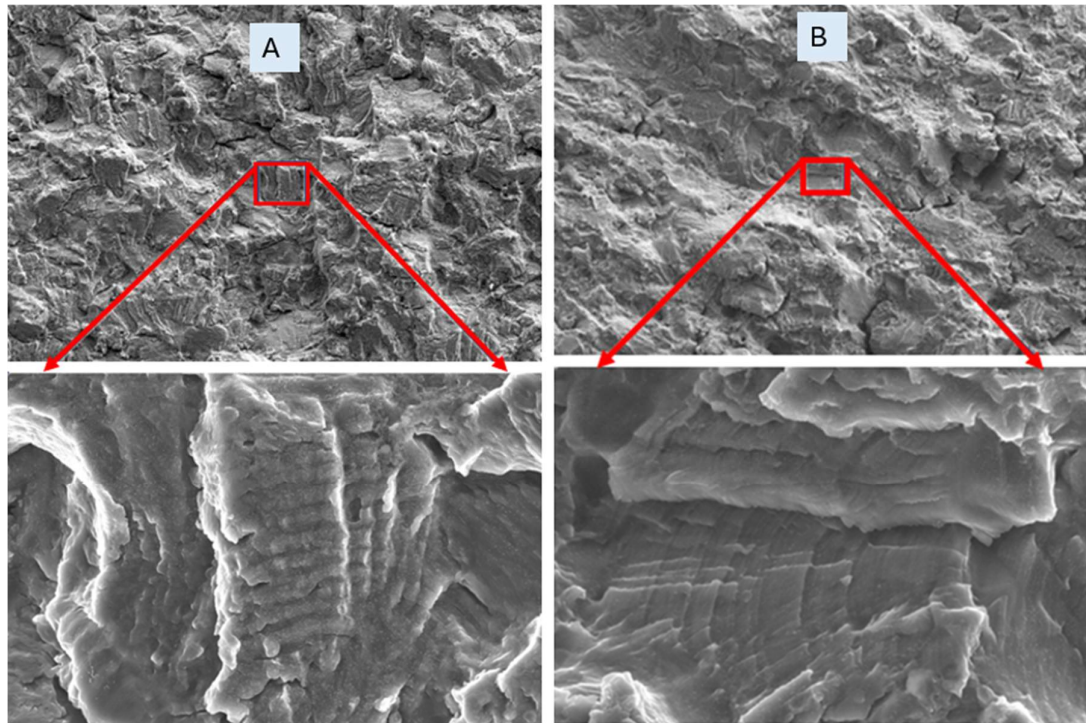
- h) Within approximately 0.013 inch of the origin, the fracture surface had a mostly faceted feathery appearance with limited areas showing striations. A view of typical fracture features in this area near the origin is shown in figure 24 (D). Further from the origin, fracture features transitioned to more areas showing striations, and mostly striations were observed at a distance of 0.018 inch. The fatigue striations were observed on varied planes and growth orientations consistent with crystallographic influence from individual grains, and figure 25(A) shows typical fatigue features observed in this region. At deeper crack depths, fine striations were observed between more prominent crack arrest lines such as the area near the fatigue boundary shown in figure 25(B).

Figure 25: A & B- SEM image of fatigue fracture features approximately 0.0358 inch and 0.563 inches away from the primary origin respectively

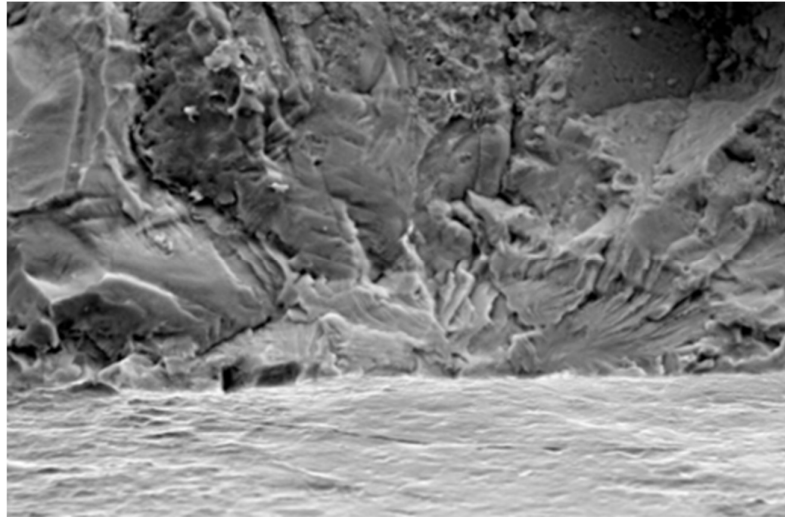
- i) The primary origin area was partly obscured by non-conductive deposits that remained on the surface after cleaning. However, several of the secondary origins were free of deposits. The origin areas showed feathery trans granular features emanating from the blade surface such as the image of a typical secondary origin shown in figure 26.

Figure 26: SEM image of a secondary origin area

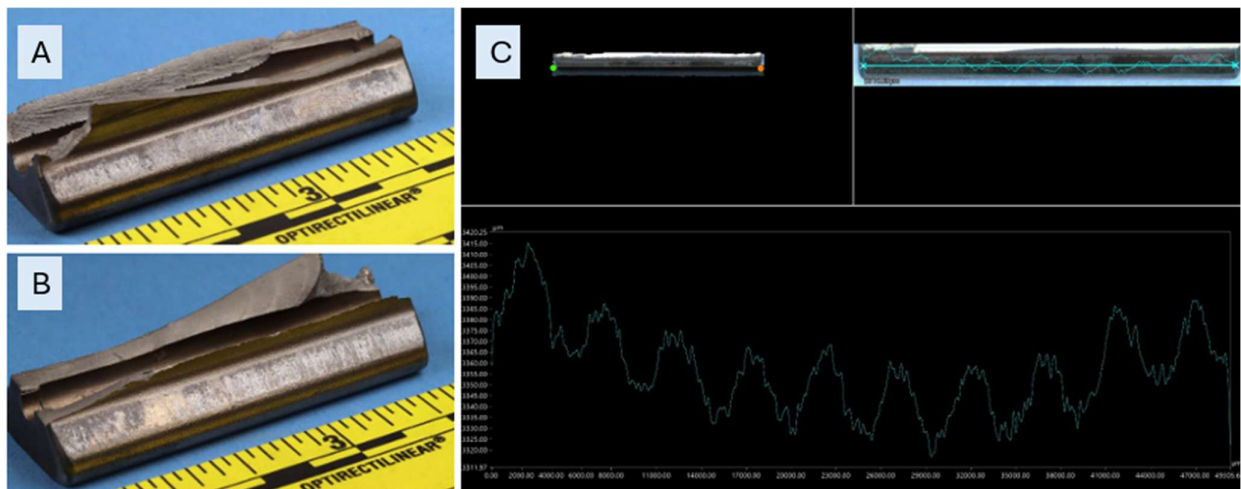
- j) Views of the disk slot contact faces for the blade 1 dovetail are shown in figure 27 (A&B). The contact face showed patches of areas with relatively reflective features with underlying darker areas associated with disk slot contact where the surface appeared smeared slightly in the radial/chordwise orientation. Gold-colored areas consistent with relatively undisturbed surfaces were present between the darker patches. The smearing and darker patches were more prominent on the convex side shown in the lower image in figure 27 (B).

Figure 27: Oblique views of the blade 1 dovetail piece showing the concave-side (A-upper image) and convex-side (B-lower image) disk slot contact faces. C - Relative vertical height map along a longitudinal trace of the concave-side contact face on blade 1 acquired using a Keyence VHX-7000 optical microscope

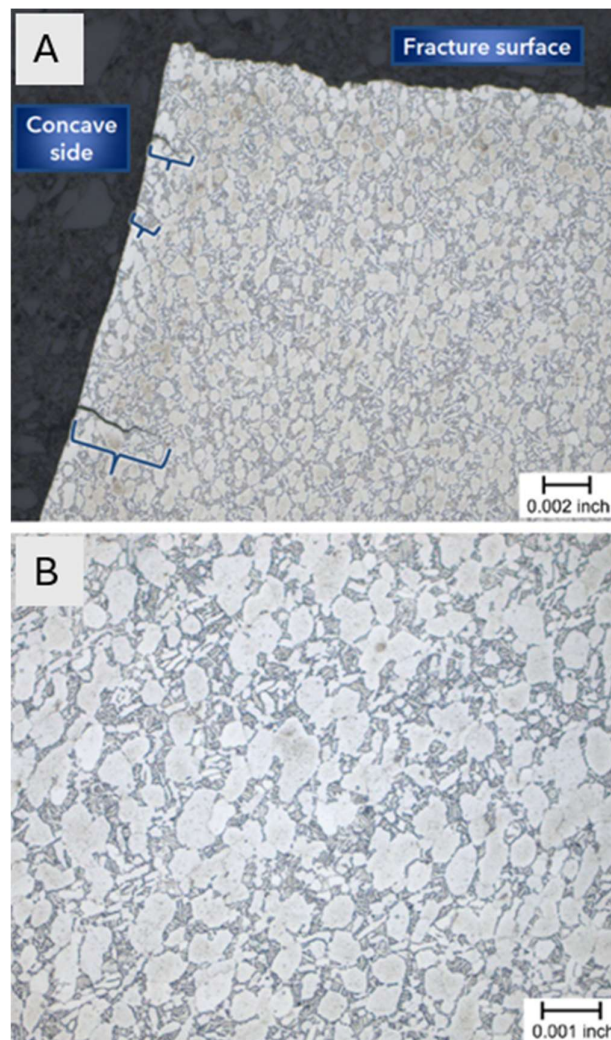
- l) A transverse cut was made through the blade 1 dovetail at the location of a secondary origin on the fracture surface to prepare a metallographic cross-section. The secondary origin selected for the metallographic examination was located closer to the leading edge relative to the primary origin (arrow to the right of the primary origin as viewed in figure 23). The sectioned piece was then mounted in a metallographic mount, polished, and then etched using Kroll's reagent.
- m) In figure 28, an overall view of the microstructure adjacent to the fracture surface at the concave side of the cross-section is shown in the upper image, and a closer view of typical microstructural features is shown in the lower image. The microstructure consisted of alpha grains (appearing white) intermixed with areas of alpha plus beta (appearing darker).

Figure 28: The fracture surface and adjacent surface in the dovetail radius (A) and the typical microstructure at higher magnification (B).

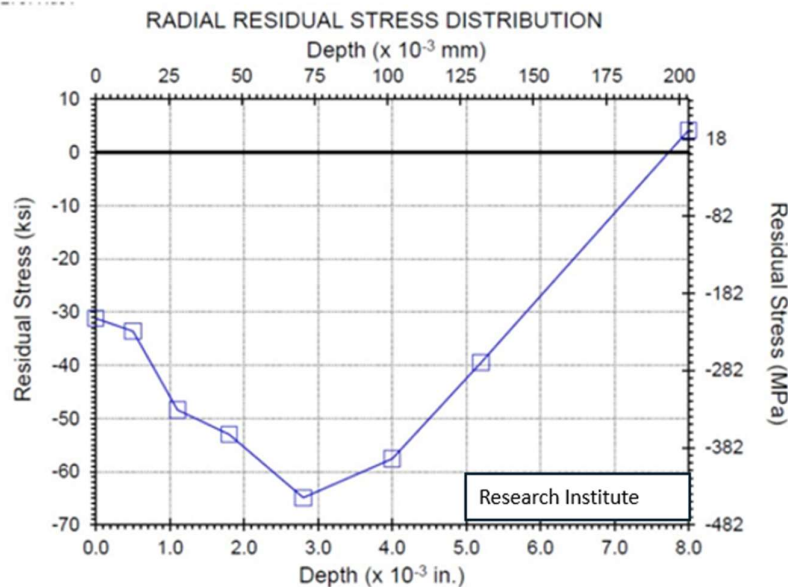
- n) Another transverse cut was made through the dovetail piece of blade 1 near midspan, and the trailing piece was sent to one Research, institute for depth profile measurements of residual stress in the radial direction using x-ray diffraction. Measurements were made in the dovetail radius between the disk contact face and the fracture surface, and results are shown plotted in figure 29. Measurements showed compressive stresses at the surface and up to a depth of nearly 0.008 inch with a peak compressive stress of -448 MPa.

Figure 29: Chart of residual stress in the radial direction measured in the dovetail radius on the concave side of blade 1.

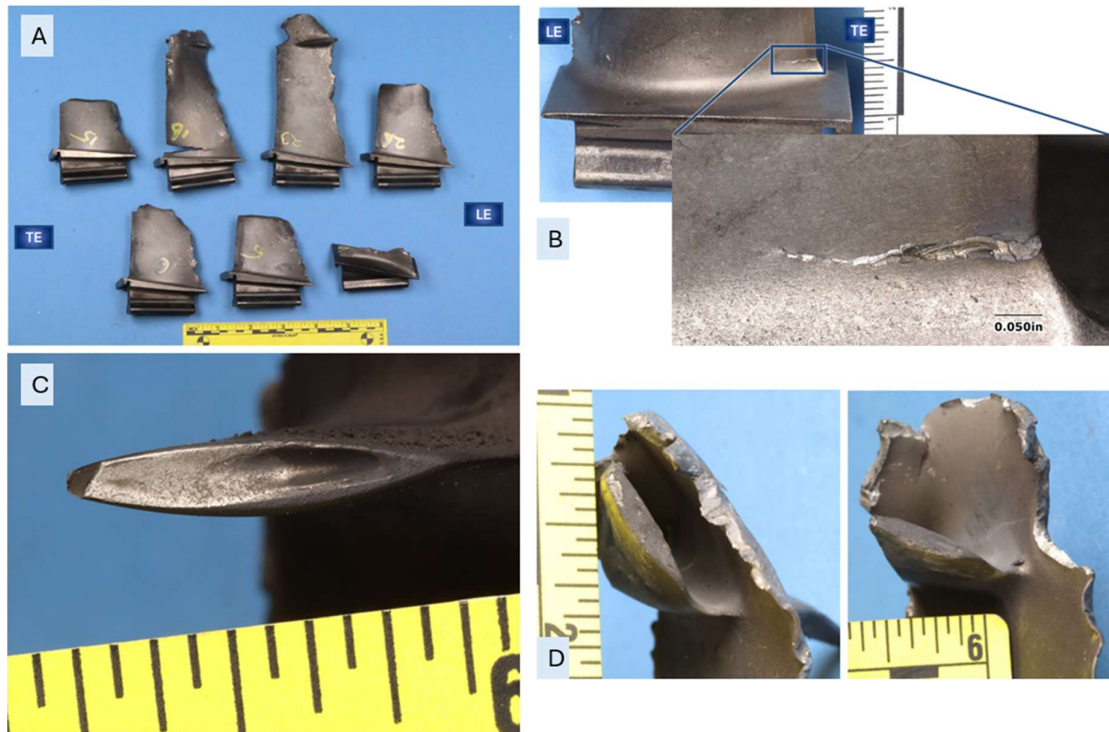
- p) The dovetail radius region on each of HPC 3rd stage blades 2 through 31 was cleaned and expose the surfaces for examination using a stereo microscope at up to 80x magnification. No evidence of a crack was observed in any of the examined dovetail surfaces.

Figure 30: A- Closer view of 7 blades showing representative damage signatures. B- Trailing edge crack on blade 5. C - Fretting contact on the clapper end face on the convex side of 31st blade. D- End faces of clappers on the convex sides of 21st blades (left image) and 23 (right image) showing surfaces covered with black deposits.

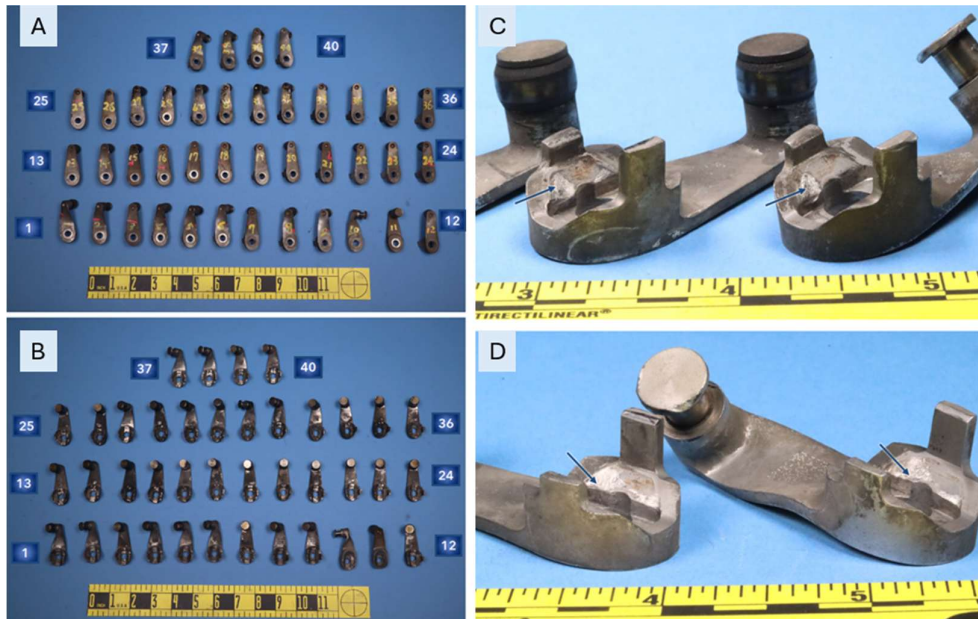
a) Overall views of the HPC VIGV levers are shown in figure 32(A&B). Most of the lever arms were twisted to varying degrees between the control pin and the VIGV spindle attachment, except for VIGV levers 20 and 26. The bushing on the control pin was missing from many of the levers, and the bushing was fractured on several others. Closer views of several selected VIGV levers with representative damage are shown in figure 32 (C&D). Many of the levers showed fretting contact damage at the VIGV spindle contact areas as indicated with arrows in figure 32 (C&D). Similar fretting damage was also observed on the relatively undeformed VIGV levers 20 and 26. The fretting damage had a relatively shiny appearance consistent with relatively recent damage from high loads following the blade out event.

Figure 32 : (A&B)- (A &B)- The HPC VIGV levers. (C&D)- The VIGV levers showing representative damage signatures.

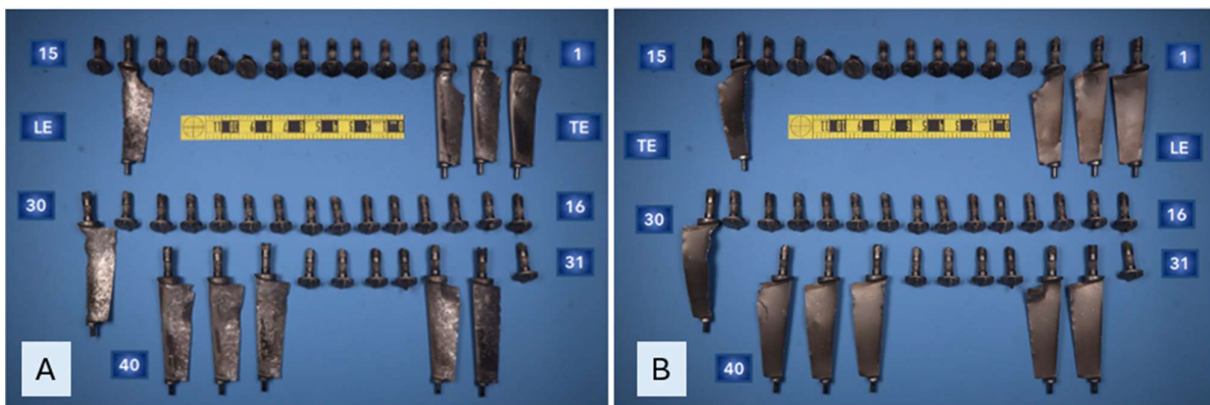
- a) Overall views of the HPC VIGV pieces recovered from their installed positions are shown in figure 33. Most of the VIGVs were fractured adjacent to the platform associated with the outer spindle. The remaining intact VIGVs showed impact damage at the leading and trailing edges and substantial impacts on the convex side of the airfoil. Airfoils were bowed to varying extents across the span such that the convex side was deformed to a concave shape in the spanwise direction. The airfoil fracture surfaces adjacent to the outer platform for the fractured VIGVs were heavily damaged, but no evidence of a preexisting crack was observed on the fracture surfaces, including the fracture surfaces for VIGV numbers 20 and 26. The outer spindle surfaces that contacted the VIGV levers had fretting damage that corresponded to the fretting damage observed on the VIGV levers.

Figure 33: The HPC VIGVs (A- Convex side) & (B- concave side)

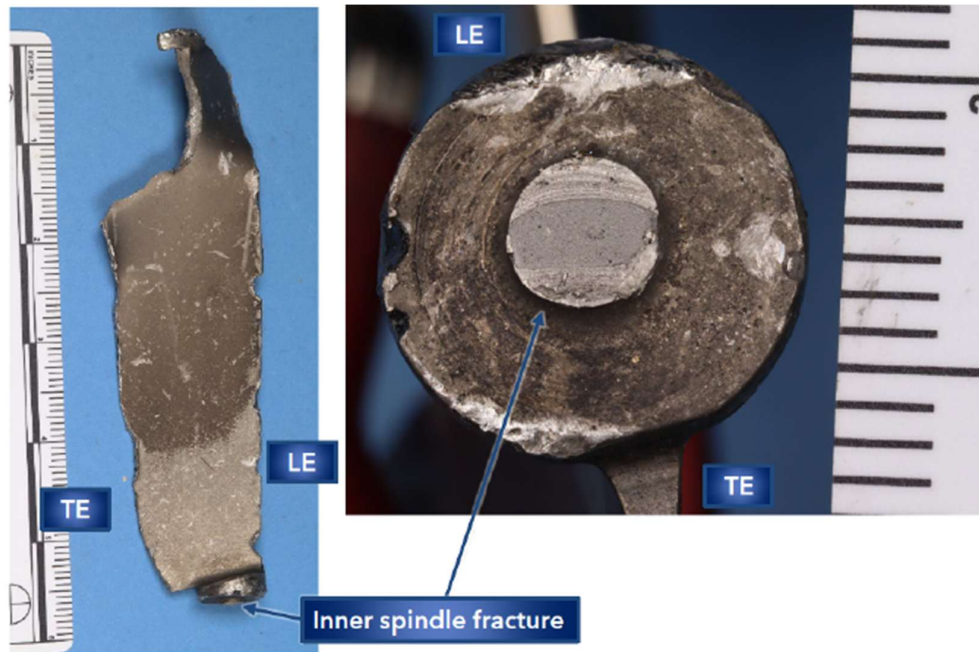
- e) The HPC VIGV shown in figure 34 was sectioned chordwise near the inner platform to for an SEM examination of the spindle fracture surface. The origin area was relatively broad and had a relatively shallow smooth area near the surface that transitioned to rougher features with ductile tearing. **Overall, the fracture features were consistent with progressive fracture from cyclic overstress loading.**

Figure 34: VIGV piece recovered from the fan case (left image). The inner spindle fracture surface (right image).
