**Final Investigation Report  
on**

**Serious Incident of Airprox involving M/s EL AL Israel Airlines Ltd.'s Flight no. ELY081 and  
M/s Qatar Airways Flight No. QTR8E in Mumbai OCC, on 24 March 2024**

**Government Of India  
Ministry of Civil Aviation  
Aircraft Accident Investigation Bureau**

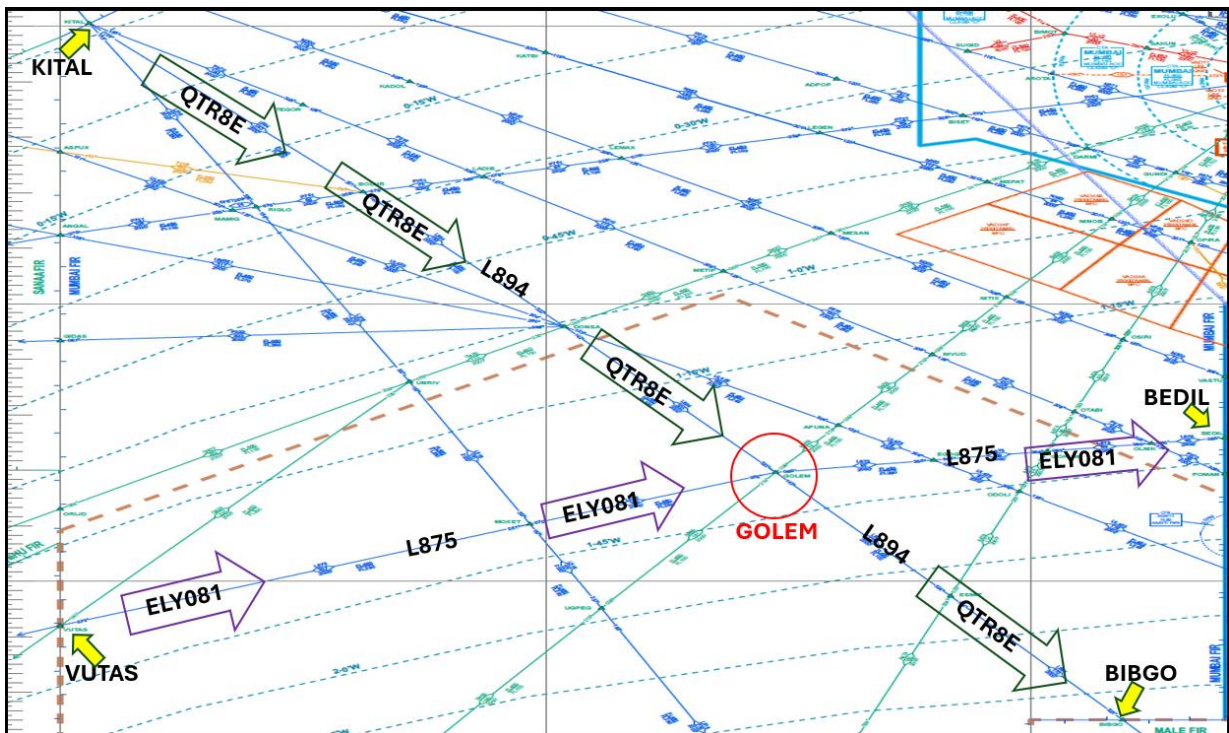
Figure 1: Depicting Flights Route, Entry, Crossing & Exit waypoints in Mumbai FIR

FL350 via Waypoint VUTAS and maintain FL350 along route L875 before exiting via Waypoint BEDIL. The Routes L875 and L894 intersect at Waypoint GOLEM within the Mumbai FIR (see Figure 1).
