**Final Investigation Report on Serious Incident: Airprox
Between
Turkish Airlines, Airbus, A330-223F, Türkiye, TC-JOO
and
Flydubai, Boeing, B737 MAX 8, United Arab Emirates, A6-FKR
On
30 August 2025 in Mumbai FIR (INDIA)**

**AIRCRAFT ACCIDENT INVESTIGATION BUREAU
MINISTRY OF CIVIL AVIATION
GOVERNMENT OF INDIA**

Date and time of serious incident	30 August 2025, at 23:47 (05:17 A.M IST)	
Type of Occurrence	Airprox (Loss of Longitudinal and Vertical Separation)	
Place of incident	Mumbai oceanic control area at approximately 197 miles east of Waypoint TOTOX on route P574.	
Applicable Standard	Aircraft on reciprocal tracks: Where lateral separation is not provided, vertical separation of 1000 feet shall be provided for at least 10 minutes prior to and after the time, the aircraft are estimated to pass, or are estimated to have passed. (Reference ICAO Doc 4444 para 5.4.2.2.3)	
	Aircraft1	Aircraft2
Operator	Turkish Airlines	Flydubai
Flight Number	THY6380	FDB2JQ
Type of aircraft	A330-223F	B737 MAX 8
Registration	TC-JOO	A6-FKR
Flight Rule	IFR	IFR
Sector	VOMM - LTFM	OMDB - VOCL
Route	P574-TOTOX-L555	N629-TOTOX-P574
Phase	Climb	Cruise
Type of Flight	Scheduled (Cargo)	Scheduled (Passenger)

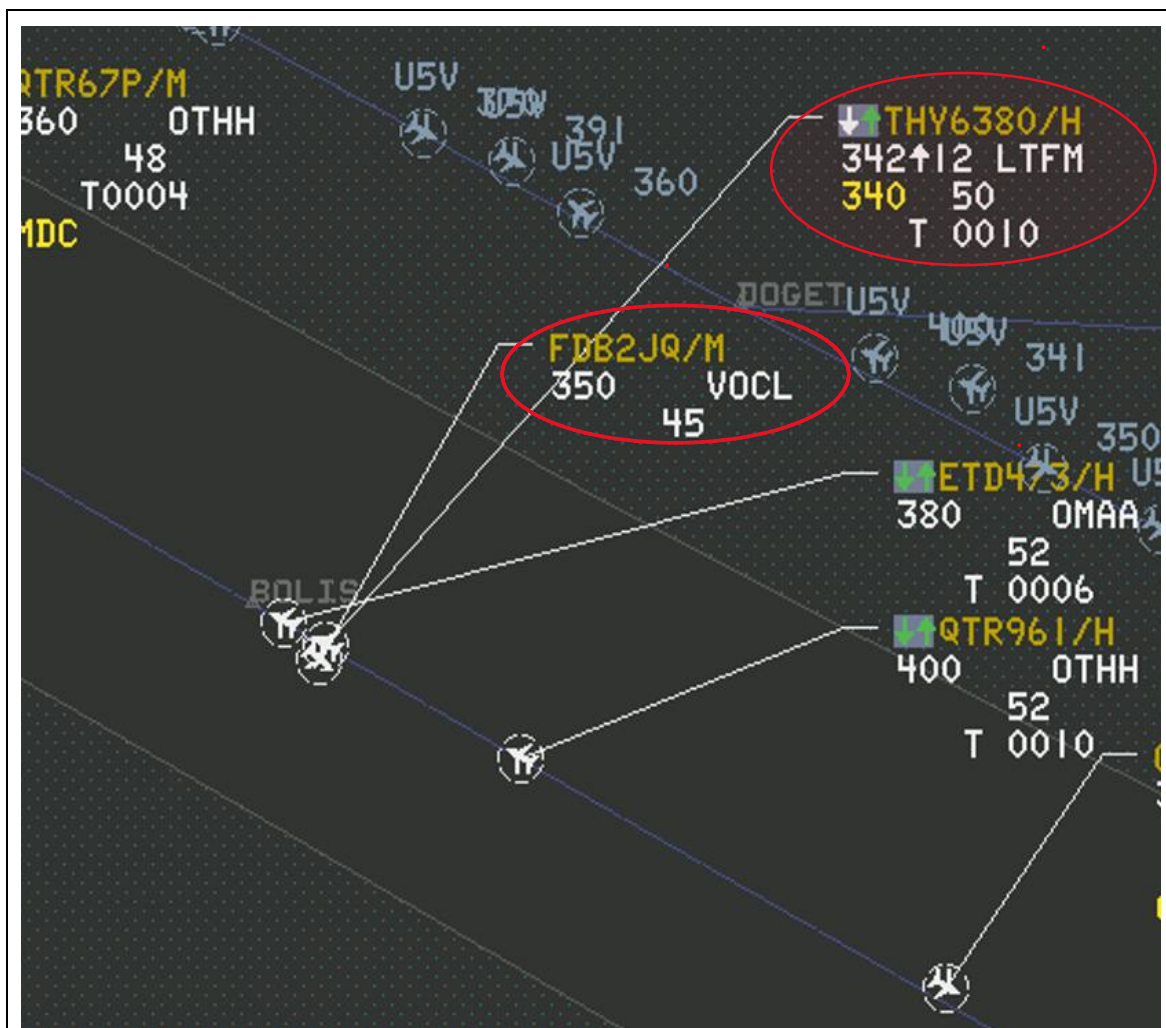
Fig: 02 Position of THY6380 passing FL342 in climbing phase and FDB2JQ at FL350 (Screen shot of Controller work Position in OCC, by Mumbai ATC)

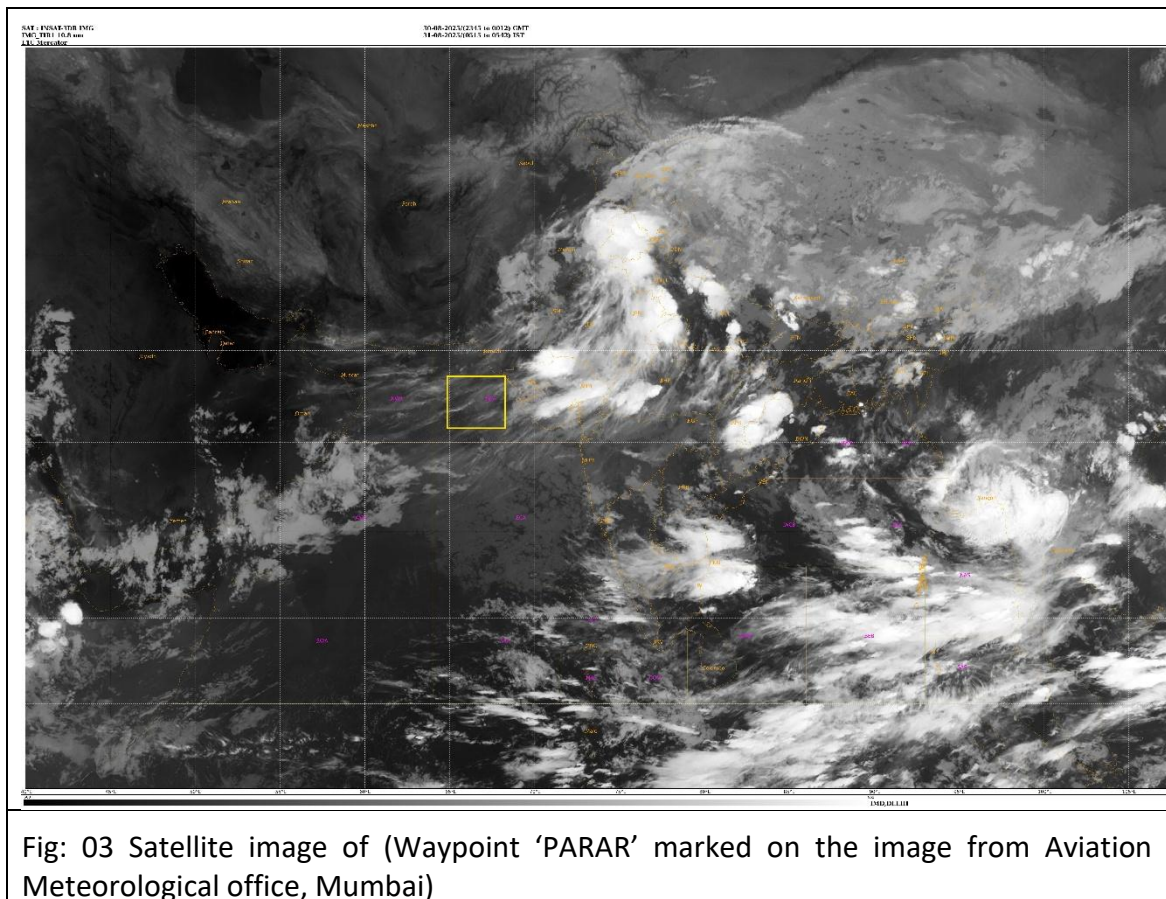
The weather as per the satellite imagery provided by the meteorological department, India during the time of the serious incident depicted that no significant cloud cover was observed. (Fig: 03)

Yellow box marked on the Satellite image represents the approximate location at which the incident occurred. There were no significant convective clouds present around the location of the incident. There were some patches of medium cloud i.e Altocumulus clouds.

The image also shows an Easterly wind with wind speed 10 kt- 15kt and Temperature between -37°C to -36°C at FL 340 around the location of incident.

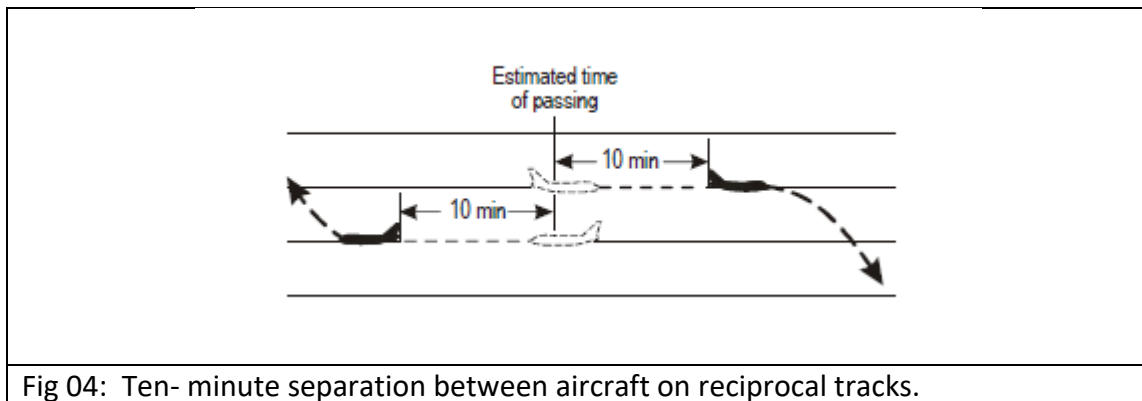
Aircraft on reciprocal tracks. Where lateral separation is not provided, vertical separation shall be provided for at least ten minutes prior to and after the time the aircraft are estimated to pass, or are estimated to have passed (Fig: 04). Provided it has been determined that the aircraft have passed each other, this minimum need not apply.

Fig 04: Ten- minute separation between aircraft on reciprocal tracks.

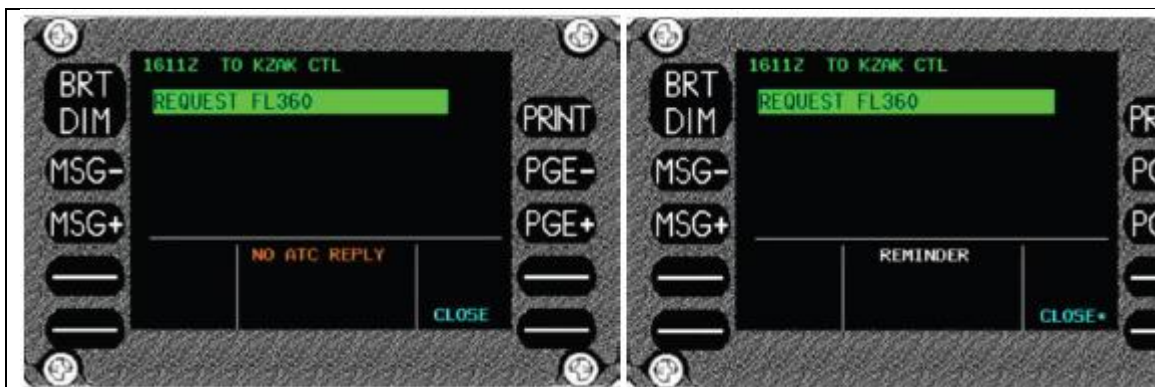
At 23:46:06, in absence of an ATC uplink message with a MRN, the onboard ATC datalink system displayed a reminder message on the DCDU associated with the visual cockpit ATC MSG pb light. The PB lights are the attention getters for the flight crew to have a look at the ECAM pages to deal with different kind of messages with ATC that are not only clearances but also report request, negotiation, information or reminder messages.

Fig 06: Example of the reminder messages displayed on the DCDU

At approximately 23:48, the blue ATC message light illuminated to get the pilot attention and have a look at the DCDU screen where a reminder message was presented. FO interpreted this reminder message as a clearance message to climb FL360 that is presented differently-
