**Final Investigation Report on accident involving Cessna 172-S aircraft  
bearing registration VT-FSF operated by FSTC Flying School Private Limited  
at Bhiwani on 17<sup>th</sup> June 2023.**

**Aircraft Accident Investigation Bureau  
Government of India  
Ministry of Civil Aviation**

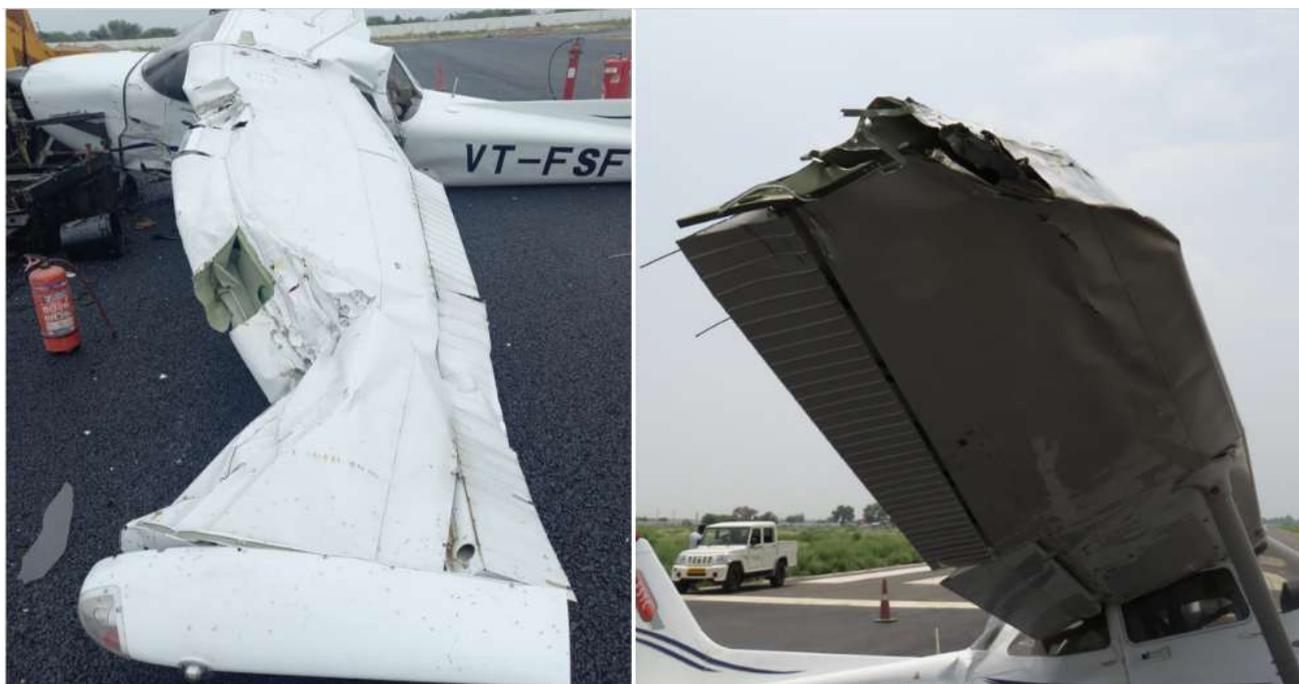
Figure 1

The aircraft suffered significant damage due to impact with paver machine. The wing's port side, the outboard section and areas near the engine installation were broken. The wing itself was extensively damaged, along with the left-side aileron and flap. Similarly, the starboard side of the wing, the wingtip, wing root and flap were damaged.

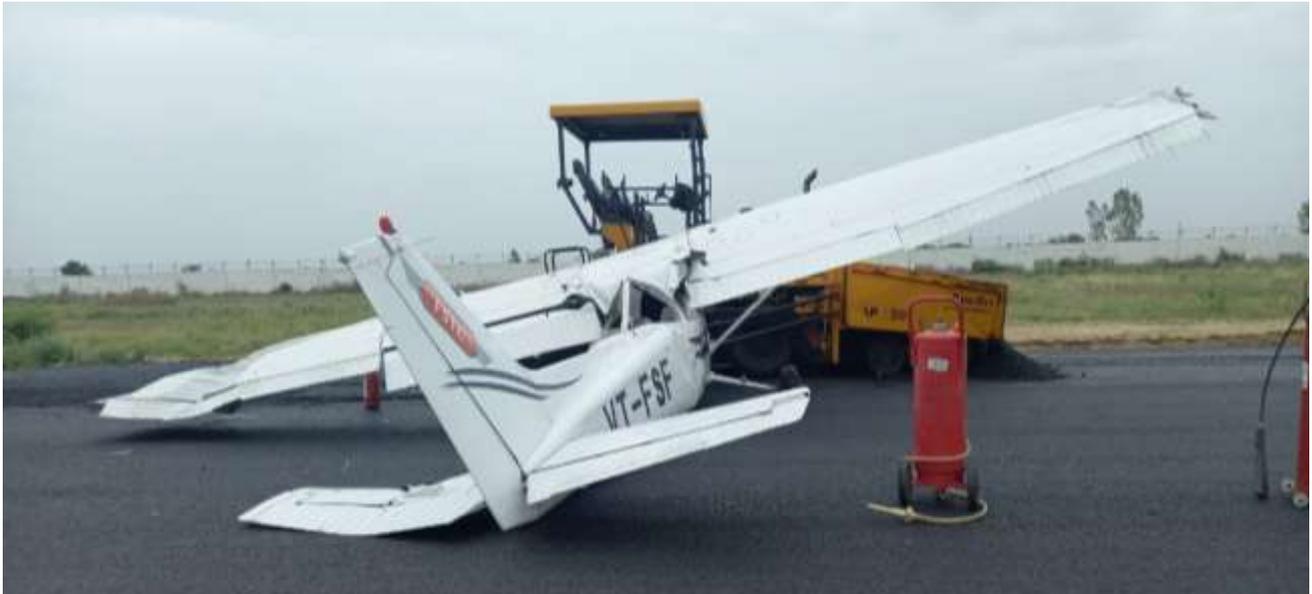
Figure 2

The engine side exhibited a damaged cowling, a fully damaged propeller, and broken landing gear on the port side. The nose landing gear, windshield, and door/window on the port side were also damaged. The cockpit incurred full damage. Total fuselage was damaged. Integral fuel tank area was damaged

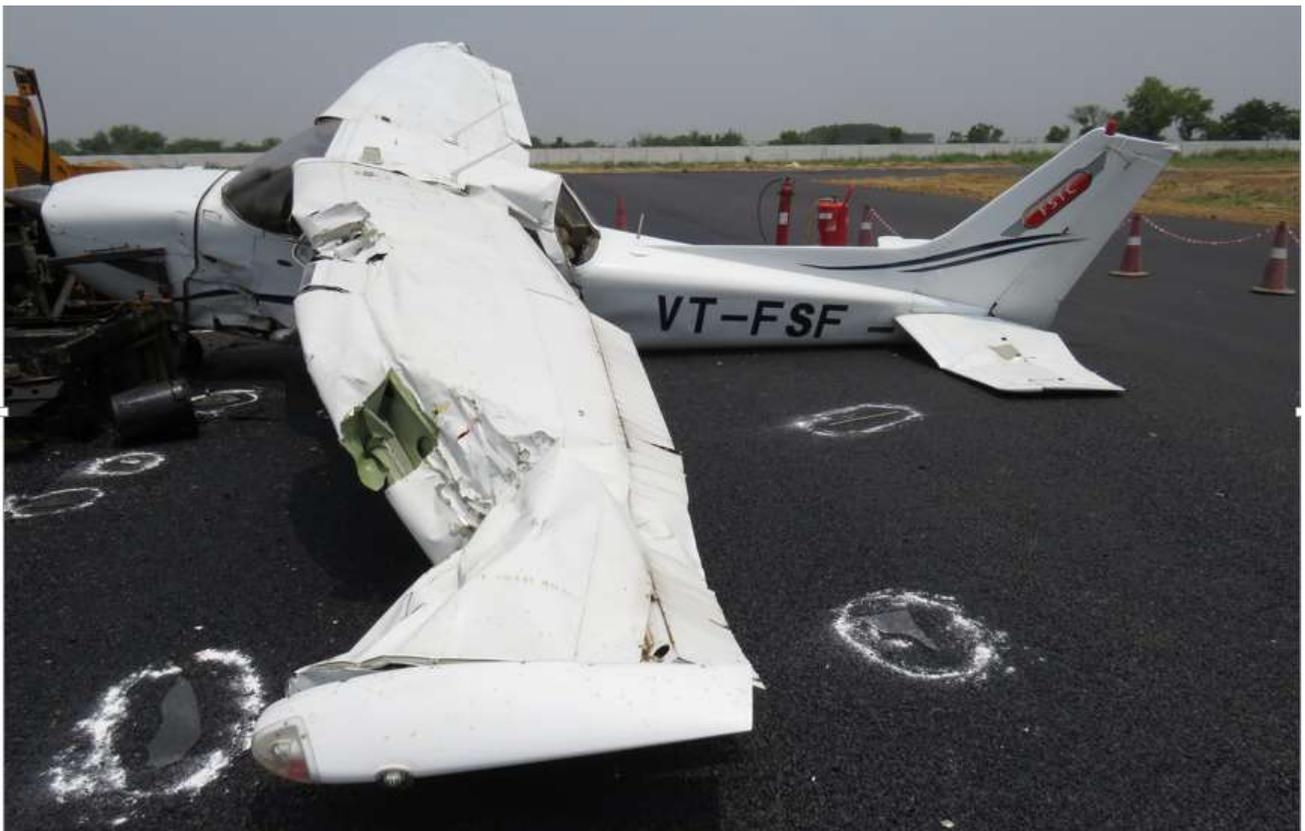
Figure 3

and a fuel leak beneath the integral fuel tank area was observed. Other damages included a broken baggage door, damaged landing gear on the starboard side, and damaged horizontal stabilizers on both sides, a fully damaged left-side elevator and rear windshield.

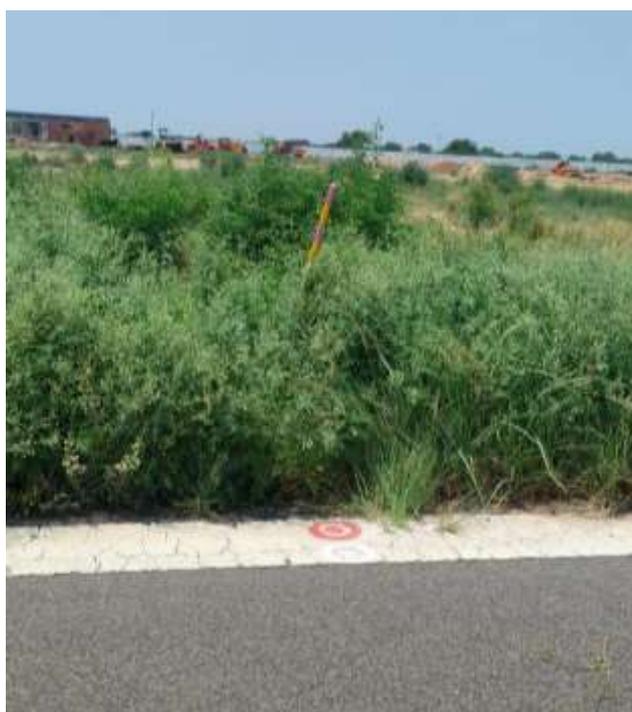
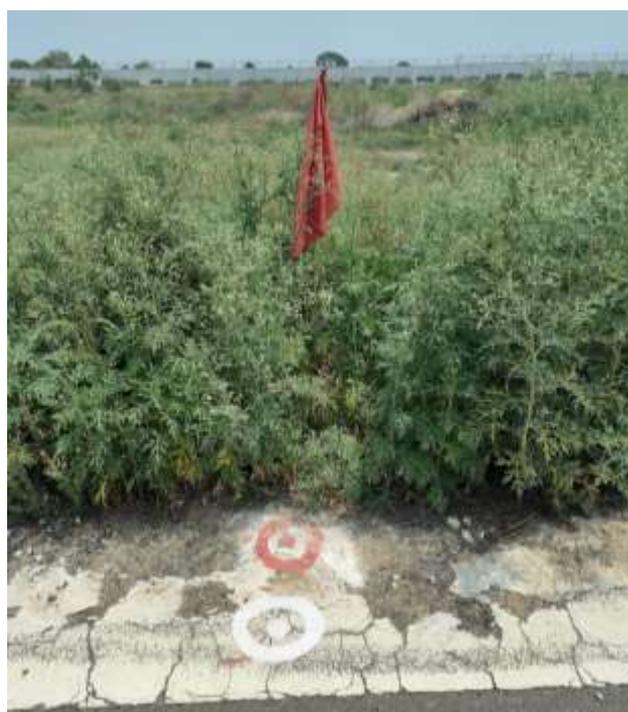
The aerodrome is not a DGCA licensed aerodrome. Standard runway markings for Designator, Threshold, Center Line and Runway edges etc were available. Marking for aiming point or touchdown zone are not provided. As a practice, the FTO has placed two flags on both side of the runway at middle of the runway length to provide indication to their crew to carry out missed approach in case the aircraft has not touched down till this point. However, due to growth of vegetation, visibility of both flag poles was obscured. On one side of the runway the flag itself was missing and only the pole was in place.

Figure 6 : Damaged Red Flags and Excessive vegetation growth around the Red Flag

3.1.8 The flag poles on either side of runway indicating the middle of runway length were covered with vegetation. The flag on one side was missing.

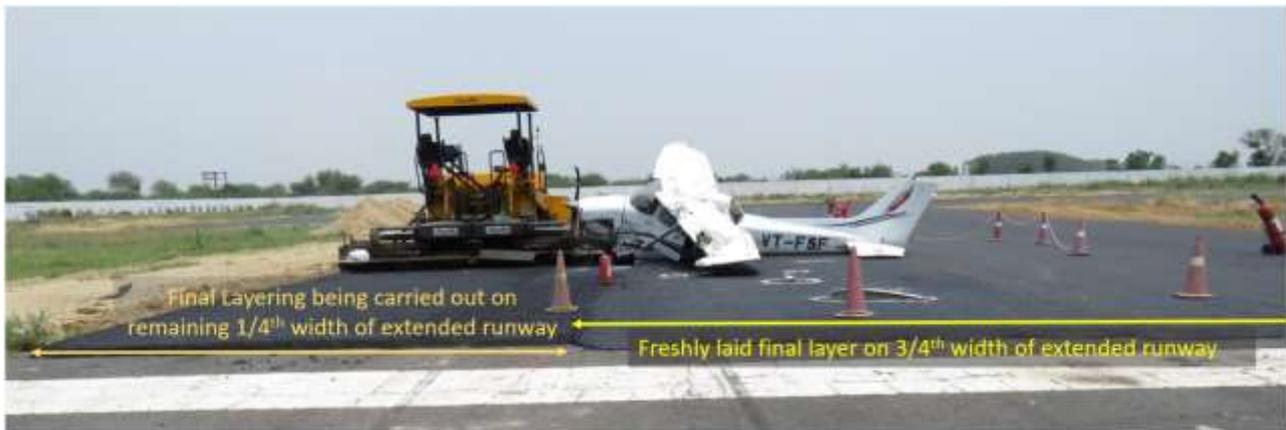
**Figure 8: Status of work on the extended runway**

on about 3/4<sup>th</sup> width of extended portion was freshly carried out and the work for final layering on last 1/4<sup>th</sup> width was underway at the time of accident. The Paver Machine was about 36 feet from the end of runway laying asphalt on the last 1/4<sup>th</sup> width of Runway when the aircraft came and hit the paver machine. Paver Machine along with workers and other equipment and vehicles was operational at the time of accident.

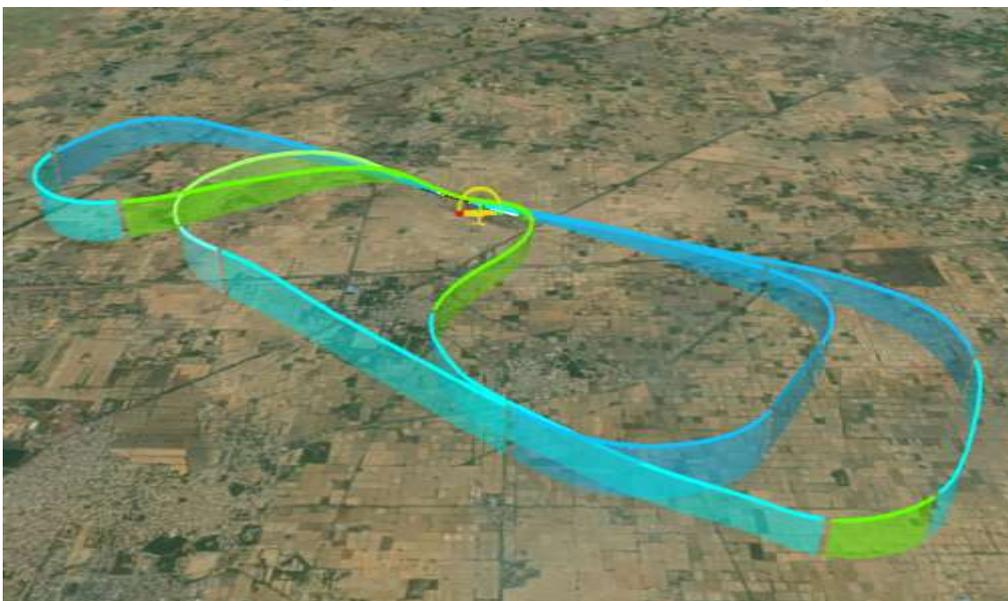
**Figure 9: Flight track**

shown in the figure 9. Further, as per the Garmin G1000 data, the sequence of events are as follows.

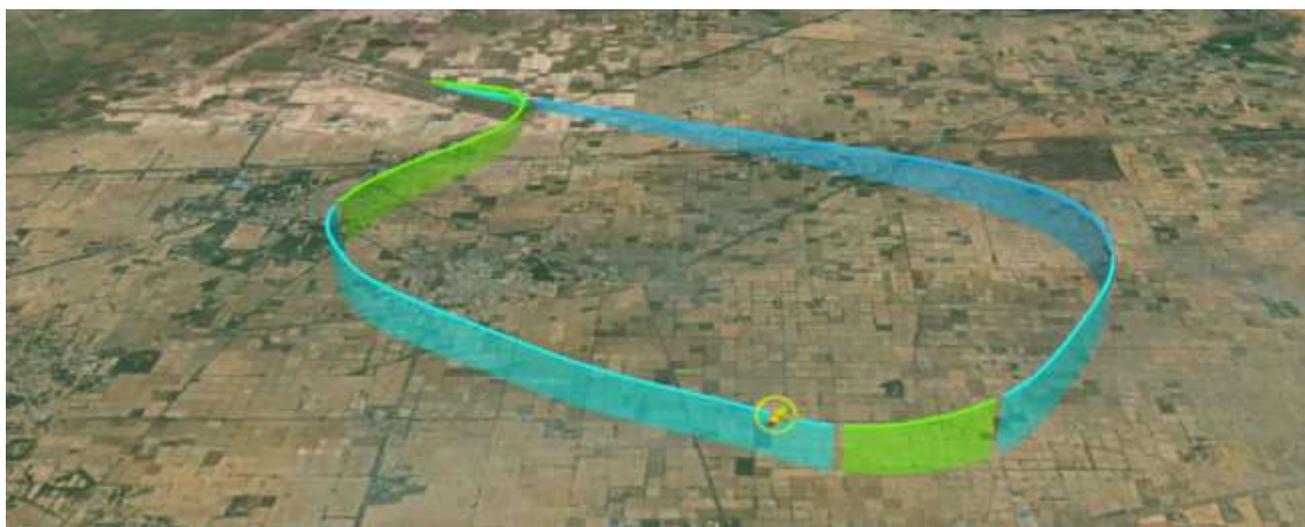
The aircraft was then realigned with runway 12 and took-off at 08:57:50 UTC. At mid-crosswind, engine failure was simulated and then resumed normal (Figure 10). Within the same circuit pattern involving runway 12, engine failure was again simulated at mid-downwind, before making an approach for runway 30. The aircraft was high (307 ft AGL approx.) on the threshold and at 09:02:46 UTC, a go-around was carried out.

**Figure 10 : Flight Track, take-off from runway 12 and approach to runway 30**

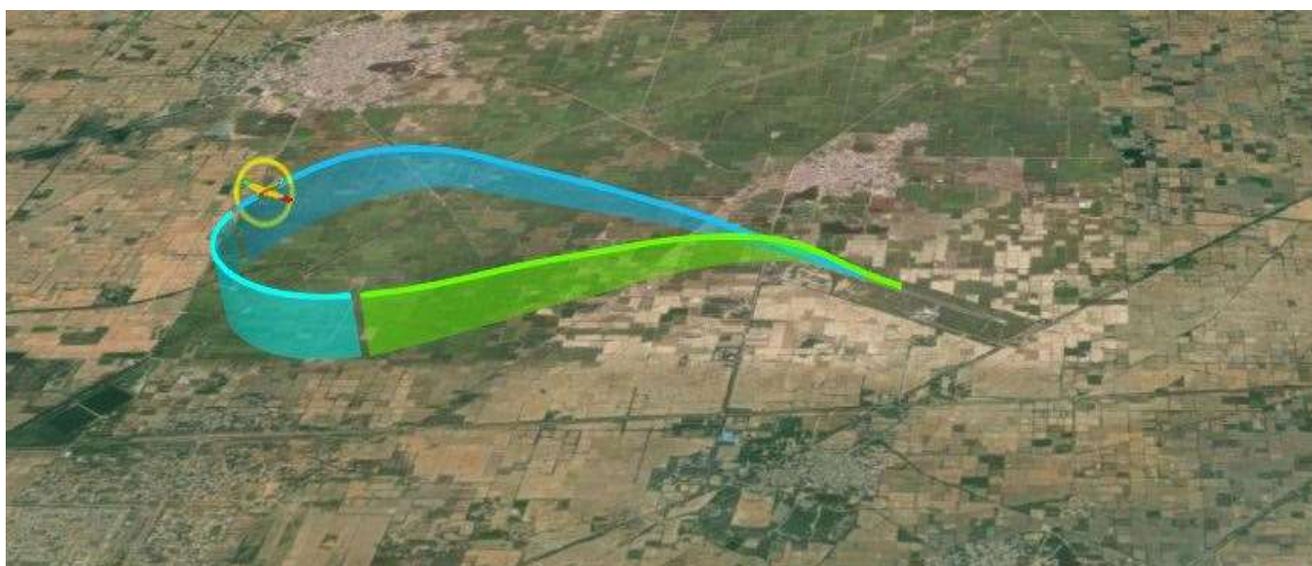
Continuing the circuit from runway 30, AFI simulated an engine failure at the beginning of the downwind leg and then approached runway 12 (Figure 11). At the time of crossing the threshold, the speed was 91.4 knots and altitude was approximately 161 ft AGL. At 09:06:19 UTC another go-around was initiated.

**Figure 11: Circuit from runway 30 continued and approach for runway 12**

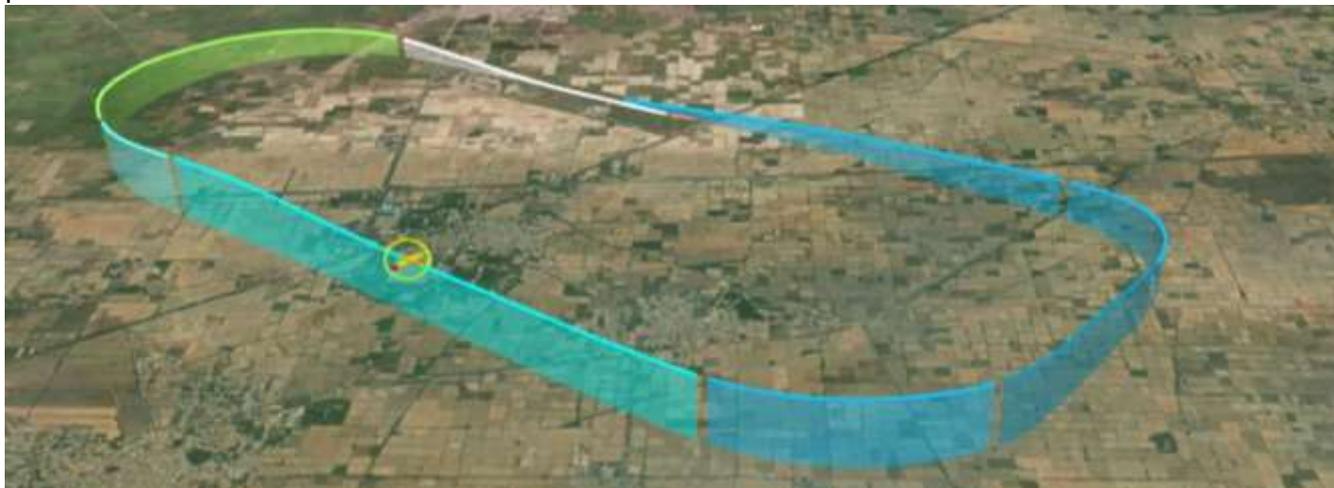
Figure 12: Circuit from runway 12 and final approach

After the go-around from runway 12, an engine failure was again simulated at the end of the downwind leg for runway 12 at an altitude of about 1148 ft AGL and airspeed was 75 knots. As aircraft again approached runway 12 it was high (Figure 12). This time aircraft was pitched down in an attempt to land and airspeed increased from 75.44 knots to 89.44 knots. The recommended approach speed with flaps is 65 kts and without flaps is 70 kts. The vertical speed also increased and went upto -1104.47 feet per minute.

At that time 09:11:13 UTC, the aircraft crossed threshold. The altitude was 81 feet AGL and Airspeed was 89 knots. Aircraft continued its approach and made a delayed touched down with the airspeed at 54 knots. The distance covered from 50 ft AGL to touchdown was approximately 3018 feet as per the software application being used by the FTO for Flight Data Monitoring. Aircraft continued its ground roll and exited the runway 12 as it was not able to stop within the remaining runway length. Aircraft entered extended portion of runway at 09:11:40 UTC and airspeed was 35.24 knots. The speed abruptly reduced to zero indicating collision with obstacles in the extended portion of runway. Also, the recorded parameters found to be erratic and incomplete. Hence, rest of the data were omitted for the analysis.

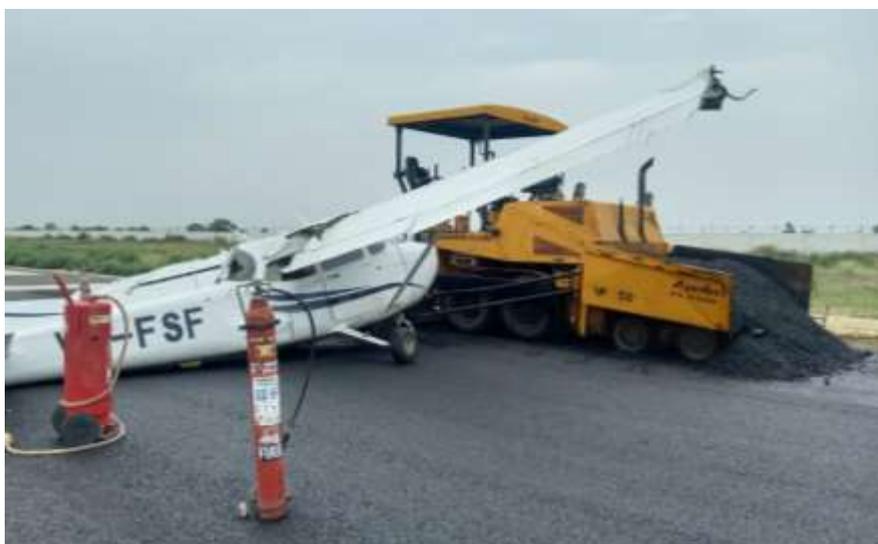
Figure 13: Freshly laid surface and paver machine loaded with asphalt

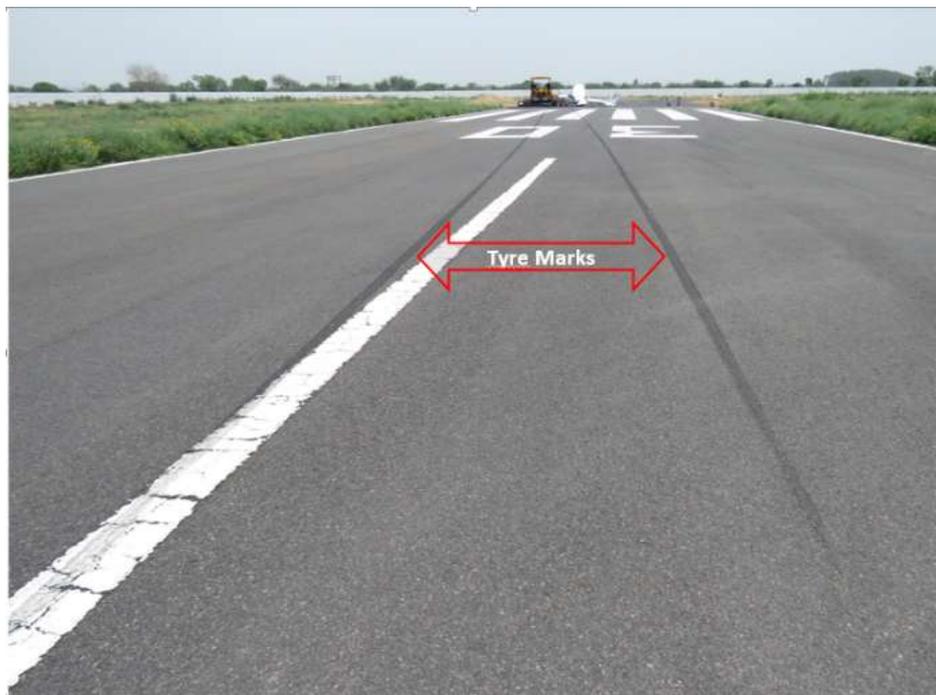
Figure 14: Tyre Marks

The investigation team was able to identify the marks of aircraft tyres on the runway. The marks could be traced back to about 375 ft from the end of runway 12. The tyre marks indicated that the aircraft remained slightly right of the centerline after a late touchdown and crossed over to the left of the centerline about 140 feet before the end of Runway 12.

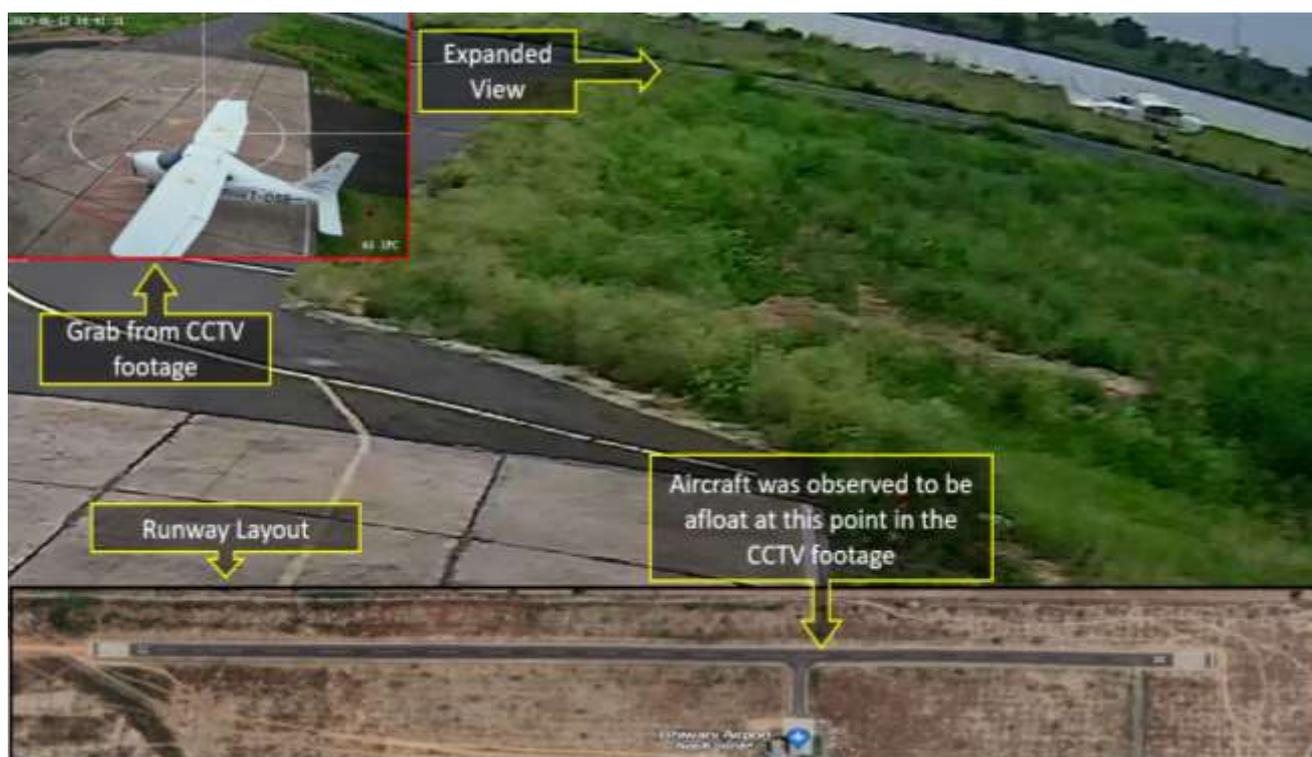
Figure 16 : Aircraft afloat near the Apron as observed from the CCTV footage

footage shows that the aircraft was still gliding above the runway while it was crossing the taxiway that connects to the apron.
