**Final Investigation Report on
Serious Incident of Airprox between ALH MK III (Defence Helicopter) and
A319-112 Aircraft VT-SCV (AIC788) operated by Air India at Port Blair
Airport on 02 Feb 2024**

**AIRCRAFT ACCIDENT INVESTIGATION BUREAU
MINISTRY OF CIVIL AVIATION
GOVERNMENT OF INDIA**

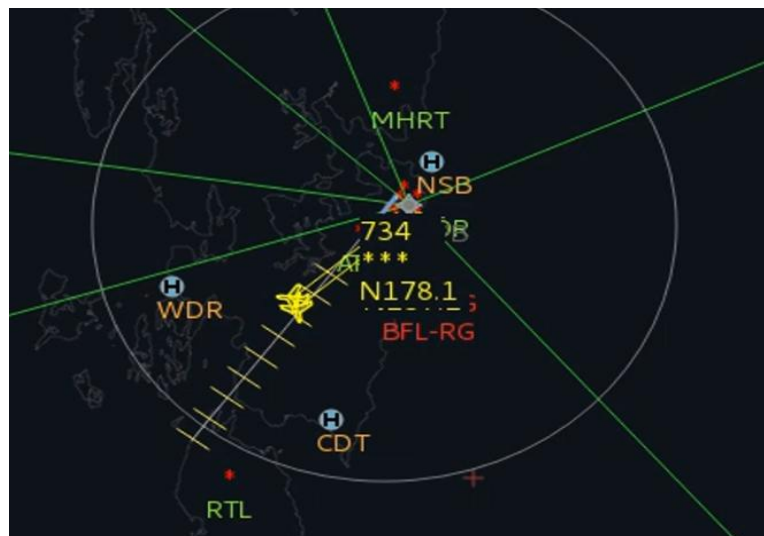
As the helicopter had proceeded on the outbound leg for a minute, the departing faster aircraft AIC 788 took off and caught up with helicopter at 2700 feet from its rear end. At 02:58:53 Hrs, the Helicopter reported TCAS TA alert at 2700 feet and turned right to keep clear of the take-off path of AIC788. At 02:59:24 Hrs, AIC788 contacted Approach and reported that the traffic was in sight and therefore it had descended. However, AIC788 did not receive any TCAS advisory.

Figure 1 Both Helicopter and AIC 788 came into close proximity and executed corrective maneuvers.

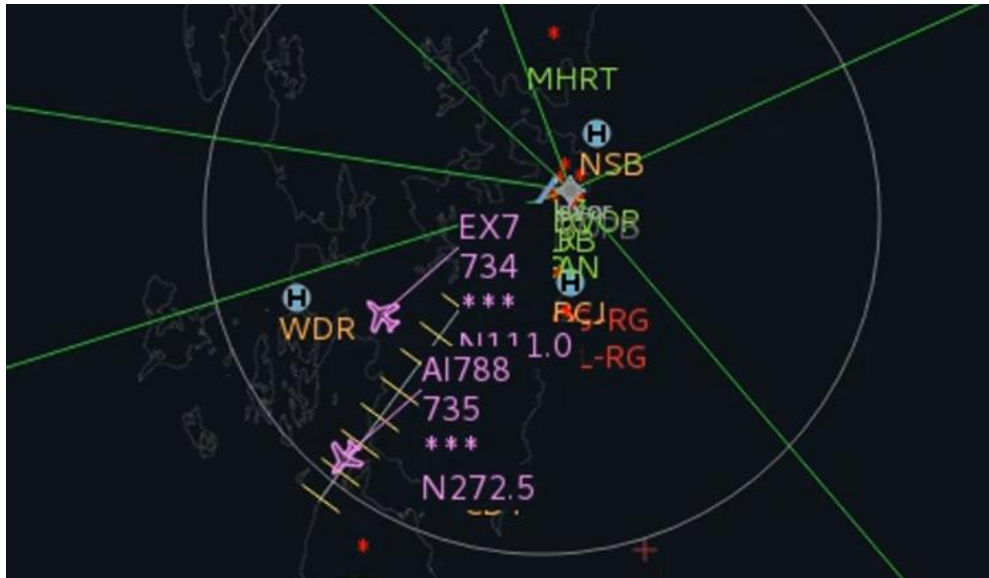
It was observed that the helicopter was not visible on radar during the outbound leg until it was approximately 1-2 nautical miles out overhead and simultaneously the radar blip of departing AIC 788 also appeared on the radar display at 1 nautical mile of departure end. Further, radar identification was carried out only after both aircraft had completed the avoidance maneuvers post occurrence of the airprox event. On subsequent enquiry, it was stated by the ATC controller that the radar in use was a primary radar, which had inherent limitations, and was most likely the reason for the radar blip being lost from the display.

Figure 2 AIC788 continued its flight, while helicopter discontinued the approach.

- 4.1 In view of finding 3.1.10, considering the increased traffic, Indian Navy may consider the provision of secondary radar system at Port Blair with the capability to aid the controller in managing the traffic efficiently while avoiding similar situations.
- 4.2 In view of finding 3.1.18, Recommendations from previous investigation reports regarding coordination with defence authorities should be implemented on a priority basis, and a

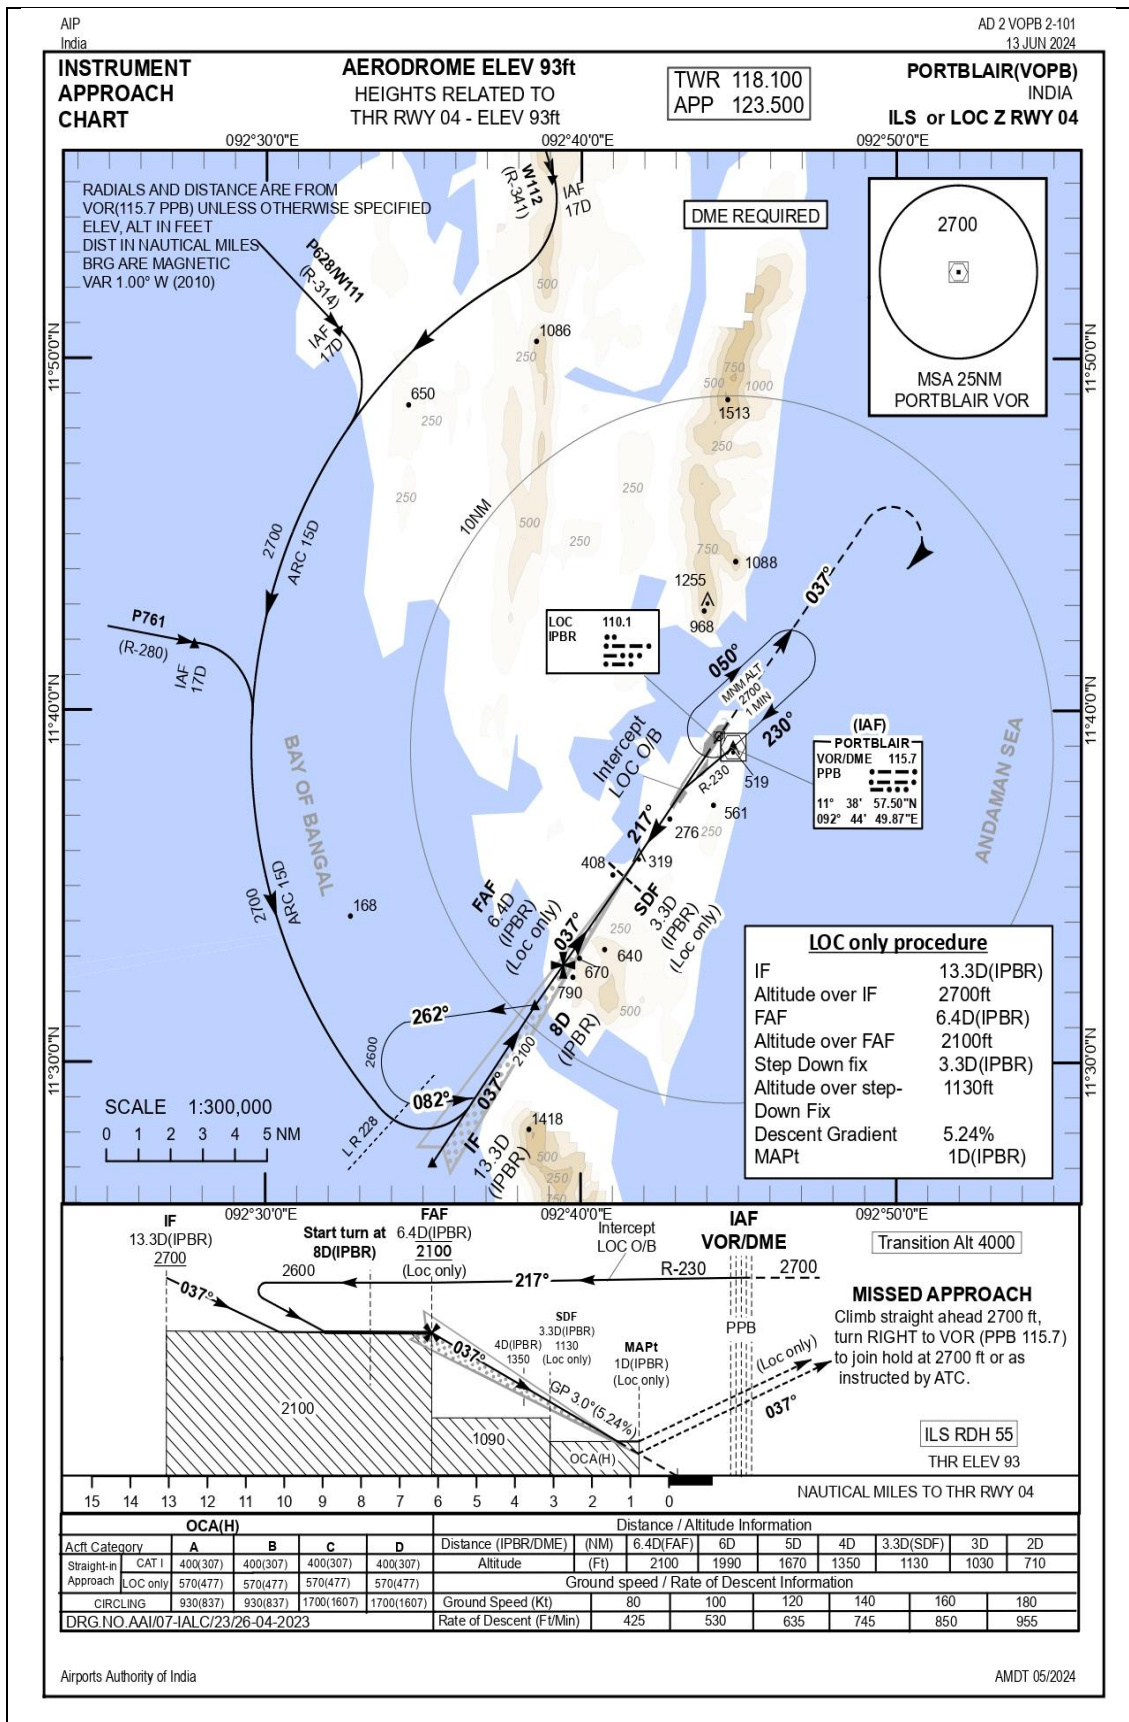
Figure 3 Instrument Approach RWY 04 via overhead
