**Government of India**  
**Ministry of Civil Aviation**  
**Aircraft Accident Investigation Bureau**

**Preliminary Report:** Accident involving M/S Chimes Aviation Pvt. Ltd.'s Cessna 172S aircraft bearing registration VT-CAZ at Dhana Airstrip, Sagar district in Madhya Pradesh, India on 10 December 2025.

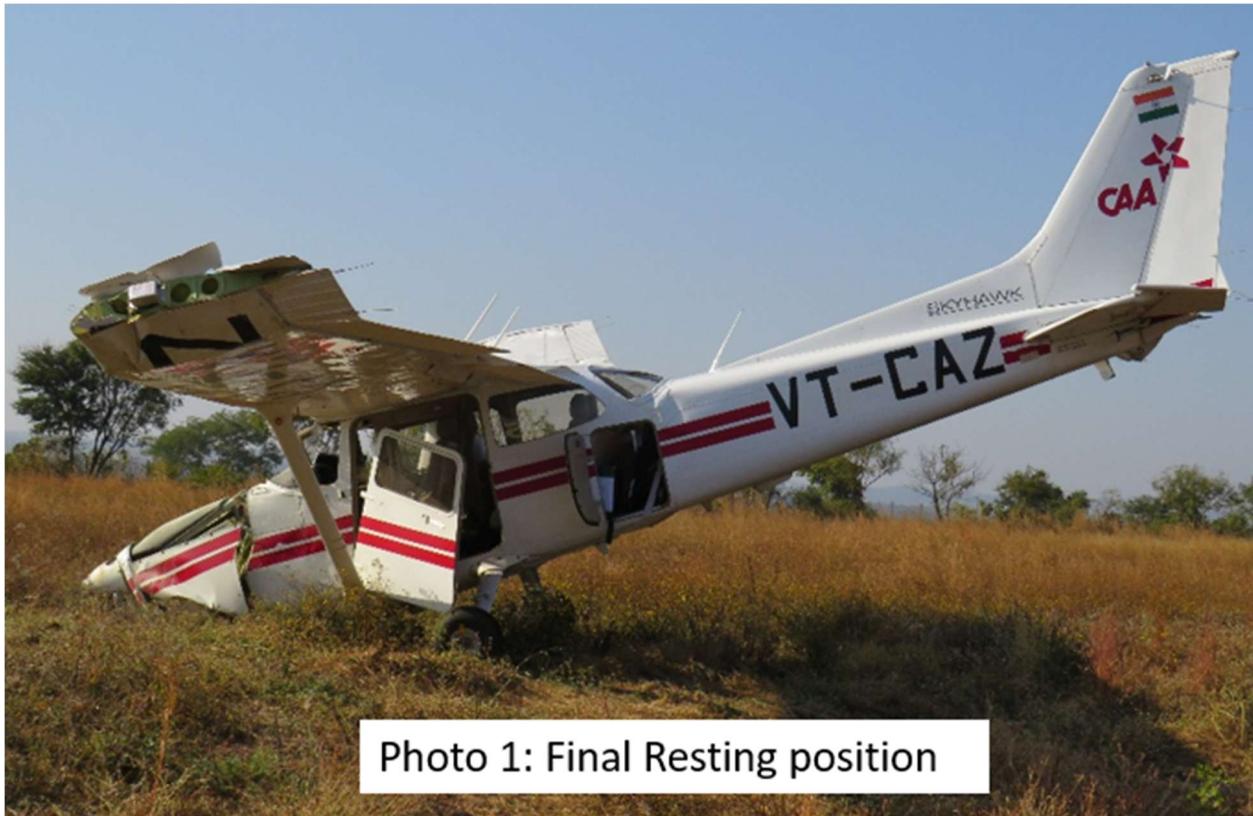
The aircraft lost its control while landing on runway 35 at Dhana Airstrip and crashed near middle marker on the unpaved surface to the left of the runway. The wreckage was mostly confined to the final resting position except few parts such as broken/shattered propeller blade parts, wing tip portion etc.

Photo 1: Final Resting position

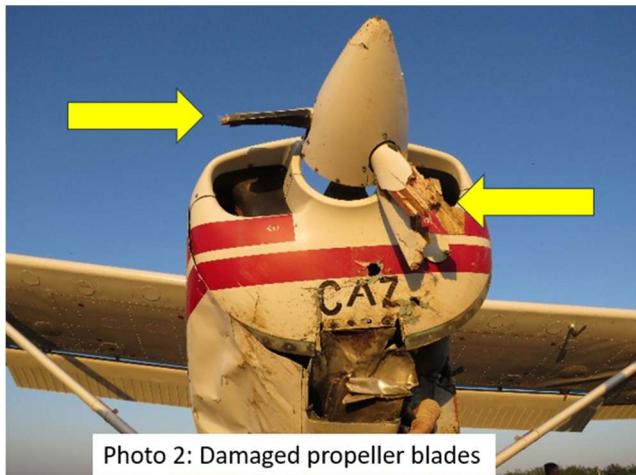
- a) Propeller Spinner was found broken and all Propeller blades were found broken into pieces from the shank and were scattered all around the main wreckage.
- b) Area near to the aircraft's forward undercarriage was found smashed. The Nose Landing Gear (NLG) was found damaged and was found separated from its attachment point.

Photo 2: Damaged propeller blades

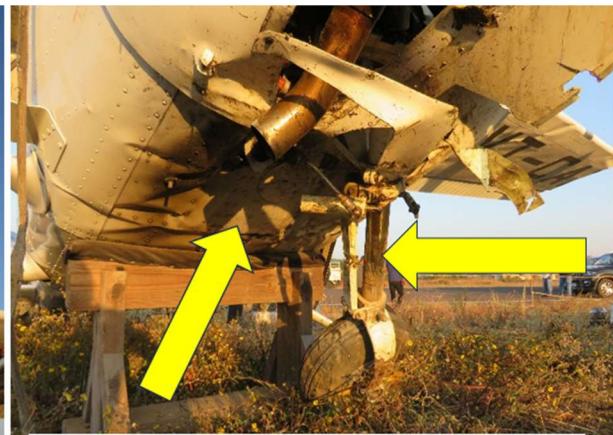
Photo 3: Damaged Forward under carriage & NLG

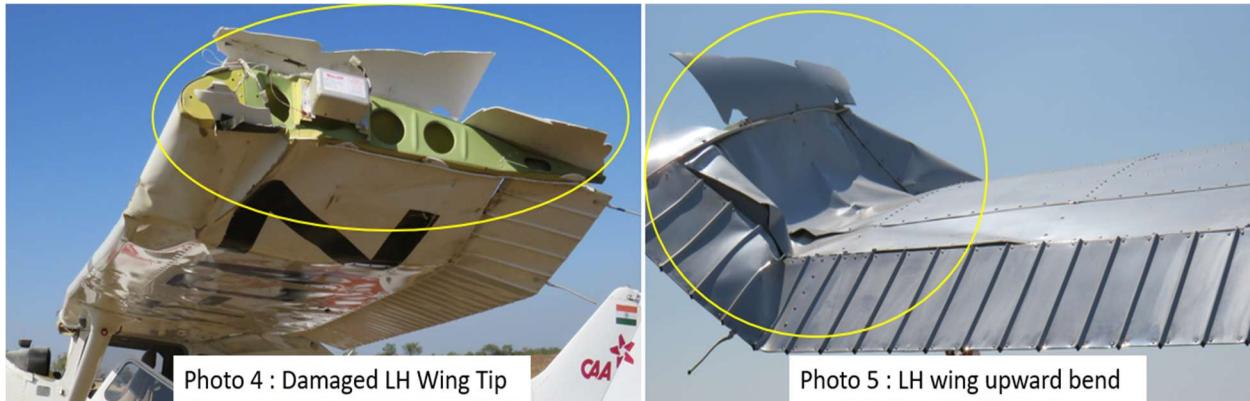
e) LH wing tip was found damaged. LH wing close to the wing tip was found bent upward.

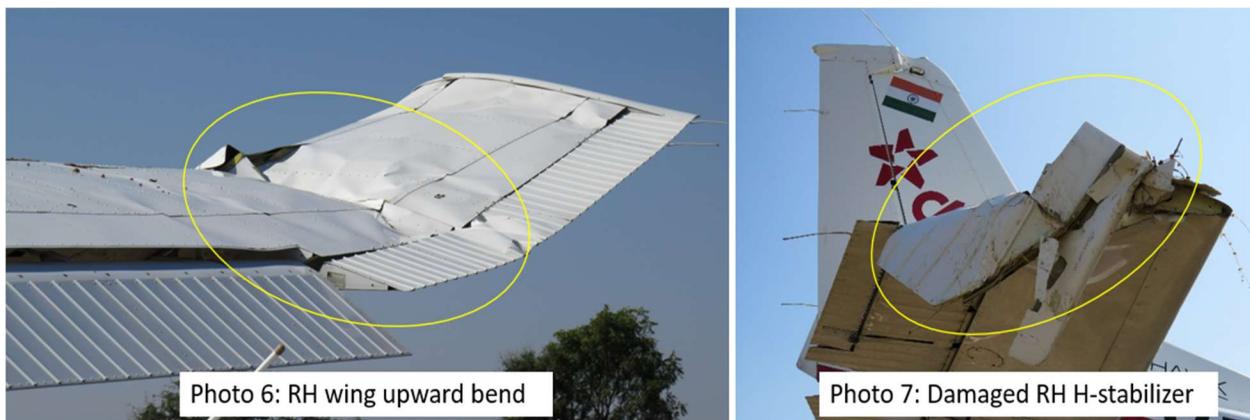
f) RH wing tip was found damaged. RH wing close to middle of the wing was found bent upward.
