PRELIMINARY REPORT
ON
ACCIDENT TO M/S PAWAN HANS LTD
AIRBUS HELICOPTERS AS365N3 BEARING REGISTRATION
VT-PHY NEAR MAYABUNDER ON 24th FEBRUARY 2026

Government of India
Ministry of Civil Aviation
Aircraft Accident Investigation Bureau

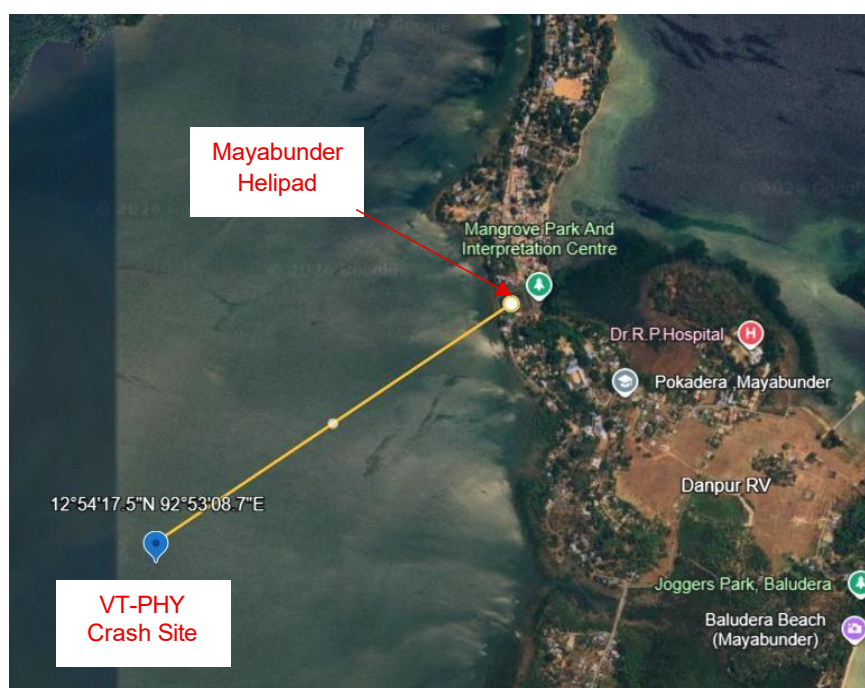
Fig1: Location of the Crash Site

The aircraft wreckage was located approximately 1.6 Km from Mayabunder Helipad at a radial of 235 degrees approximately. Fig.1 refers. The wreckage was available mostly as a single unit and separation of starboard horizontal & vertical stabilizer, a few skin panels and landing gear doors were observed due to impact. The aircraft was resting on the seabed on its Starboard side (water level being 4-5 Ft during low tide). The Port side of the fuselage along with its Port Landing Gear was visible above the waterline. Fig 2 refers.

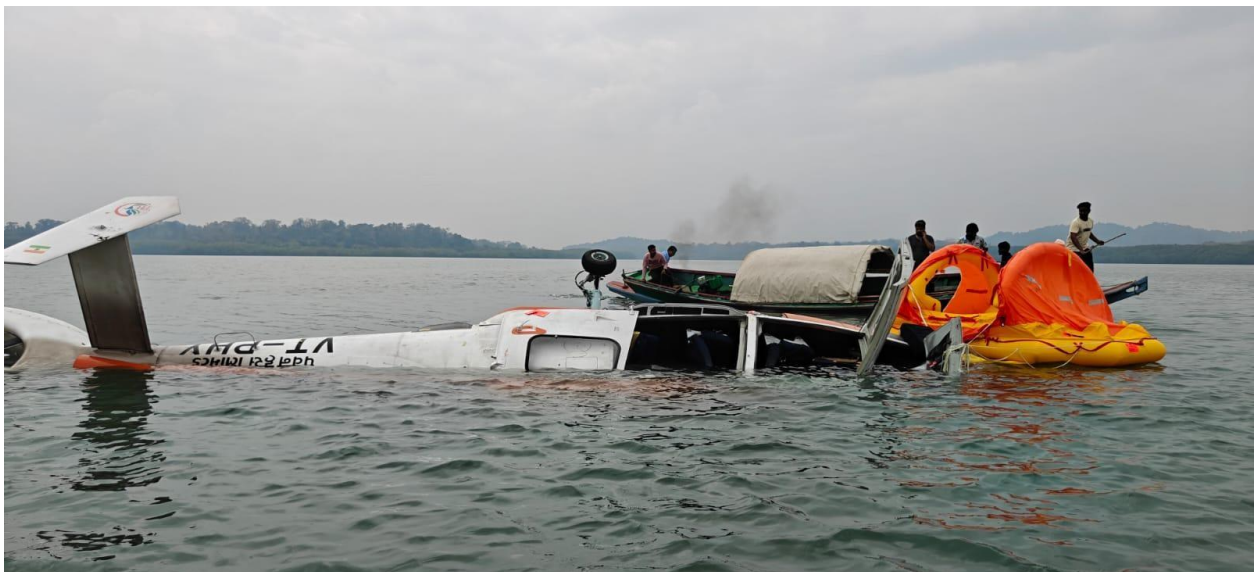
Fig 2: VT-PHY at Crash Location

On contact with water body, the helicopter floats did not activate. The helicopter toppled to its Starboard side and as the depth of the sea at the crash location was only 4-5 ft, the port side of the helicopter was above the waterline. Both the crew members managed to

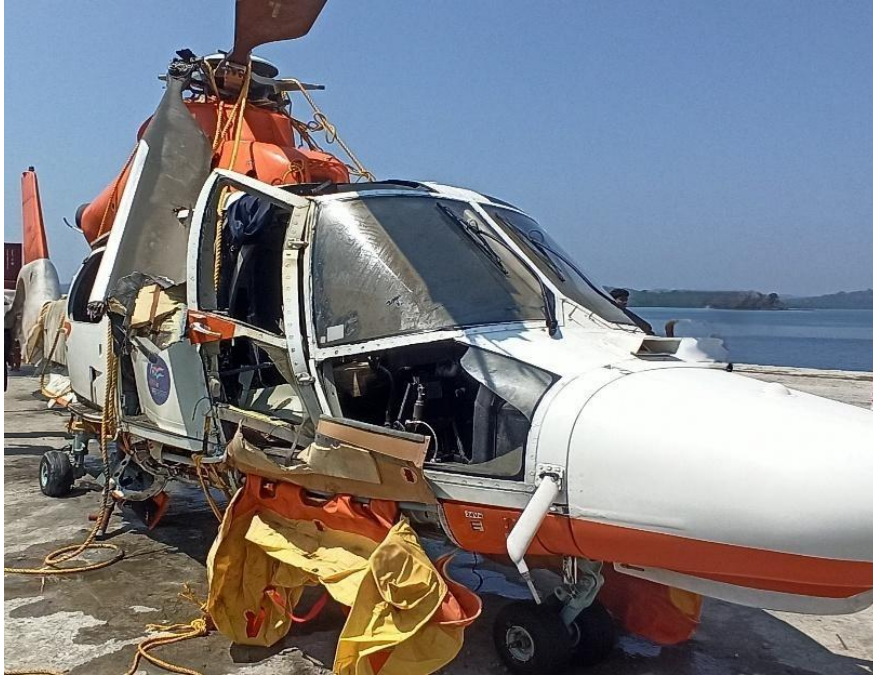
Fig 3: VT-PHY after Salvage Operations

- All 04 Main Rotor Blades found broken at various lengths
- Main Rotor blade Hub Star Flex and Beams found damaged
- All 03 Pitot Tubes found damaged
- The top and bottom Perspex windows of the RH side pilot door were found broken
- RH & LH Forward Floats found open
- LH and RH fixed landing doors found separated
- RH upper cover of the Fenestron was found damaged
- Tail Rotor blade Hub found damaged with broken blades piercing the Fenestron
- Tail Rotor Gear Box attachment tube damaged

- The wreckage was salvaged from the sea. SSCVFDR, Engine Control Units, Failure Annunciator Unit and Health & Usage Monitoring Unit (HUMS) units were retrieved and preserved for further analysis.
- The wreckage (Fig. 3 refers) was shifted from Mayabunder to Sri Vijaya Puram airport and secured for further examination.
- The aircraft maintenance and crew folders were collected from the operator for further analysis.
- Initial interviews/discussions with the crew and witnesses were carried out.
- BEA, France has appointed Accredited Representative along with technical advisors

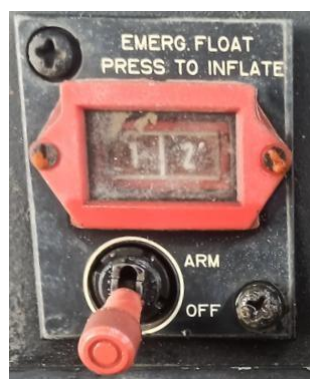
- Throughout the complete sortie, the crew were wearing the complete safety harness including the shoulder straps, whereas the passengers were wearing only the lap straps but not the shoulder straps.
- The floats were not armed in the cockpit during the approach although the same is required by the Standard Operating Procedure for operations at Port Blair as approved by DGCA in the company operations manual.

During the wreckage examination, the float switch was found to be in off position.

Fig 4: Float Switch in OFF position

- a) DGCA may issue directions to M/s Pawan Hans Ltd, to ensure strict adherence to usage of all available passenger seat restraint mechanisms and life jackets (wherever applicable). DGCA may conduct spot - checks on operations of all commercial helicopter operators for checking the compliance of the above.
- b) DGCA may issue directions to M/s Pawan Hans Ltd to sensitize their pilots to arm floats for all applicable operations as per the approved company operations manual.
