Preliminary Report: Accident involving M/s Redbird Airways Pvt. Ltd.'s Beechcraft King Air C90A bearing registration VT-AJV in Chatra District, Jharkhand, India on 23rd February 2026.

6. Brief Description of Accident

7. Wreckage Distribution and Damage Information

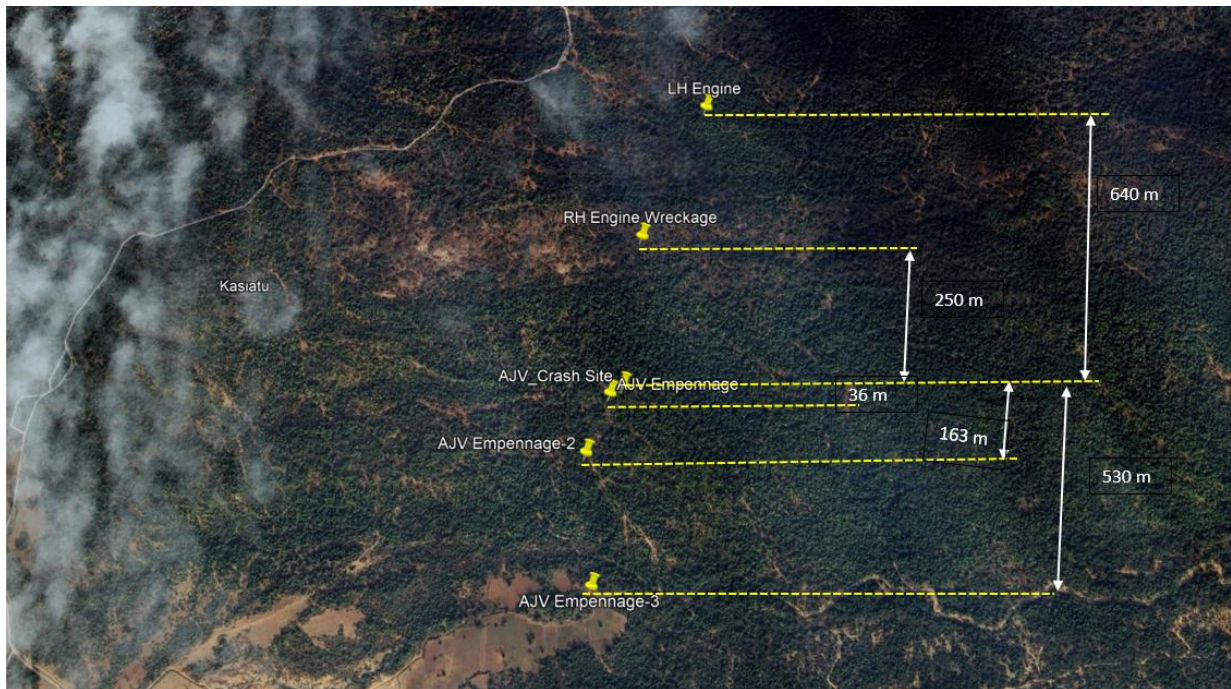
Figure 1: Wreckage Map

In the accident the aircraft was destroyed. The aircraft wreckage was found scattered within a kilometre from the main wreckage. The wreckage distribution with the help of Google Earth is depicted in the figure below:

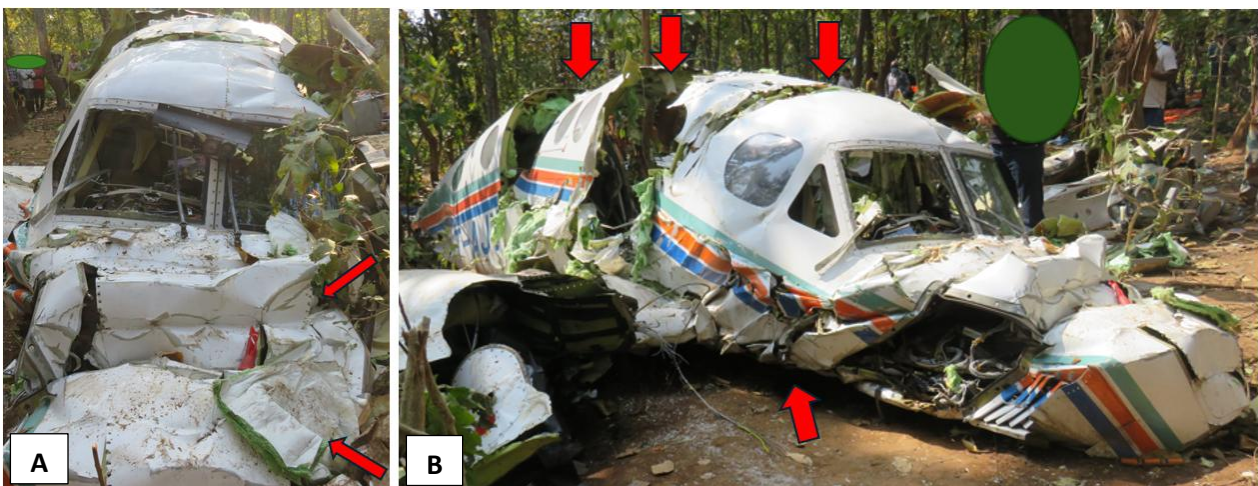
The nose section has collapsed and the nose avionics bay along with the cockpit area is completely destroyed. The fuselage was found fractured at multiple locations along its length.

Figure 2: A- Damaged Nose Section; B- Damaged Fuselage

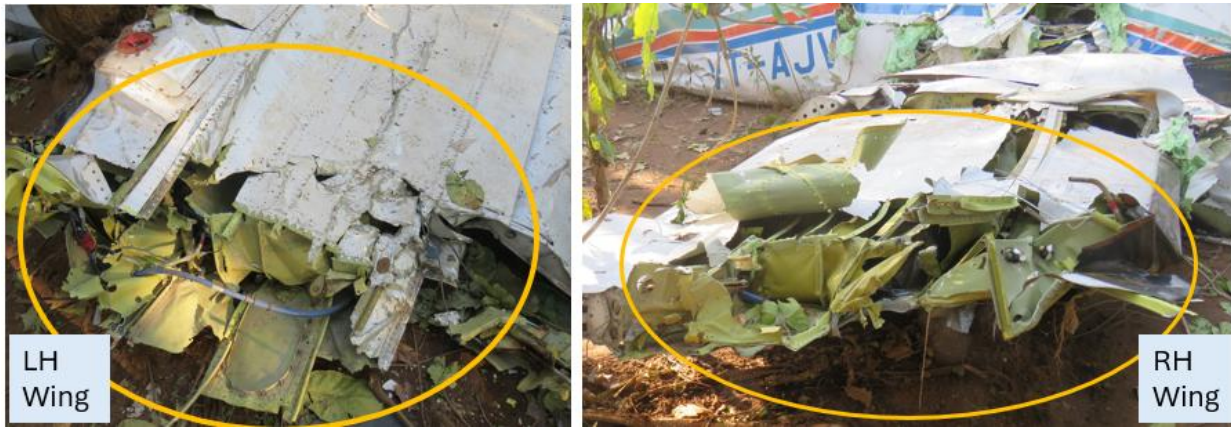
The wing tips of both left-hand (LH) and right-hand (RH) wing are found broken/separated from the wing structure.

Figure 3: Damaged LH and RH Wing

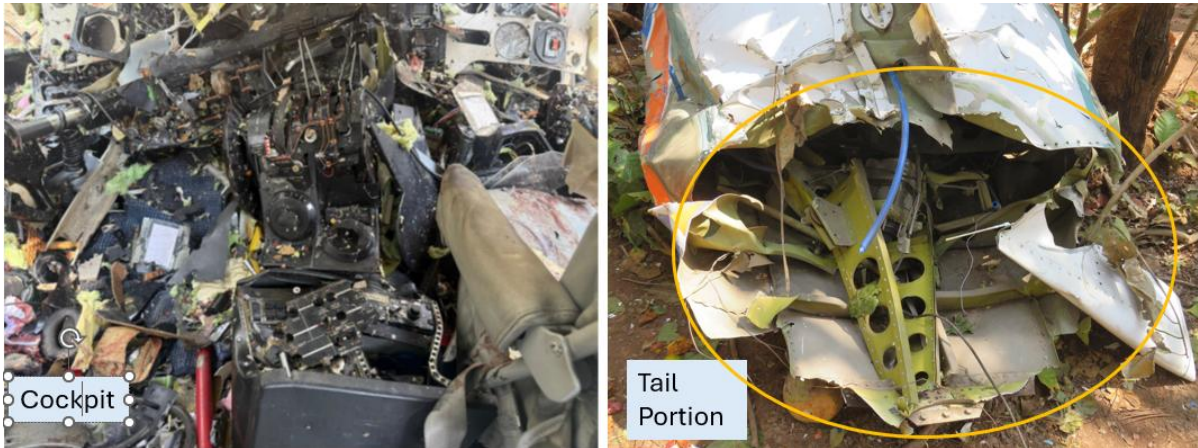
Figure 4: LH Pic- Damaged Cockpit and Instrument Console and RH Pic- Damaged Tail Portion

Cockpit of the aircraft was found heavily damaged. The empennage of the aircraft, was found separated from the main fuselage and broken into pieces. The broken parts of the empennage were found scattered (at a distance of 200-600 meters) from the main wreckage.

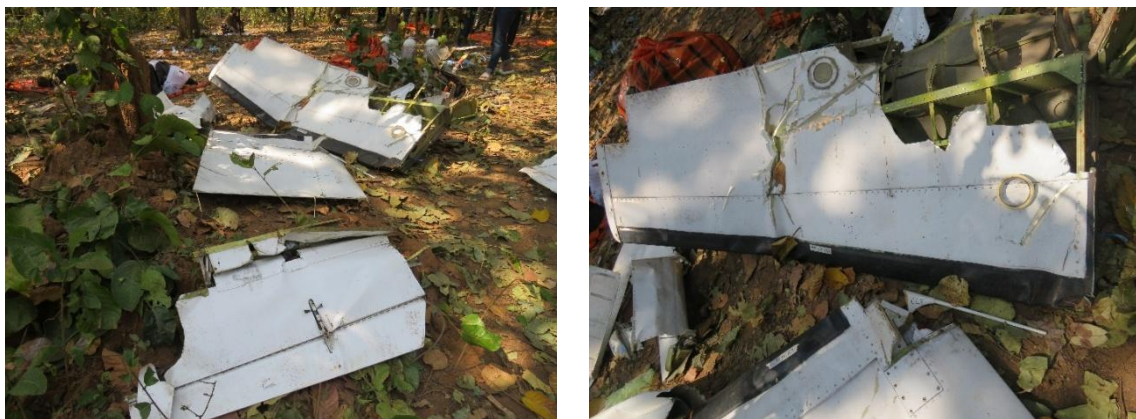
Figure 5: Broken Empennage

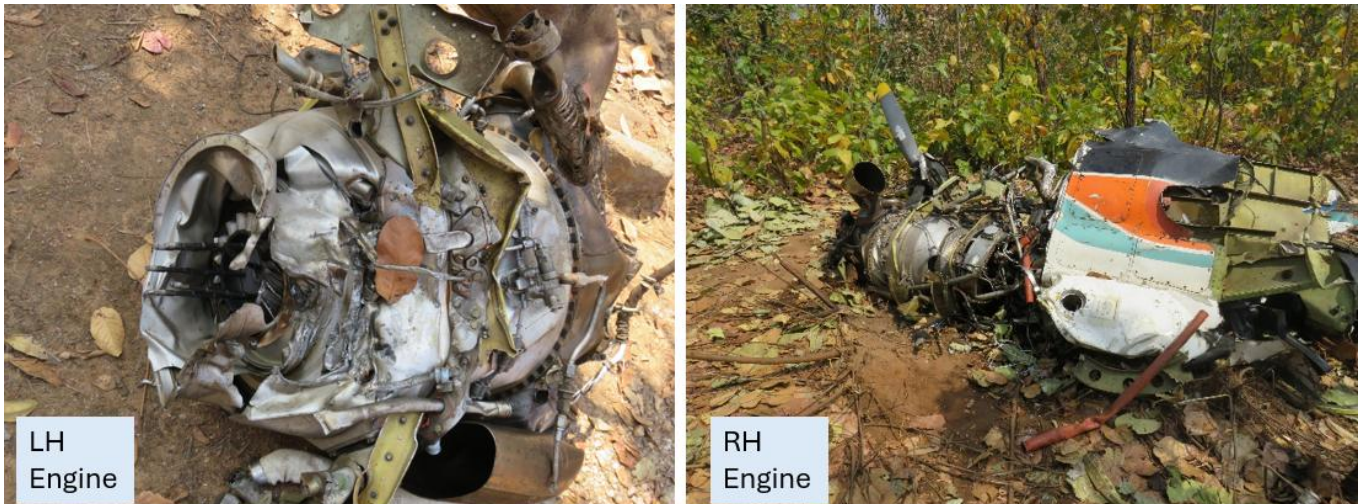
Both the engines, along with propellers, were found separated from the wing. RH engine was found approximately 250 meters from the main wreckage and the LH engine was found nearly 640

m away from the main wreckage. The mounting fixtures of the RH engine were found along with the separated engine. The LH engine was found along with the engine nacelle.

Figure 6: Damaged LH and RH Engines
