**Government of India**  
**Aircraft Accident Investigation Bureau**  
**Ministry of Civil Aviation**

**PRELIMINARY REPORT: ACCIDENT TO M/S KESTREL AVIATION AW119MKII HELICOPTER VT-RNK ON 07.06.2025 AT SERSI**

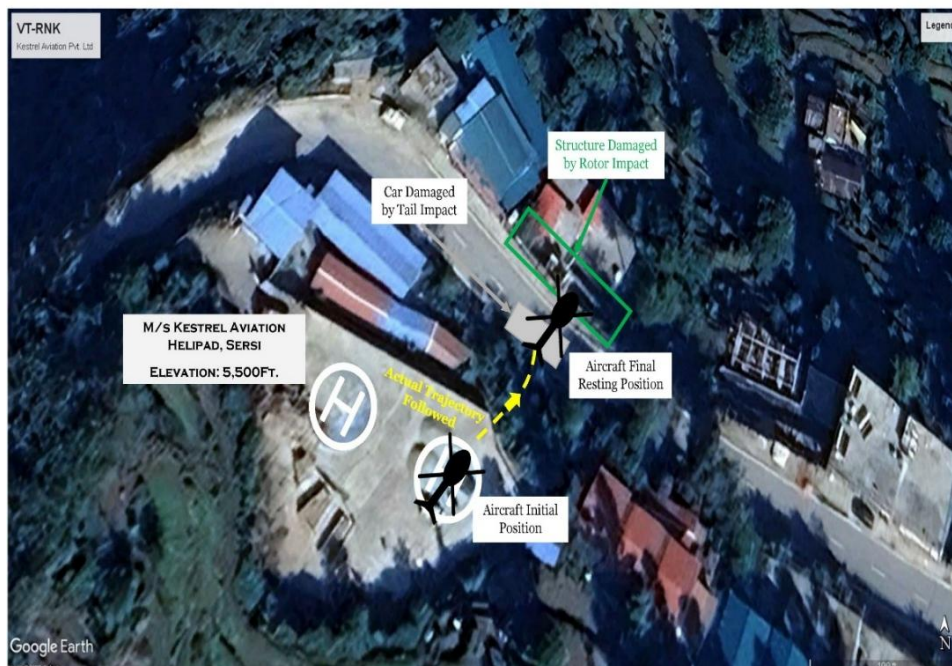
At approximately 1253 Hrs. IST, VT-RNK lifted off from the Kestral Aviation Helipad at Sersi with 05 passengers on board and the pilot for Kedarnath ji Helipad. This helipad is around 40 to 50 feet above the national highway. After take-off the helicopter made a counter-clockwise turn and initiated flight towards Kedarnath. As seen in CCTV footage available from the helipad, soon after liftoff, the helicopter began to lose altitude. While the main fuselage cleared the edge of the elevated helipad, the tail rotor guard and tail rotor blades hit the edge of the helipad, causing significant damage to the Tail rotor blades Tips and leaving visible grooves on the concrete edge of the helipad.

Following the tail rotor strike, the helicopter kept losing height and crash-landed on the national highway situated immediately below the helipad at approx. 40 to 50 feet. During the crash landing, the helicopter impacted a commercial shop structure on one side of the road and a parked vehicle on the opposite side, causing damage to both. The helicopter sustained substantial structural damage, including separation of the tail boom and collapse of the landing gear. The aircraft came to rest in a perpendicular position to the road effectively blocking the entire roadway.

Fig 1: Trajectory of Crash Landing

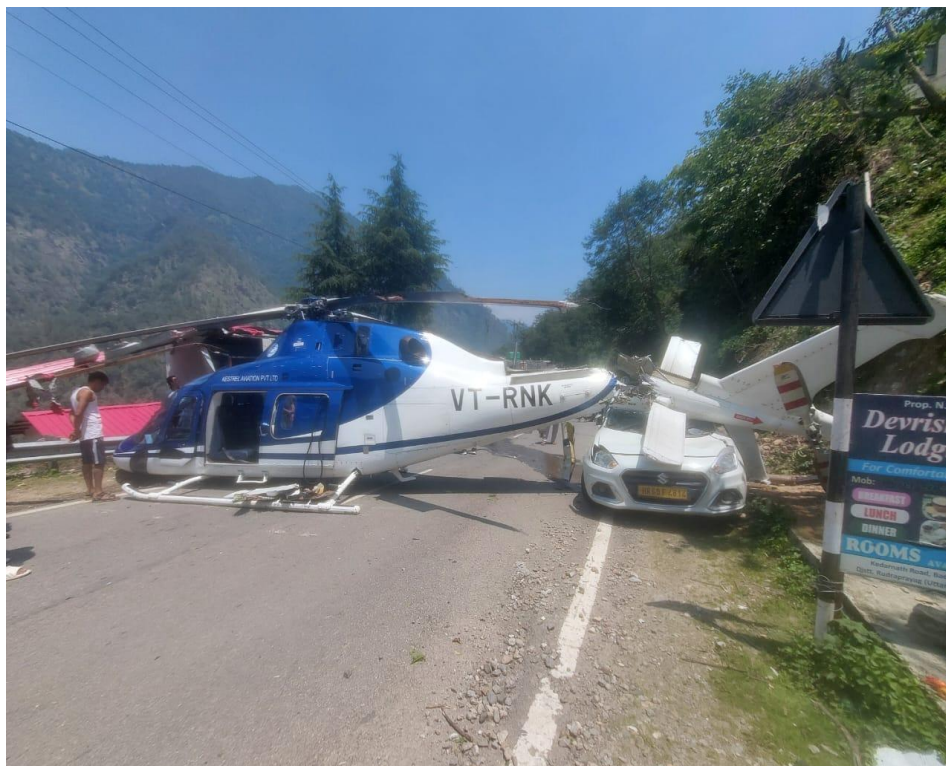
Fig 2: Helicopter Wreckage at the Site

Section	Component	Damage Description
Cockpit	Pilot & Co-pilot Windshield	Damaged
	Pilot Lower Windshield	Damaged
	Radom	Damaged
	Pilot & Co-pilot Door	Damaged
	Forward and Aft Cross tubes	Broken
	Right Cabin Footstep	Damaged
	Cockpit Door Post	Damaged
Main Rotor Head	All 4 Main Rotor Blades	Damaged
	Main Rotor Hub	Damaged
	Main Rotor Damper	Broken
	Main Rotor Grip	Damaged
Tail Boom	Rear Body	Damaged
	Tail Drive Shaft	Sheared Apart
	Tail Boom	Detached from Horizontal Stabilizer to Tail Rotor
	Tail Rotor Blade	Damaged
	Tail Skid	Damaged
Cabin Area	Passenger Door Windows (Both)	Damaged
	VHF Antenna (Side)	Damaged
