Preliminary Report:

Serious incident involving M/s Air India Limited, type- A320-251N bearing registration VT-TYA at Mumbai Airport, India on 21 July 2025.

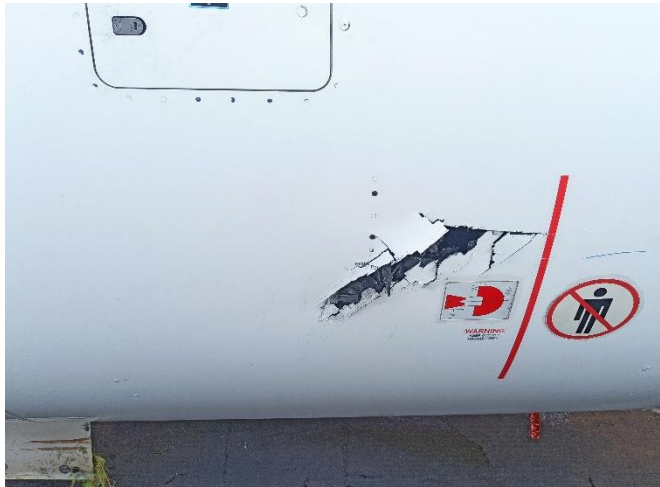
- Main wheels #2, #3, and #4 were found deflated. Tyre pressure of Main wheel# 1 was 205psi. Cut marks were noticed on Main wheels #2, #3, and #4.
- Engine #2 inlet cowl was damaged: FOD ingested into bypass section. Both forward and aft acoustic liners were damaged.
- Engine #2 fan cowl damage observed on both Left Hand and Right-Hand sides.
- Grass ingestion found in Right-Hand and Left-Hand Main Landing Gear (MLG) and Nose Landing Gear (NLG) area.
- Grass ingestion noted in the belly area.
- Aft cargo panel fairing was damaged.

Fig 1: Damage to Engine# 2 cowling outboard side

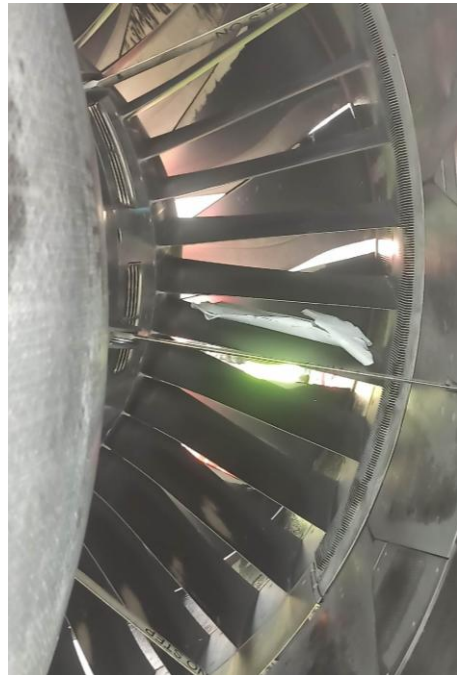
Fig 2: FOD ingested into bypass section of Engine# 2

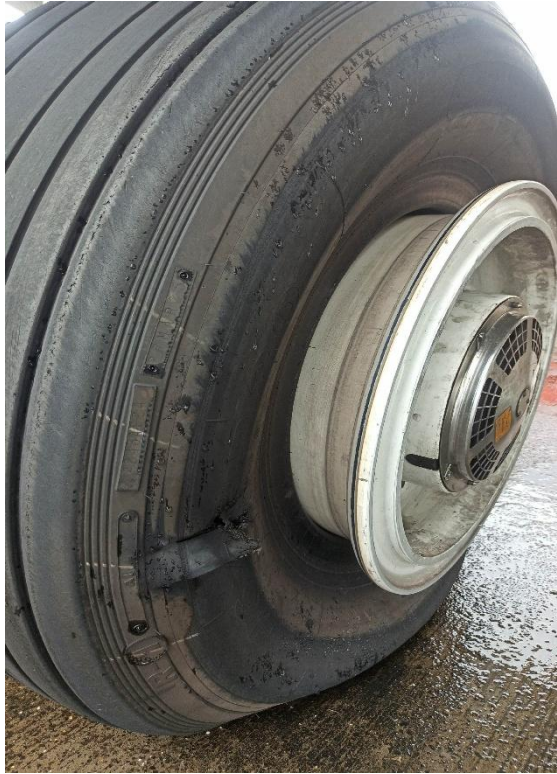
Fig 3: Cut mark on main wheel# 2

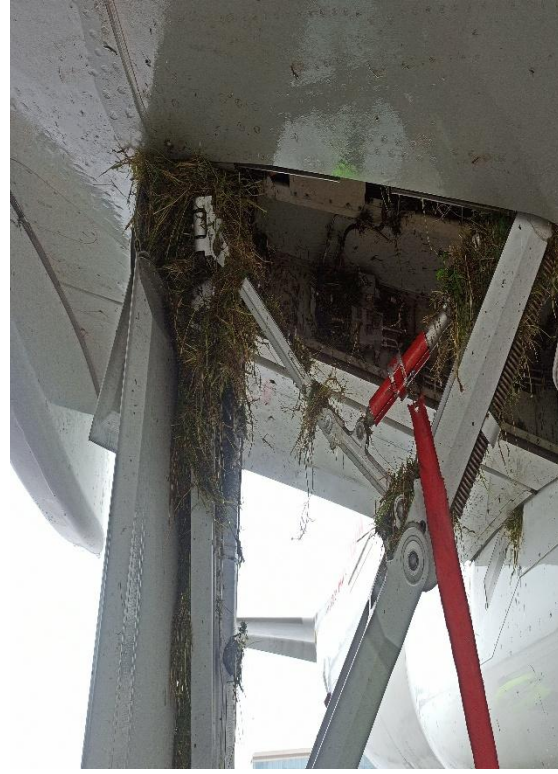
Fig 4: Grass ingestion at RH MLG

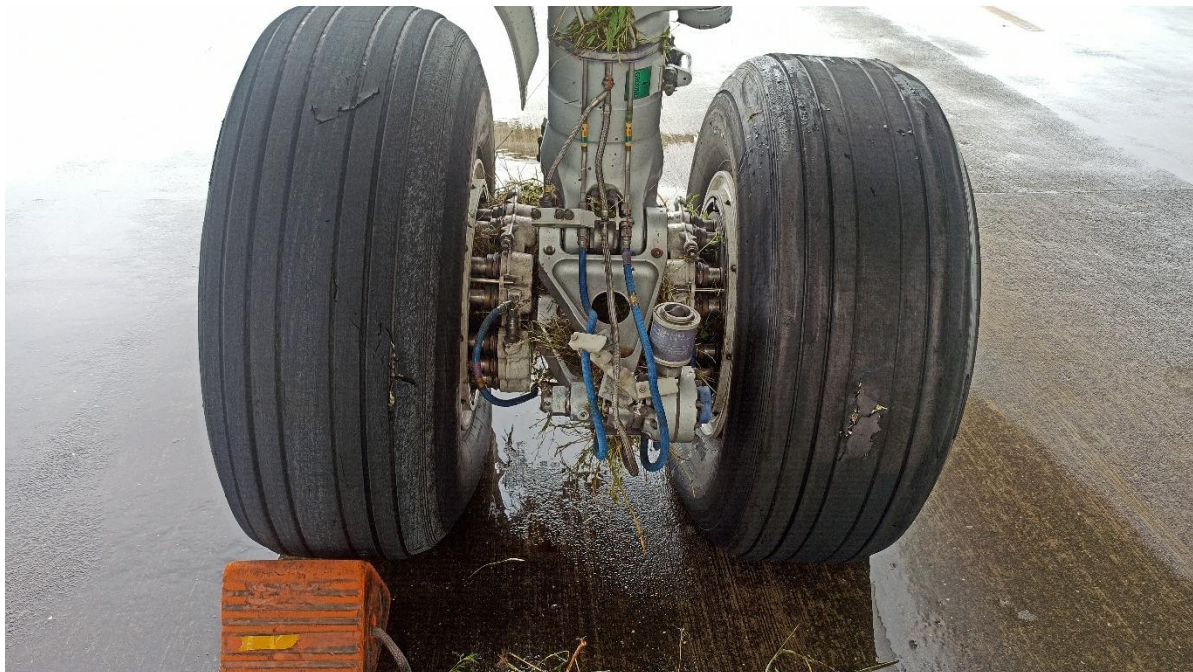
Fig 5: Cut marks on main wheel# 3 and 4 (front looking backward)

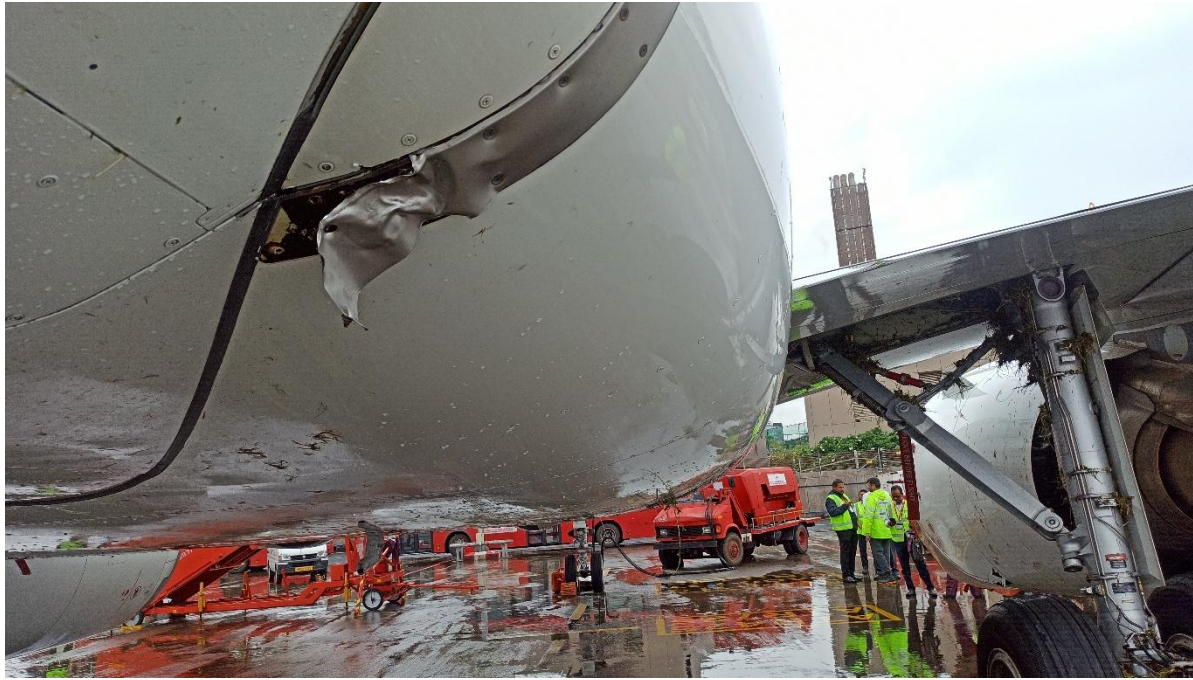
Fig 6: Damage to aft cargo 198BB panel fairing

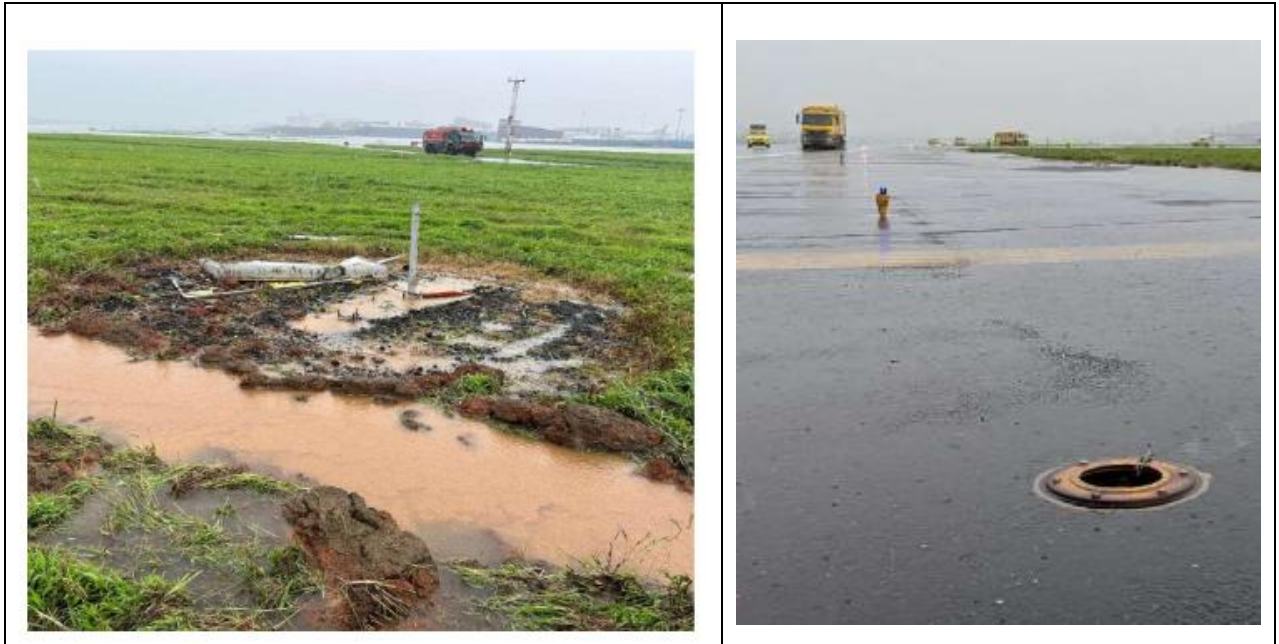
- Total 03 Runway Edge Lights found damaged.
- Total 02 Taxiway lights were found damaged (at shoulders of Taxiway 'N4' and 'E').
- Total 02 Exit Signboards found damaged.

Fig 7: Damage to Aerodrome facilities

- Subsequent to the occurrence, Runway was cleaned to clear mud, grass, and FOD.
- Rectification work on damaged fixtures of edge lights and TWY lights was done.
- NOTAM was raised for non-availability of Runway exit signboards.
- During inspection of the Runway by Follow Me Jeep, subsequent to the occurrence, PAPI and AGL were reported to be glowing normally.
- The last friction test was undertaken at 03:00 IST dated 21 July 2025, before the occurrence and values were within limits.
- All runway lights of RWY 09/27 were at maximum intensities prior to landing of AI2744.

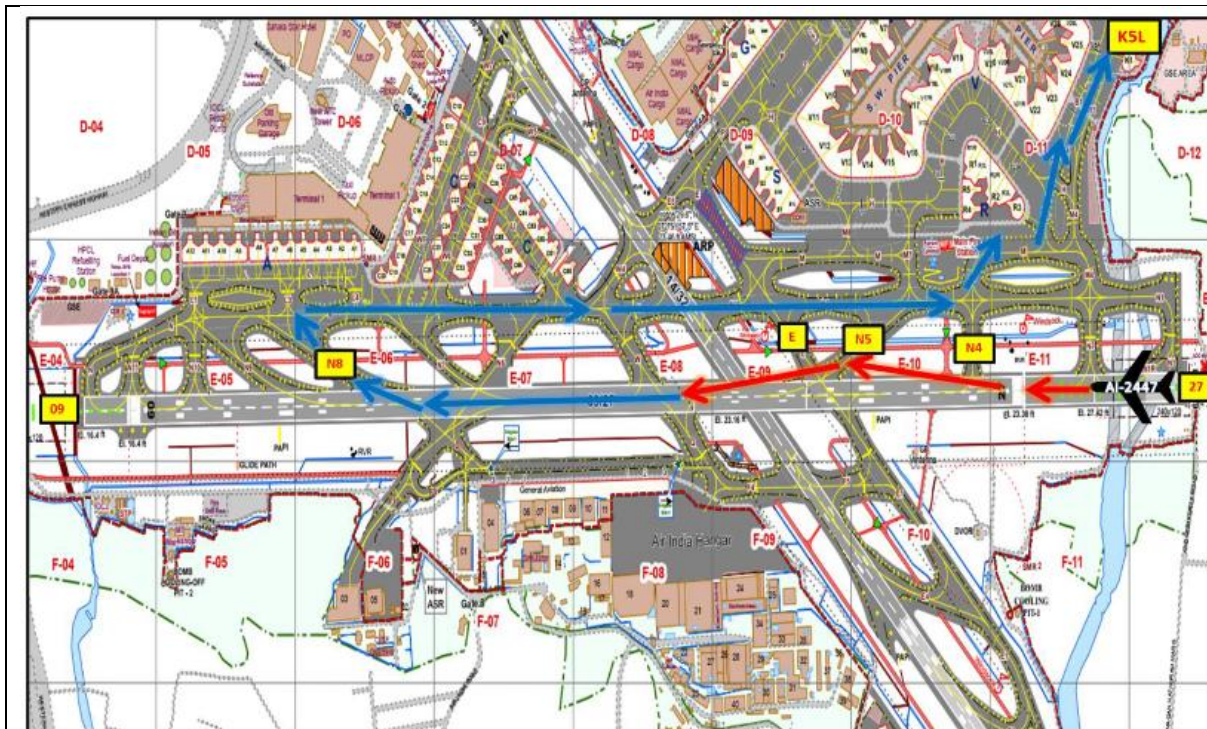
While landing at Mumbai Runway 27, the aircraft made touchdown on the right edge and subsequently its Right-Hand Main Wheels and Nose Wheel entered grassy area on right side of runway. The aircraft continued its landing roll on the grassy area until the intersection of the runway whereby the aircraft was brought back to the centreline of the runway. The aircraft later taxied on its own power to the bay K5L and parked normally.

Fig 8: Approximate path followed by AI2744 (not to scale). The aircraft AI2744 drifted towards the right side of RWY 27 as seen in the red arrow. Later it had aligned with RWY centreline and taxied to Bay K5L as indicated in blue arrow.
