**Final Investigation Report**  
**on**  
**Accident to M/S Rajiv Gandhi Academy for Aviation Technology,**  
**Cessna 172R Aircraft, VT-RGT on 08 Feb 2023**

**Government Of India**  
**Ministry of Civil Aviation**  
**Aircraft Accident Investigation Bureau**

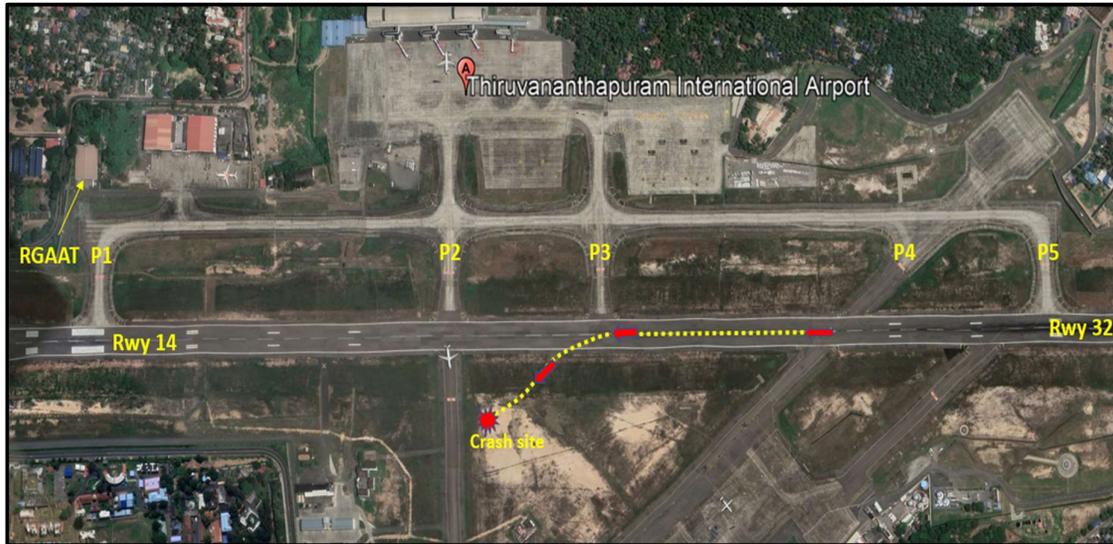
Figure 5: Accident aircraft track

a) Aircraft lined up on the runway 32 via P 4 taxiway. ATC gave the take-off clearance, Student pilot released the break and gradually added power. The aircraft started rolling. After rolling for approximately 350 m and at about 40kts, the aircraft started veering towards left. In order to maintain the centerline the Student pilot applied the full right rudder. But aircraft continued veering to the left. Then the Student pilot cut the power. However, the aircraft exited the runway near the taxiway P3, after rolling approximately 85 m.

In unpaved surface, the aircraft continued rolling in the same direction. After rolling for approximately 210 m, the aircraft NLG stuck in the sand and the aircraft bank towards right due to natural slope of the terrain. Consequently, the nose wheel assembly gets pushed backwards toward left side and right forward engine cowling takes the ground impact from lower right side which dislodges the cowling from lower fasteners. The propellers sustains slight bend due to low engine power and stops due to contact with ground. As the aircraft contacted ground with nose low and right wing down attitude, the aircraft tail flips forward due to momentum and aircraft banks left due to reactive bounce from right side. The aircraft left wing tip contacts the ground and the tip breaks. The aircraft finally came to rest in upside down position.

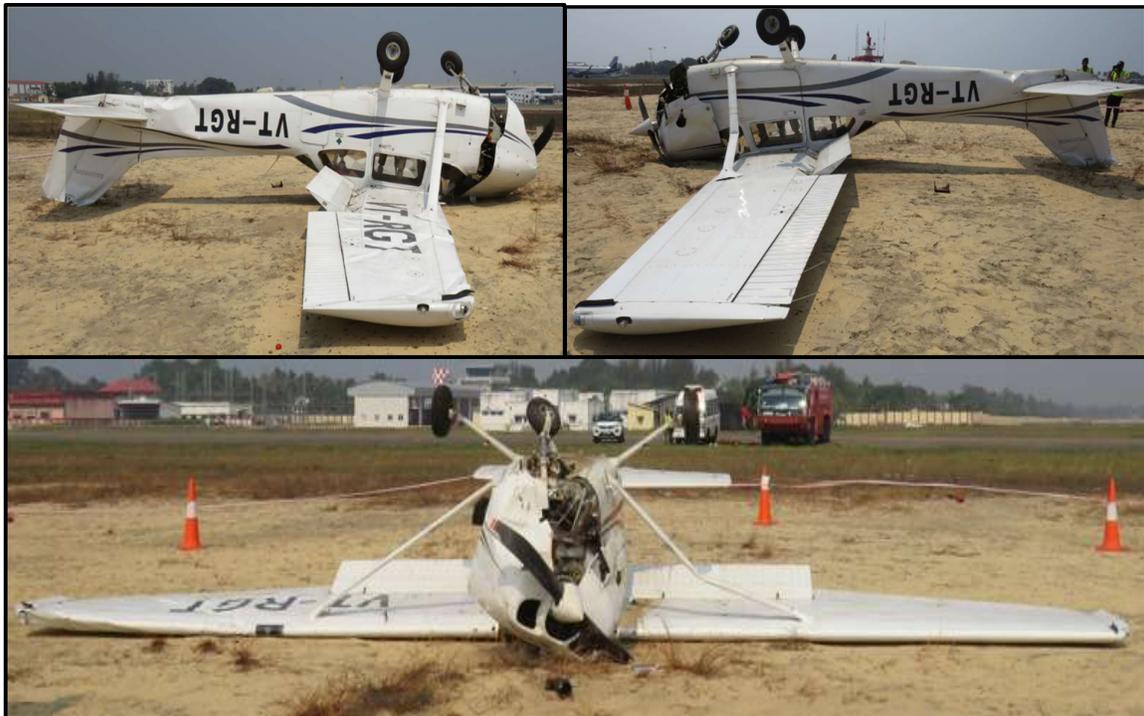
Figure 9: Aircraft Final Rest Position.

b) The wreckage was confined to one place except few aircraft parts which sheared off due to impact and scattered for example Navigation light cover, Induction air filter and air intake duct were found separated from the main wreckage.

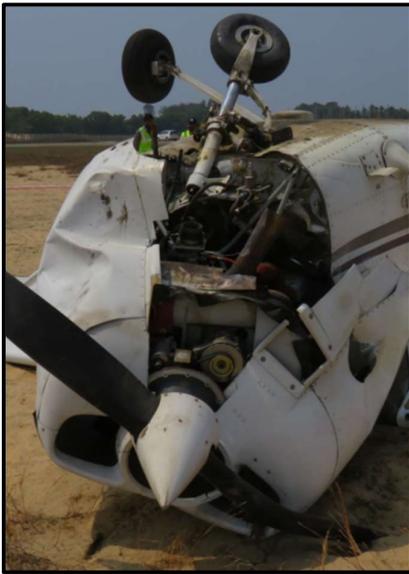
Figure 10: Damaged Nose section

1. Nose Section: Nose wheel, shock strut was found detached from the firewall and ripped the area of attachment and bent towards bottom fuselage in fully extended position. Upper portion of the firewall buckled forward. Upper torque link found broken at the attachment due to impact. Left steering rod end was found broken.

The bottom nose cowling was found split apart and the engine mount was found bent and cracked.

Both Propeller blades bent backwards from the center portion. Spinner was found intact.

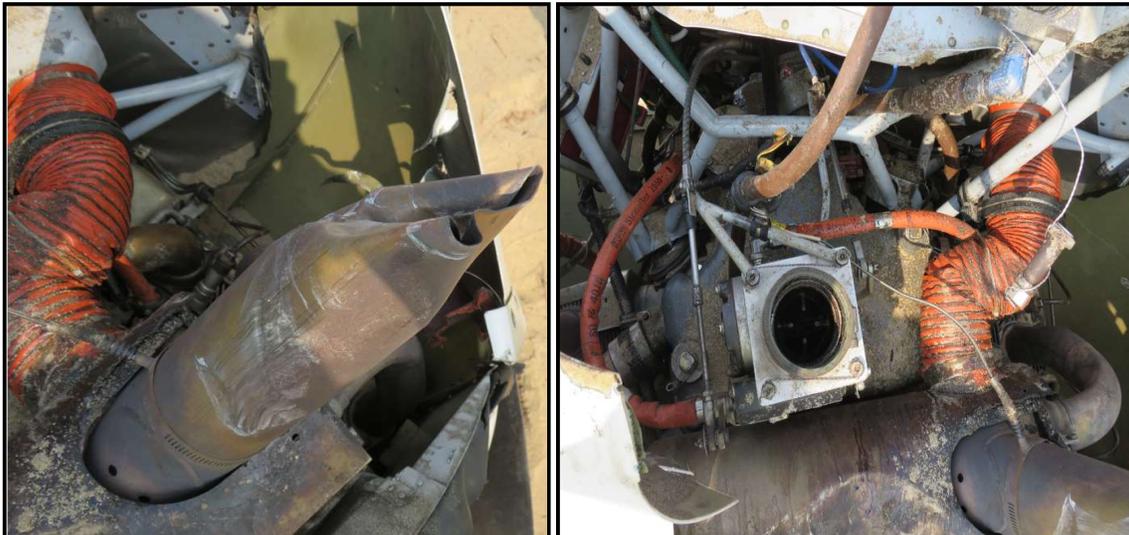
2. Engine: Engine mount was found extensively damaged with bents and broken tubes. Front baffles bottom portion under the starter was found bent. Induction air filter and air intake duct attach to the fuel servo unit

were also found cracked and separated from engine. Same was lying on the ground near the nose of aircraft. Battery mounting bracket attachment on firewall was found buckled forward. LH Magneto ground lead was found detached from the terminal leg. Fuel strainer unit found broken and the filter element exposed. Engine exhaust muffler and pipes found damaged.

Figure 11: Damaged part e.g. Exhaust muffler

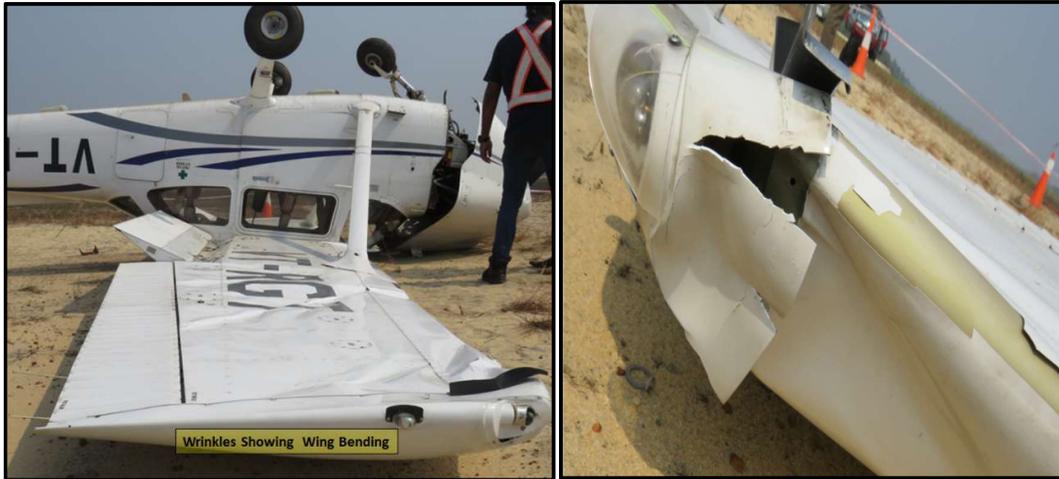
3. Left wing: Navigation light glass and cover were found broken. Skin, out board of strut attachment was found buckled heavily at the area of registration marking. Leading edge, outboard of taxi light buckled and dented near the tip. Leading edge of the wing tip was found broken.

Figure 12: Damaged LH wing

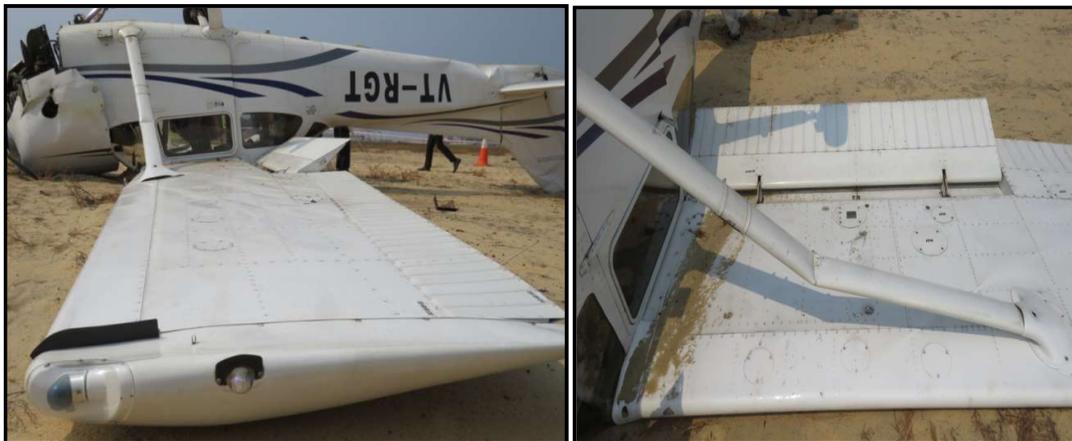
4. Right wing: Navigation light glass dislocated cover was found intact. Wing strut have sharp bent at the center.

Figure 13 Damaged RH wing

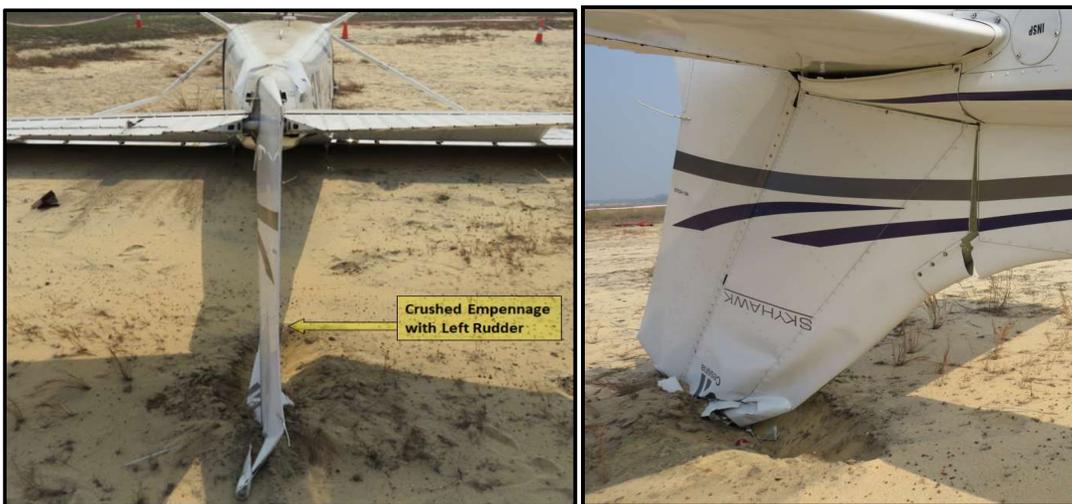
Figure 14: Damaged tail section

5. The fin and rudder tips were found buckled and damaged due to impact on ground.

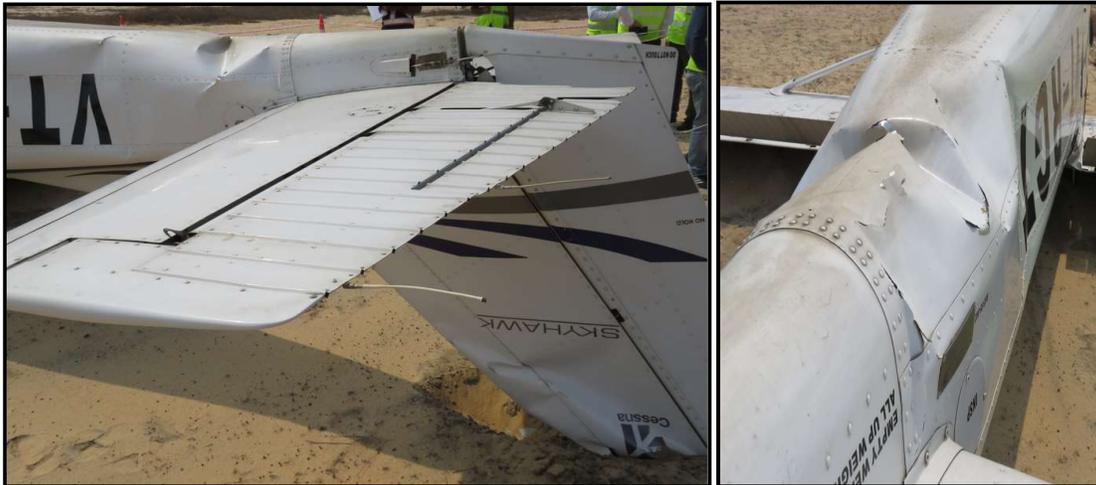
Figure 15: Damaged tail boom section

6. Tail section was found with large dent at bottom of the horizontal stabilizer.

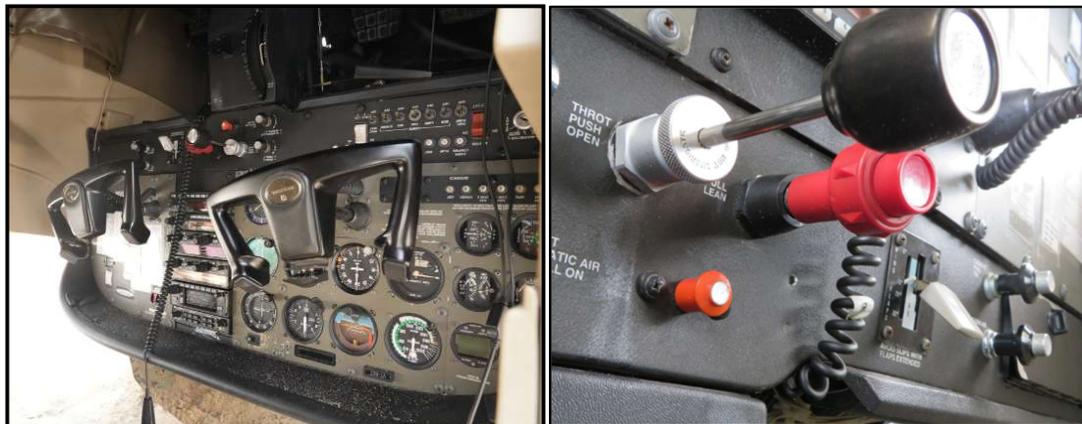
- The throttle lever was in pulled out position whereas the mixture lever was at rich position.
- The flap lever and indicator position was at 10°.
- The trim setting was at take-off.
- As per fire service personnel's statement post-accident, the master switch & Ignition switch was switched off, the ELT was disconnected and fuel shut off was also closed by Flight Instructor. During the wreckage examination same was confirmed by viewing the cockpit instrument panel.

Figure 16: Cockpit instruments condition post-accident

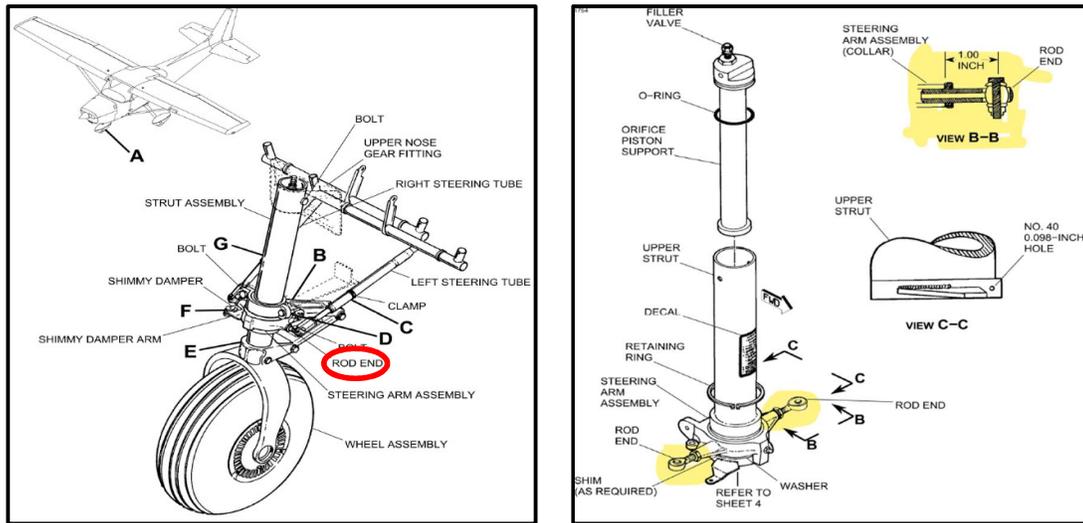
Figure 17: Rod End (Courtesy to Cessna POH)

During wreckage examination, broken LH side Rod end (refer below fig) of the NLG steering arm assembly was found. However, the RH side Rod End was found intact.

As per Metallurgical laboratory failure analysis report, the LH side Rod end of the NLG steering arm assembly failed under overload i.e. due to impact.
