**Final investigation report on accident involving Diamond DA-40 aircraft VT-FGC
belonging to M/s IGRUA
on 13 June 2022 near Fursatganj, Uttar Pradesh.**

**Aircraft Accident Investigation Bureau
Government of India
Ministry of Civil Aviation**

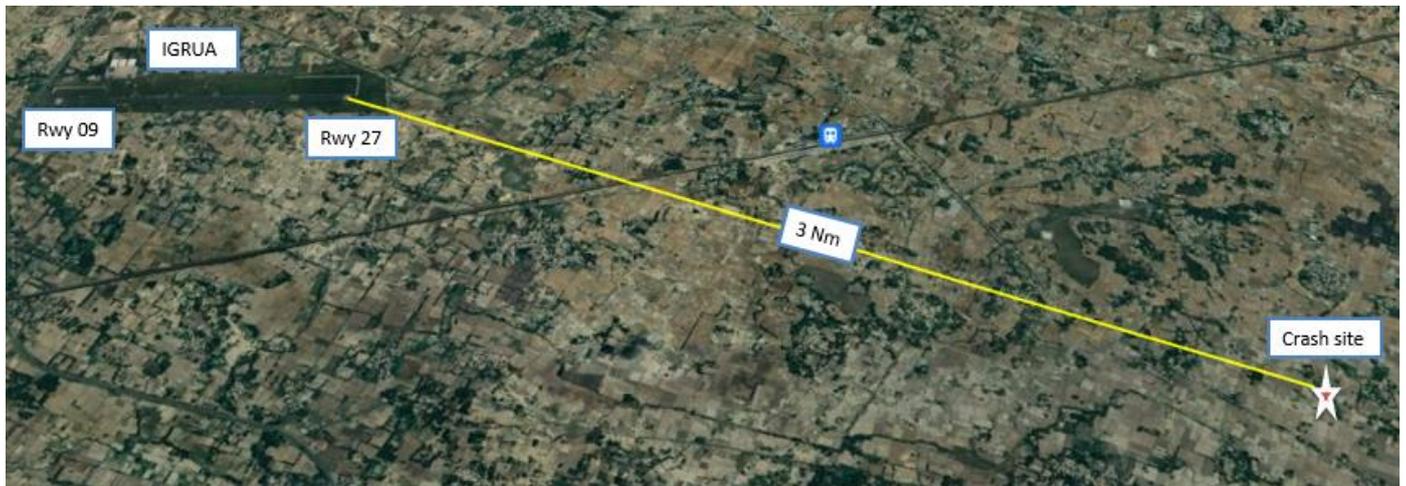
Figure 1: Accident Site

Student pilot did not receive any injury in the accident. However, the aircraft, due to impact forces, was substantially damaged. Further, ELT of the aircraft did not activate and no signal was transmitted by the unit during this accident.

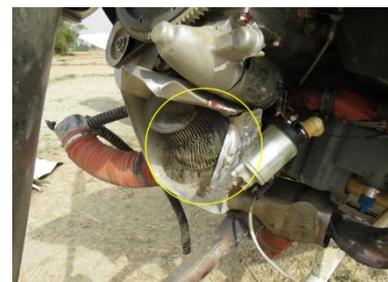
Figure 10: Air Filter

While carrying out the emergency landing, the left wing of the aircraft initially made contact with the tree's branches. Subsequently, the lower nose section of the aircraft hit a tree limb, as evident from the impact mark observed on the engine's air filter.

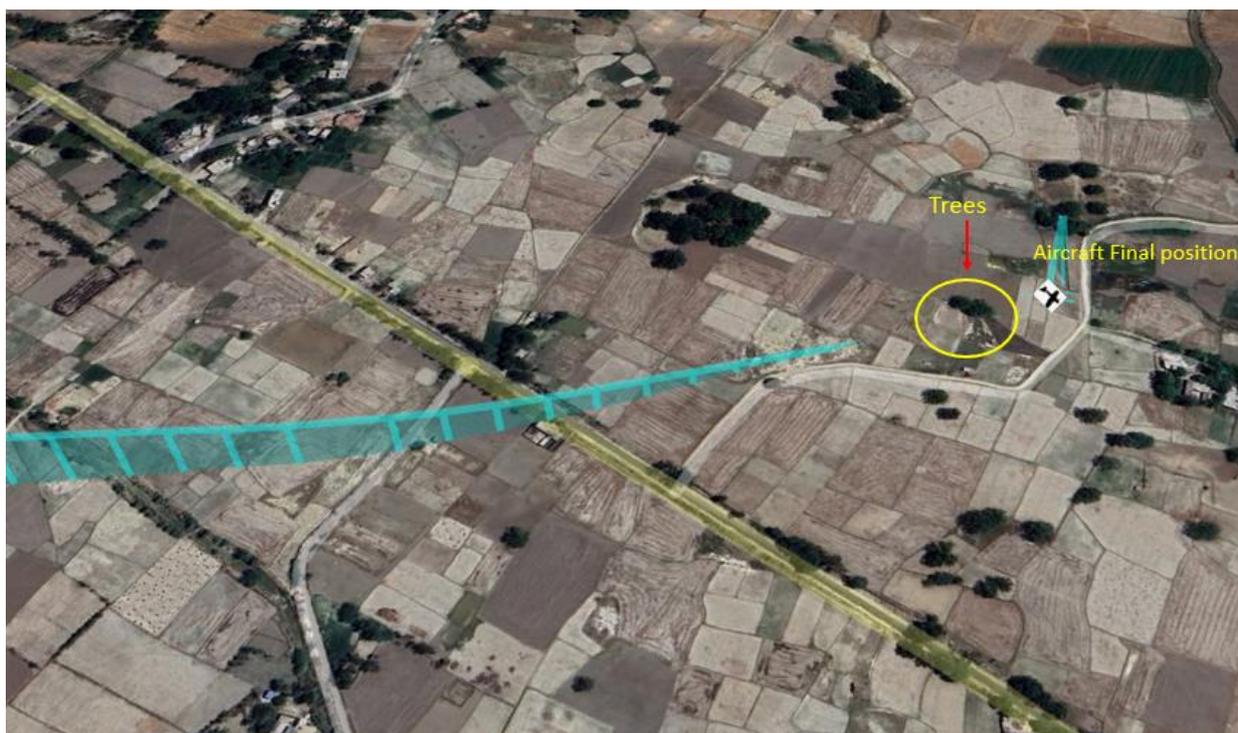
Figure 11: Location of trees (obstacles)

The left wing of the aircraft got severely damaged indicating that this surface experienced the highest impact during the crash. Further, during collision, trees acted as a pivot which resulted into aircraft's directional change as well as momentum. As much of the momentum was absorbed, therefore it caused a significant reduction in aircraft's forward acceleration and subsequent impact with the ground was less severe.

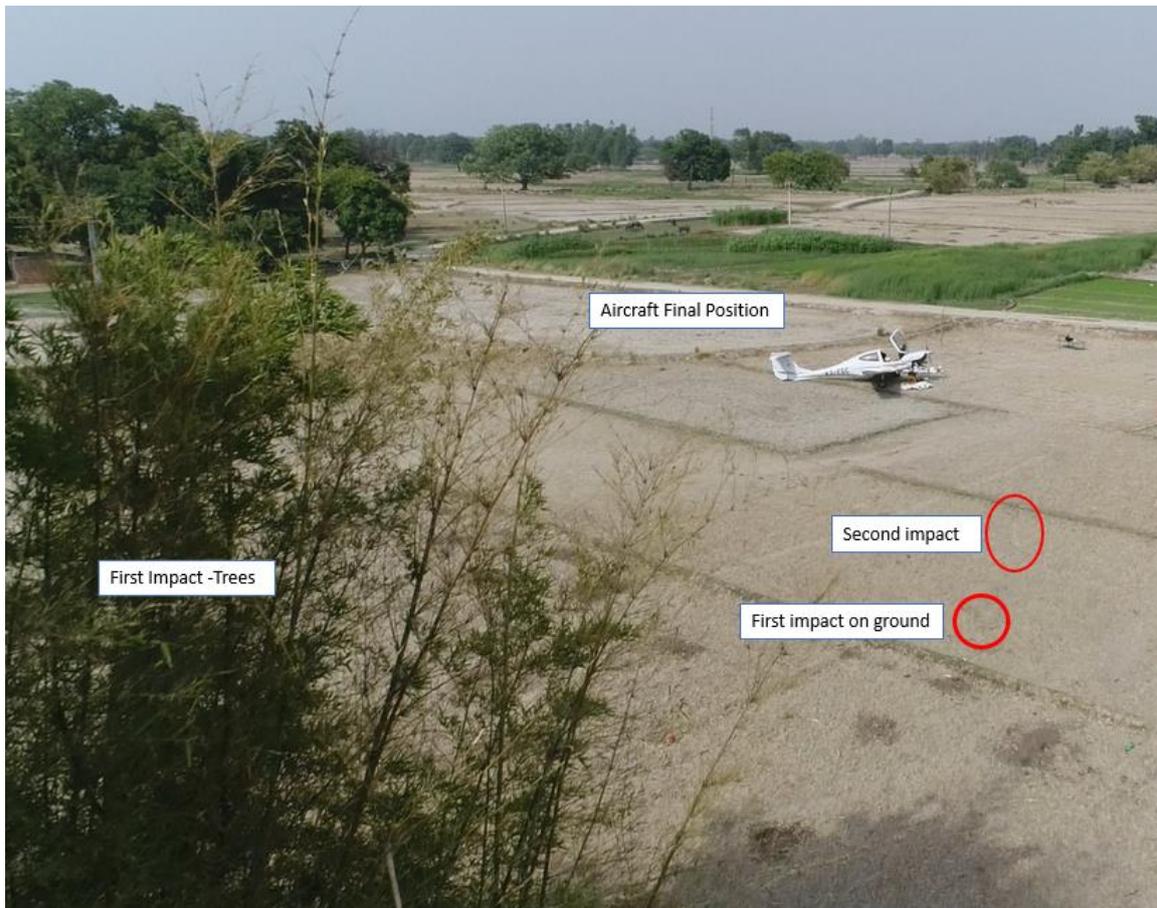
Figure 12: Aircraft Final position

After collision, aircraft's attitude further changed, causing both the left wing and the nose landing gear to contact the ground simultaneously. As the aircraft landed in nose down attitude, one of the propeller blades also struck the ground and sustained a bend towards its tip section. Further, the nose landing gear sheared off from strut area. The left main landing gear strut was also found bent revealing that aircraft was in left roll before it impacted with ground.

After aircraft's main wheels made contact with ground, it appears that the aircraft bounced in air as landing gear tyres imprint were not observed ahead of second point of impact till the aircraft came to halt at final rest position.

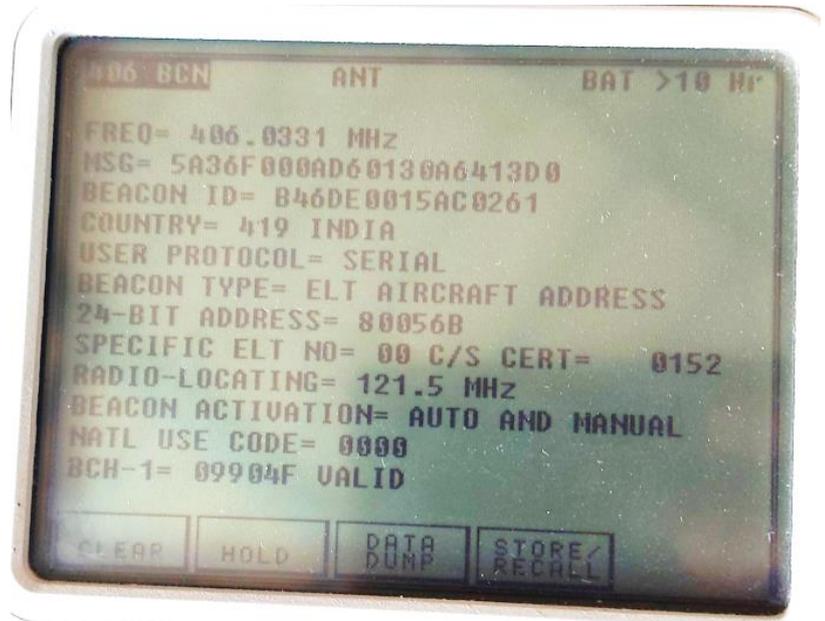
Figure 14: ELT Test Record

During inspection by the concerned AME, the continuity of ELT System was examined. All the wires and switches were found intact. ELT was found secured at its installed position and no loose connection was observed. ELT Antenna area was examined and no damage was found.

As per the inspection report, no discontinuity or abnormality was found in the system. Thereafter, ELT was disconnected and brought to operator's hangar where ELT testing was carried out following permission from ATC. (Please refer Fig No. 9). To carry out the test, 4000 IFR tester was used and the result was found satisfactory.

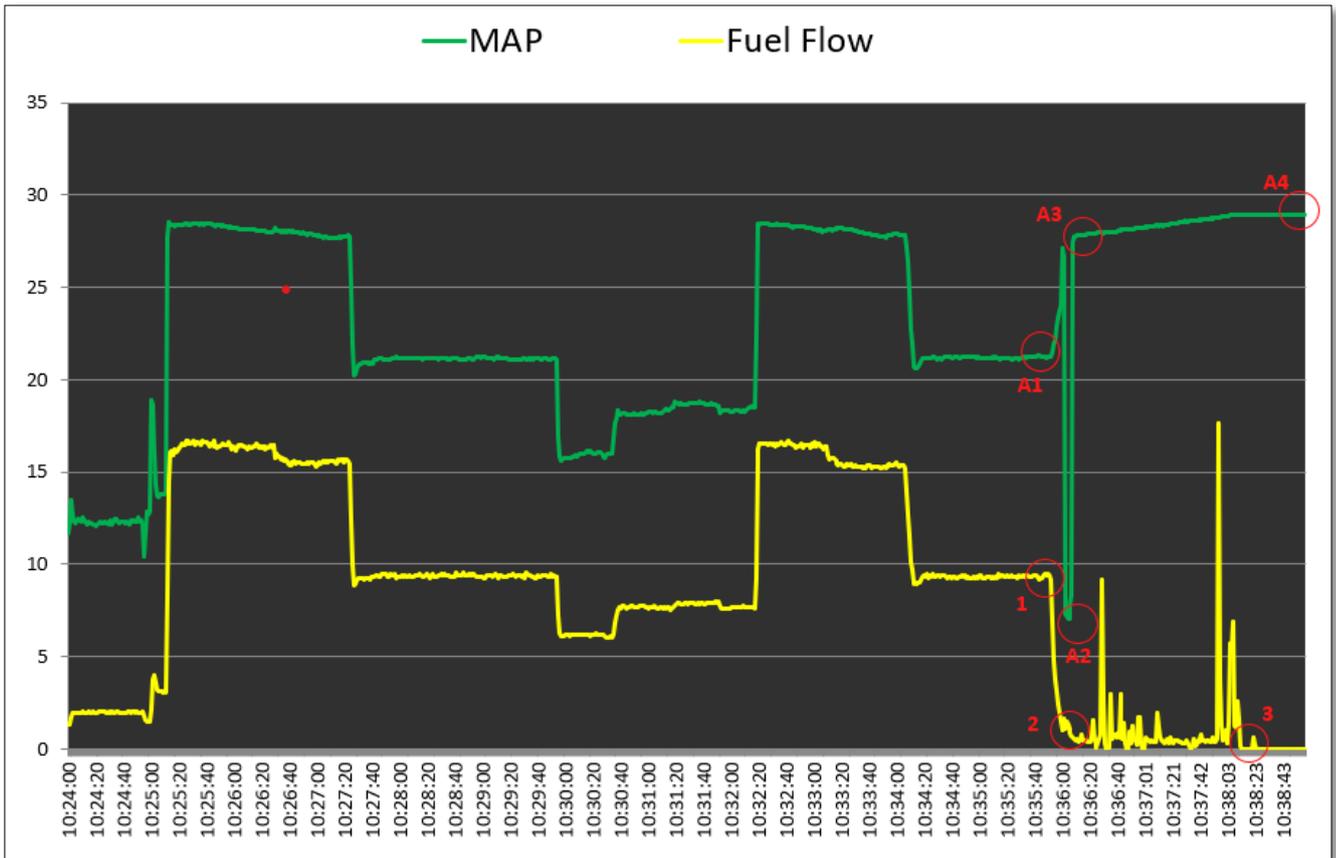
Figure 17: Graph 2 (Flight Time versus Fuel Flow & MAP)

1. Fuel flow suddenly dropped from 9 gal/hr to 1 gal/ hr.
2. Between point 2 and 3, Fuel flow was not uniform and two peaks were also observed

- A1. MAP initially increased from 21 psi and reached upto 26 psi
 A2. Suddenly dropped from 26 psi to 7 psi
 A3. MAP again reached upto 27 psi and remained constant thereafter till the aircraft collided with trees. MAP did not varied as per the fuel flow readings.

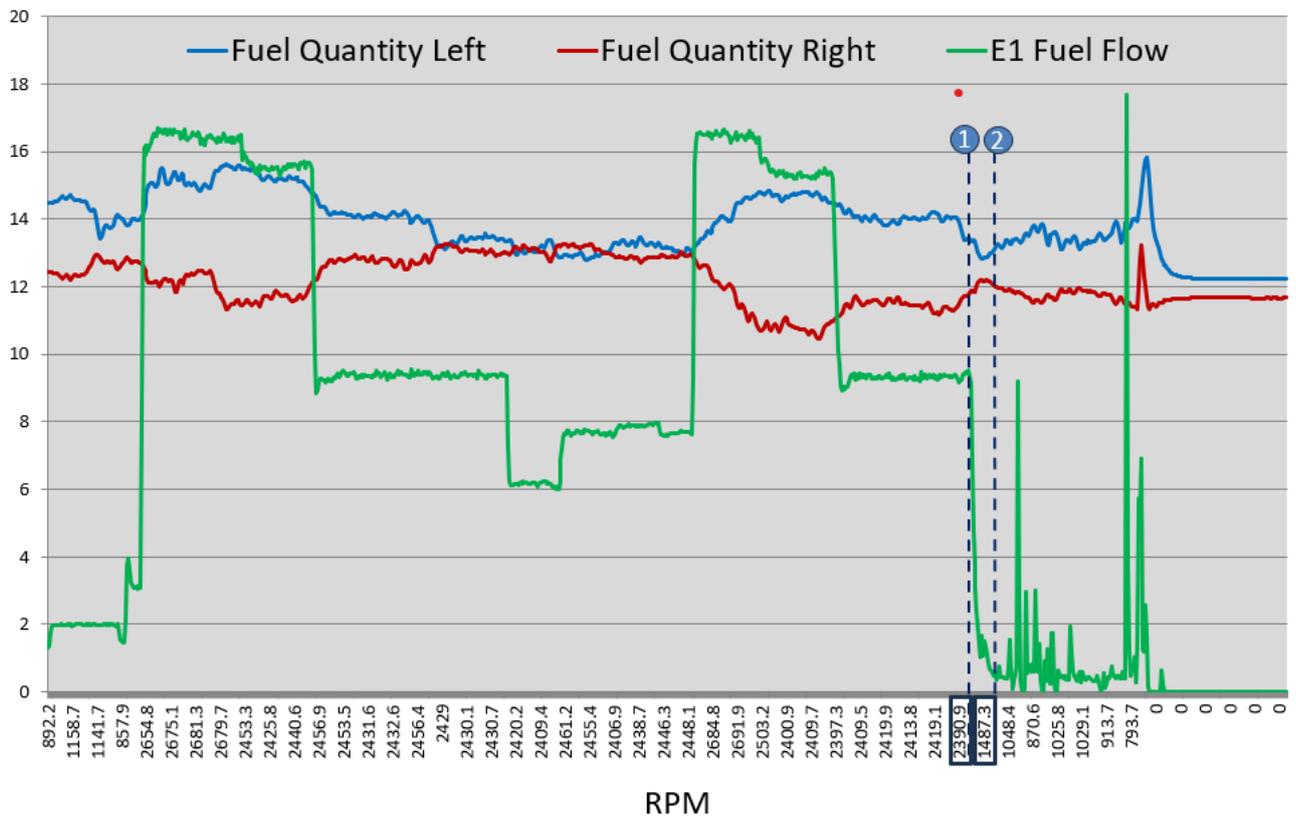
Figure 19: Graph 4 (RPM versus Fuel parameters)

1. Engine rpm was around 2390 at 10:35:43 IST when the fuel flow was approx. 9 gal/hr.
2. Engine rpm reached 1487 at 10:36:02 IST while the fuel flow also decreased upto 1 gal/hr.

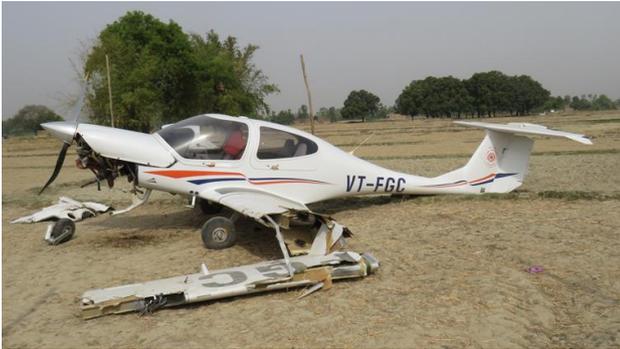
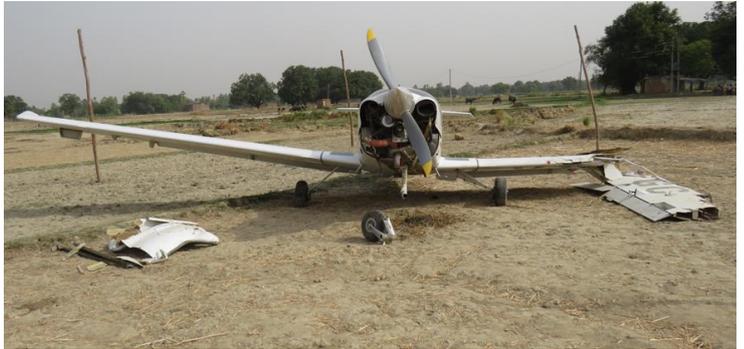
1. The left wing was fully damaged from Approx 5.1 ft from fuselage

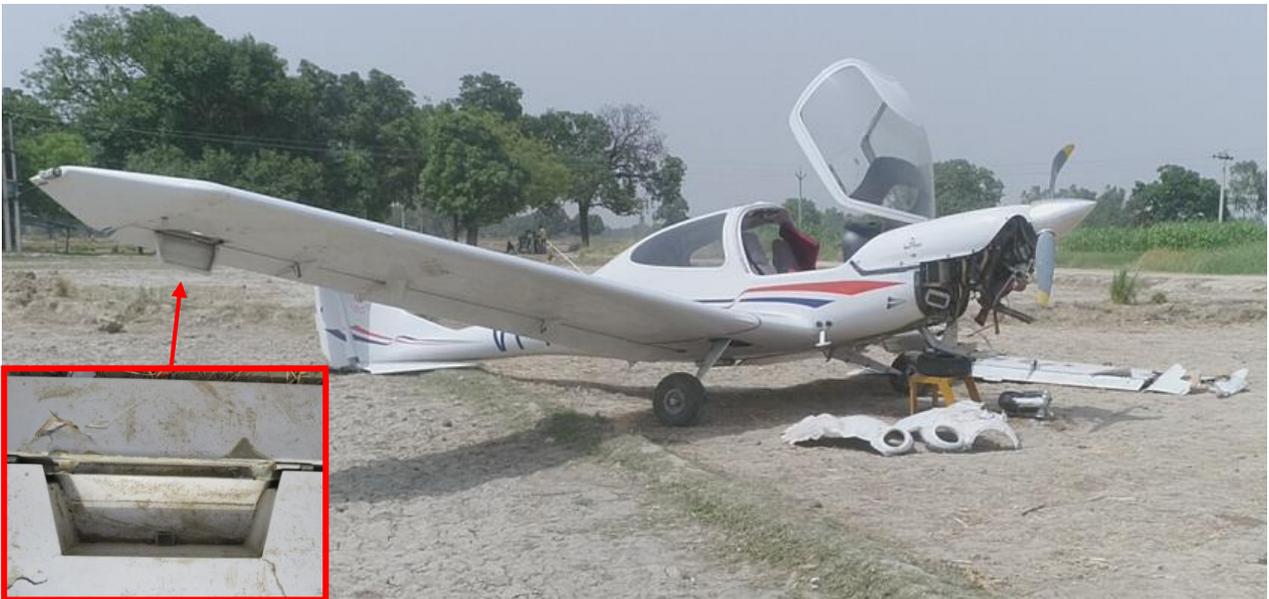
2. Right wing aileron mass balance found damaged

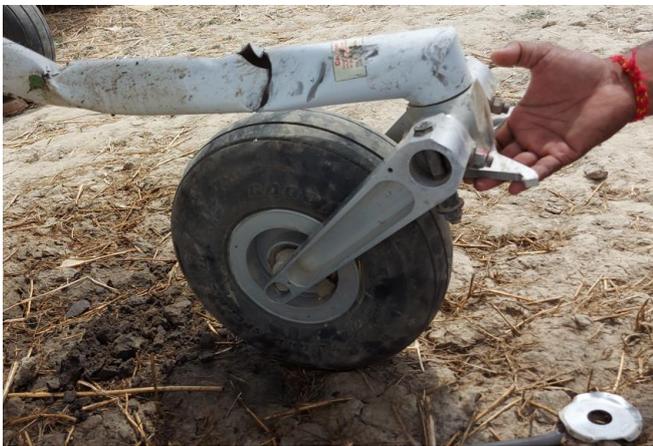
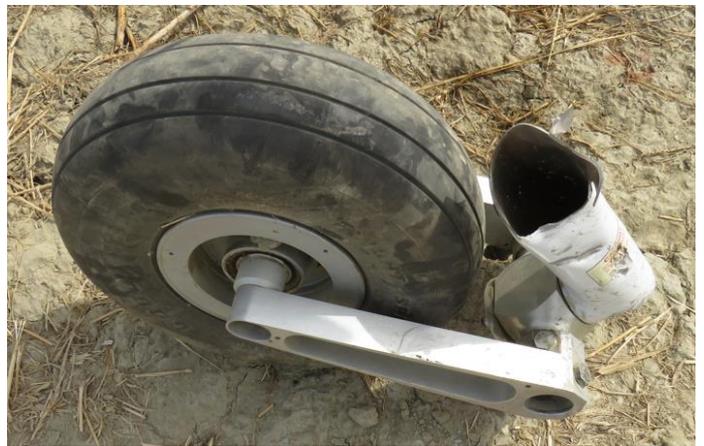
3. Nose landing gear strut found broken from approx 21cm from forward

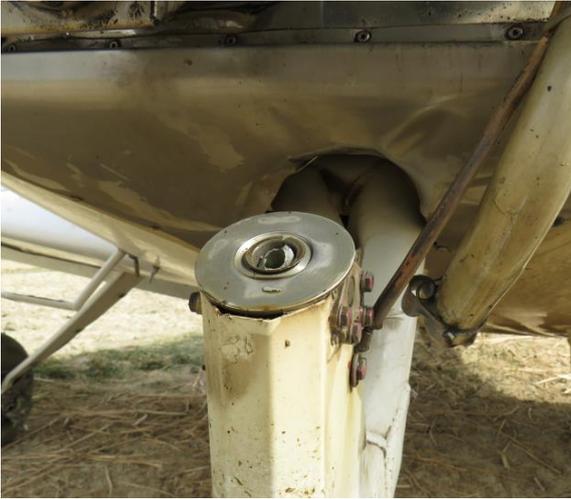
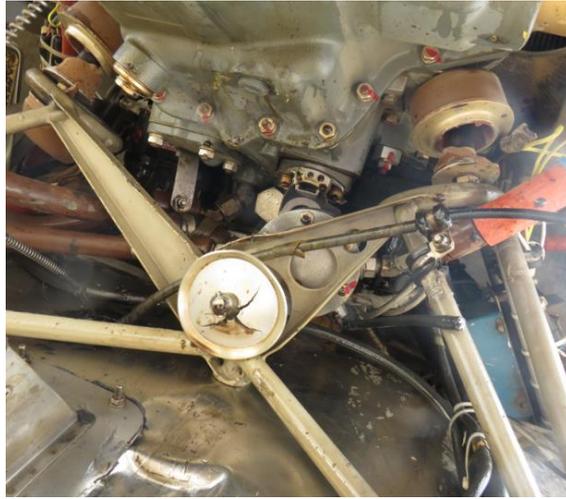
4. Nose landing gear elastomeric pack found broken and all rubber segments detached from elastomeric pack

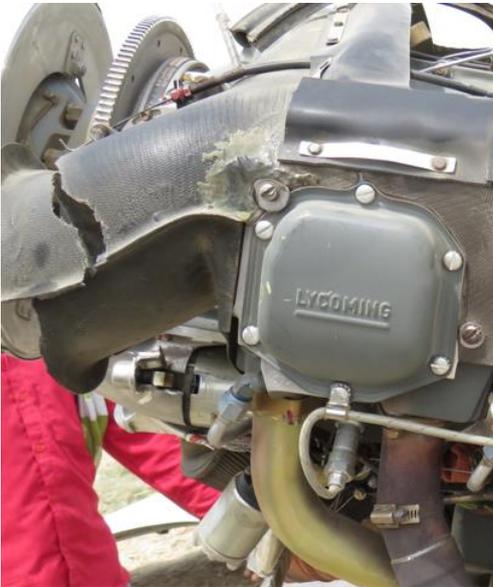
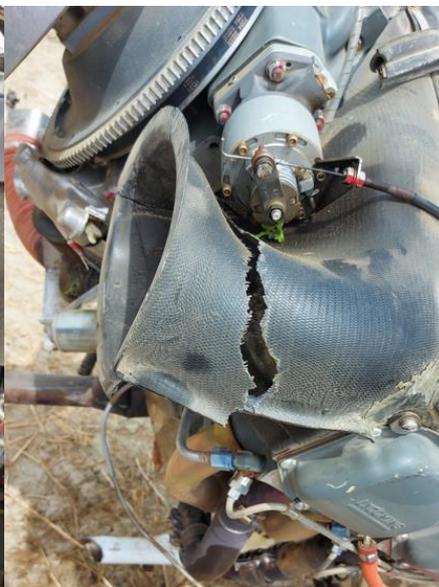
5. Cylinder No 2 baffle found fractured

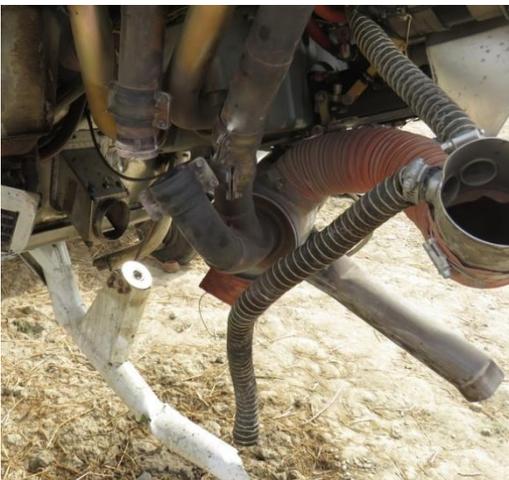
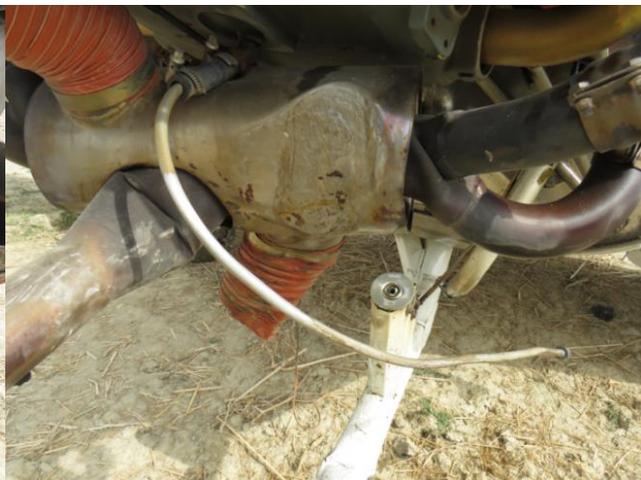
6. Exhaust stack found bent Exhaust muffler found compressed and damaged

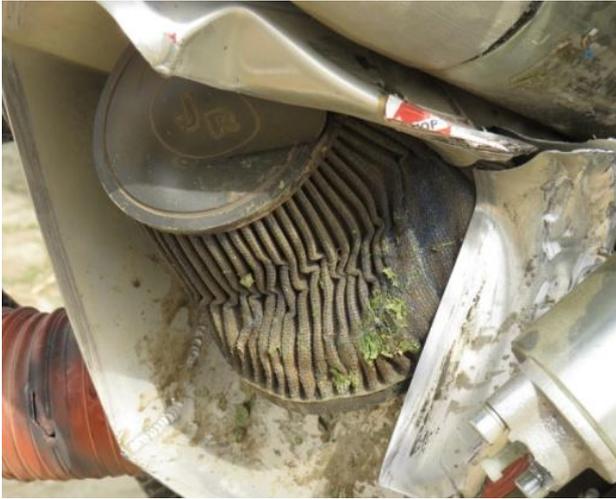
7. Induction air filter box found damaged

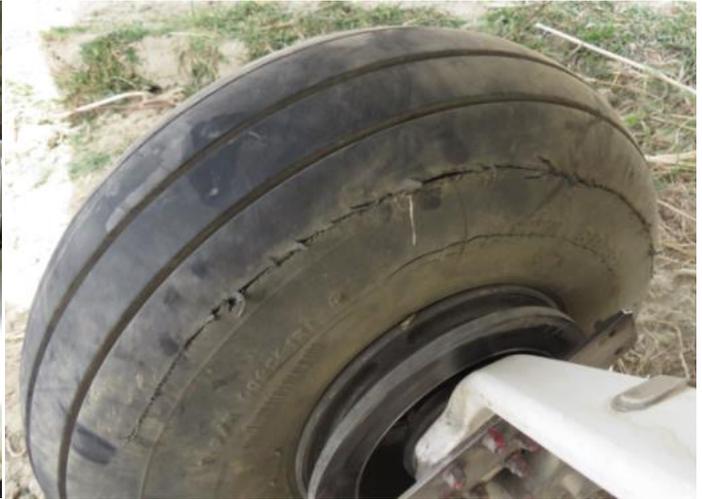
8. Cut marks found on RH main wheel tyre

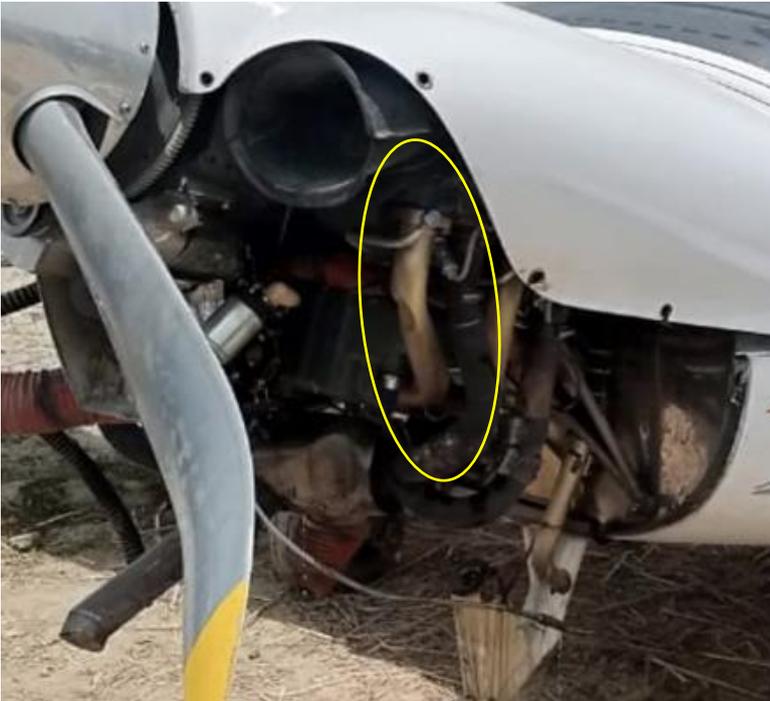
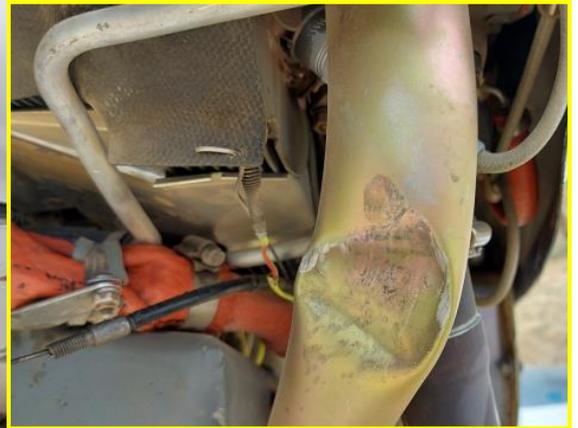
9. Intake pipe of Cylinder no 2 & 3 are found damaged and dented.

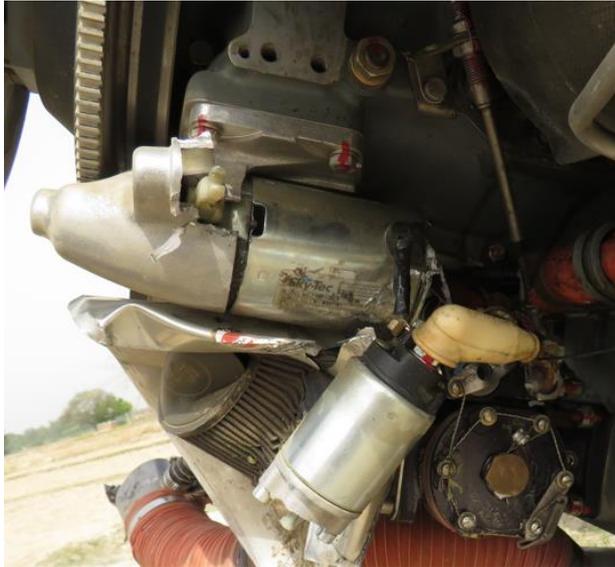
10. Starter solenoid found separated from starter

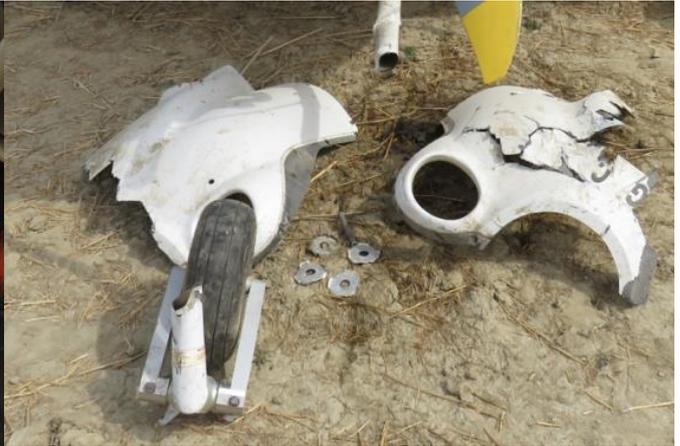
11. Engine cowling damaged

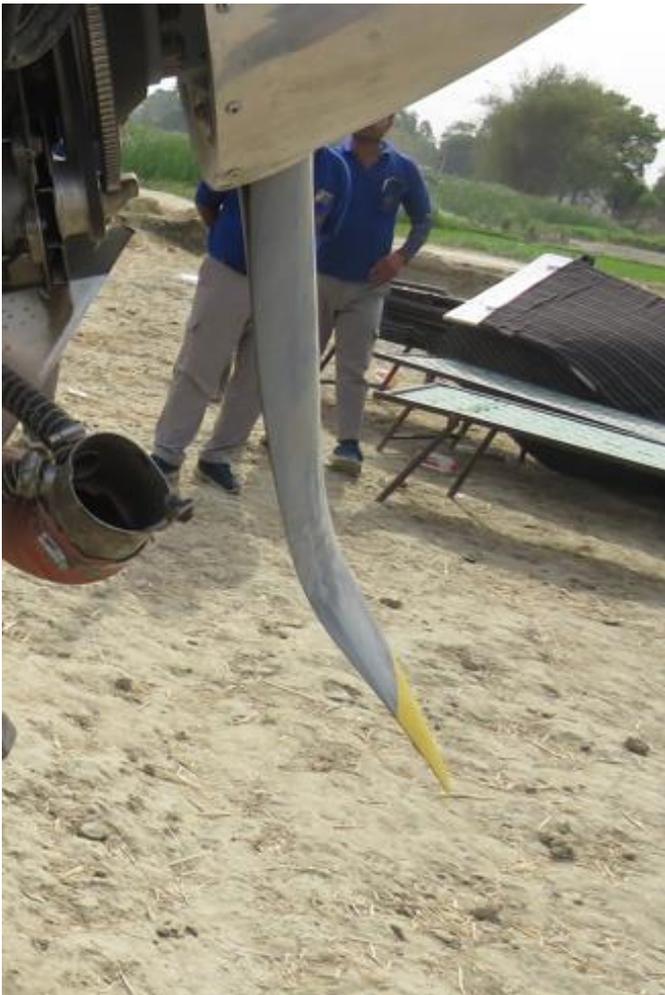
12. No 1 Propeller blade found bent from approx. 33 cm from tip.

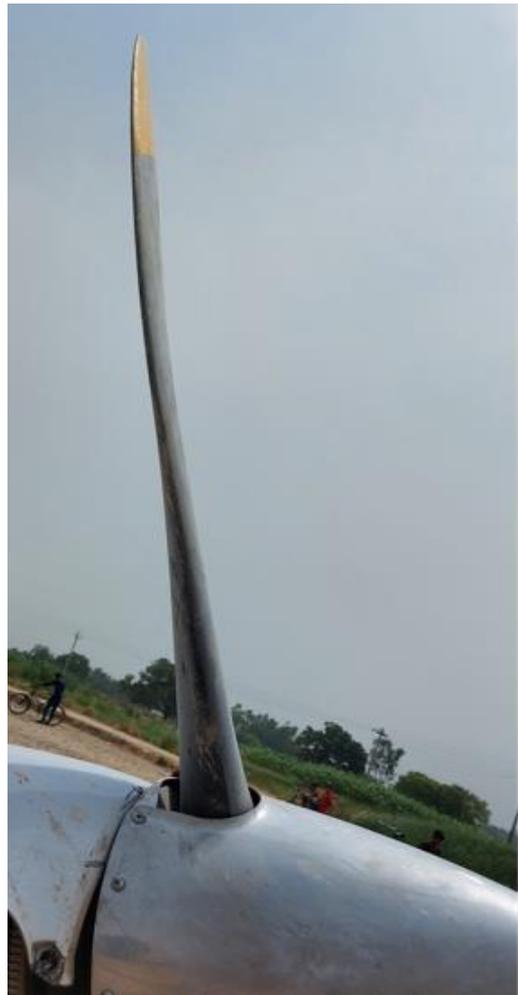
13. No 2 Propeller blade found slightly twisted from root to tip

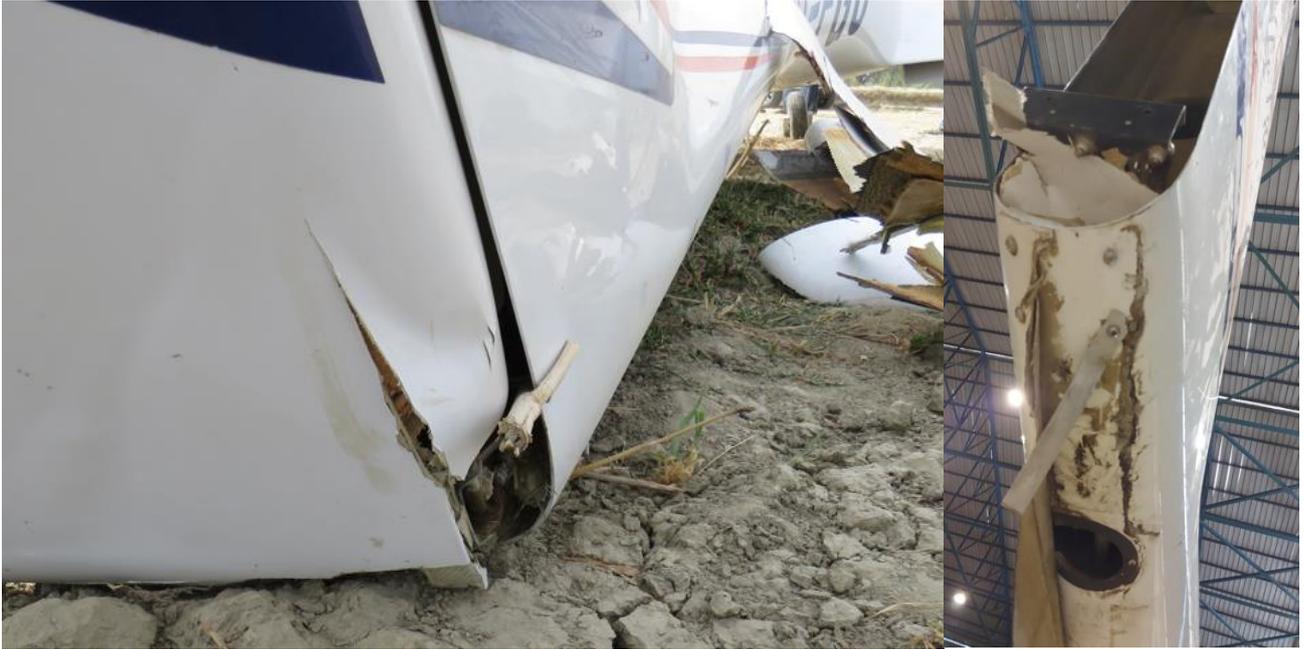
14. Rudder bracket found damaged towards right side

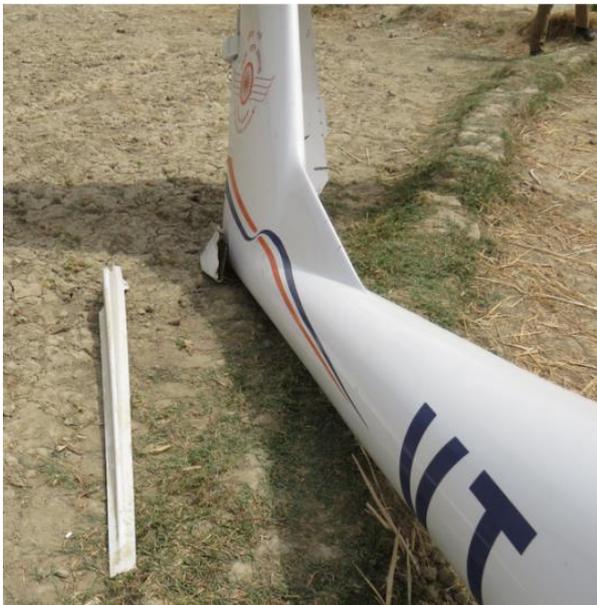
15. Dorsal fin found cracked at 2 places

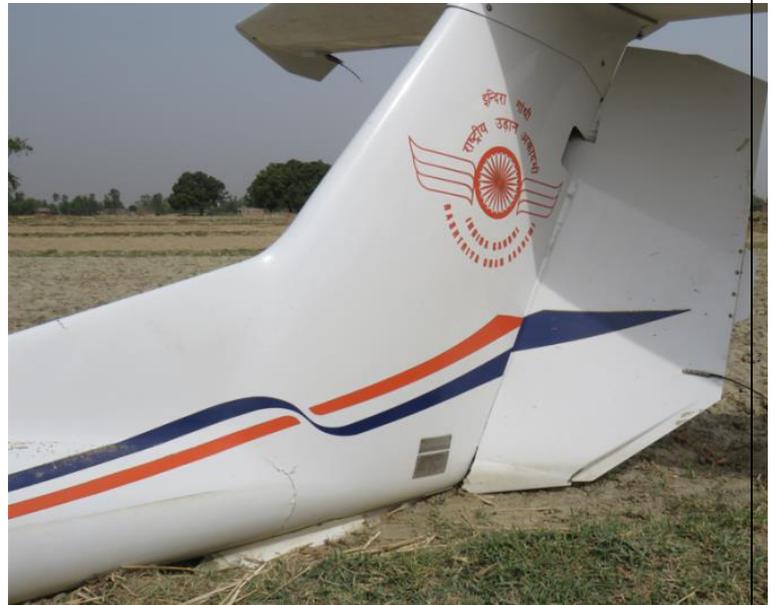
16. Ventral fin found damaged

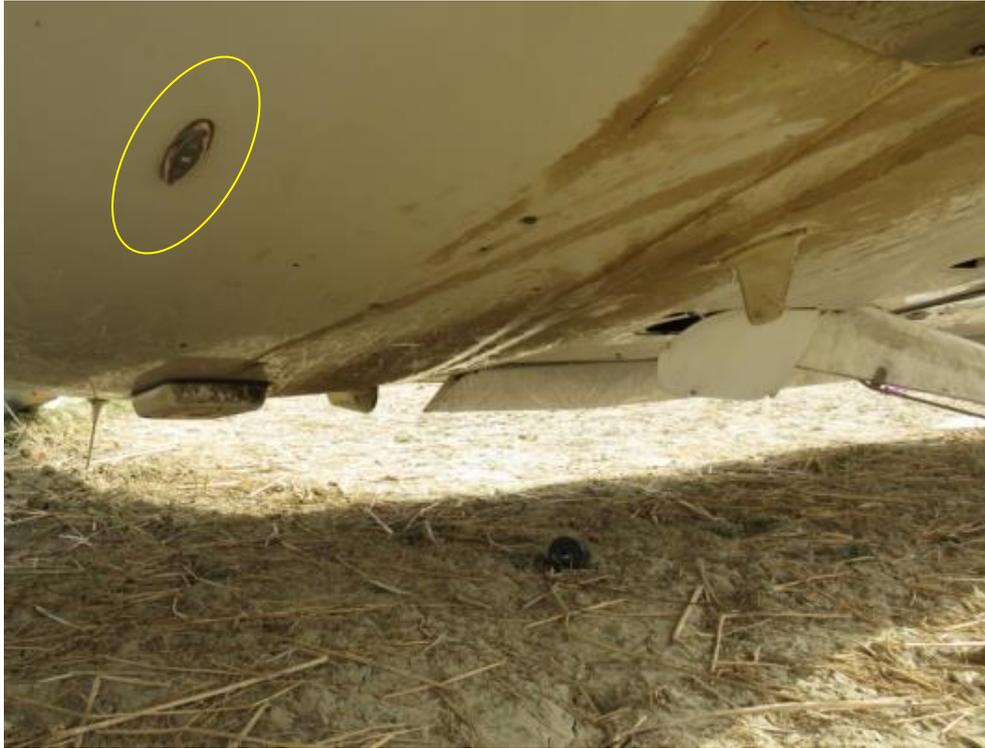
17. DME antenna found broken

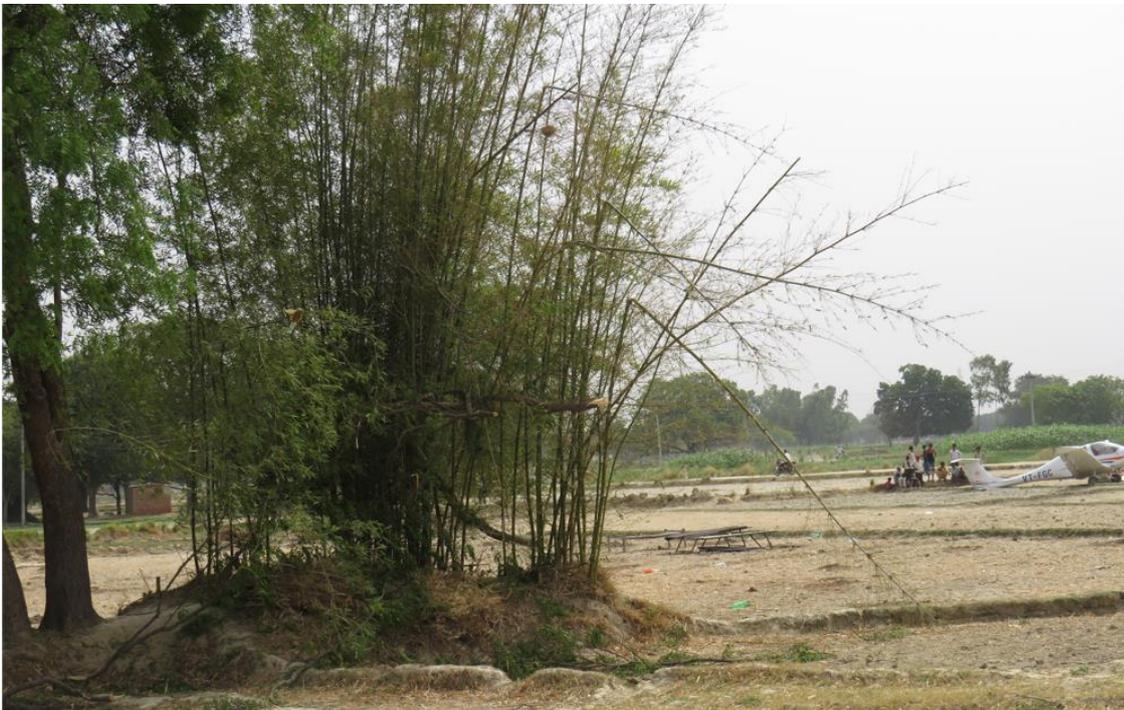
Few branches of neem tree and bamboo found broken
