1.	Aircraft	Type	Learjet 45XR
		Nationality	Indian
		Registration	VT- DBL
2.	Owner and Operator	M/s VSR Ventures Pvt Ltd	
3.	Pilot	ATPL Holder	
	Extent of Injuries	Minor	
4.	Co Pilot	CPL Holder	
	Extent of Injuries	Serious	
5.	No. of Persons on board	06	
6.	Date & Time of Accident	14.09.2023, 1132 UTC	
7.	Place of Accident	Mumbai Airport	
8.	Co-ordinates of Accident Site	Lat : 19° 5' 27.9" N, Long: 72° 51' 46.9" E	
9.	Last point of Departure	Visakhapatnam Airport	
10.	Intended landing place	Mumbai Airport	
11.	Type of Operation	Non scheduled	
12.	Phase of operation	Landing

On 14 September 2023, M/s VSR Ventures owned Lear jet 45XR aircraft VT-DBL was involved in an accident while landing at Mumbai Airport at approximately 11:32 UTC. The aircraft was operating a non-scheduled passenger flight from Visakhapatnam to Mumbai, under the command of a PIC (Pilot in Command, an ATPL holder) and a Co-pilot (a CPL holder). There were six passengers on board.

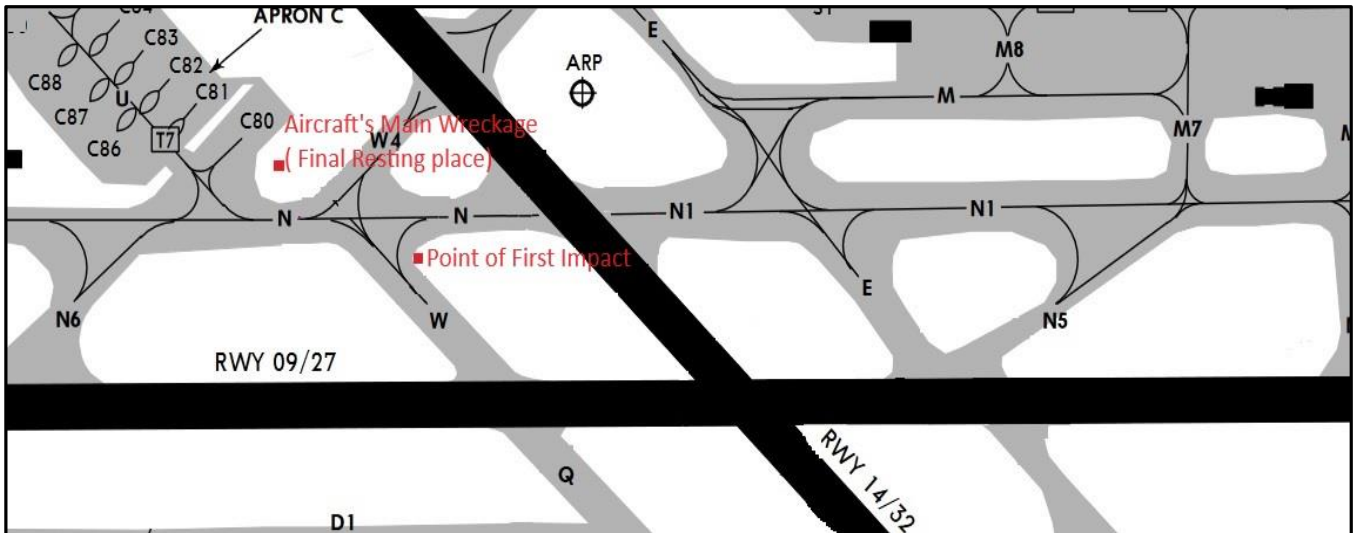
As a result of the impact, the aircraft suffered complete destruction. Initially, it crash-landed on an unpaved area at the intersection of Taxiway W and Taxiway N, causing the fuselage to fracture into two segments and skid, ultimately coming to a halt near an unpaved area close to the intersection of Taxiway U and Taxiway N, near stand C80. Broken parts of the aircraft were scattered along its path (Taxiway N) toward the final stop.

**Figure 1: Point of First Impact and final resting position**

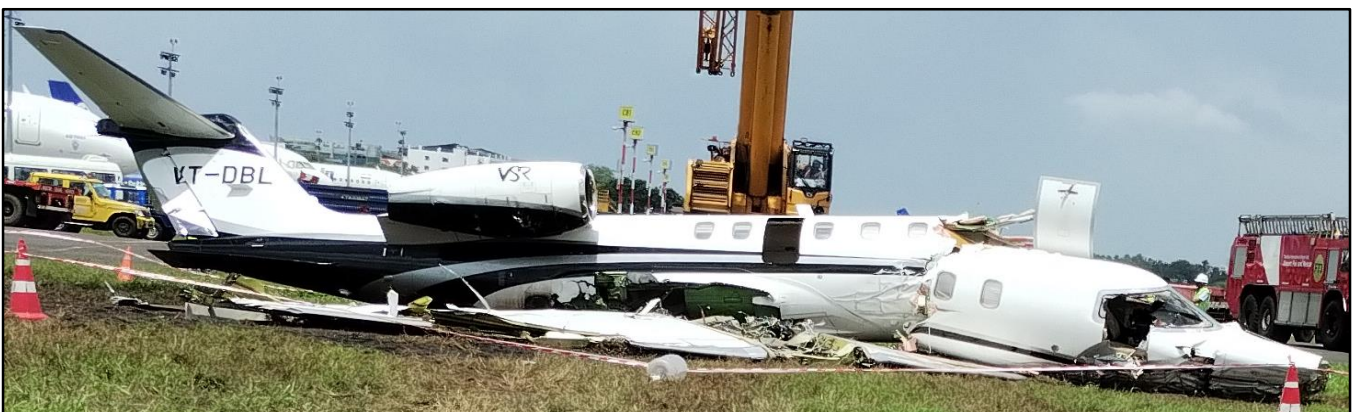
During onsite inspection, it is observed that the Nose section of the aircraft sustained damage. The wing separated, and the forward section of the fuselage broke away from the central fuselage. Both the nose landing gear (NLG) and main landing gear (MLG) were broken. However, the empennage and both engines remained attached to the fuselage. There were scorch marks beneath the right-hand side engine.

**Figure 2: Aircraft's Main Wreckage**
