**Government of India**  
**Ministry of Civil Aviation**  
**Aircraft Accident Investigation Bureau**

**Preliminary Report:** Accident involving M/S Redbird Flight Training Academy Pvt. Ltd.'s TECNAM P-Mentor aircraft VT-RFO at Potlai, near Suktara Airfield, Seoni District, Madhya Pradesh, India on 08 December 2025.

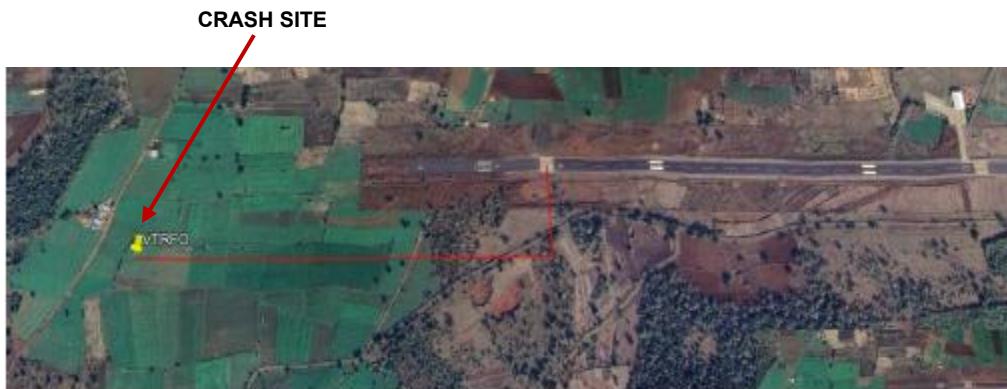
The aircraft wreckage was located approximately 920 m from the threshold of Runway 10 and offset approximately 210 m from the runway centerline of Suktara airfield. The wreckage was available mostly as a single unit. Only minor disintegration had occurred. The aircraft was resting on its nose and front fuselage belly after damaging the landing gears, in a slightly nose down attitude.

PIC 1: CRASH SITE LOCATION NEAR SUKTARA AIRFIELD

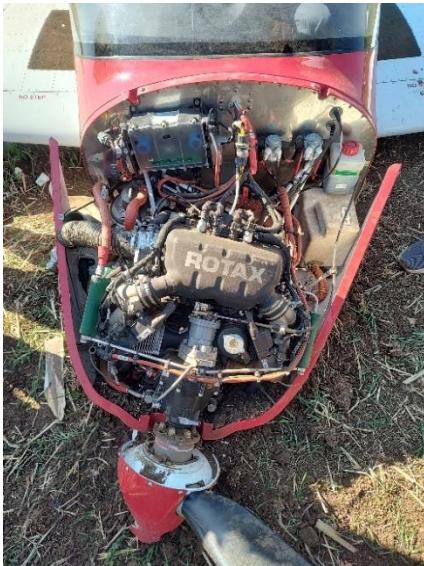
- Both Propeller blades had broken and Spinner damaged
- Both top and bottom nose cowlings damaged
- Firewall and Engine Mount bent
- Nose Landing Gear broken
- Both LH and RH Landing Gear bent. Crack in LH Landing Gear attachment
- Skin and structural damages in the forward fuselage belly area
- RH Wing Root Fairing damaged
- Engine Oil System Radiator, Coolant Radiator and Exhaust damaged

**PIC3: NOSE SECTION & PROPELLER DAMAGED**

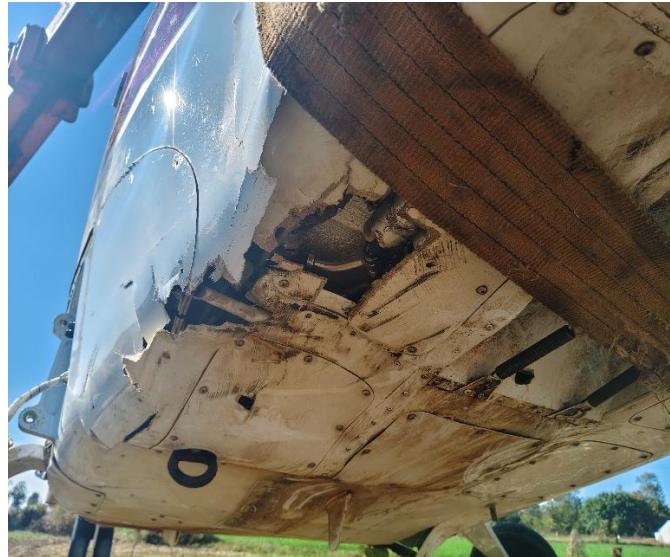
**PIC4: FUSELAGE BOTTOM SKIN/STRUCTURE DAMAGED**

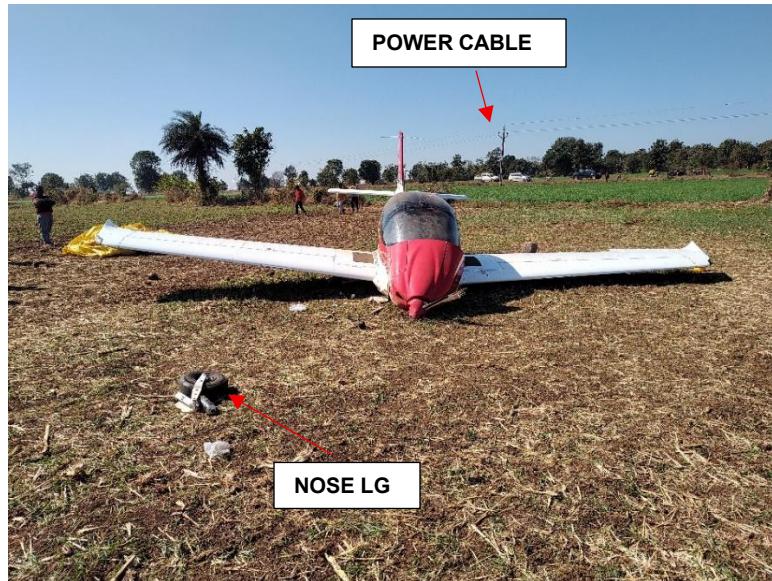
On 08 December 2025, TECNAM P-Mentor aircraft bearing registration VT-RFO, belonging to M/s Redbird Flight Training Academy Pvt. Ltd., was planned for a Circuit & Landing (C/L) Check by a flight instructor with a trainee pilot from Suktara Airfield, Madhya Pradesh. This was the fifth sortie for the day for VT-RFO, no abnormality being reported on the aircraft during the earlier sorties of total 06:50 hrs. Both pilots reported for duty as per the flying schedule and underwent pre-flight breath analyzer test. The test results were satisfactory. Aircraft chocks-off time was approximately 1150 UTC while Sunset time was 1158 UTC. The aircraft took off from Runway 10 and performed the first touch-and-go at 1208 UTC and the second at 1216 UTC. As per the statements of the crew, around 1225 UTC, after turning onto the final segment, the instructor, noticing the runway perspective, instructed the trainee to increase power. The trainee responded that the power was already set at approximately 75%. Both pilots noticed a loss of RPM, following which control was taken over by the instructor. The instructor informed ATC of a forced landing and maneuvered the aircraft to the right of the approach path, maintaining landing configuration. However, the aircraft struck a power cable and crash landed in a nearby field. There was no fire. ELT got activated. The instructor sustained a minor injury whereas the trainee pilot sustained a maxillary fracture which is a serious injury. The aircraft sustained substantial damages during the accident.

**PIC 5: POSITION OF THE AIRCRAFT WRECKAGE VIS-À-VIS POWER CABLE**
