# GOVERNMENT OF INDIA MINISTRY OF CIVIL AVIATION AIRCRAFT ACCIDENT INVESTIGATION BUREAU

# FINAL INVESTIGATION REPORT OF ACCIDENT TO B737-800 AIRCRAFT VT-SYK AT MUMBAI ON 01/07/2019

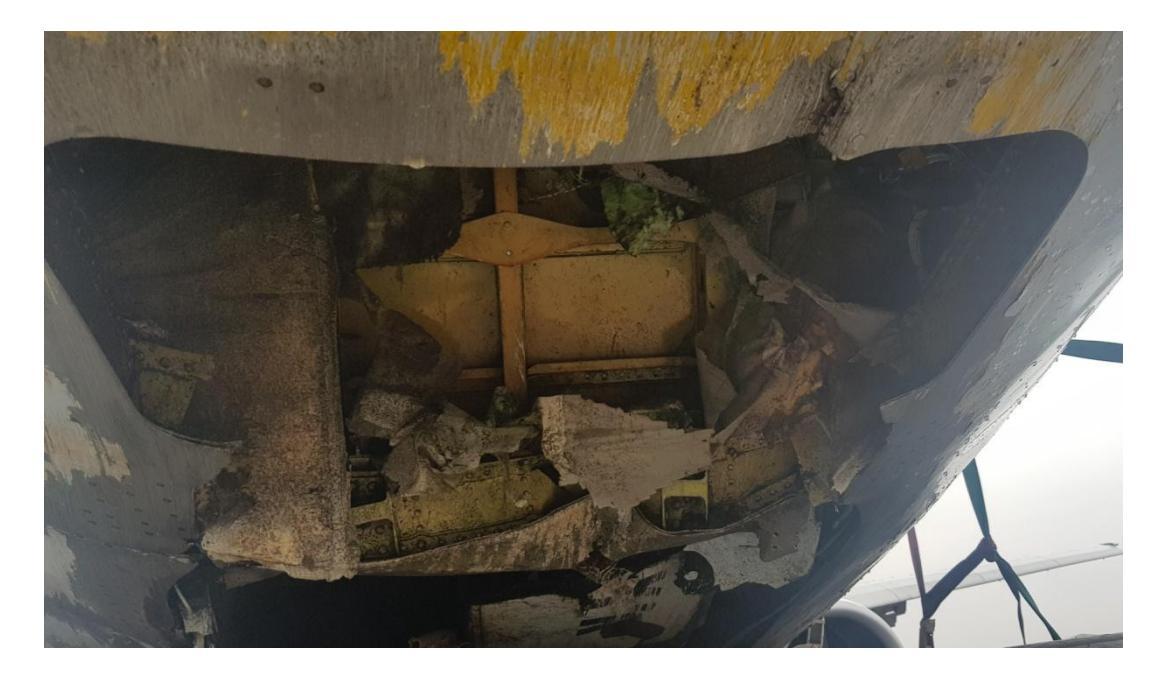
Aircraft nose gear collapsed and the aircraft was found resting on engines & forward lower section of fuselage. Collapsed NLG penetrated in E & E compartment. Section 41 skin got buckled below floor level with extensive damage to belly area till section 41.

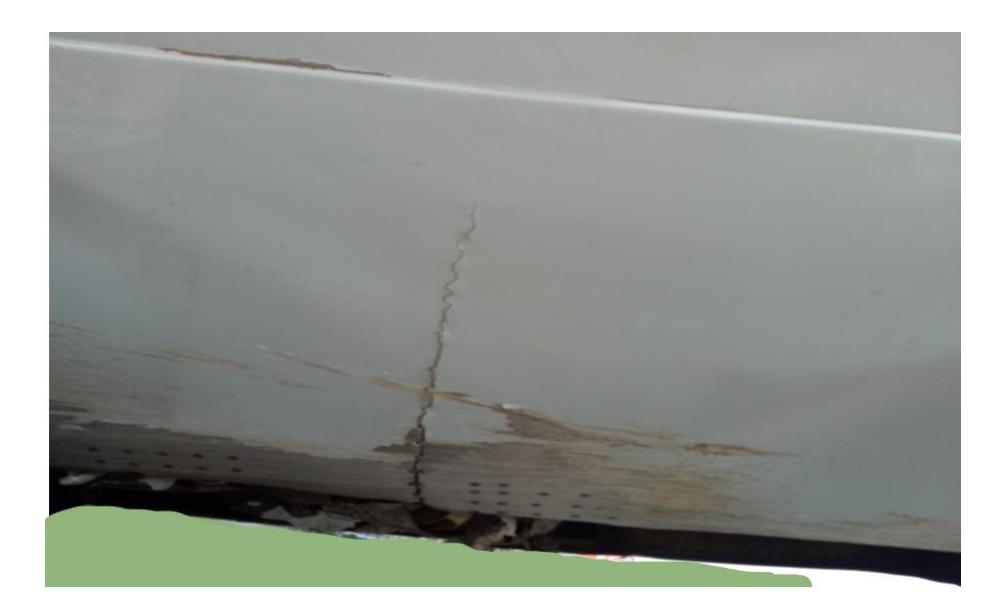
Forward portion of Nose Radome hit the approach lights and got damaged. 10 inches crack was observed which exposed inner area & Weather radar antenna.

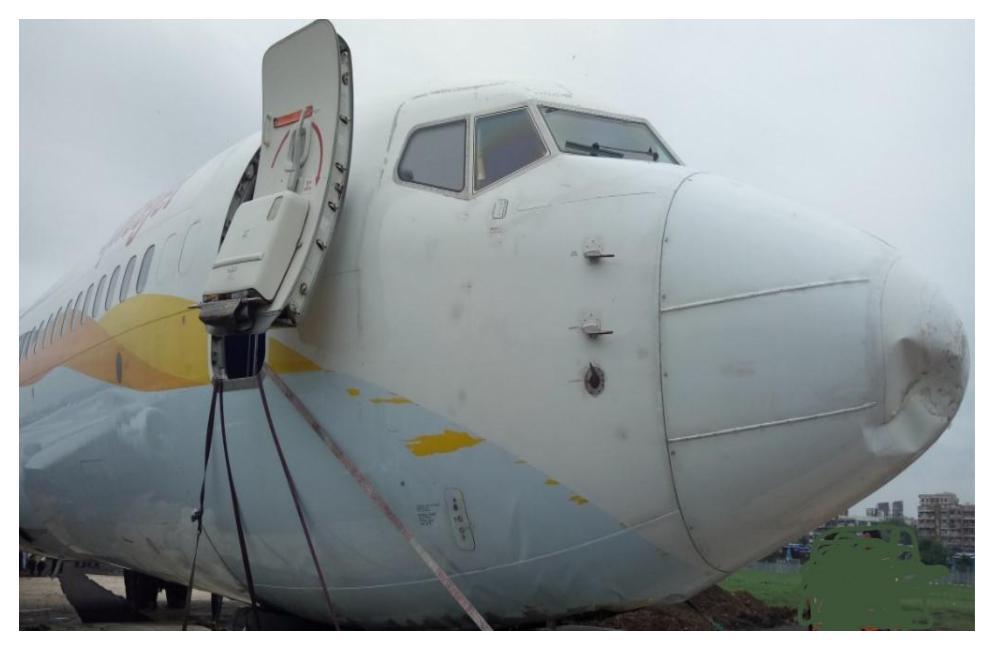
There were dents, scratches on both sides of fuselage and damage to retractable landing lights.

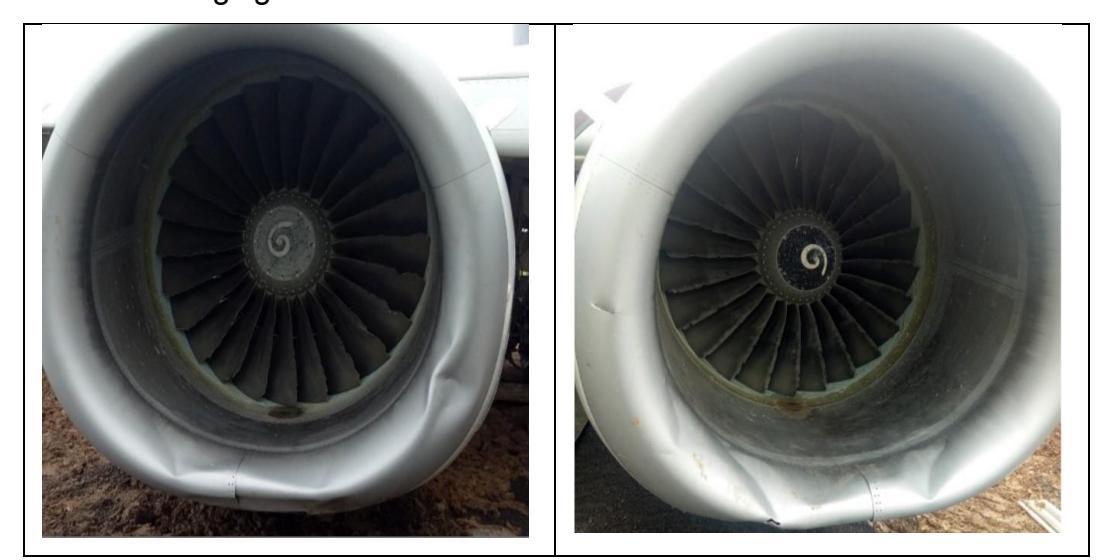
Extensive damage was observed on both engines. Aircraft had dragged for approximately 615 feet and then rested on bottom portion of engine cowls. Both inboard & outboard fan cowls were damaged and Intel Cowl lip section

skin was found torn at several places. Inboard reverser cowl was found to be in deployed condition with damage observed at several places.

Stones & mud were observed inside deployed cowl area. Outboard reverser cowl was in retracted position with bottom portion damaged. All fan blades were found damaged beyond AMM limits. Core ingestion (FOD) caused damage to IGVs.

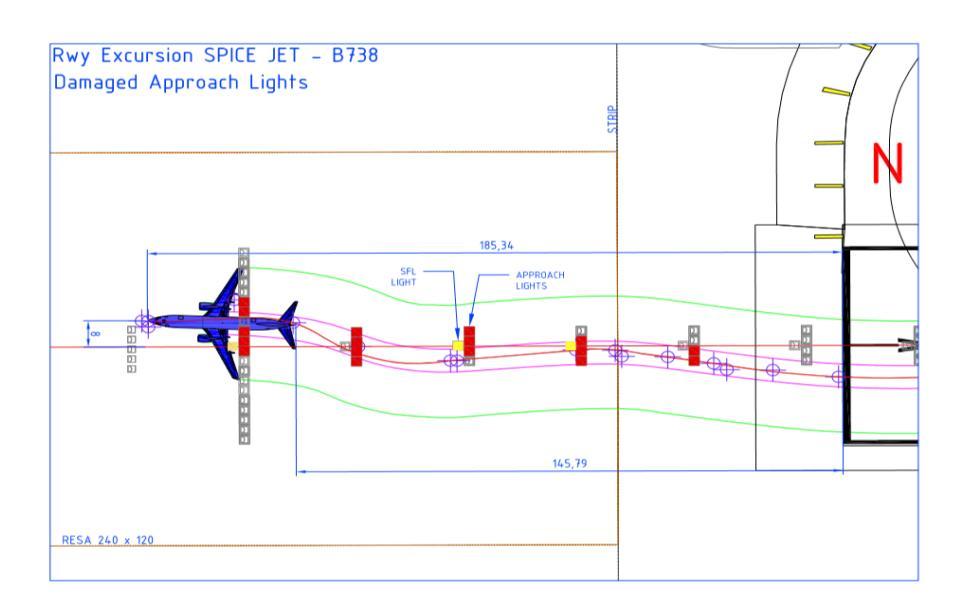
The aircraft after touchdown exited the runway as shown above and along its ground track, broke lights (shown in red). The aircraft was substantially damaged, however, the wreckage was self-contained.

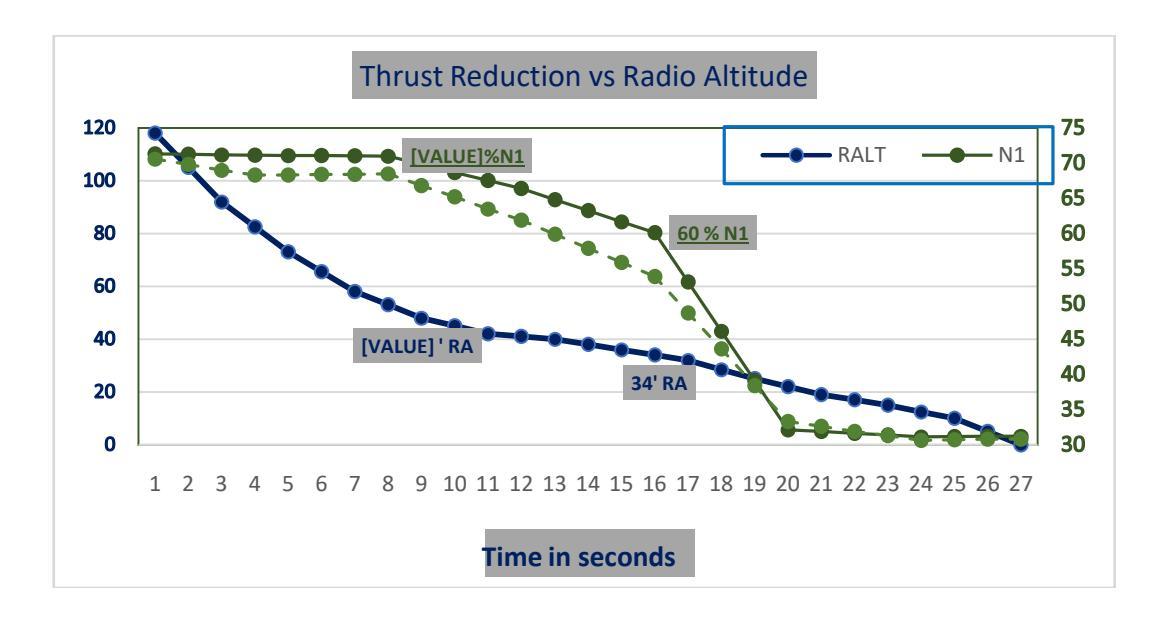
The pilots disconnected the autopilot and the auto thrust at 118 feet radio altitude. When the auto throttle was disconnected, the thrust setting was approximately 70% N1 for both engines. The Thrust was maintained at approximately 70% N1 from 120' RA to 53' RA leading to an increase in CAS from 154 to 172 Knots.

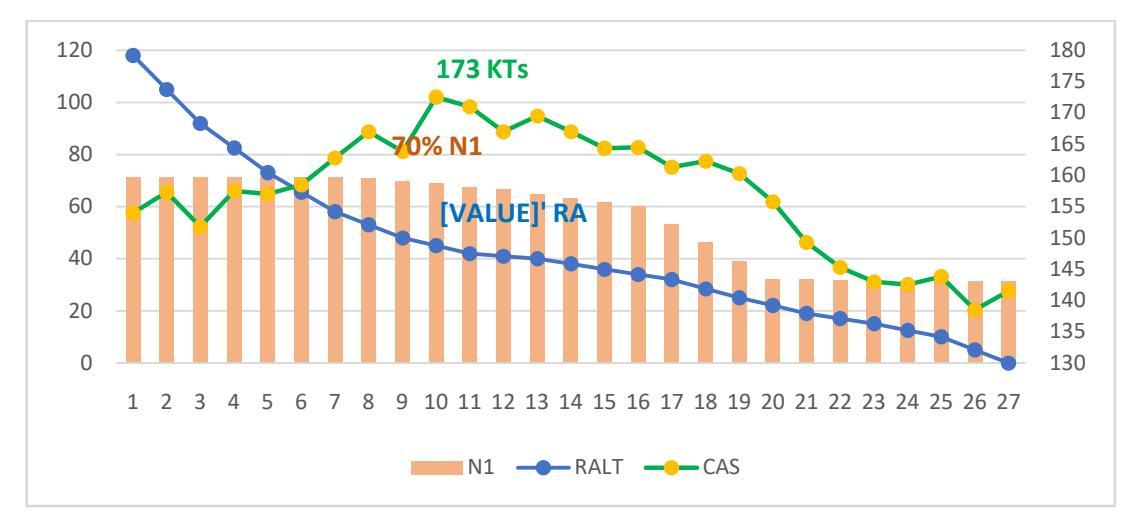
The thrust levers were reduced from 71% N1 to 60% N1 at 53' RA over 9 seconds. The thrust levers were further reduced from 60% N1 to idle at 34' RA over 4 seconds.

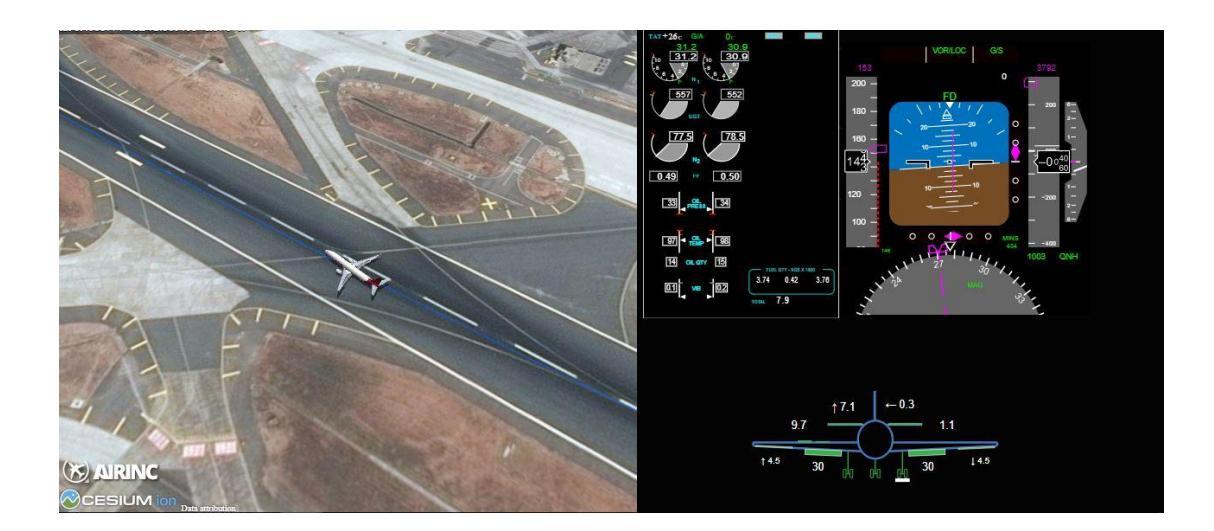
The Image below shows the touchdown slightly to the left of centreline with a slight bank to the right at 144 Kts. This position is 5807 feet past the landing threshold with 3881 feet of runway remaining. The location is abeam Taxiway N7.

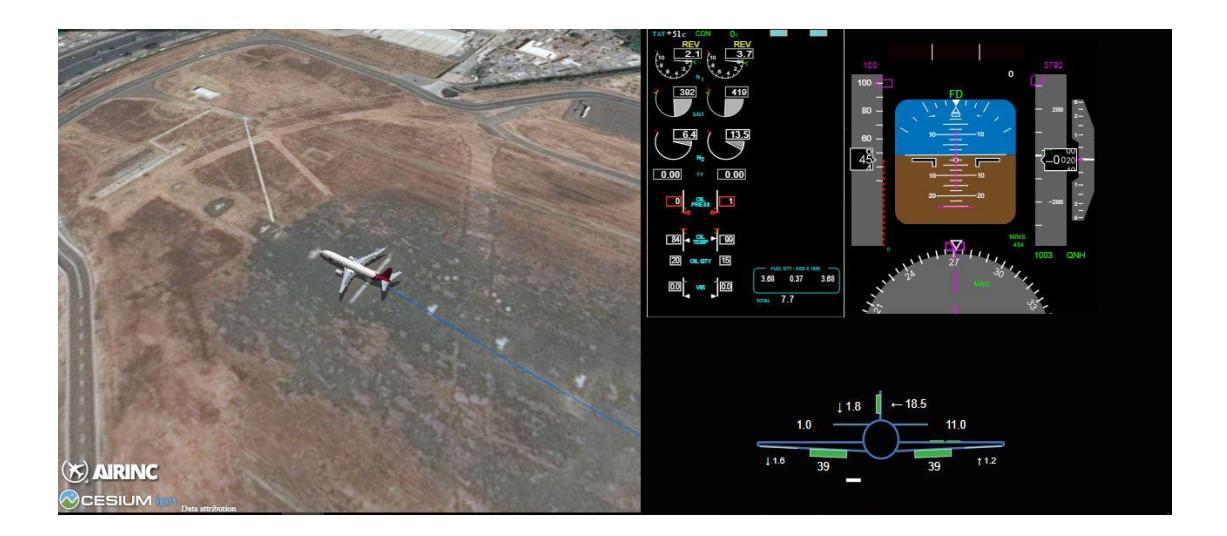
The Image below shows the aircraft stop position. The aircraft has a 2.5<sup>°</sup> nose down attitude. The engines have been shut off and speed brakes retracted 31 seconds after the aircraft had reached this position. The landing gear sensors are not indicated due to extensive damage to the aircraft. The aircraft remained intact.
