FINAL INVESTIGATION REPORT ON SERIOUS INCIDENT TO M/S INTERGLOBE AVIATION LTD (INDIGO) A320 NEO AIRCRAFT VT-ITJ AT GUWAHATI ON 24 MAR 19

AIRCRAFT ACCIDENT INVESTIGATION BUREAU MINISTRY OF CIVIL AVIATION GOVERNMENT OF INDIA

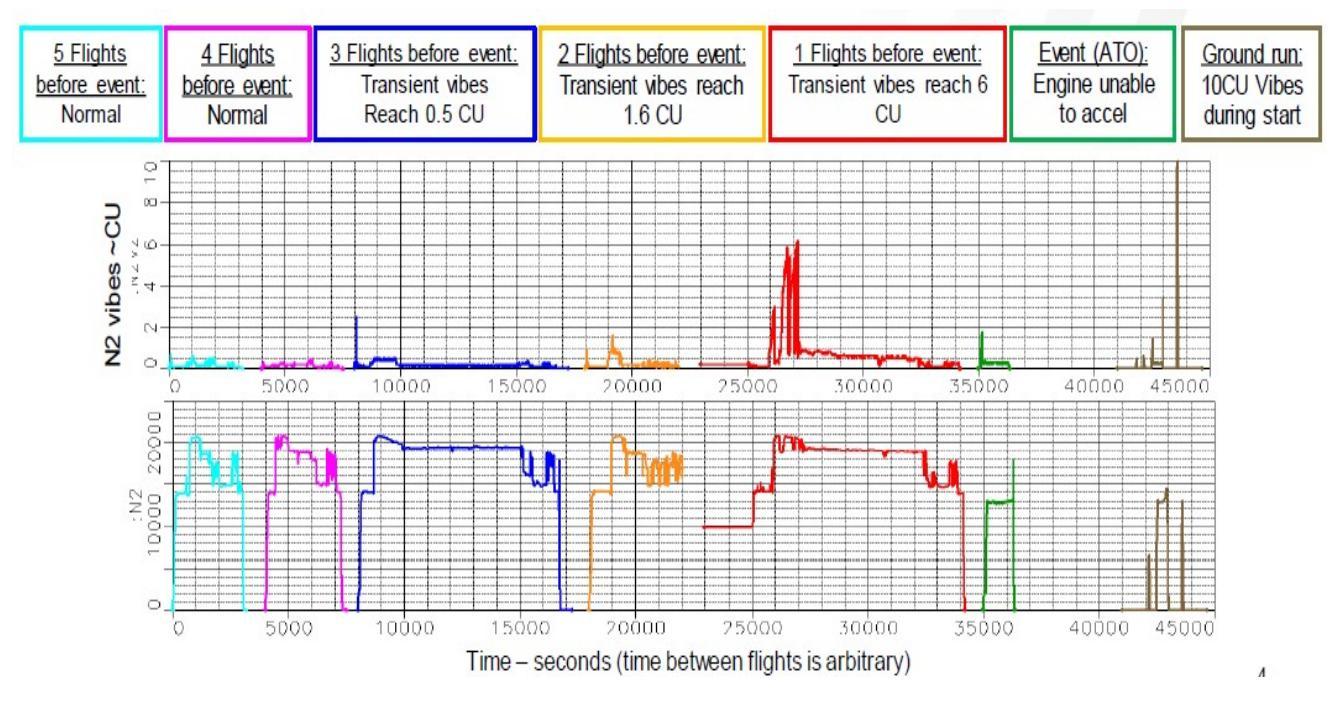
FIG 5: DFDR DATA ANALYSIS

(a) Engine N2 vibrations reached upto 10 CU during start.

(b) Engine was unresponsive to TLA input on flight following aborted takeoff (ATO).

(c) Engine was unable to accelerate.

(d) During sector Amritsar Guwahati, Engine #2 N2 vibration had reached upto 6 CU.

<u>Note</u>: No abnormal shifts in engine #2 performances, oil system or effector scheduling at time of crack propagation was noted during DFDR analysis

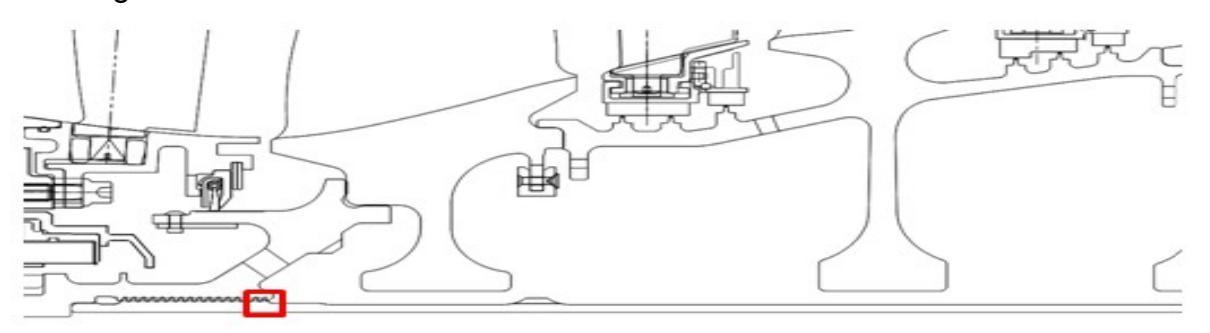
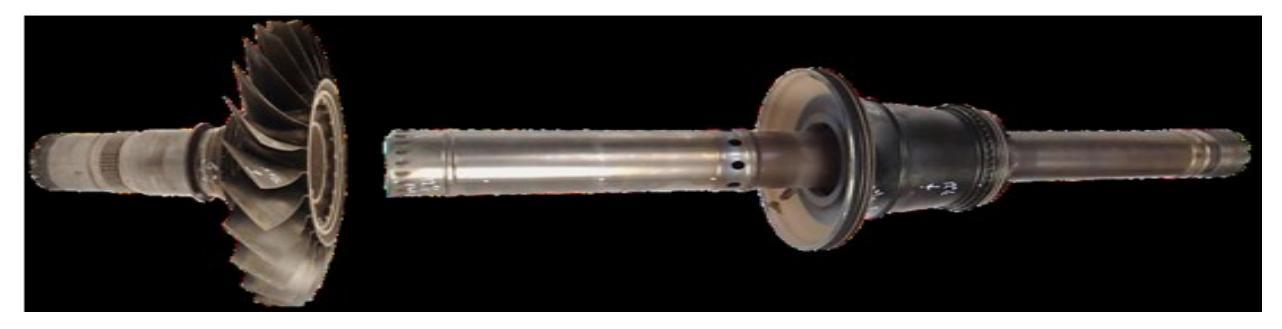
FIG 6: TIE SHAFT & FRONT HUB

After the incident, the engine #2 was despatched to OEM facility for root cause analysis. During investigation, HCF (High Cycle Fatigue) Crack was observed in Tie shaft and Ni (Nickel) Front hub. Tie shaft crack was radial through wall and Front hub cracks were axial through threads.

Investigation of Eng#2 at OEM facility revealed that cracked Shaft resulted in excessive rotor whirl which created large tie shaft bow (imbalance). Rotor whirl drives

vibration into N2 sensor. Vibration at N2 sensor pickup prevents engine from accelerating if weight on wheels is present.

The cause of the incident was a High Cycle Fatigue crack generated on front Hub / Tie shaft which resulted in excessive rotor whirl and tie shaft imbalance which led to propagation of vibrations at high thrust settings.

<u>In short term action</u>, OEM has incorporated more durable coating to tie shaft threads for improved wear life. Changes incorporated by OEM have the following effects on the performance of Engine:-

- a) New coating system will have better capability under load.
- b) Adds new coating to Tie Shaft threads.
- c) Hub retains current coating to increase robustness of joint.
