FINAL REPORT ON ACCIDENT INVOLVING BEECHCRAFT KING AIR C90A AIRCRAFT VT-JIL OPERATED BY M/s JET SERVE AVIATION PVT LTD AT MUMBAI ON 06TH MAY 2021

Government of India Ministry of Civil Aviation Aircraft Accident Investigation Bureau

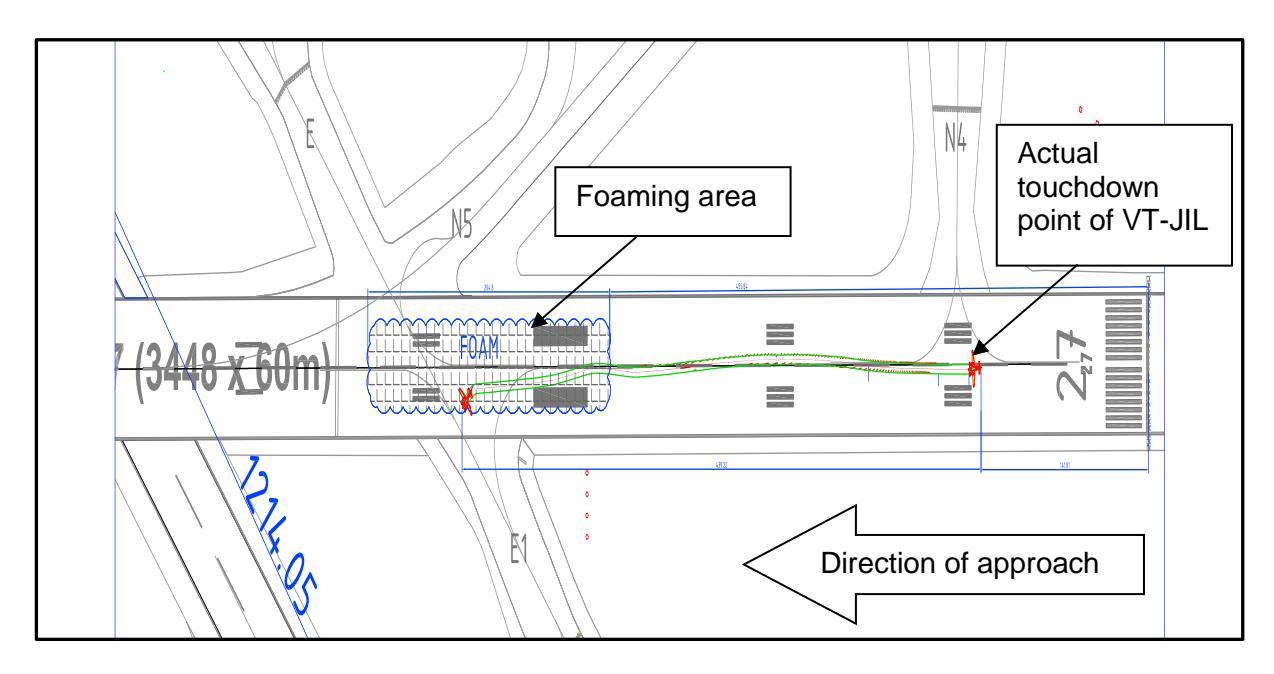
Figure# 12 Runway Foaming and touchdown point of VT-JIL

The crew replied to the ATC query that the aircraft would touchdown after 200m from the threshold. Before landing, approximately 205m of the runway, starting from a distance of about 455m from Runway27 threshold, and about 6m on either side of the runway Centerline, was carpeted with the available extinguishing agent.

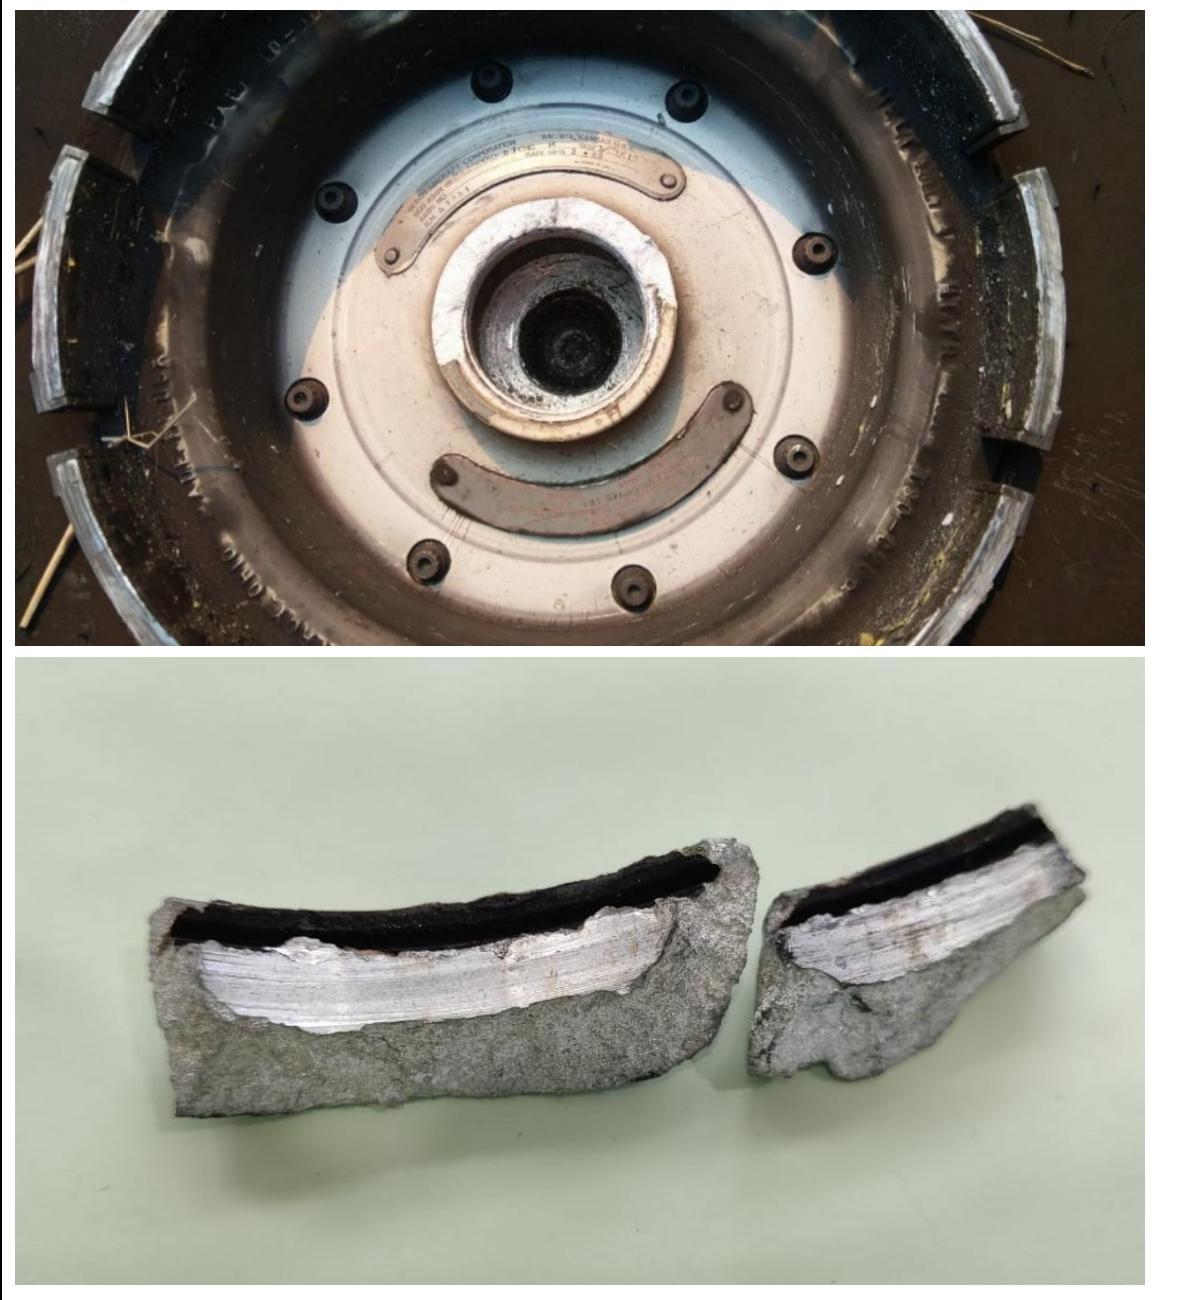
LH main wheel got separated from aircraft during take-off and found near runway 32. Metal pieces pertaining to separated LH main wheel were found on runway. Photos of separated LH main wheel and its metal pieces reflecting damage are depicted below:

Figure# 23 Damaged separated wheel and its metal pieces recovered from Nagpur airport

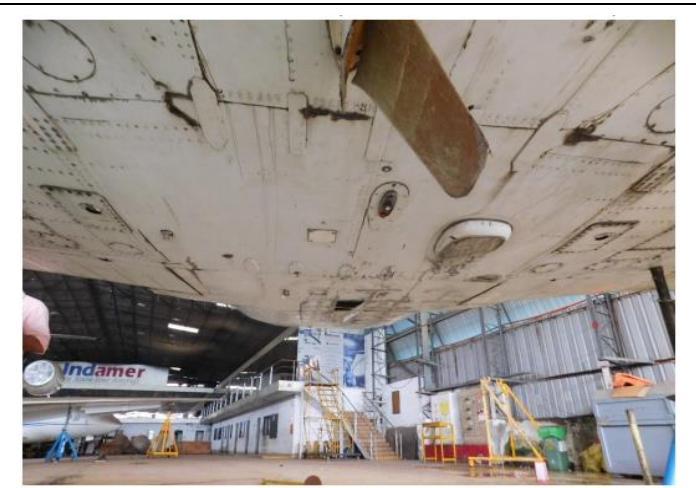
Figure# 24 Antennas installed on belly of the aircraft were found damaged due to rubbing.

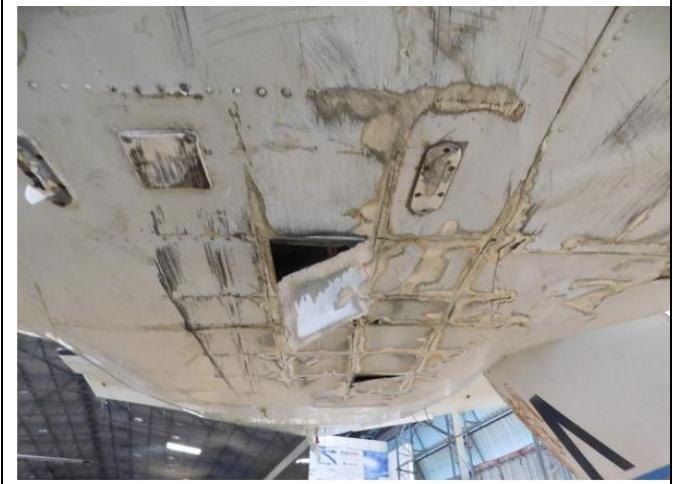
Figure# 25 Aircraft belly area was found heavily rubbed; fuselage skin was found peeled off.

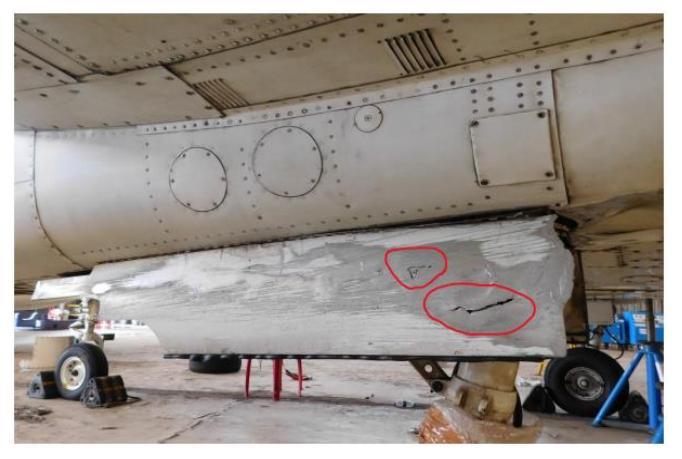
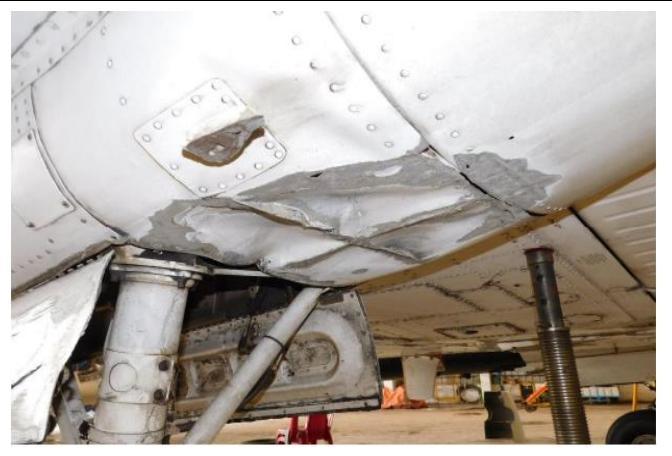
Figure# 26 Rubbing mark, scratches and cuts of 4" x 1" and 1.5" x 2" was found on LH MLG O/B door. Door hinge assembly was found fully broken due to rubbing.

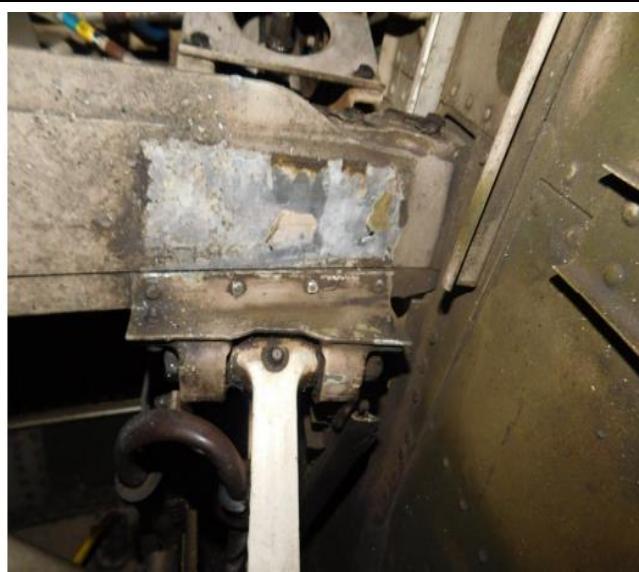
Figure# 27 In LH wheel well, Bumper block was missing.

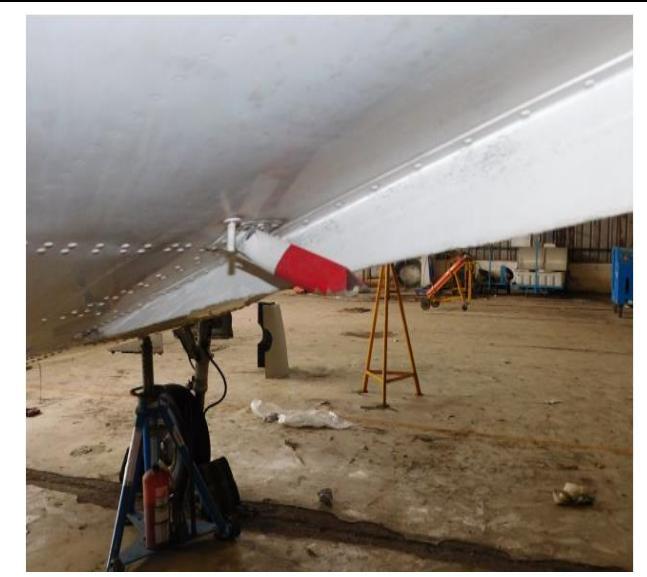
Figure# 28 On tail section, drain tube was found damaged.

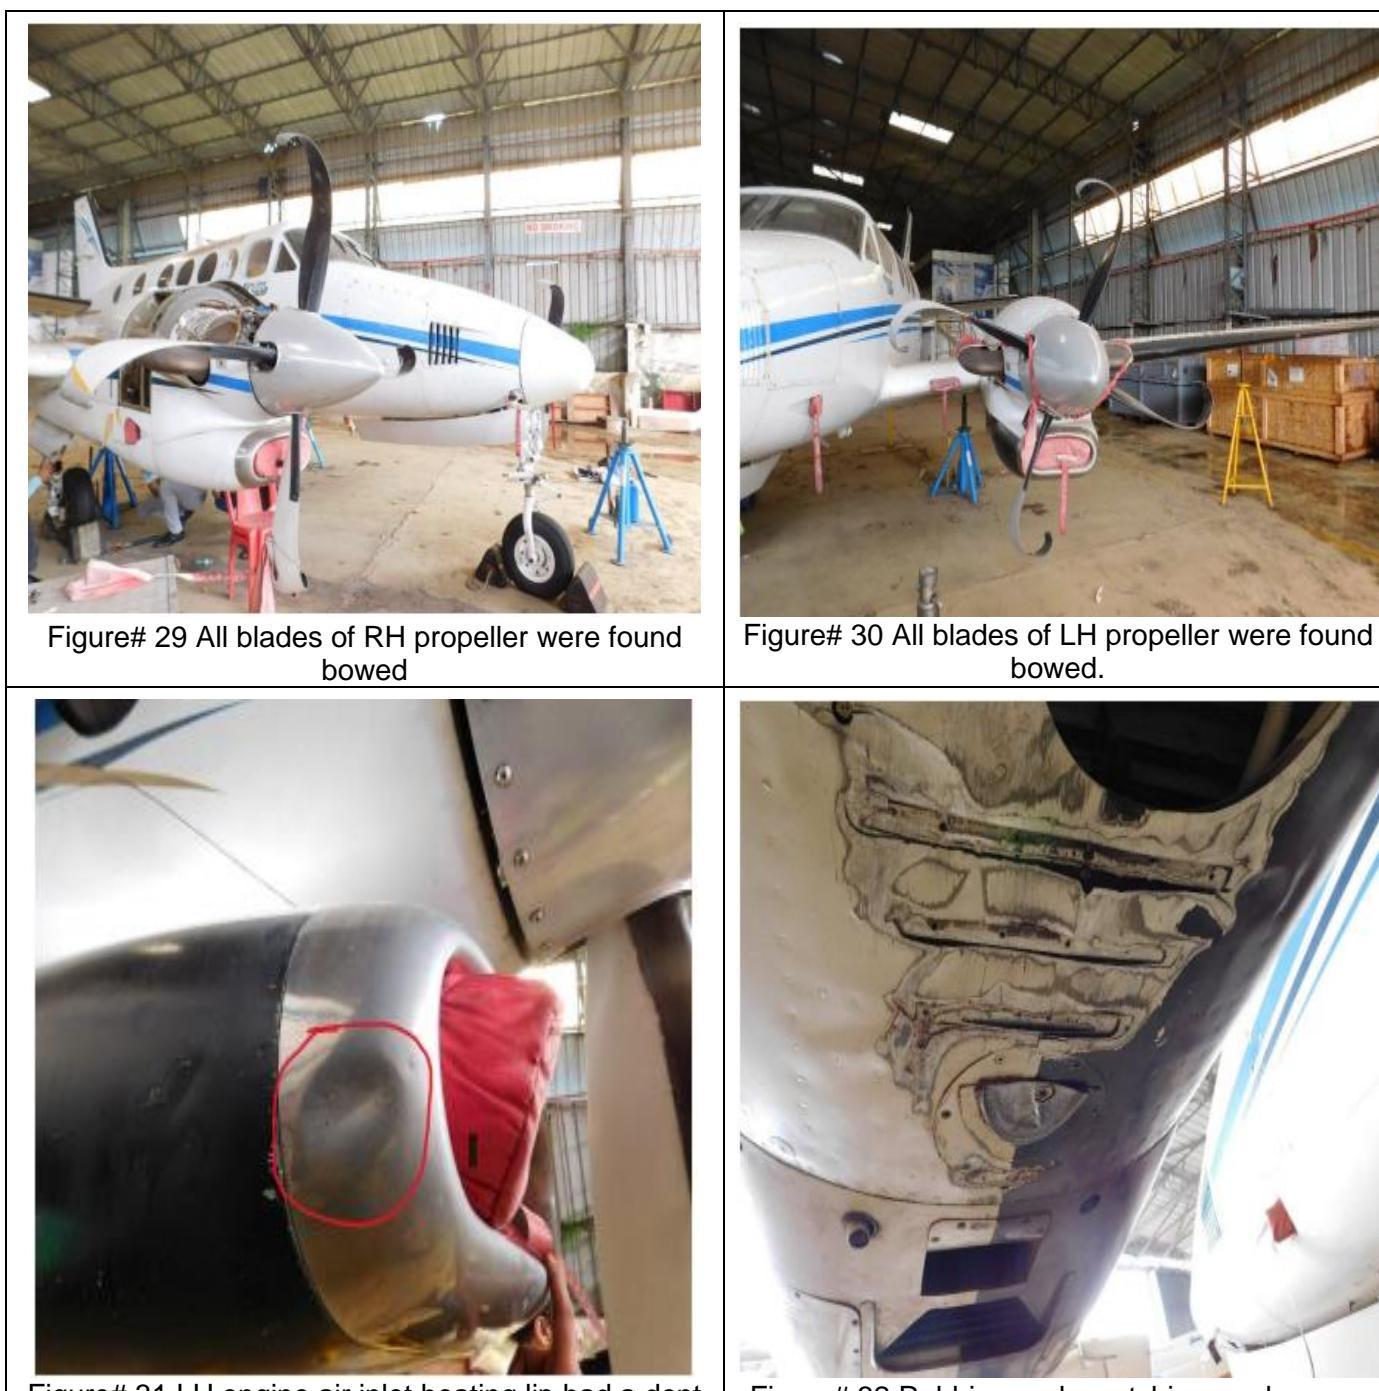
Figure# 31 LH engine air inlet heating lip had a dent with a dimension 1" x 1".

Figure# 32 Rubbing and scratching marks were found on LH engine nacelle tank bottom and spread across the dimension 24" x 14".

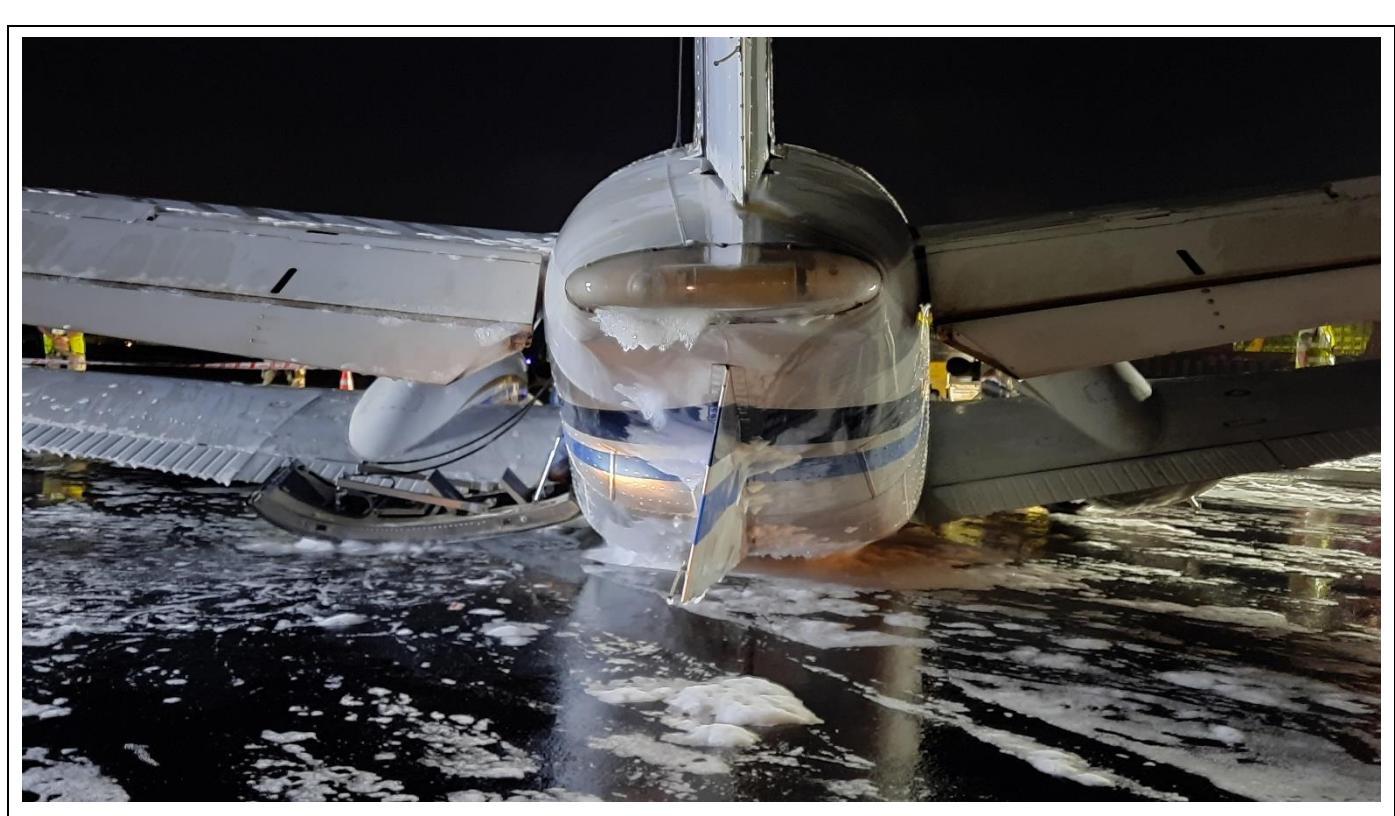
Figure# 33 Ventral Fin was found damaged. It was found bent to one side. The dimension of bent is $100^{\circ} \times 2^{\circ}$.

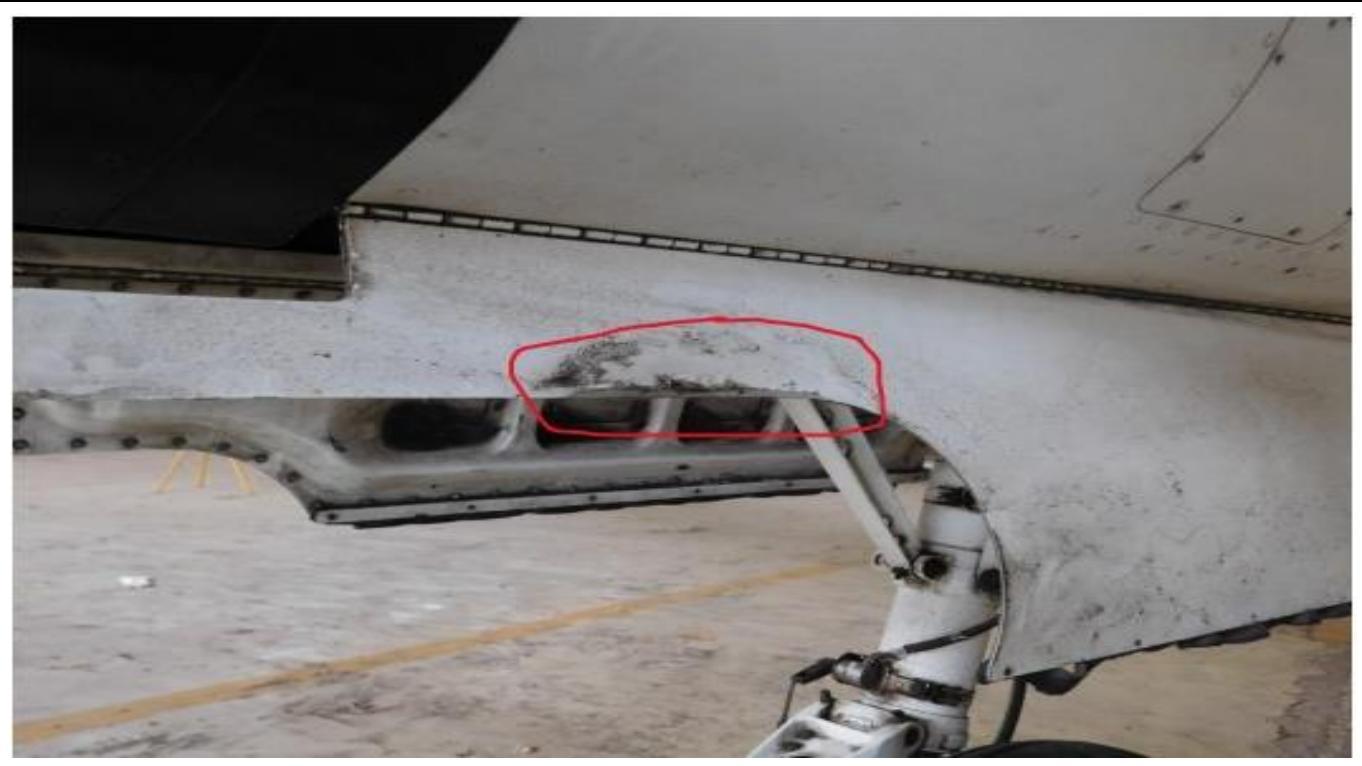
Figure# 34 RH MLG inboard door was found bent with dimension 5" x 1".

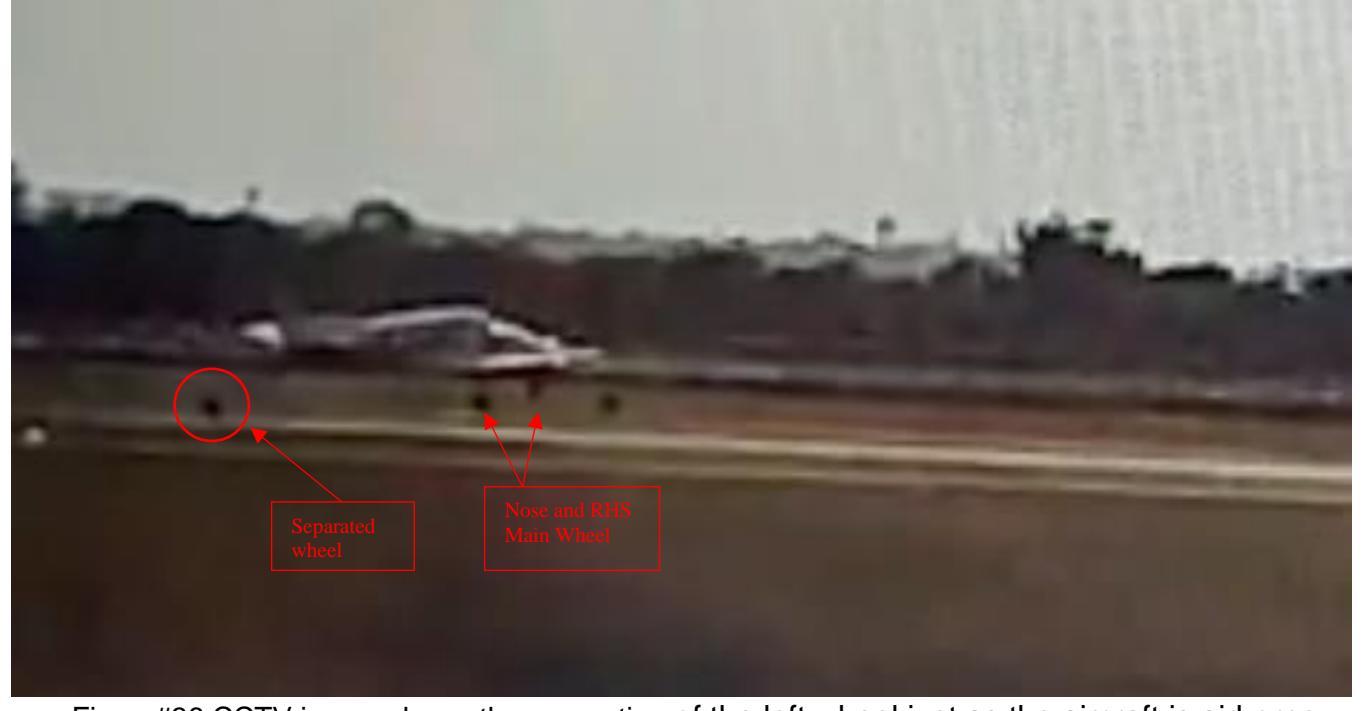
Figure#36 CCTV image shows the separation of the left wheel just as the aircraft is airborne

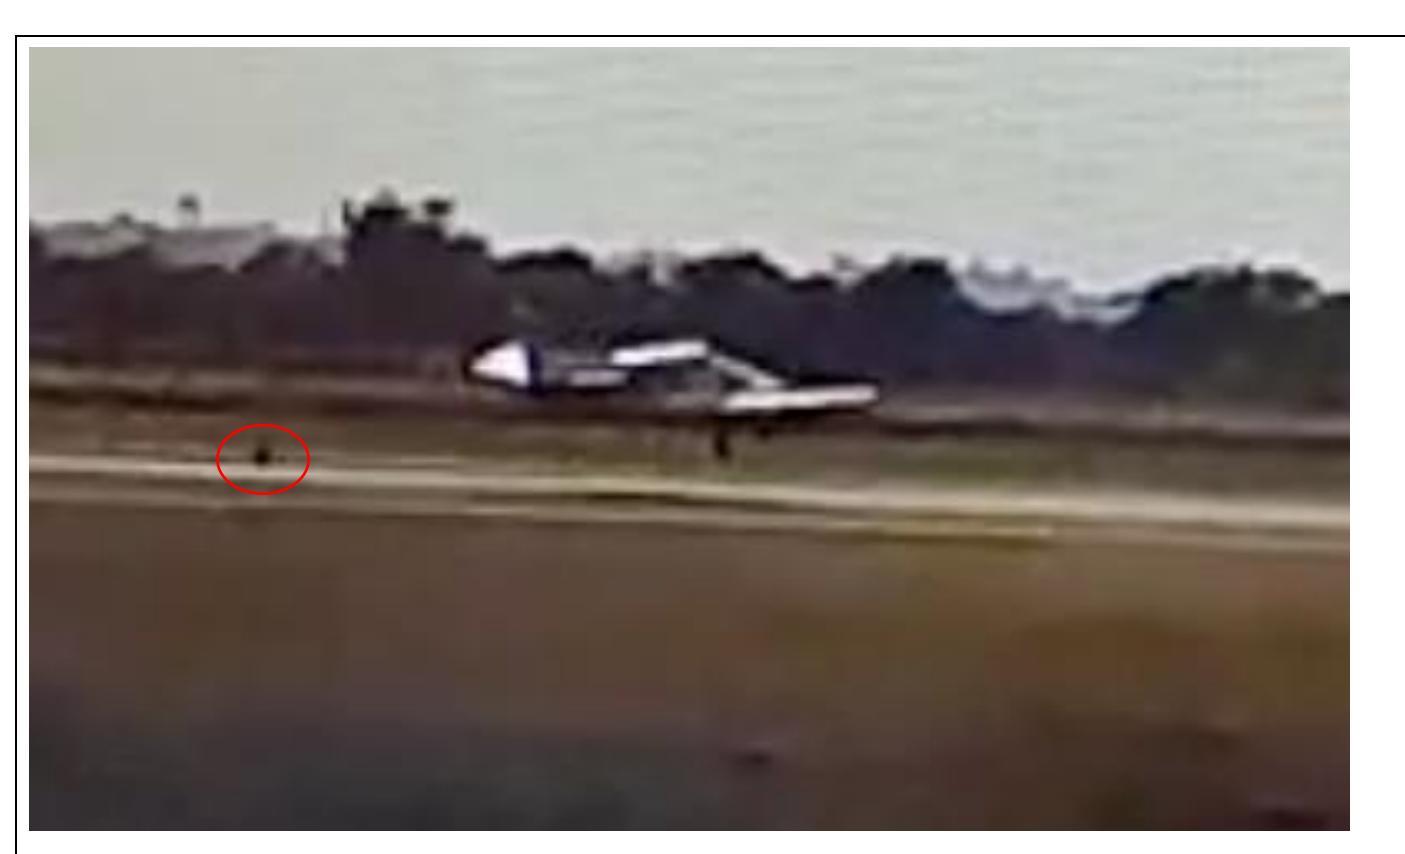
Figure# 37 LHS wheel separated during Take Off roll

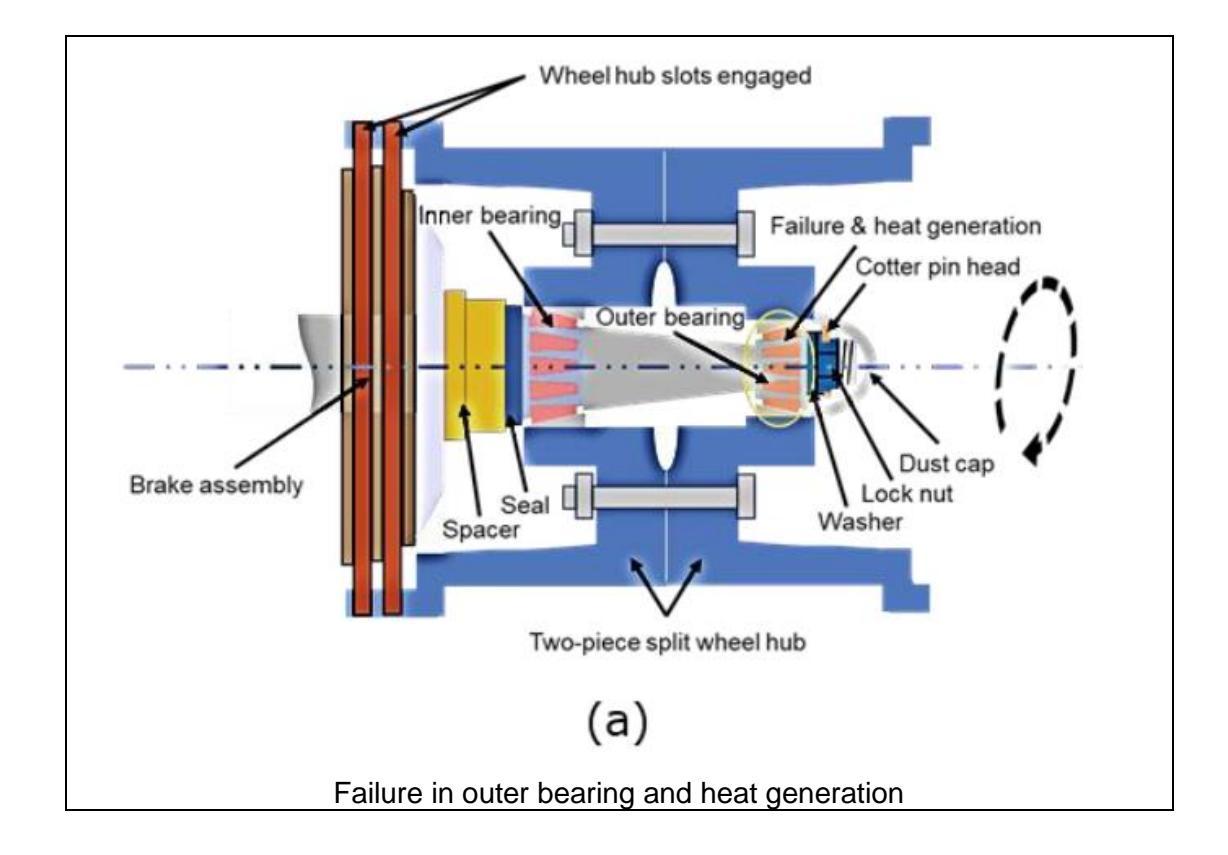
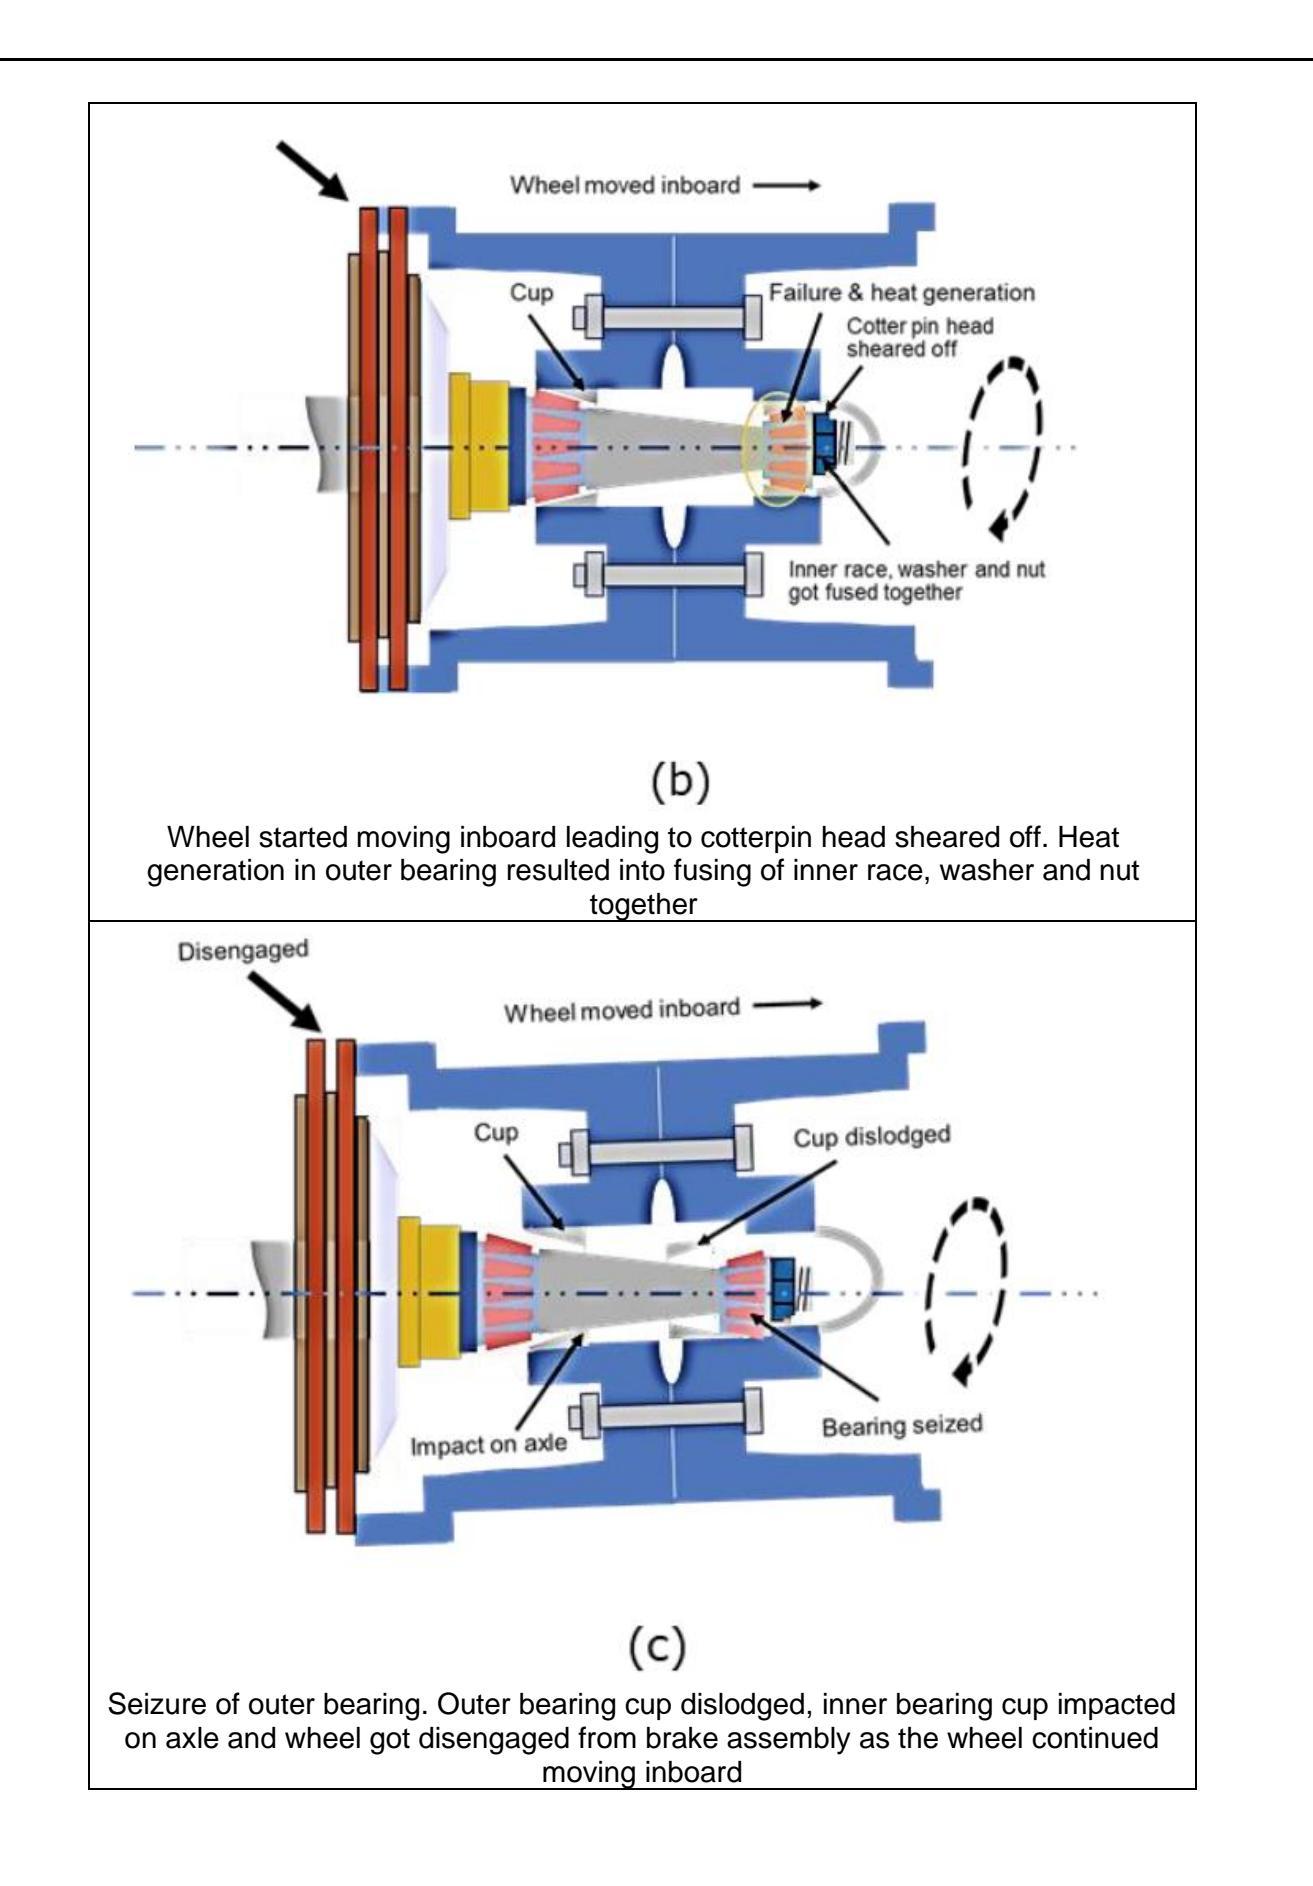
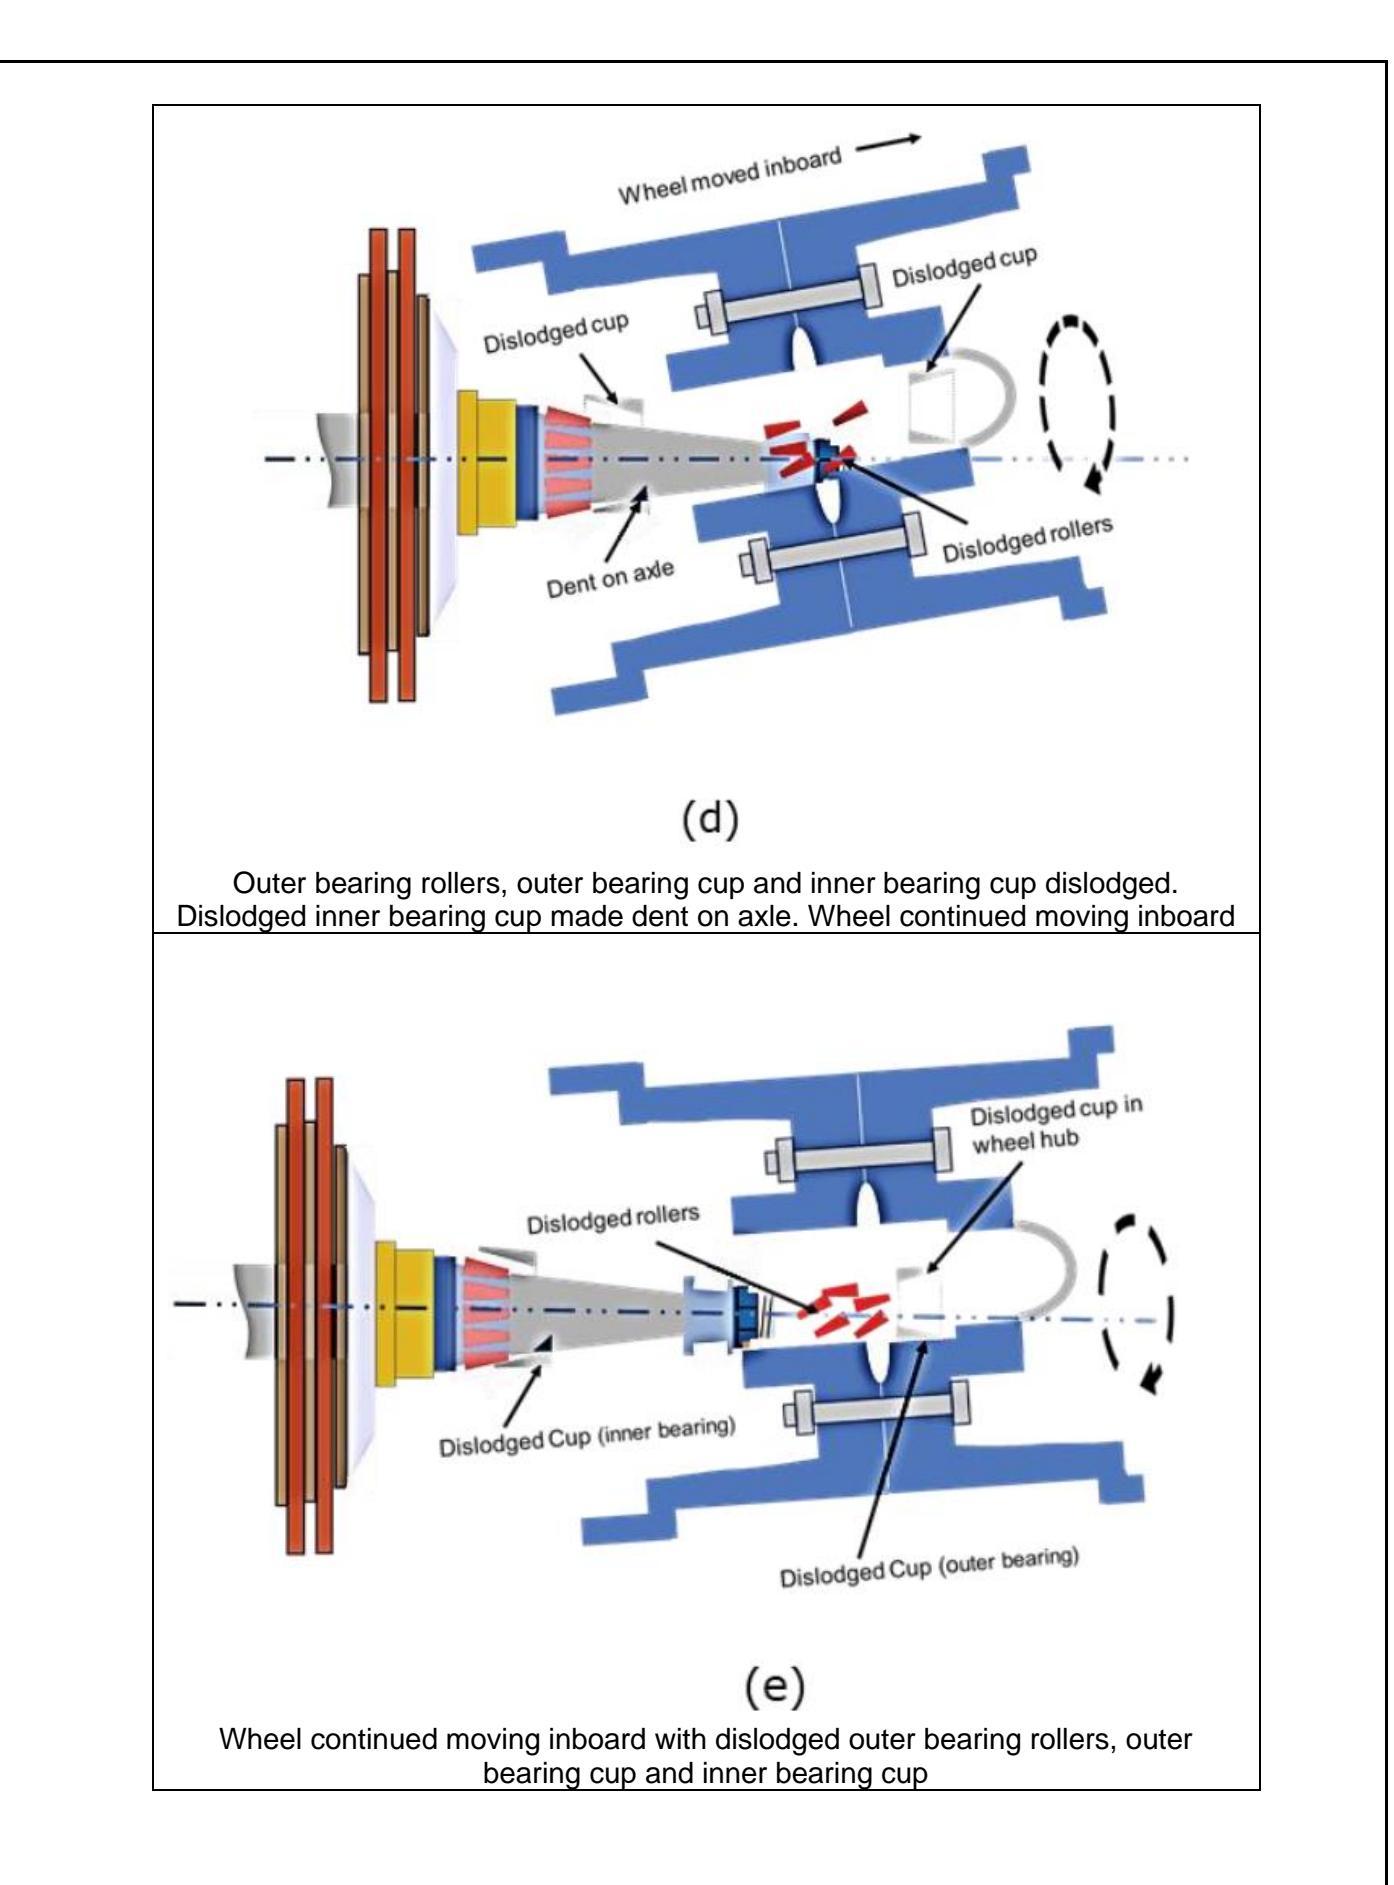
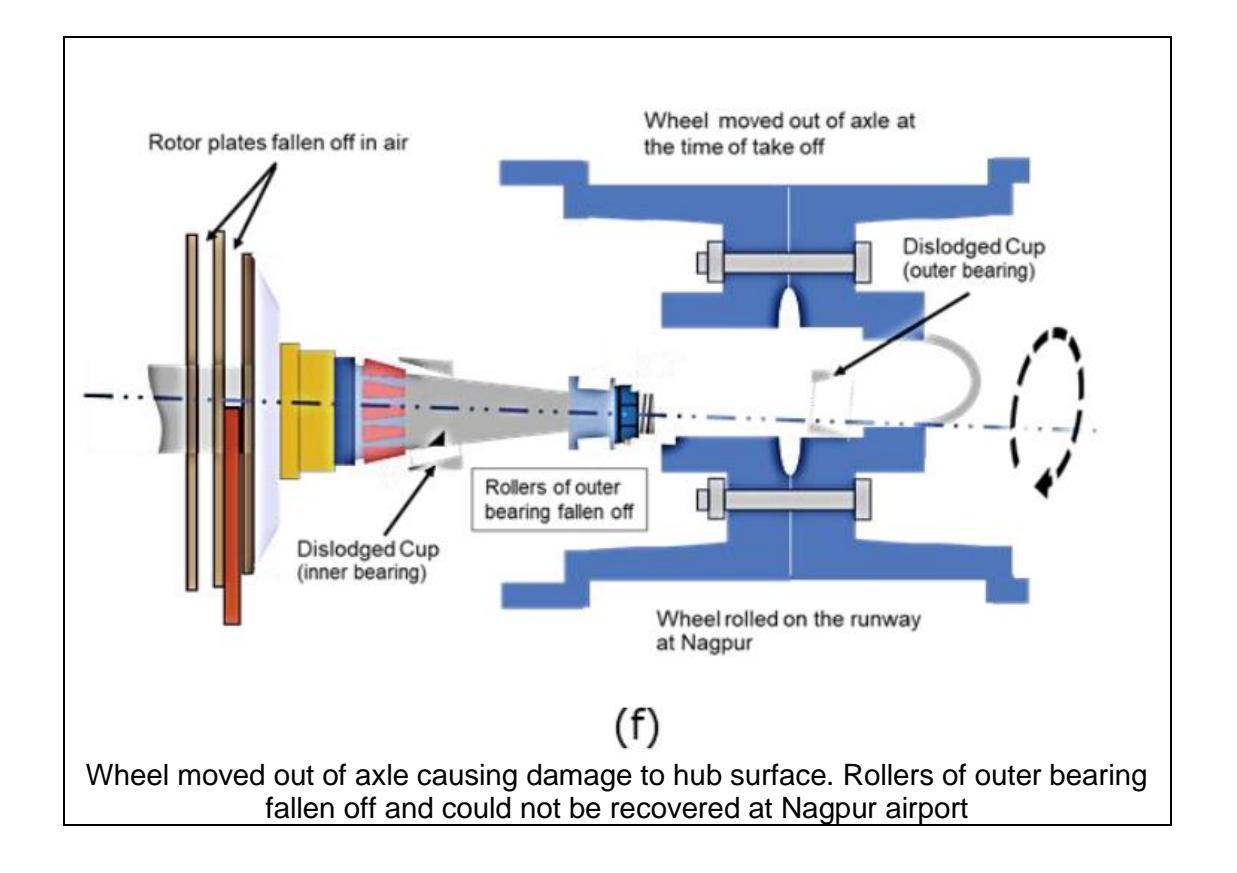
and dislodgement of the bearing cup from the wheel hub bore. Because of this failure, the retaining action of the bearing for the wheel hub was lost, and the wheel was free to move axially away from its normal position during the last take-off roll. The damages to only the cup of the inner bearing were found to be consistent with the axial movement of the wheel as the outer bearing failed. As the wheel moved inboard, it fell off from the inner bearing and impacted the axle leading to a fracture in the wheel hub bore and dislodgement of the bearing cup. A deep dent was created at the location of impact on the bottom surface of the axle in the fully extended position of the MLG. As the aircraft rolled, the wheel continued to move inboard and it came out of the axle and got detached from the MLG at the time of take-off. Figure below shows a schematic representation of the sequence of events $[(a)\rightarrow(b)\rightarrow(c)\rightarrow(d)\rightarrow(e)\rightarrow(f)]$ that led to the dislodgement of the wheel from the axle.

Figure# 39 Schematic representation of sequence of events leading to dislodgement of wheel from the port MLG axle $(a) \rightarrow (b) \rightarrow (c) \rightarrow (d) \rightarrow (e) \rightarrow (f)$

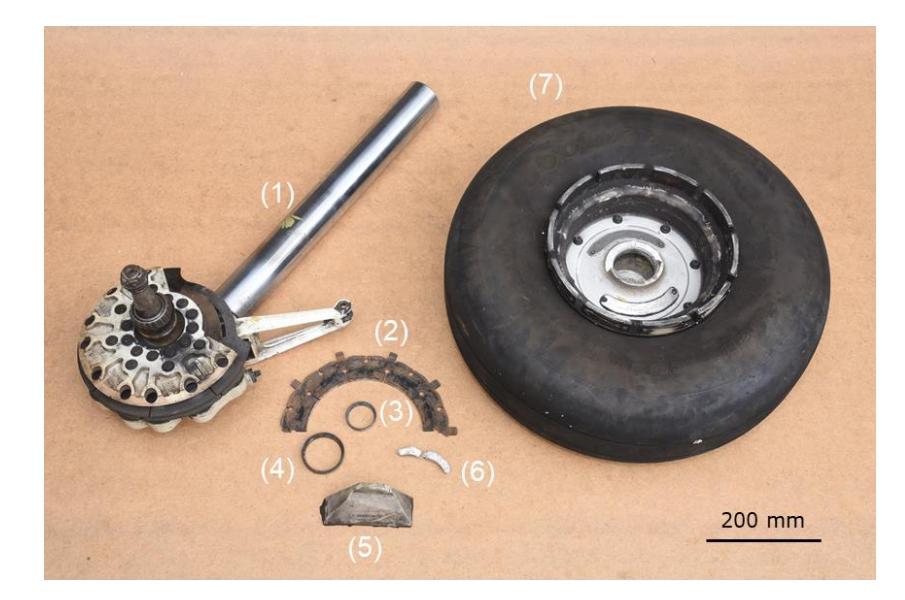
Figure 2: (1) Port MLG strut with axle assembly, (2) broken rotor plate of brake assembly, (3) cup-outer bearing, (4) cup-inner bearing, (5) balancing weight, (6) fractured part of wheel hub bore, (7) wheel

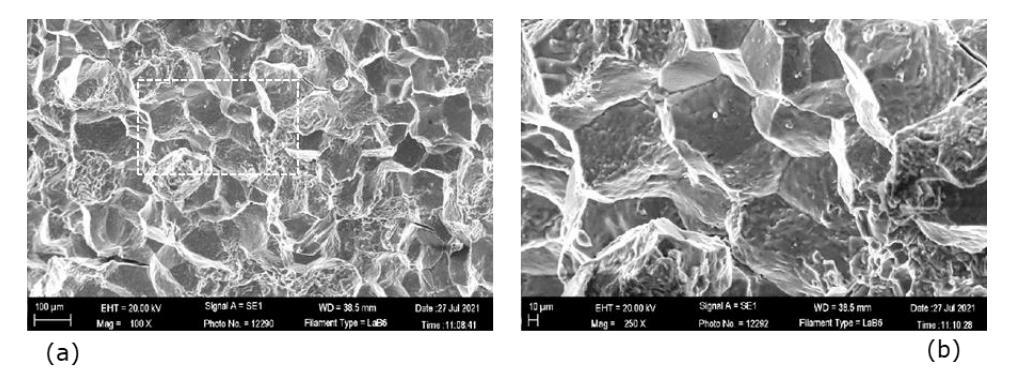
Figure 7: (a) Secondary electron fractograph showing intergranular fracture in the wheel hub bore, typical of overload fracture in cast Mg-alloy, and (b) magnified view of the region marked in (a)

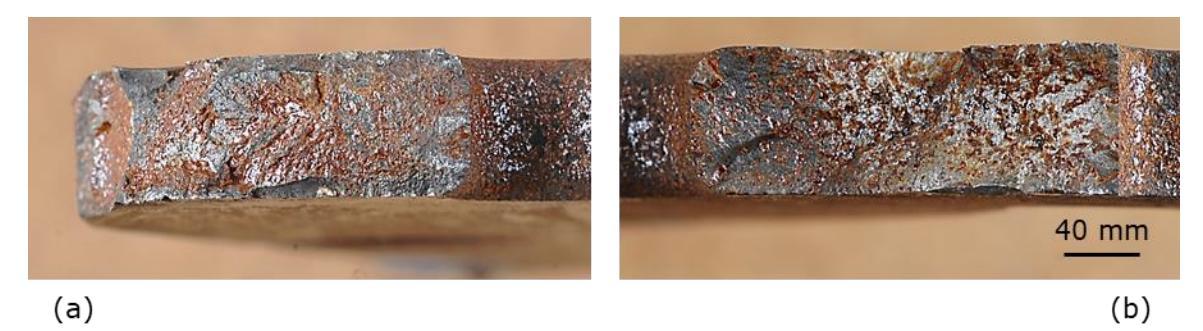
Figure 14: (a-b) Close-up views of the fracture surfaces marked `A' and `B' respectively in Fig.13(b); note obliteration of fracture features because of rubbing and rusting

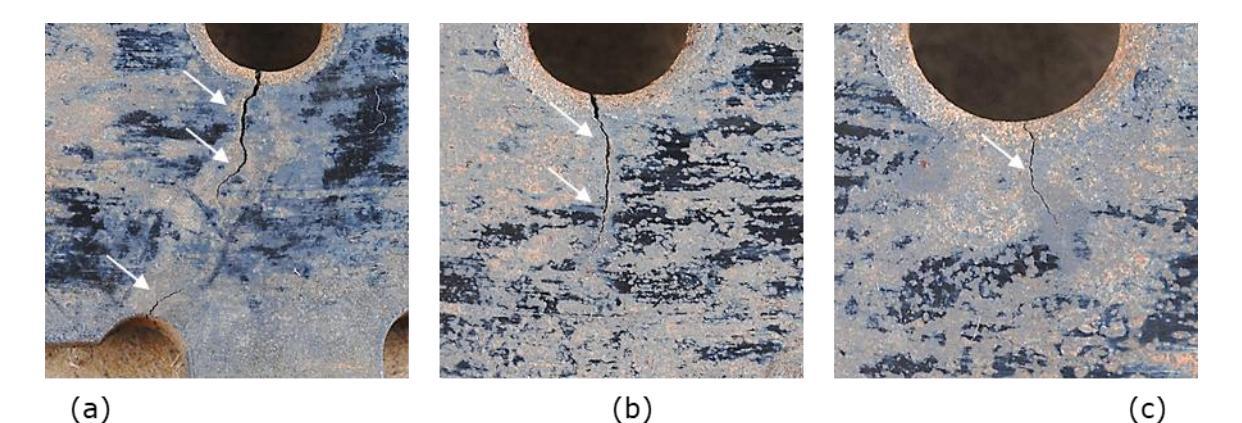
Figure 15: (a-c) Close-up views of the regions marked `1' through `3' respectively in Fig.13(b) showing incipient cracks in the rotor plate

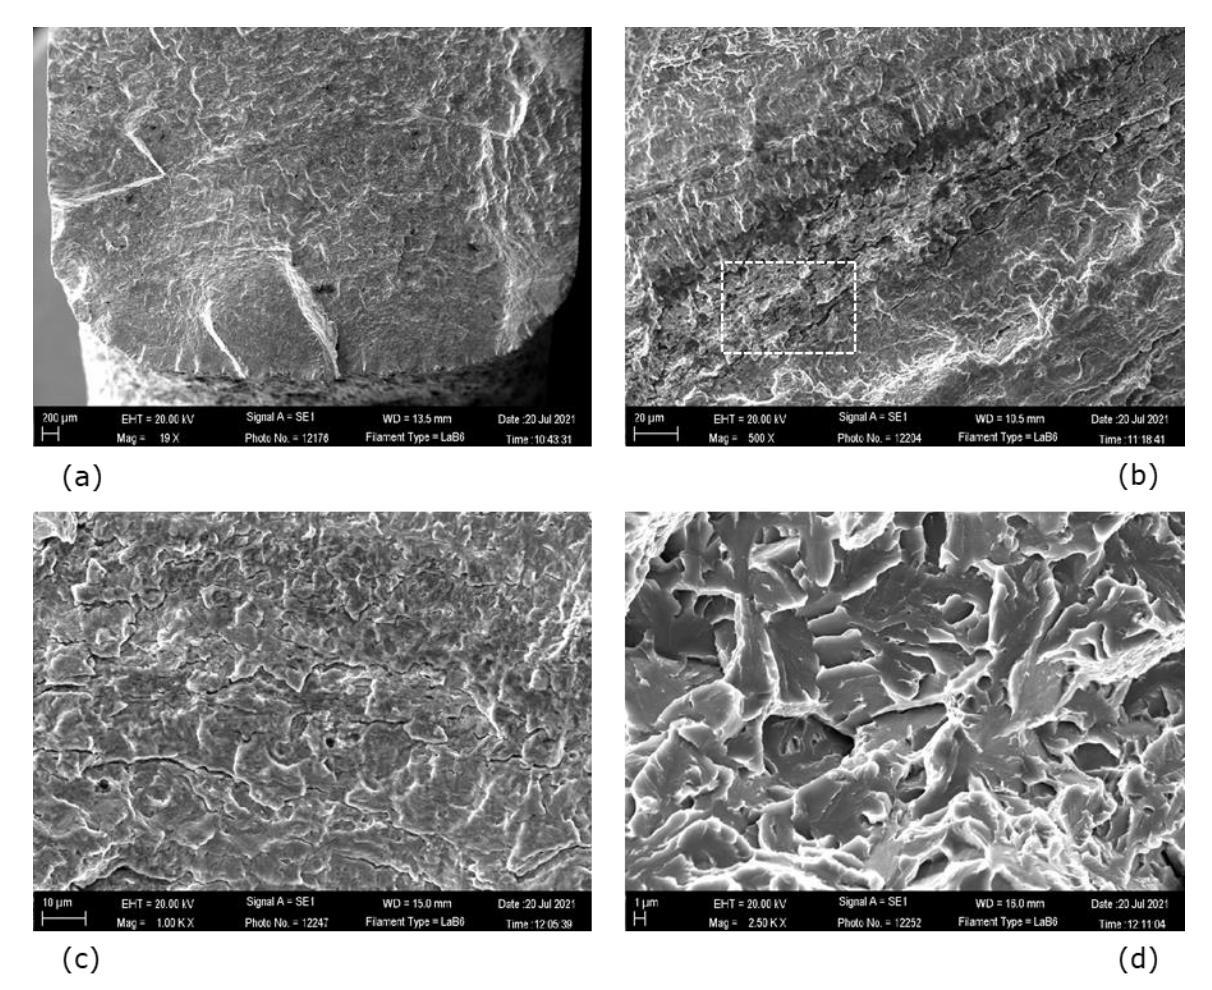
Figure 17: Secondary electron fractographs: (a) crack origin region marked X' in Fig.16(b), (b) fractograph of the region marked 'Y' in Fig.16(b) showing crack arrest marks or beach marks, (c) magnified view of the region marked in (b) showing fatigue striations, and (d) cleavage fracture in freshly opened region marked 'Z' in Fig.16(b) (fractographs recorded after rotating the fracture surface 90°CW with respect to the orientation in Fig.16(b))

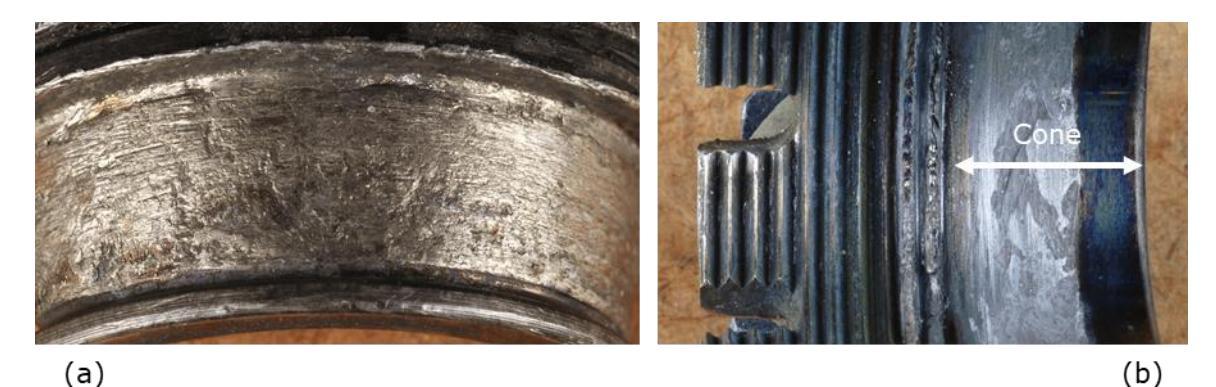
Figure 27: (a) Raceway of the cone of outer bearing showing damages, and (b) inner surface of the cone showing adherence of material

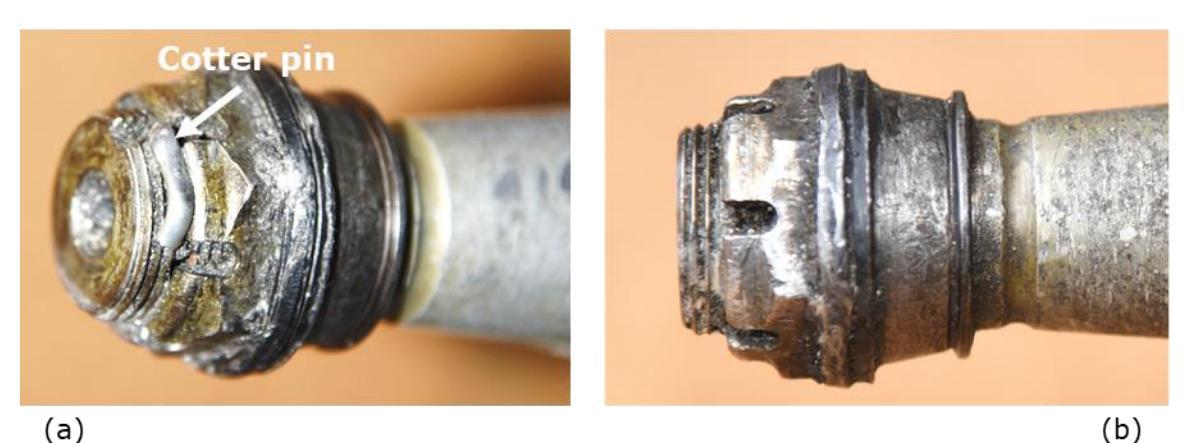
Figure 32: (a-b) Two views from diametrically opposite locations of the lock assembly on the axle; note absence of head of the cotter pin in (b)
