FINAL REPORT ON ACCIDENT INVOLVING BEECHCRAFT KING AIR C90A AIRCRAFT VT-JIL OPERATED BY M/s JET SERVE AVIATION PVT LTD AT MUMBAI ON 06TH MAY 2021

Government of India Ministry of Civil Aviation Aircraft Accident Investigation Bureau

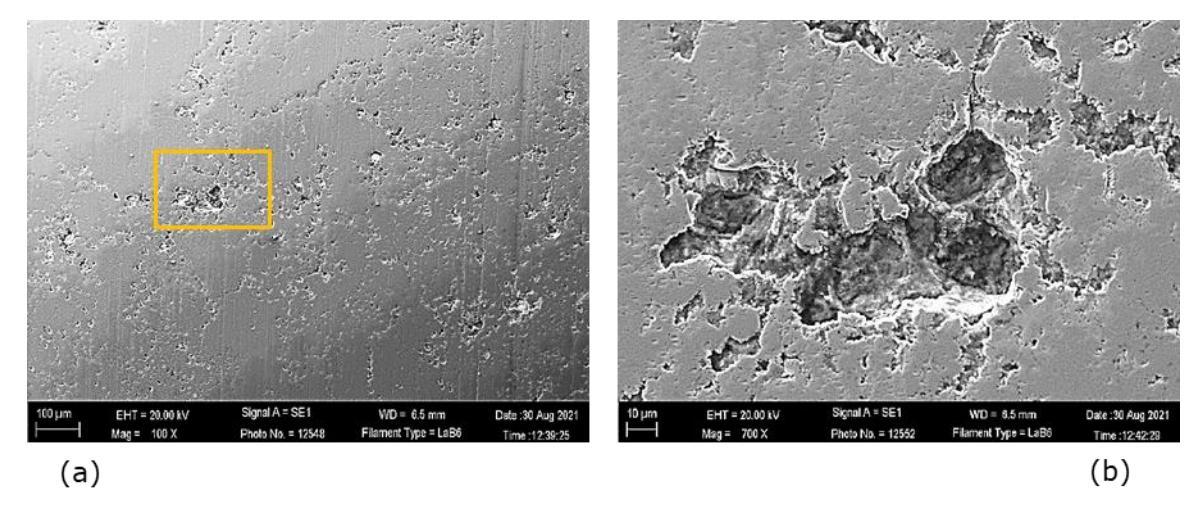
Figure 40: Secondary electron images on a typical roller of outer bearing of starboard MLG wheel assembly showing (a) widespread pitting on the roller surface, and (b) magnified view of the region marked in (a) showing spalling

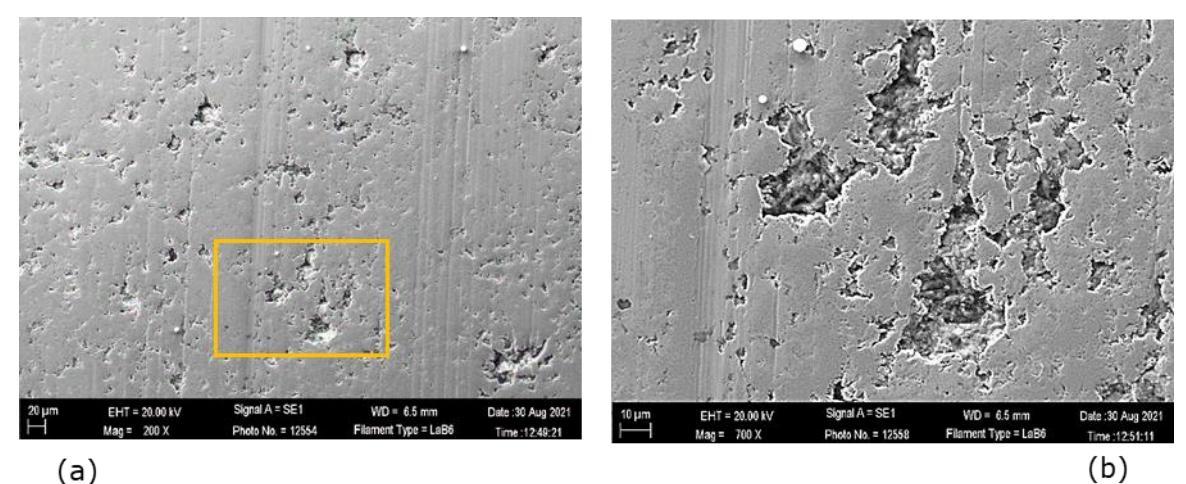
Figure 41: Secondary electron images on a typical roller of outer bearing of starboard MLG wheel assembly showing (a) widespread pitting on the roller surface, and (b) magnified view of the region marked in (a) showing spalling

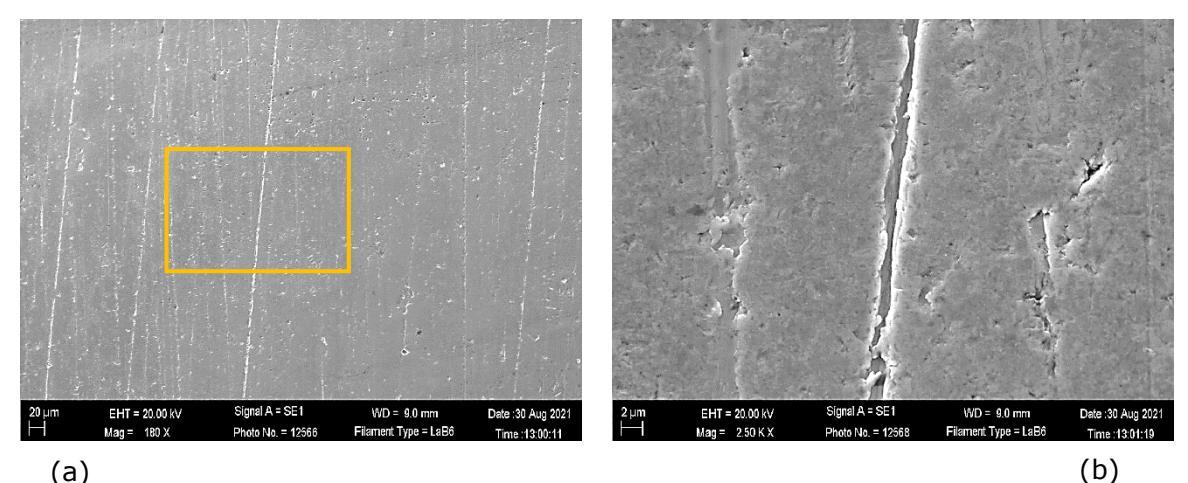
Figure 42: Secondary electron images on a typical roller of outer bearing of starboard MLG wheel assembly showing (a) deep scoring marks, and (b) magnified view of the region marked in (a)

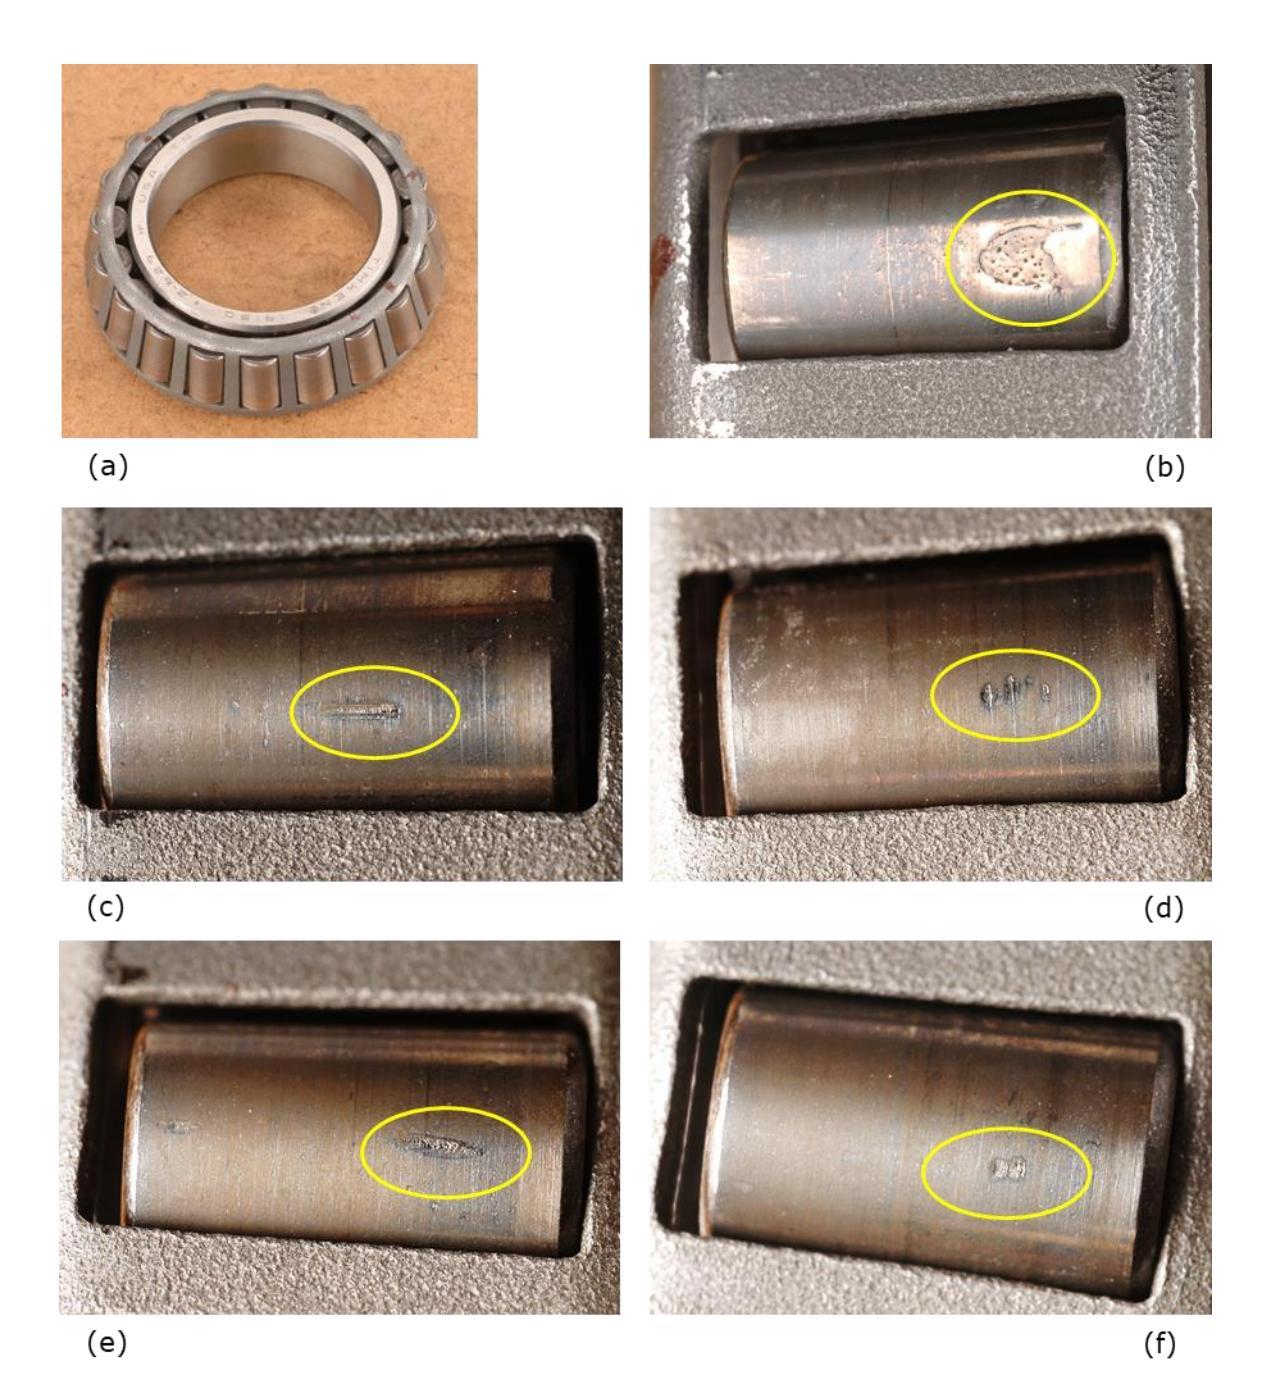
Figure 43: (a) Cone assembly of the inner bearing, and (b-f) appearance of surface and damages on five typical rollers; severely damaged regions are encircled
