FINAL INVESTIGATION REPORT ON SERIOUS INCIDENT OF AIRPROX BETWEEN VT-ITP AND VT-IFP OF M/s INTERGLOBE AIRLINES IN HAL BENGALURU AIRSPACE, ON 10/07/2018

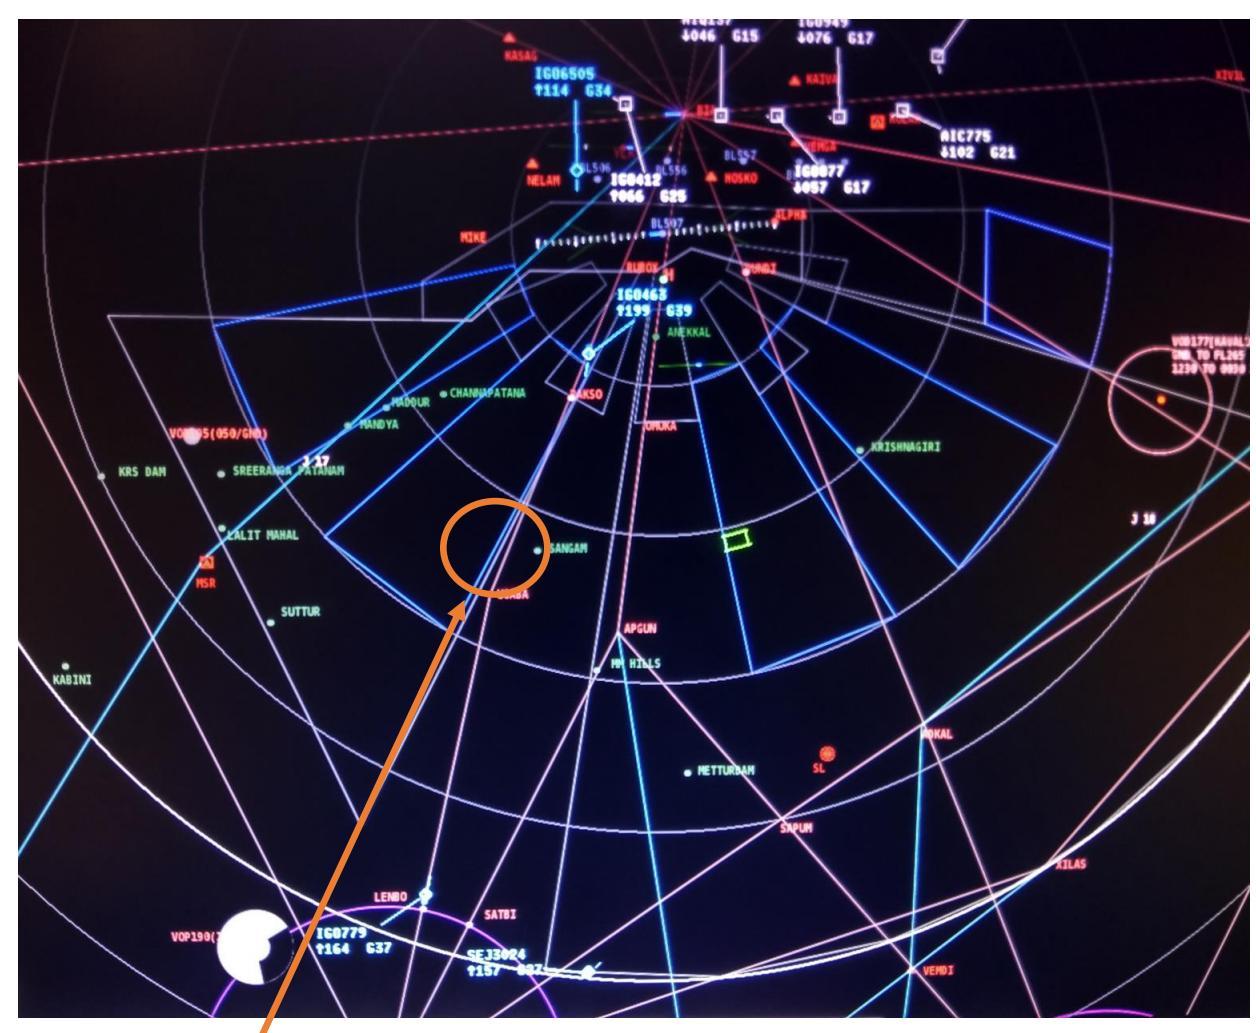
CIRCLE SHOWING PLACE OF INCIDENT

FIGURE SHOWING INITIAL POSITION OF AIRCRAFT AND PLACE OF INCIDENT

The minimum separation between the aircraft was 300 feet vertically and 4 NM lateral separation.

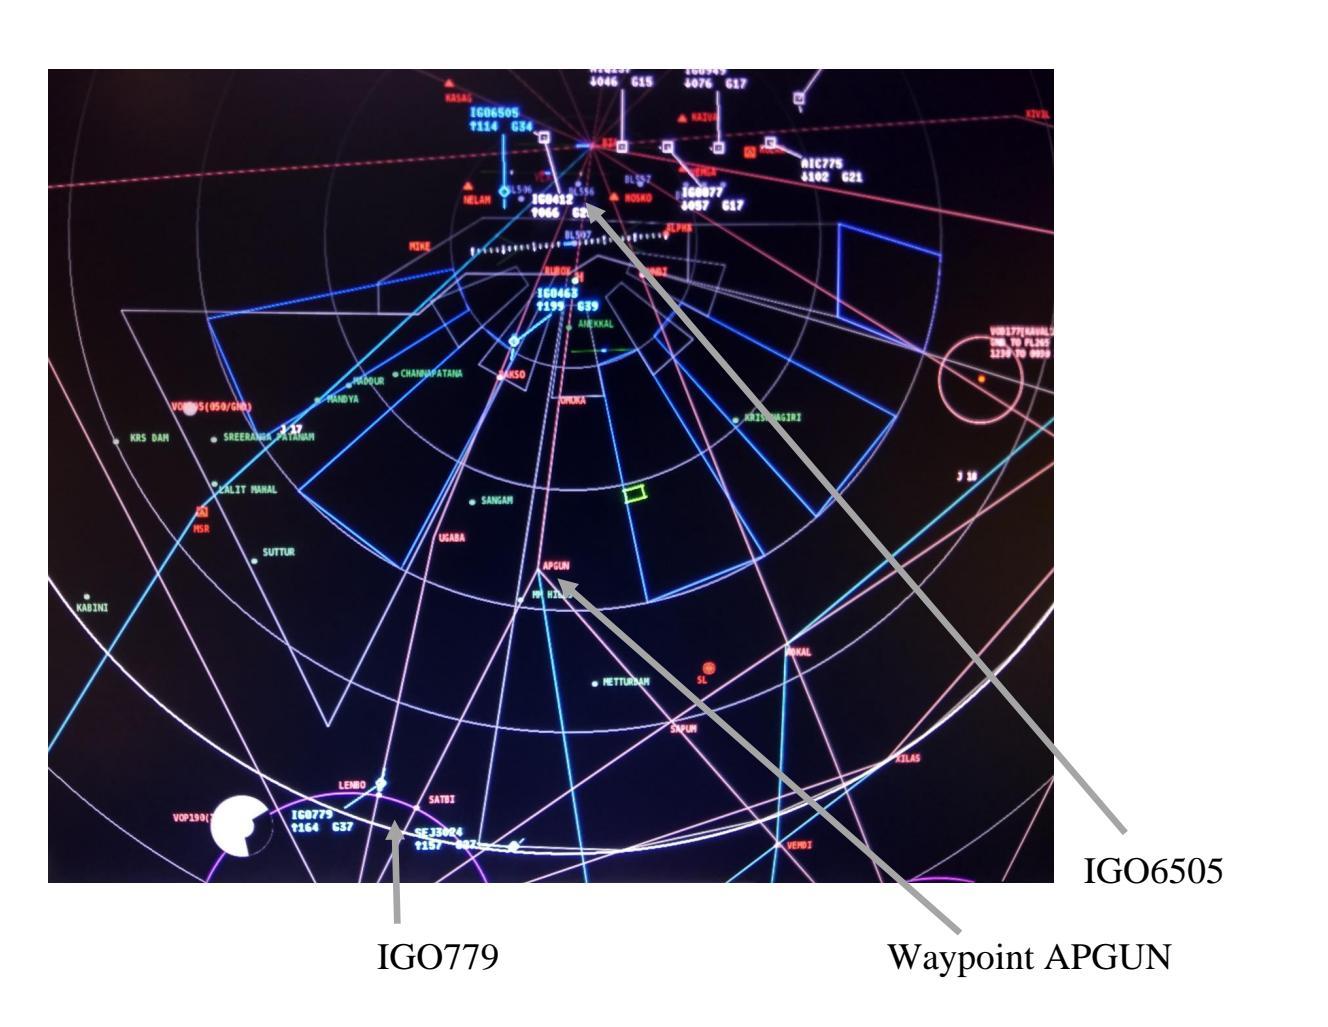
INITIAL POSITIONS OF INVOLVED AIRCRAFT

IGO779 was scheduled from Coimbatore to Shamshabad. It departed from Coimbatore at 1709 UTC. It came in contact with Radar controller at 17:19:53 UTC. IGO779 was climbing passing FL125 for FL150. After identification, Radar controller gave climb to FL300.

IGO6505 was scheduled from Bangalore to Cochin. It came in contact with Radar Controller at 17:20:41 UTC and was maintaining FL110. Controller instructed IGO6505 to proceed direct to APGUN and climb to FL280. The instruction was readback by IGO6505.

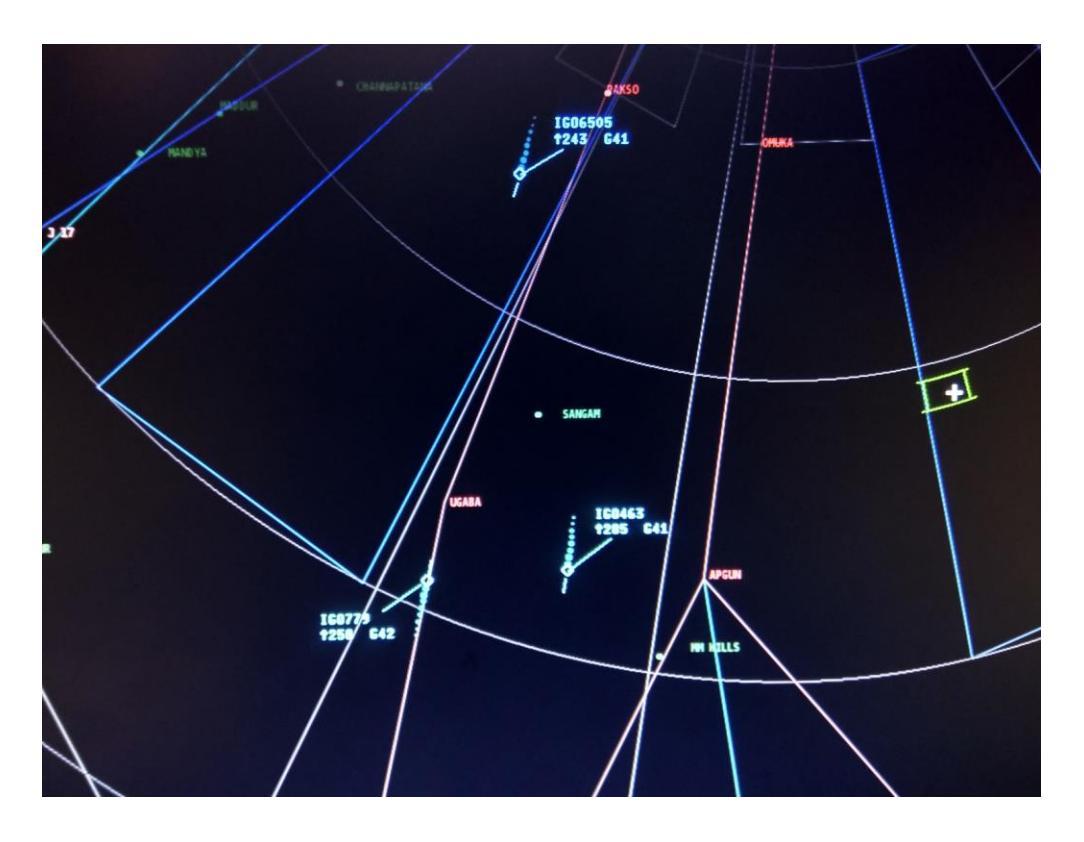
FIGURE SHOWING IGO6505 CLIMBING PASSING FL243 AND IGO779 CLIMBING PASSING FL258.

After giving clearance to IGO6505, controller was busy with other traffic in his jurisdiction. Since the time controller gave climb to both involved aircraft, the vertical separation was more than 5000 feet. Controller did not monitor the rate of climb and the level passing. It appears that the Controller presumed that the required separation existed between the aircrafts and did not observe that IGO6505 was approaching towards IGO779 at faster rate.

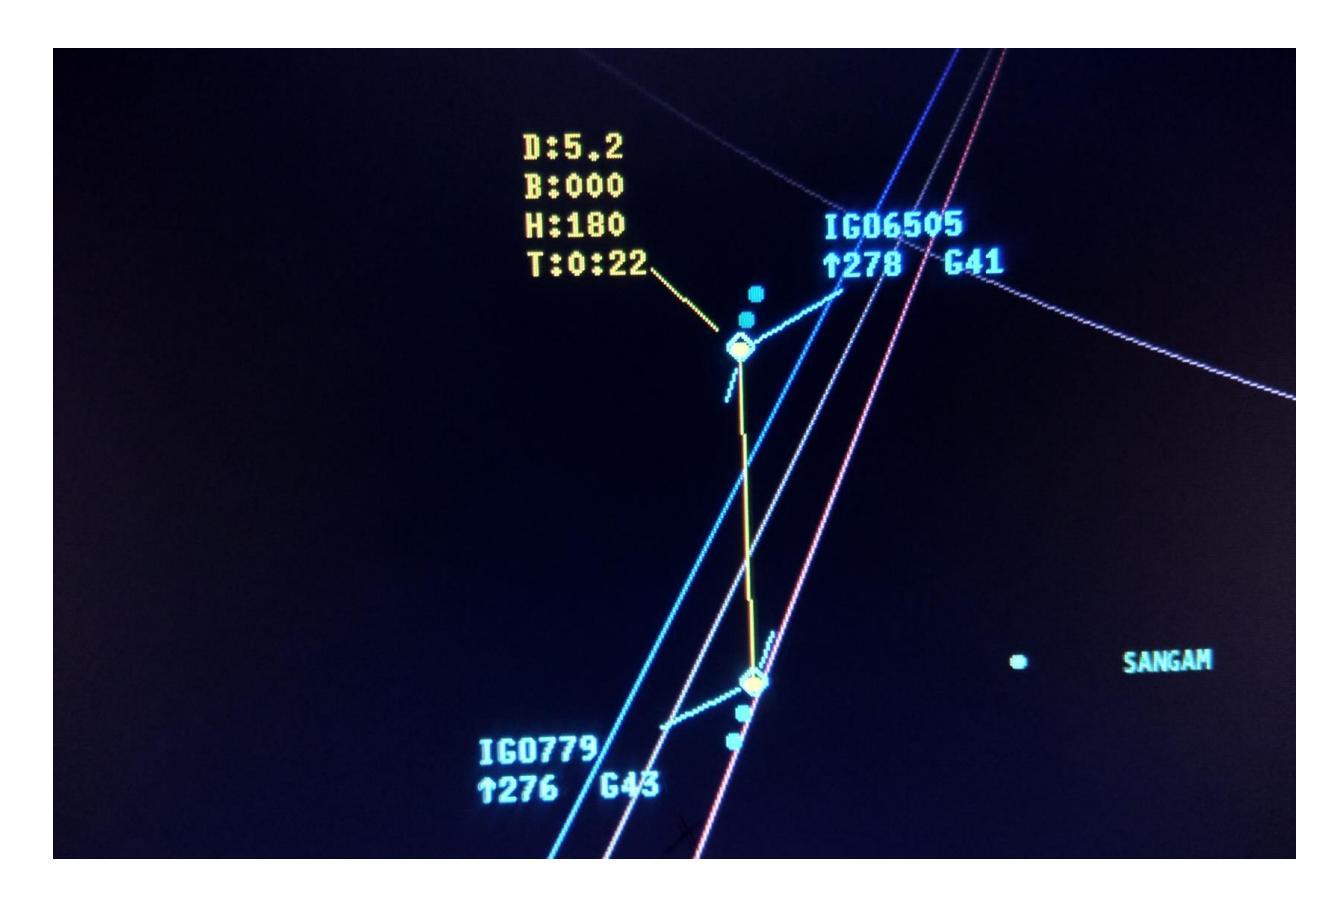
Rate of climb of IGO779 was approximately 1500 to 1600 feet per minute while Rate of climb of IGO6505 was approximately 3000 feet per minute. Rate of

climb of IGO6505 was more than the prescribed rate due to which the vertical separation reduced.

FIGURE SHOWING REDUCE IN SEPARATION MINIMA AND WITHIN 22 SEC THE SEPARATION WILL BE ZERO.

By the time controller observed that the separation is breaching, IGO779 reported TCAS RA. At 1728 UTC, IGO779 reported "IGO779 IS LEVELING OUT DUE TCAS RA 276". After IGO779 informed ATC about TCAS RA, ATC gave avoiding heading. Which is also not as per the laid down ATS procedure. If the aircraft is following RA maneuvering, as per standard procedure ATC shall not give any instruction to the aircraft. Once the aircraft is clear of RA and reported "Clear of Conflict", then only ATC can give further instruction. There was no conversation with IGO6505 after conflict. At 1729 UTC, ATC changed over IGO6505 to Trivandrum ATC unit. At 1734 UTC, ATC changed over IGO779 to Chennai
