# FINAL INVESTIGATION REPORT ON

# ACCIDENT TO M/S ARYAN AVIATION PVT. LTD.

# **BELL 407 HELICOPTER VT-SVK**

# AT TIKOCHI VILLAGE ON 23rd AUGUST 2019.

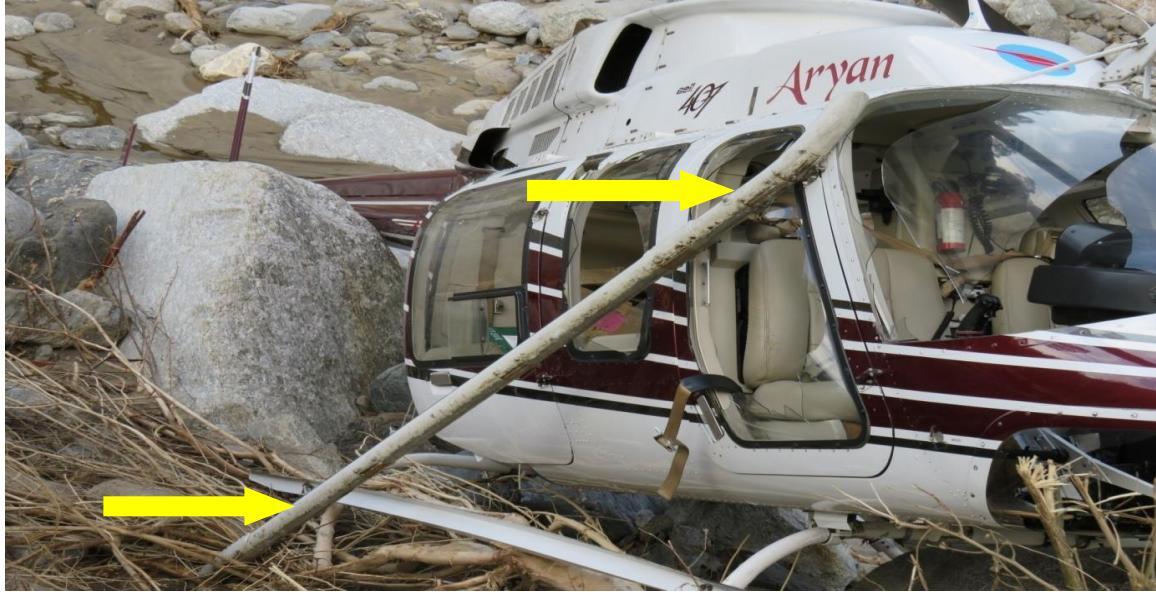
- 1. Skid assembly was found severely damaged including damage to forward & aft cross tube, LH and RH skid tube assembly, Rocker beam assembly and flight step etc.
- 2. Both cockpit side doors were found cracked and partially crushed. Window Perspex were also found broken. Doors hinges were found distorted.
- 3. Both side cabin doors were found cracked and partially crushed. Cabin Door Window Perspex were also found broken. Door hinges were found distorted.

PICTURE 1: DAMAGED RIGHT SKID ASSEMBLY.

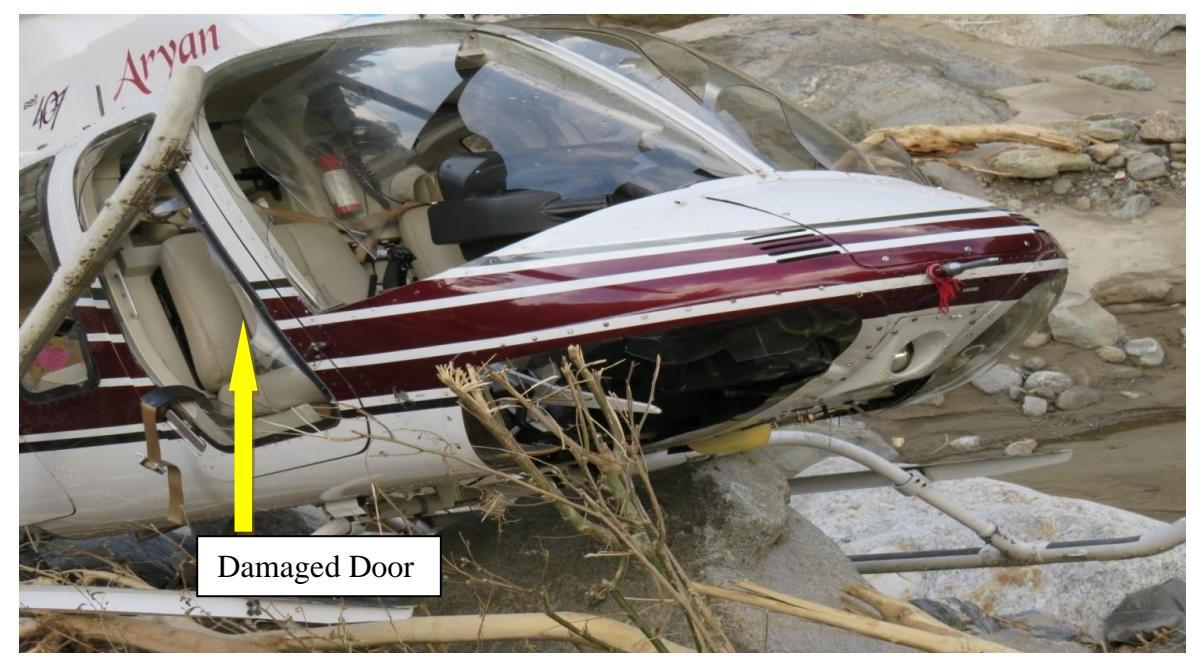
PICTURE 2: DAMAGED COCKPIT DOOR

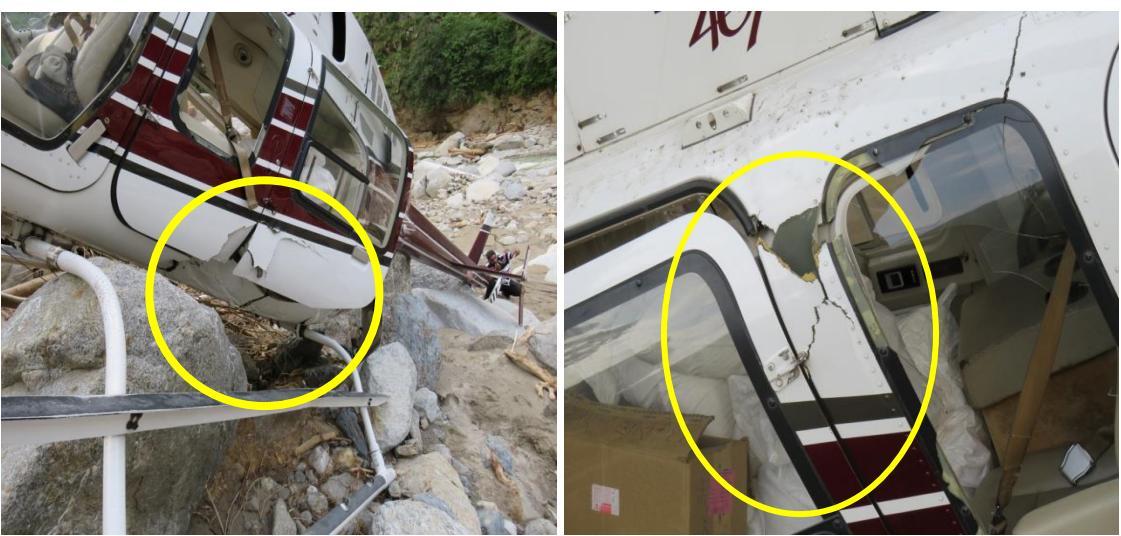
- 4. Litter door was found cracked and partially crushed, door window's glass was also found broken. Hinges were found distorted.
- 5. Baggage compartment's door was found cracked and hinges were found distorted.

PICTURE 3: DAMAGED CABIN DOOR

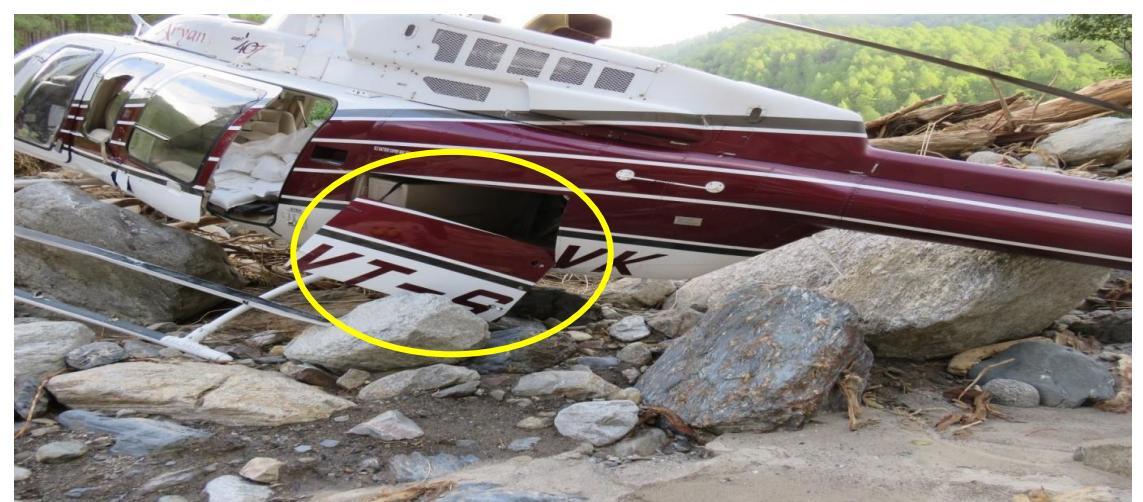
PICTURE 4: DAMAGED BAGGAGE COMPARTMENT DOOR.

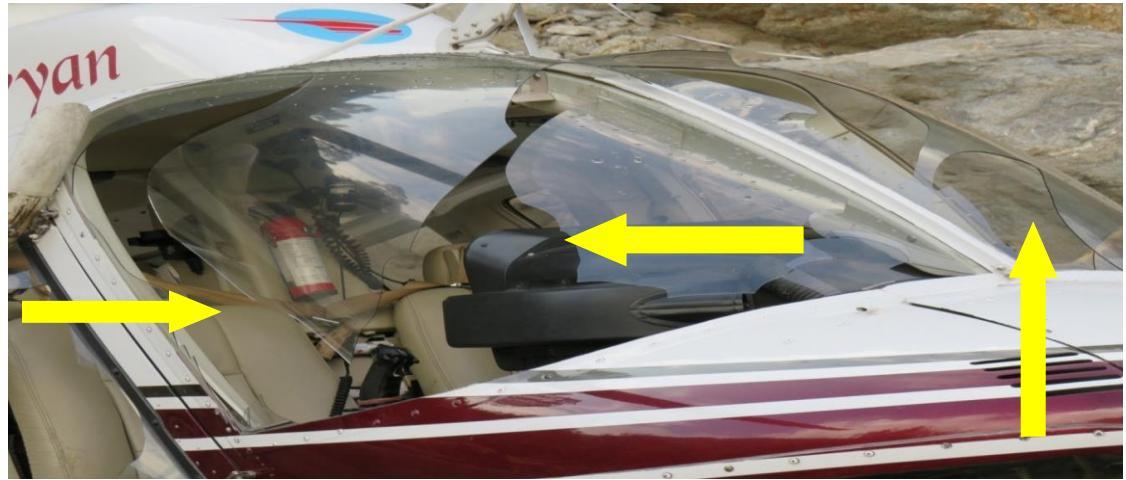
PICTURE 5: DAMAGED WINDSHIELDS

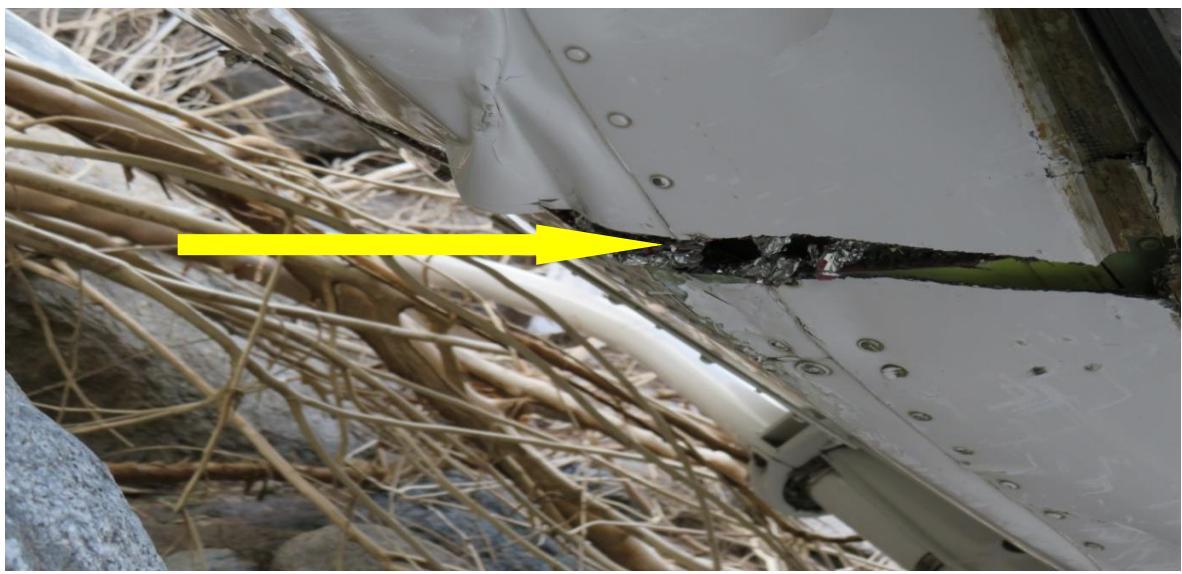
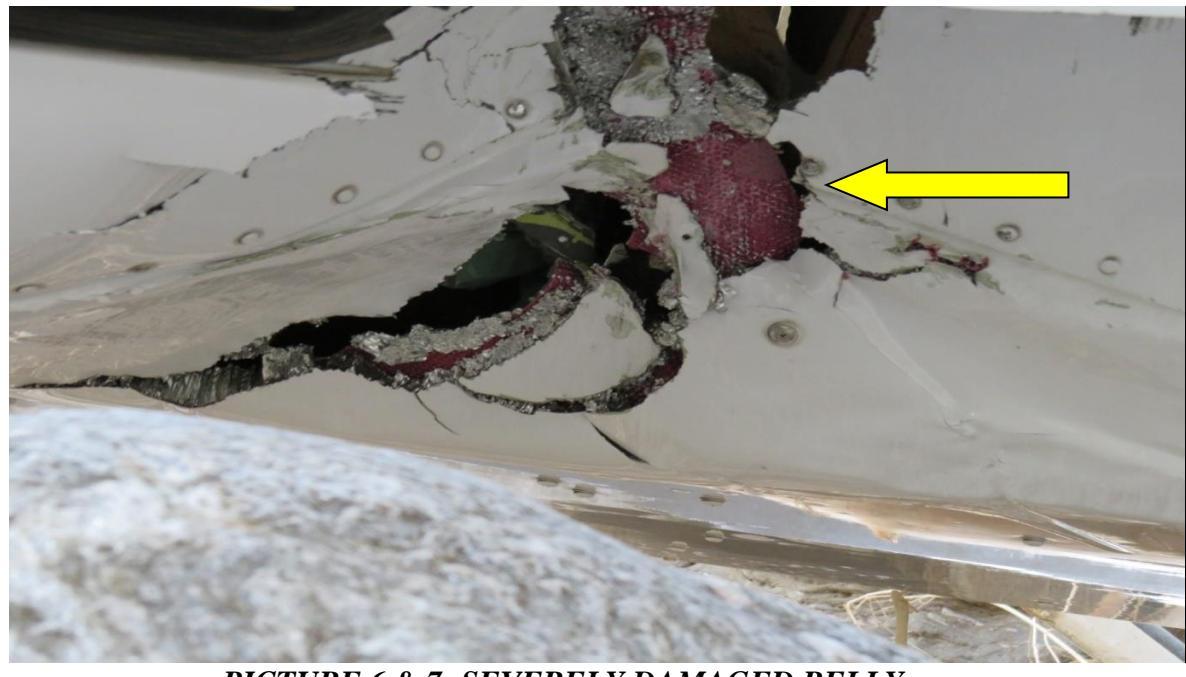
- 6. Forward, Intermediate and Aft sections were found severely damaged.
- 7. Fuselage structure was found severely damaged, which includes skin, fairing assembly of both side, shell assembly of lower cabin, aft cabin, cowlings, firewalls, longerons, roof beams and panel etc.

PICTURE 6 & 7: SEVERELY DAMAGED BELLY

However, the helicopter impacted on one of the big stones on its belly which was found punctured and crushed at the point of impact. The helicopter then slided slightly backwards during which the tail rotor got stuck to a hard surface and stopped rotating. The helicopter finally settled on the rocks in the nose up condition.

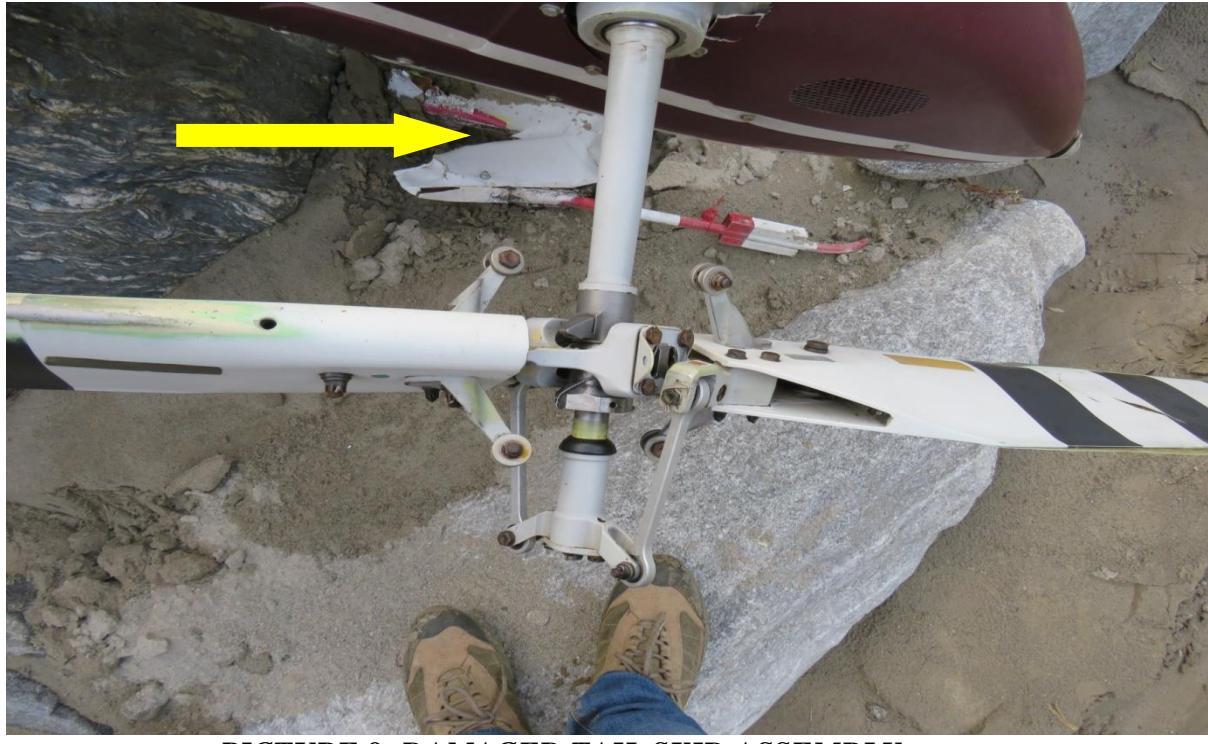
- 8. Tail boom was found damaged with a deep dent on aft side. Tail boom aft side and TGB support assembly were found completely damaged.
- 9. Horizontal Stabilizer was broken in two pieces.
- 10. Lower part of Tail Boom Fin Assembly and Tail Skid Assembly were found crushed.

PICTURE 8: DAMAGED TAIL SKID ASSEMBLY

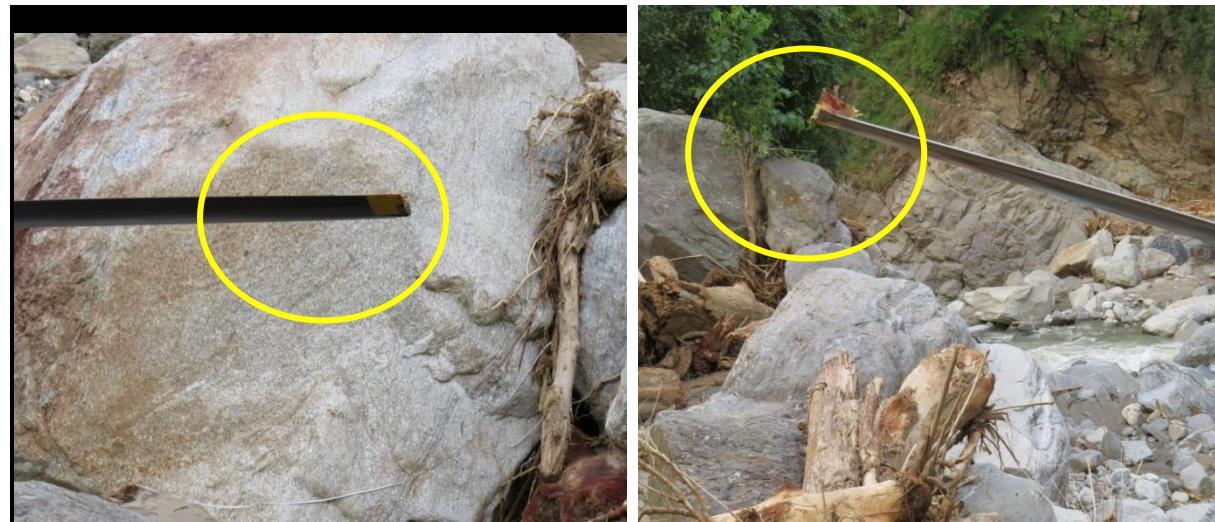
11. Tip of all three main rotor blades were found damaged.

PICTURE 9: DAMAGED MAIN ROTOR BLADES

As the main rotors were still rotating, it hit the surface on the slope due to which the tip of the main rotor blades was damaged. One of the broken pieces of blade tip was found 50 meters away from the helicopter wreckage. Helicopter's skid was damaged due to impact with rock. As the tail rotor got stuck on the hard surface while the main rotor blades were still rotating, the power transmission shaft (Tail Rotor Drive Shaft) got twisted and disengaged (Refer Picture 12). Meanwhile, pilot rolled the throttle to OFF position after settling and the Engineer on board applied the rotor brakes. Then both Pilot and Engineer came out of the helicopter from the LH door. Refer Para 1.3 for details of the helicopter damages.

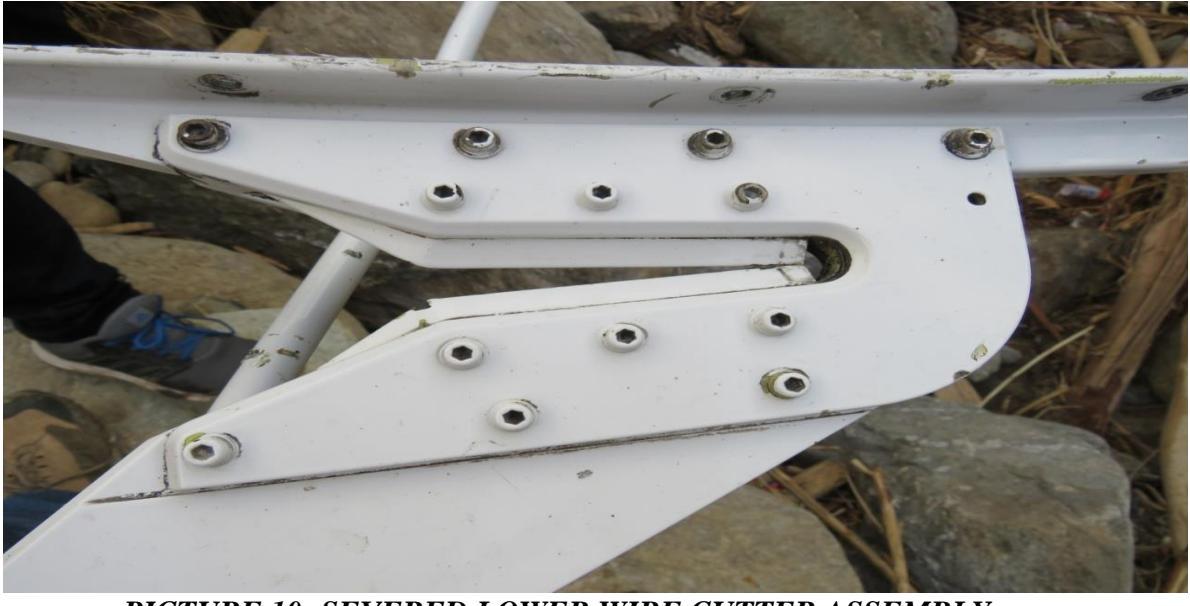
12. Lower wire cutter was found severed and damaged.

PICTURE 10: SEVERED LOWER WIRE CUTTER ASSEMBLY

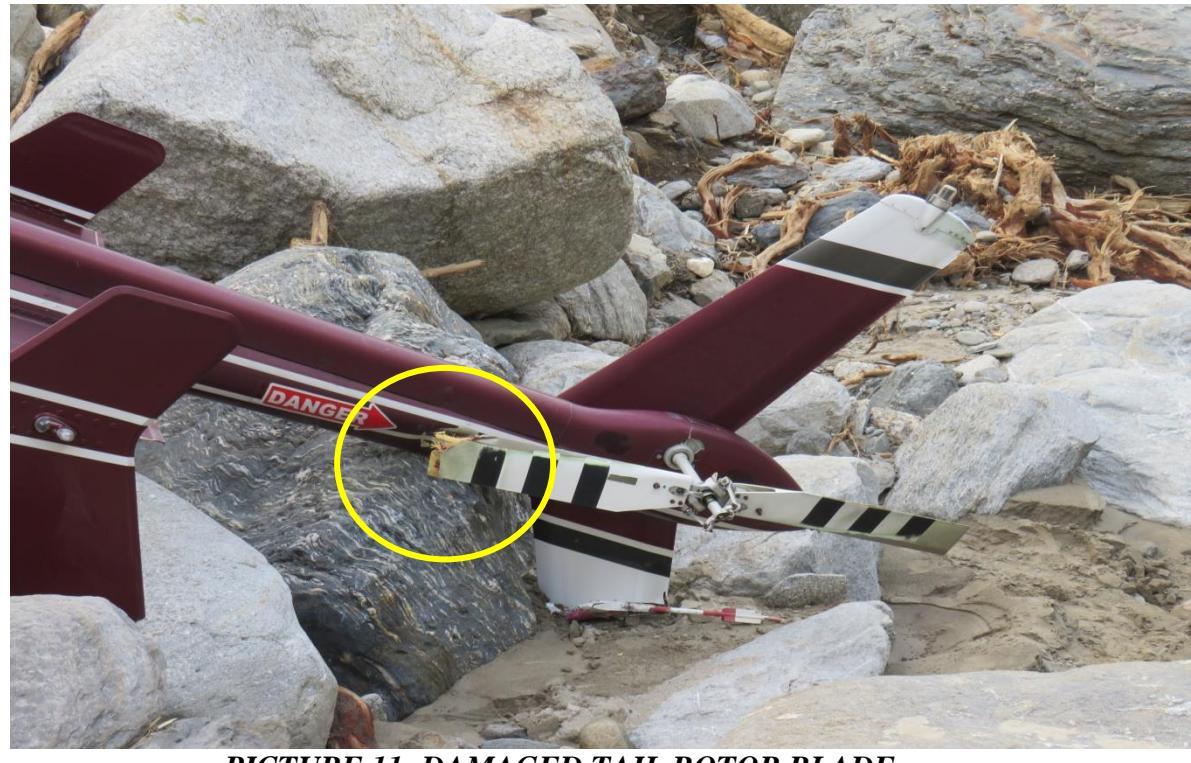
13. Tail Rotor Blade Assembly was severely damaged.

PICTURE 11: DAMAGED TAIL ROTOR BLADE

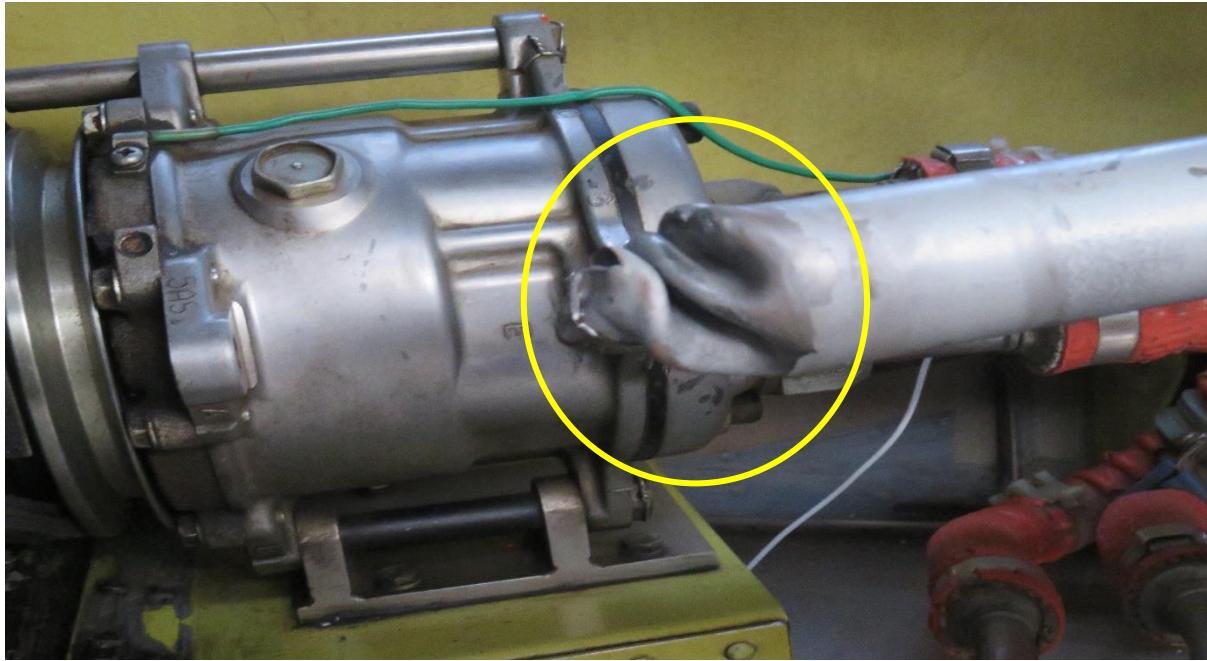
- 14. Tail Gear Box Assembly was found detached from the platform.
- 15. Tail Rotor Drive system was found damaged.

PICTURE 12: DAMAGED TAIL ROTOR DRIVE SHAFT

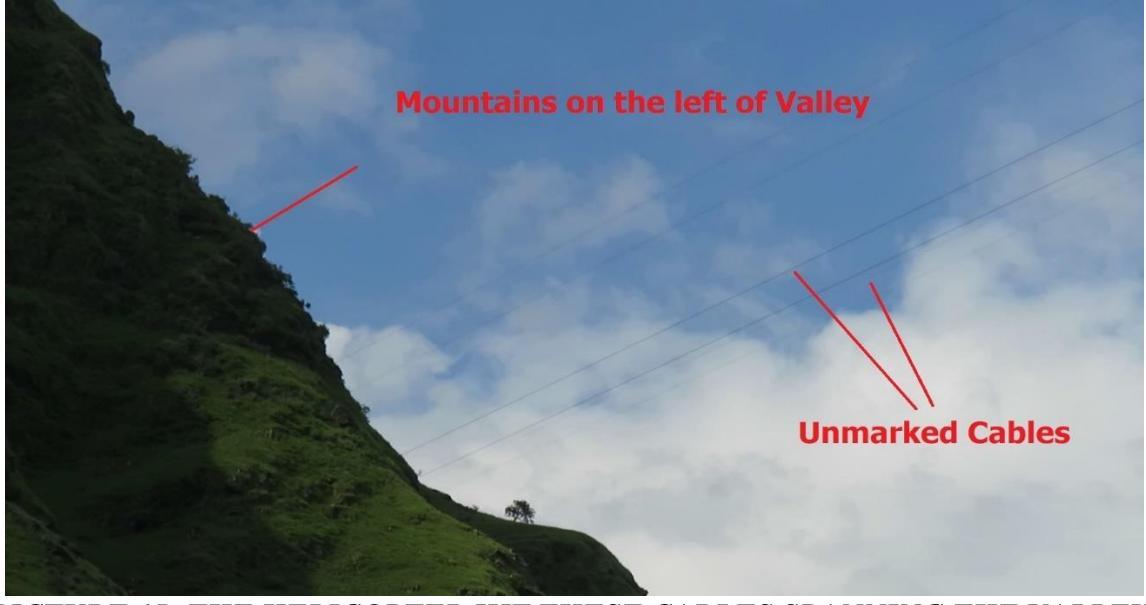
On top of descent, the helicopter hit a cable spanning across the valley. The front portion of Right skid severed from the front cross tube section and hit the Pilot side plexiglass. After hitting the cables, the helicopter tossed up in the air and became uncontrollable. The helicopter started maneuvering abruptly. As there was no suitable area for forced landing, the pilot decided to forced land on the river bed which was full of rocks and big stones. He lowered the helicopter and tried to land on a big flat stone.

PICTURE 15: THE HELICOPTER HIT THESE CABLES SPANNING THE VALLEY

The cables spanning the valley at various locations which were not marked by the local authorities was a potential hazard and contributed to the accident.

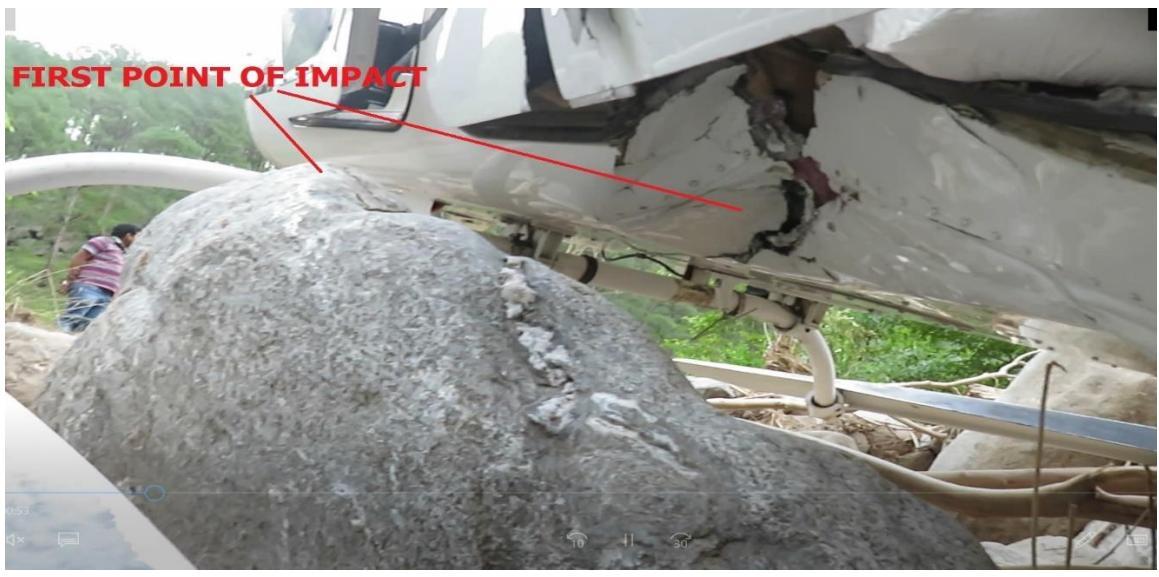
PICTURE 16: THE FIRST POINT OF IMPACT ON ROCK

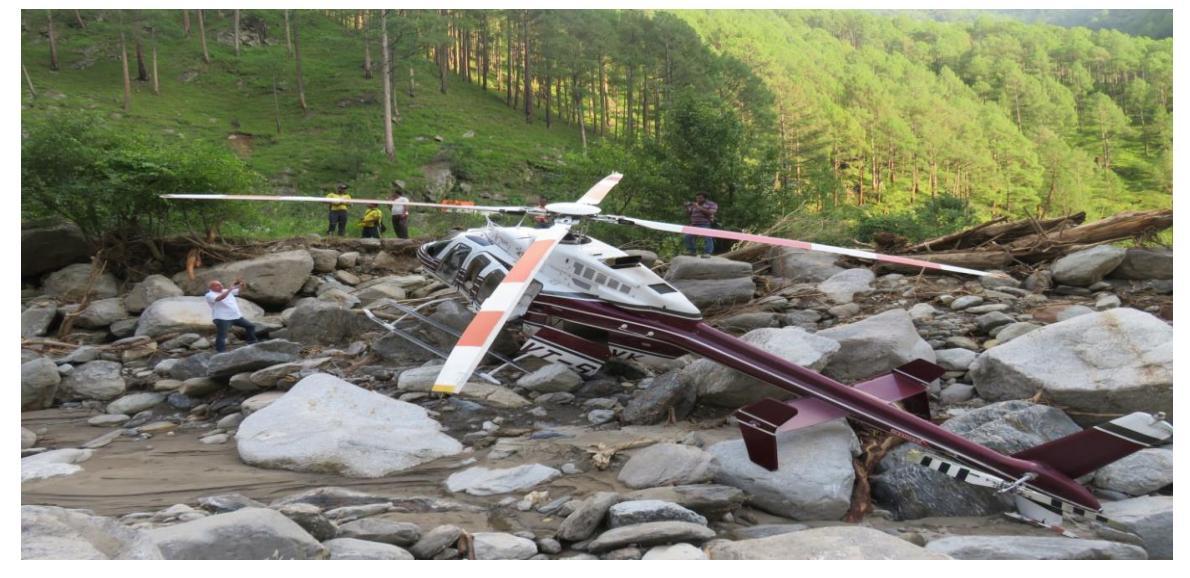
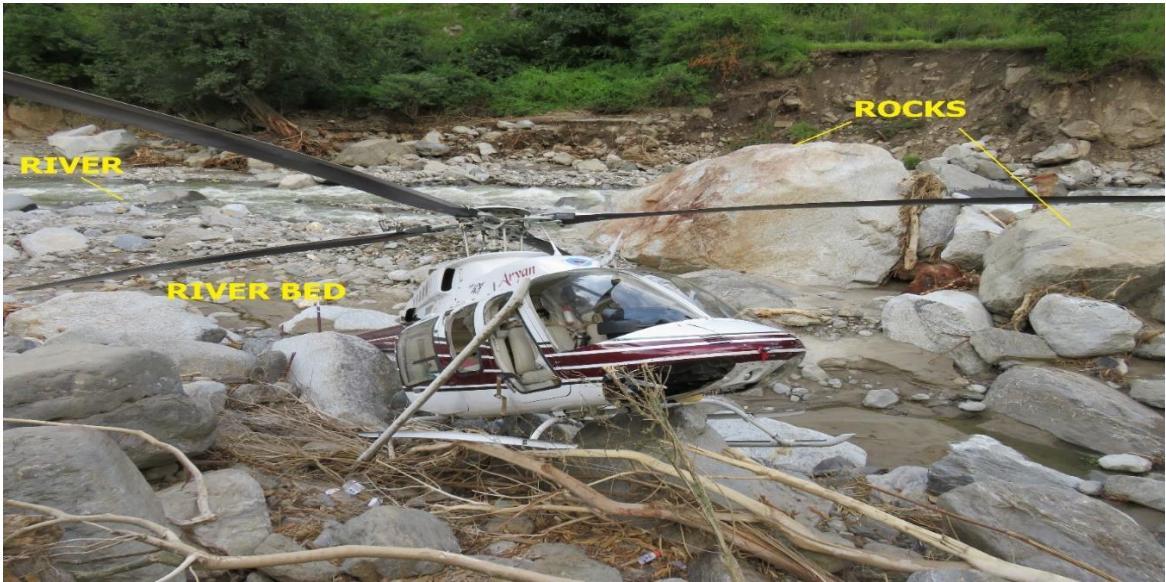
PICTURE 17 & 18: FINAL RESTING POSITION OF THE HELICOPTER

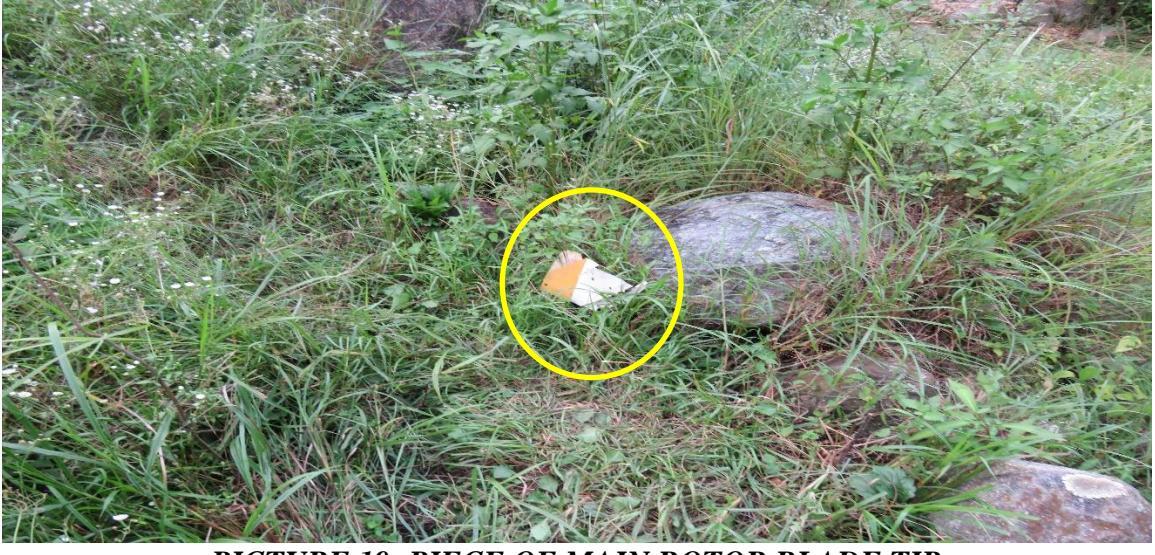
PICTURE 19: PIECE OF MAIN ROTOR BLADE TIP

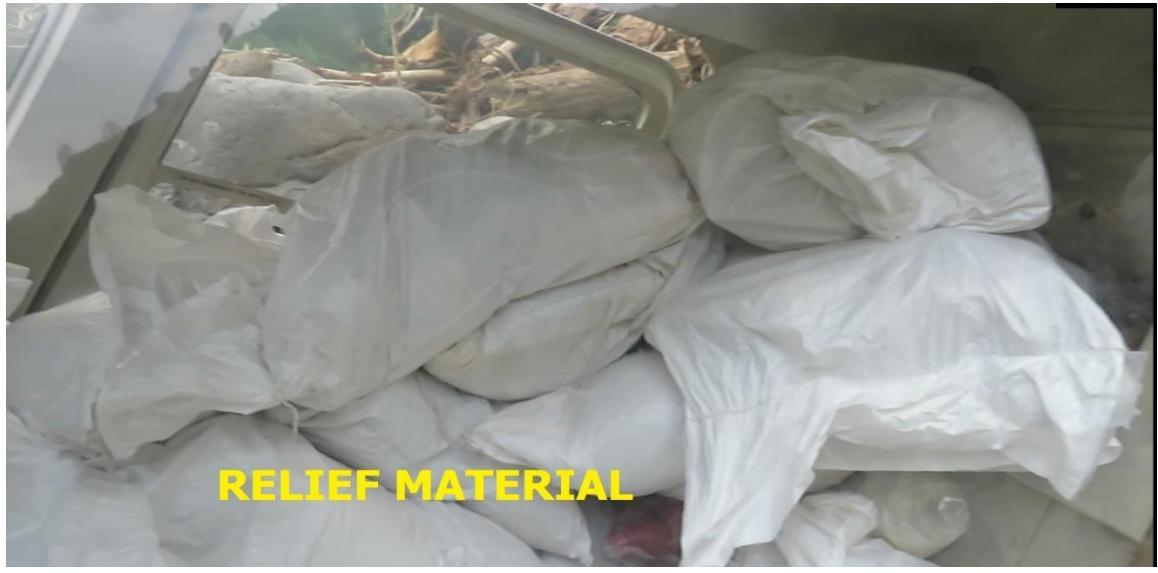
The left rudder pedal was found pushed inside. All the controls were found in serviceable condition, i.e. there was no discontinuity observed. The load (Relief Material) in the cabin was found stacked in the aft cabin above the rear passenger seat.

PICTURE 20: LOAD (30 BAGS OF RELIEF MATERIAL) IN CABIN

However, during the inspection of the helicopter wreckage at the accident site, it was observed that the loads were found stacked in the aft section of cabin above the rear passenger seat which implies that the loads were not tied and secured before the flight. This resulted in shifting of loads during the flight after the helicopter hit the cables, thereby disturbing the calculated C.G. position which led to the helicopter becoming uncontrollable.

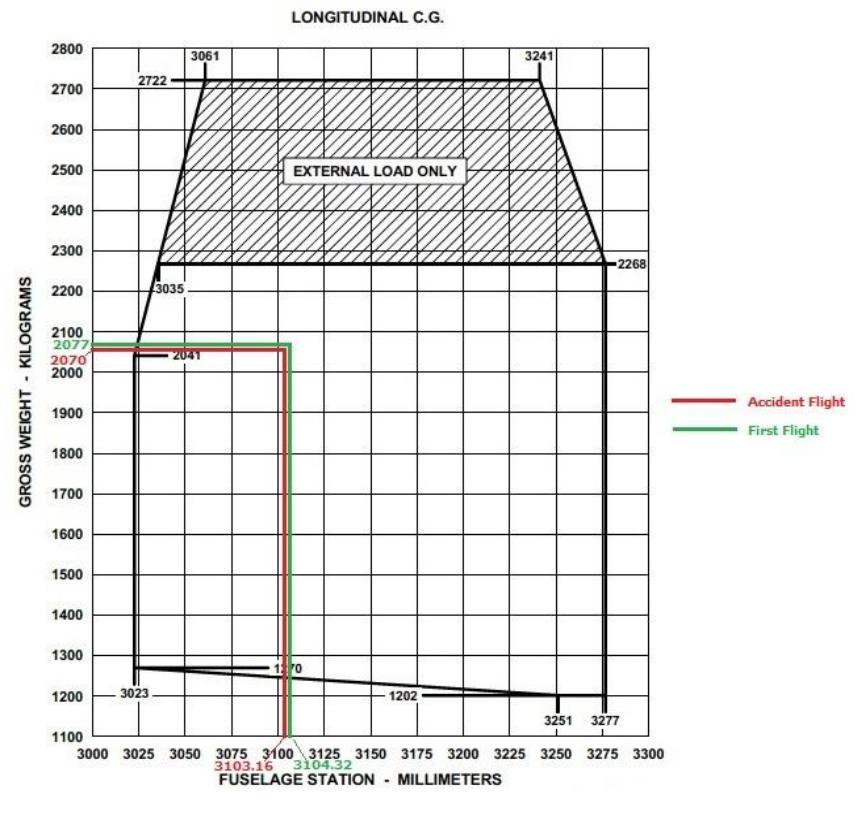
Hence, the approximate C.G location for the accidented flight was 3103.16 mm aft of datum which was within limits (Refer Pic 22 below).

<u>PICTURE 22: GROSS WEIGHT CENTER OF GRAVITY</u> <u>LIMITATION CHART</u>
