# FINAL INVESTIGATION REPORT ON SERIOUS INCIDENT OF M/s G0-AIR , REGISTRATION VT-WGR AT BENGALORE AIRPORT, ON <u>11/11/2019</u>

A Serious incident occurred at Bangalore airport on 11/11/2019 at 0152 UTC of M/s Go-Air (Type -A320, Registration- VT-WGR).

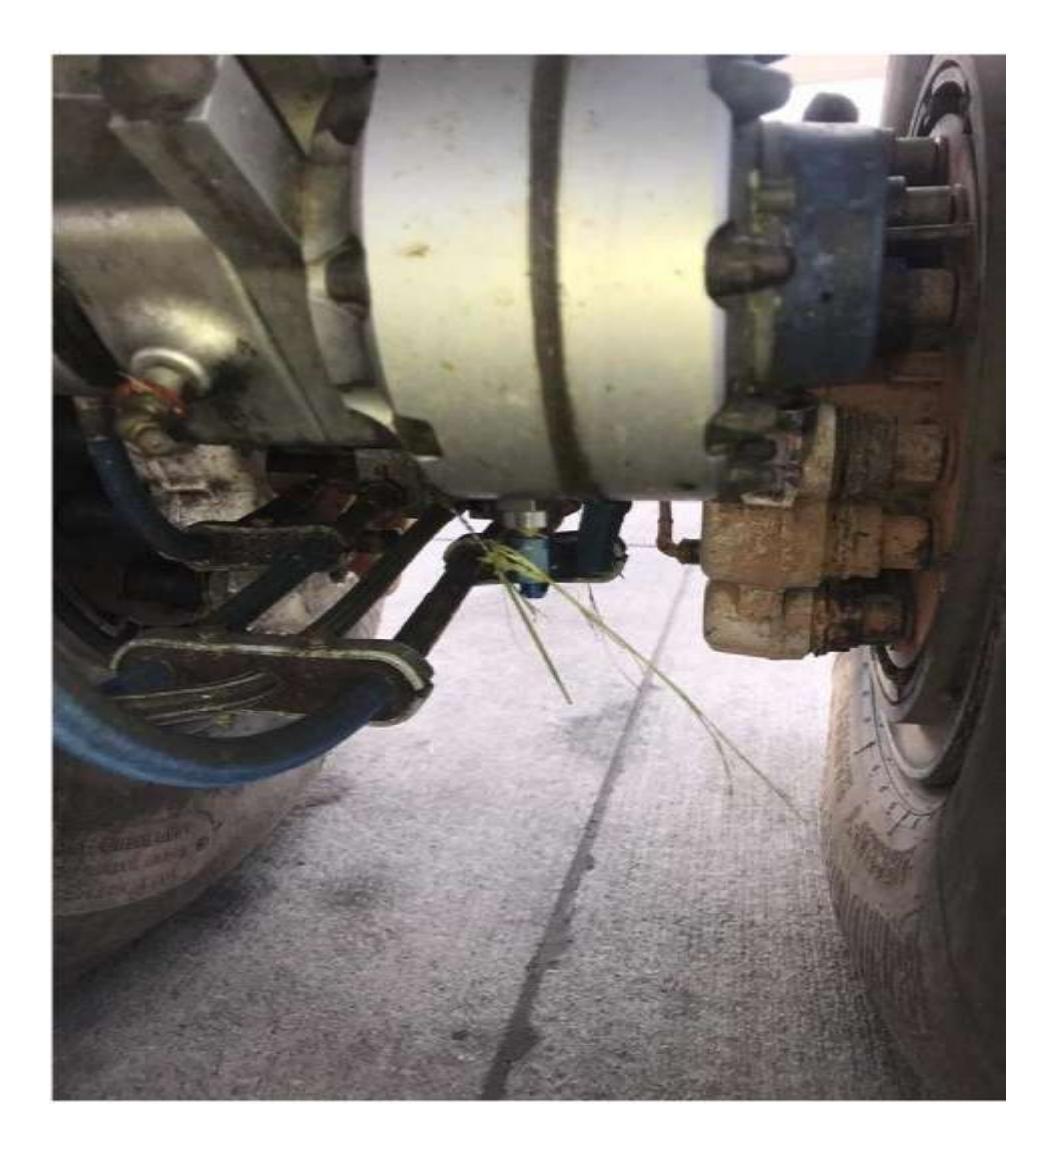
During walk around inspection at Hyderabad, mud and grass was observed on both LH & RH MLG wheels and brakes, No other external damage or abnormality was noticed. Externally, there were no signs of any FOD on engines. There was no damage on landing gear. Extension/ Retraction and free fall checks were satisfactory.

A full Bore Scope Inspection (BSI) of both engines was carried out. On ENG#1 heavy rub marks were observed on HPC Rotor 7 and 8 Outer Air seal. There was spallation of HPC Stator 7 Inner Air seal.

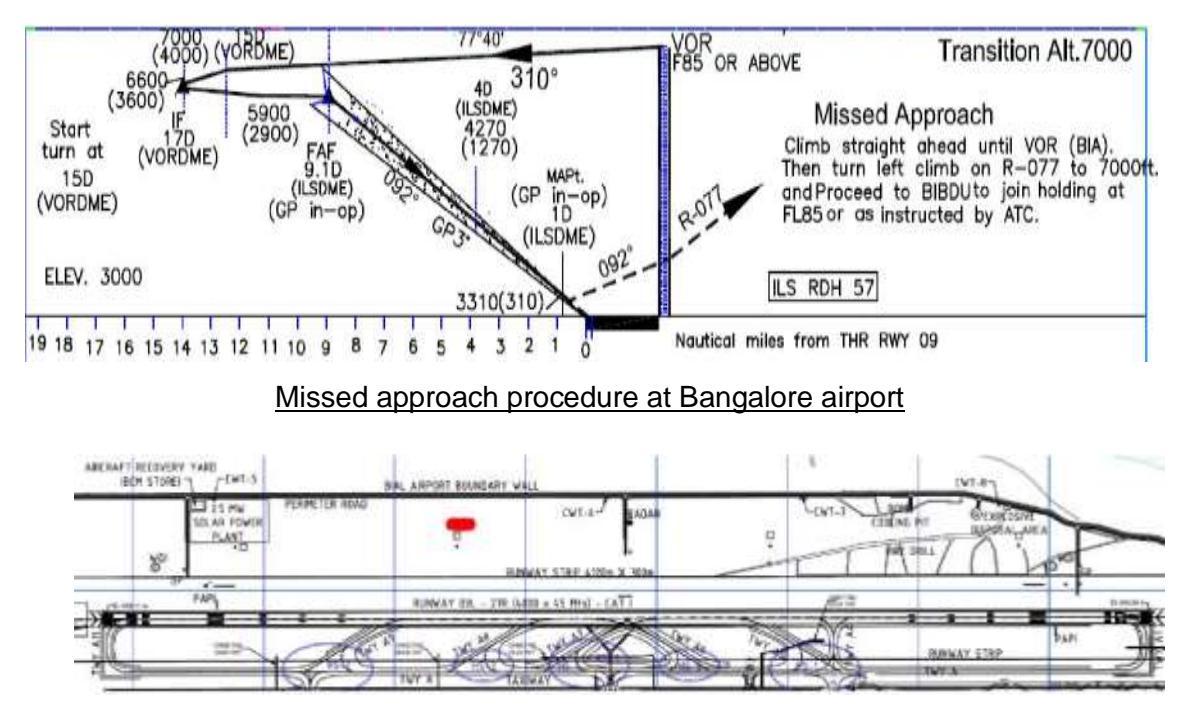
VOBL AD 2.14 APPROACH AND RUNWAY LIGHTING

The Bird Chaser who was positioned near A-8 northern shoulder (shown by red dot) reported that at the time the aircraft touched down, the visibility was low with dense fog. He could not see the aircraft but heard the sound of engines which was very loud. The Bird chaser immediately reported to the shift in-charge that an aircraft has flown just above his location.

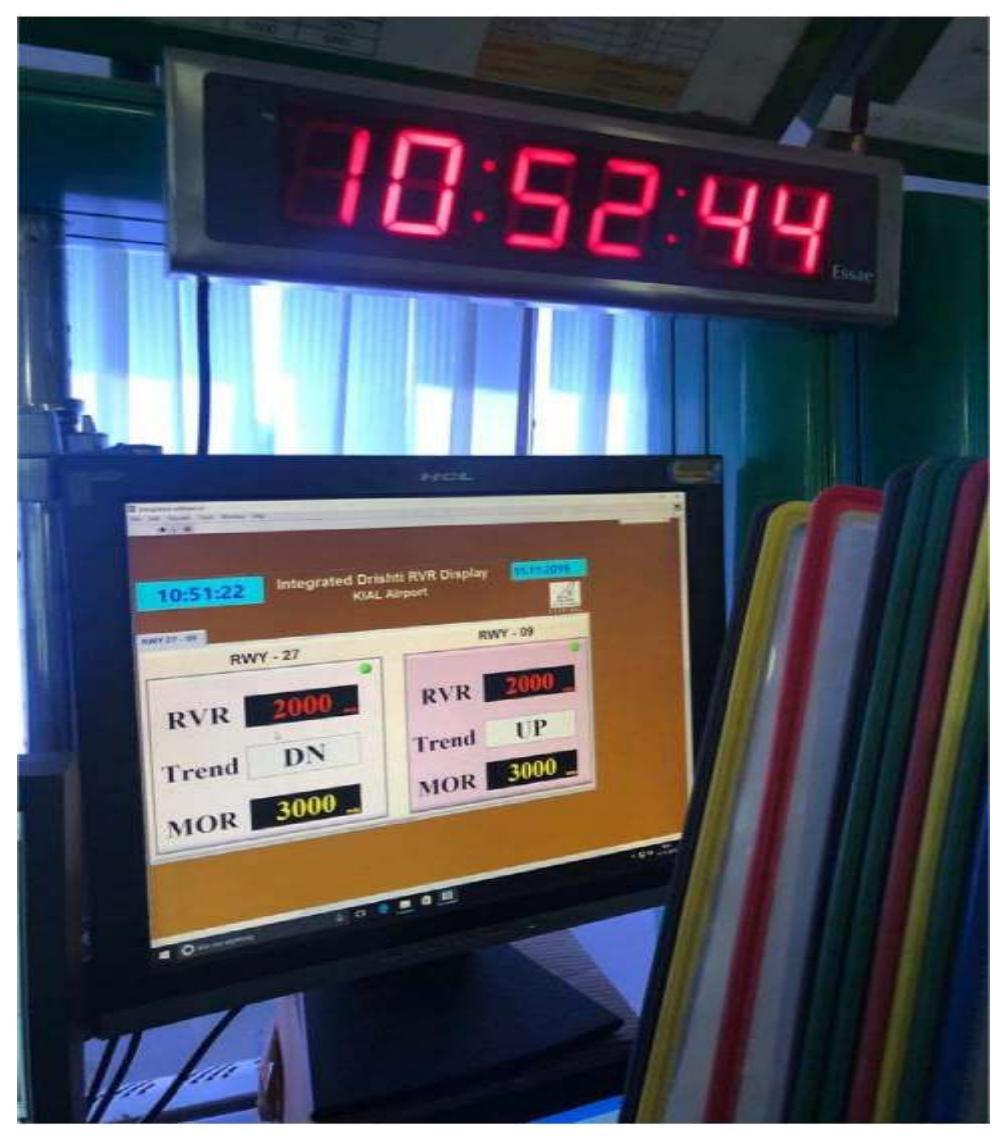
A separate screen is kept at the approach controller station, where current weather is displayed. A time lag of 82 seconds in the Dristhi display and actual UTC time display was observed.

Time lag between actual UTC window and Dristhi display (Approach position)

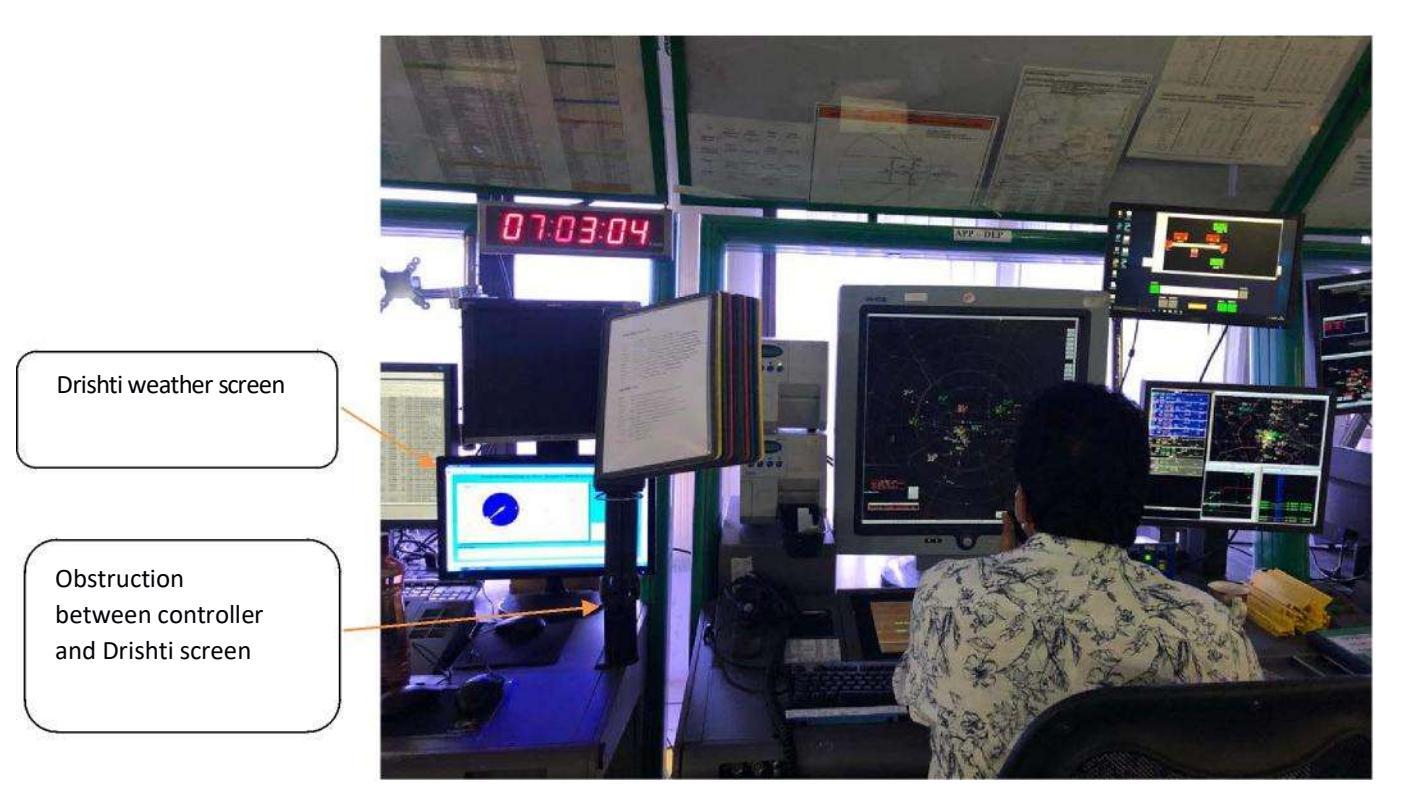
The Drishti Weather Display is not in clear line of sight for the approach controller. The display is obstructed with shift folders placed between the approach controller and the display. The controller would need to turn in order to view the display for any weather change/ update.

**Hindrance in Viewing Weather Screen**

- 4.5 AAI and IMD must ensure that the software display providing real time visibility / RVR are located in clear sight of the Air Traffic Controller for all stations.
- 4.6 IMD may carry out an evaluation for inclusion of Audio / Visual Alerts from the software being used for updating of RVR/ Visibility, whenever Visibility / RVR reduces below threshold values.
- 4.7 DGCA should extend, the Adverse weather watch system/ procedure for other seasonal variations wherein operating conditions deteriorates significantly like monsoon operations.
- 4.8 DGCA should positively provide closure report as per the time limits on the audit findings after receiving the Action Taken Reports from the Operator.

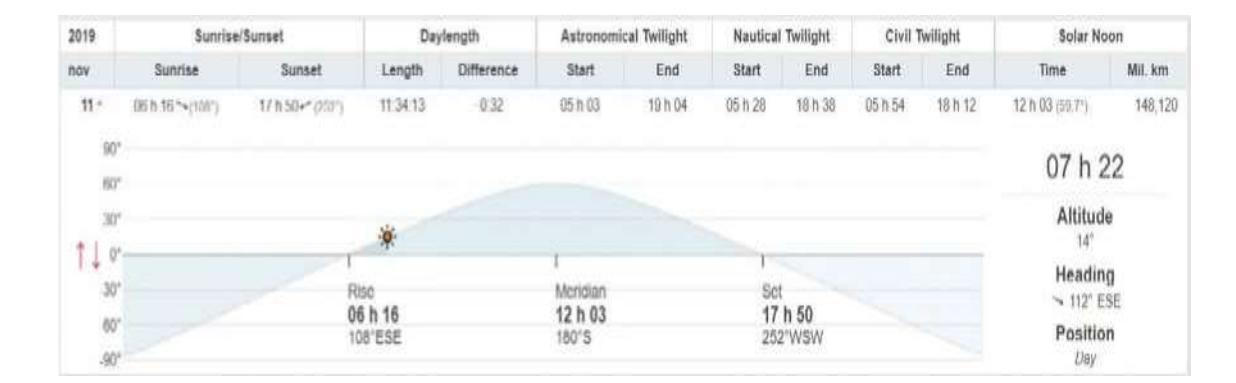
The actual RVR at the time of the approach reduced very rapidly to 125 meters. The time of the incident was just after Sunrise and the Sun was positioned at 14 degrees above the horizon and at a bearing of 112 degrees (20 degrees to the right of the runway alignment). This would have further impacted the already reduced visibility.

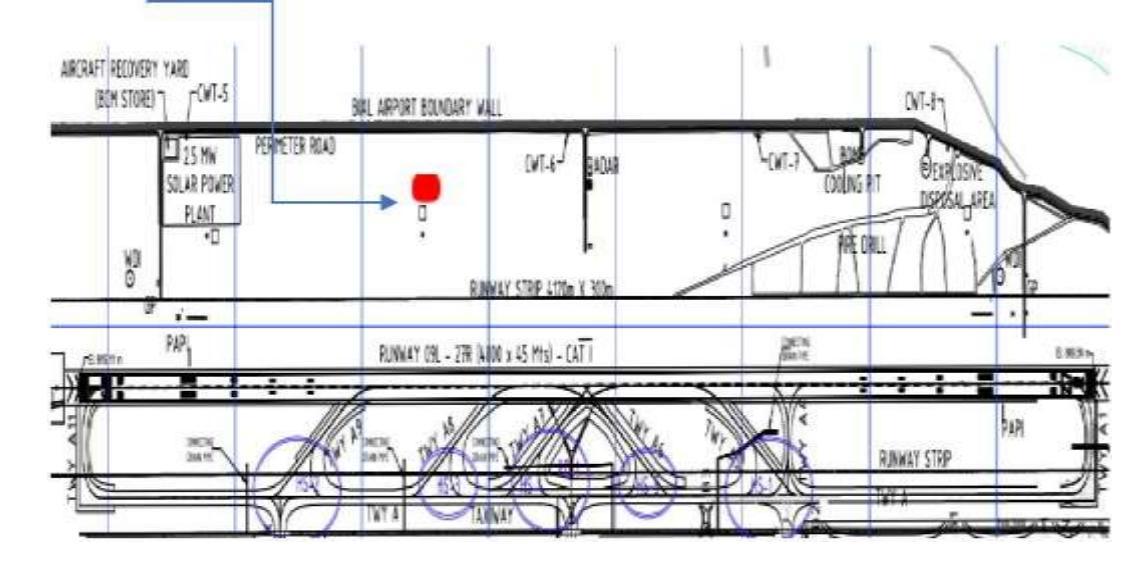
Location of the Bird Chaser

A Bird Chaser who was positioned near A-8 northern shoulder reported that the visibility was low with dense fog. The Bird Chaser heard the engines for the subject aircraft to be louder than usual. The Bird chaser immediately reported to the shift in-charge about the aircraft flying above him.

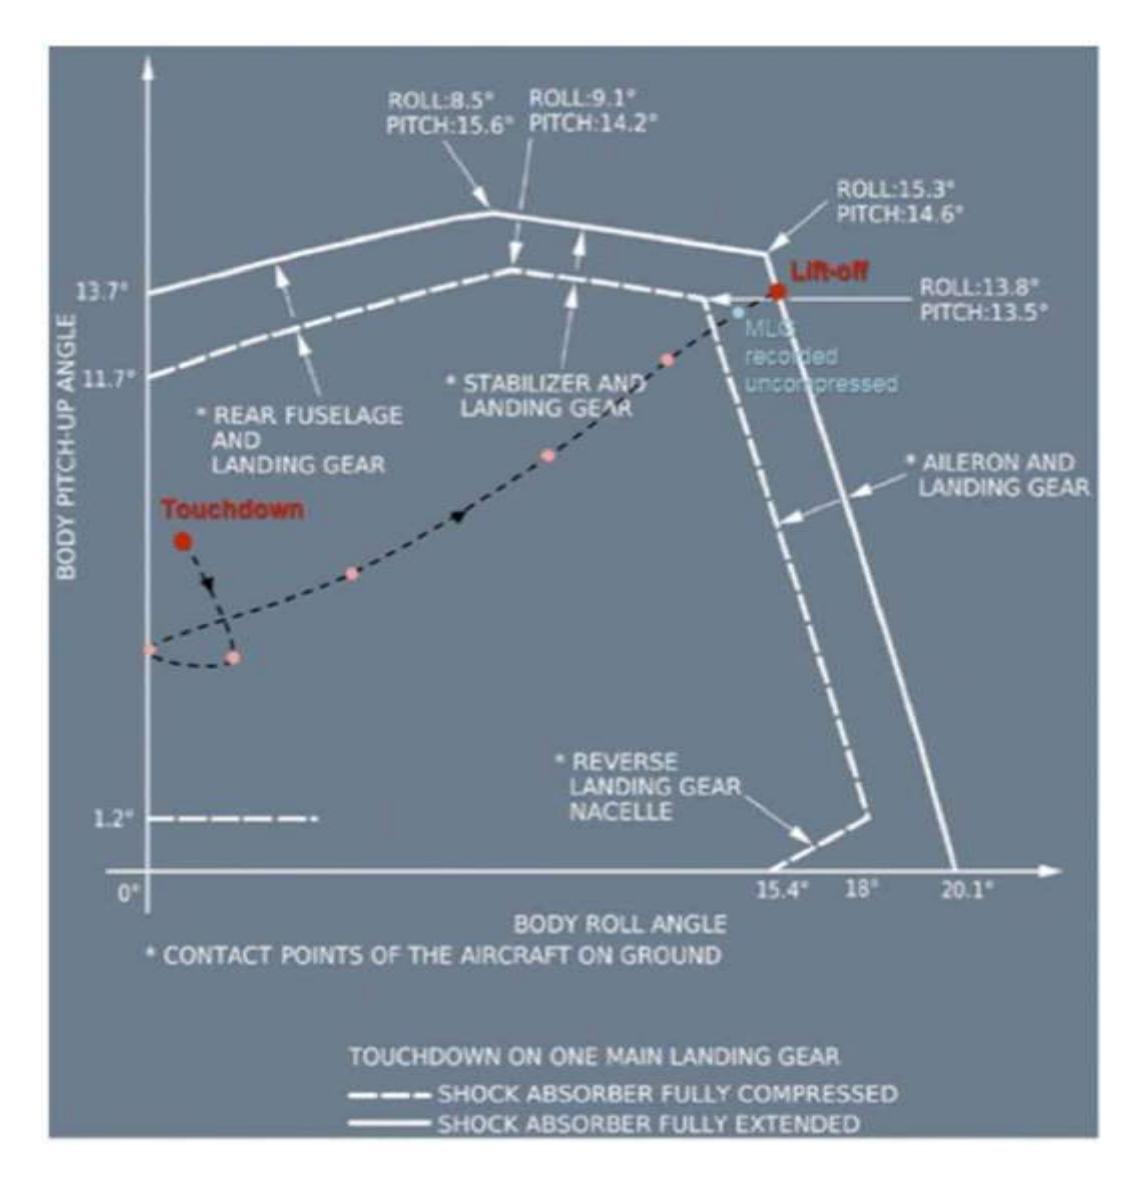
The figure above highlights the clearance margin from body contact

Airbus has given the clearance margins to avoid aircraft body contacting the ground (Body pitch up v/s body roll angle). As per this, with main landing gear fully extended and a pitch angle of +13.5°, the right aircraft aileron will contact the ground when the roll angle reaches +15.7°. In the present case, due to nose-up and right roll orders applied by the flight crew when the aircraft was on ground, pitch and right roll angles increased and reached high values close to the ground clearance diagram limits. The right aileron was close to the ground at lift off.
