FINAL INVESTIGATION REPORT ON OVERRUN INCIDENT INVOLVING FEDEX EXPRESS MD-11 AIRCRAFT FDX5033 AT MUMBAI ON 03rd June 2020

AIRCRAFT ACCIDENT INVESTIGATION BUREAU MINISTRY OF CIVIL AVIATION GOVERNMENT OF INDIA

FINAL INVESTIGATION REPORT ON OVERRUN INCIDENT TO FEDEX EXPRESS MD-11 AIRCRAFT FDX5033 AT MUMBAI ON 03 JUN 2020

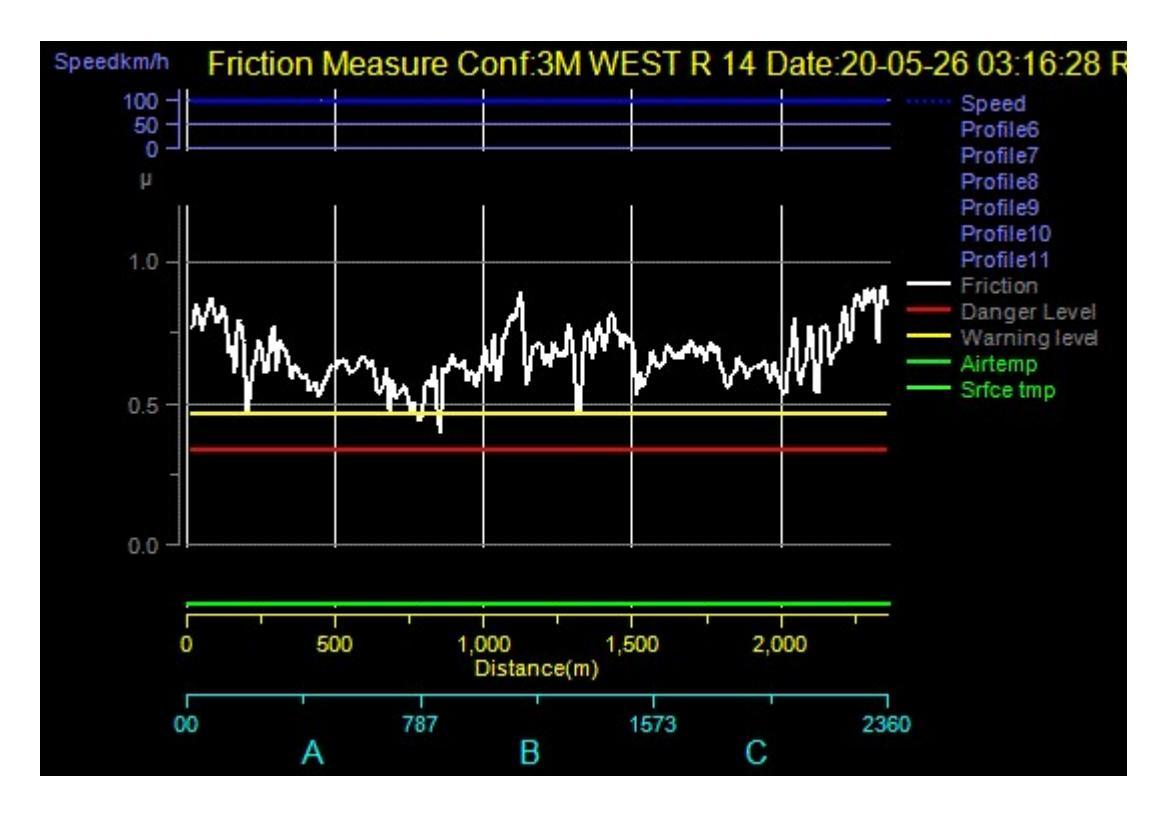
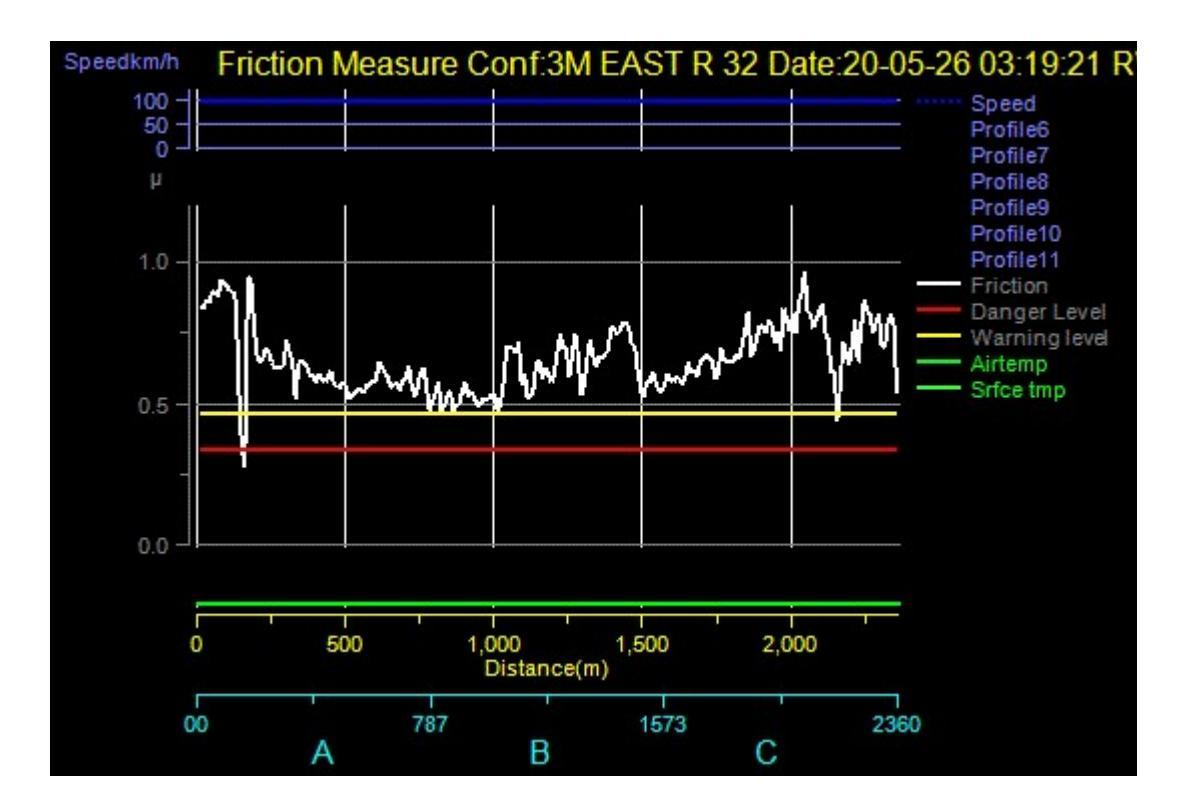
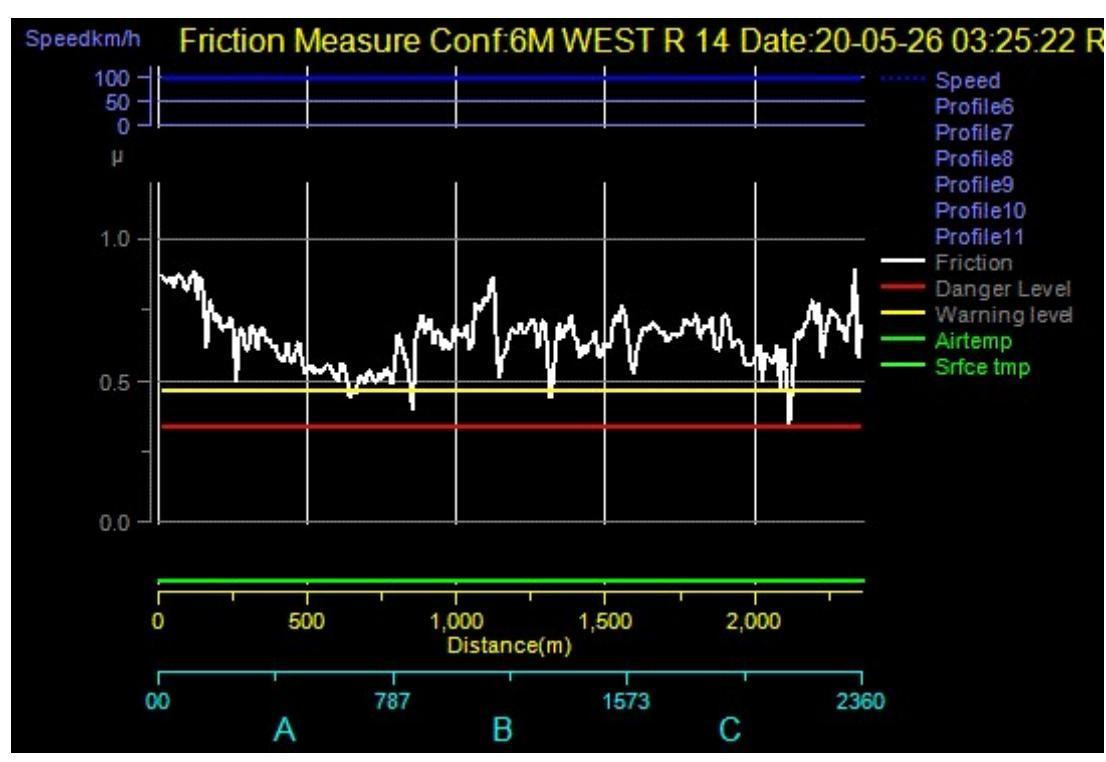
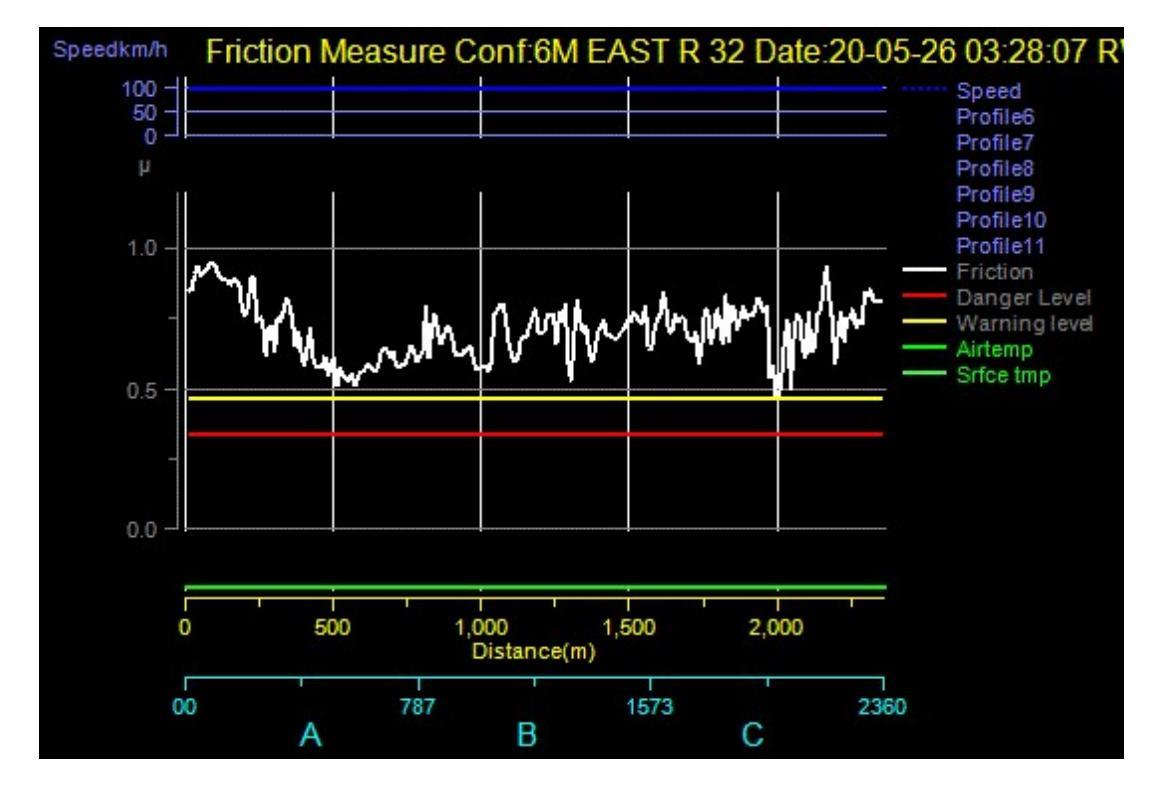
The figure - 6 to figure - 9 below are an extract of the graphical depiction of runway friction test carried out on 26 May 2020. The images indicate that towards the last 500m of runway 14, the friction measurement have touched Warning / Danger levels.

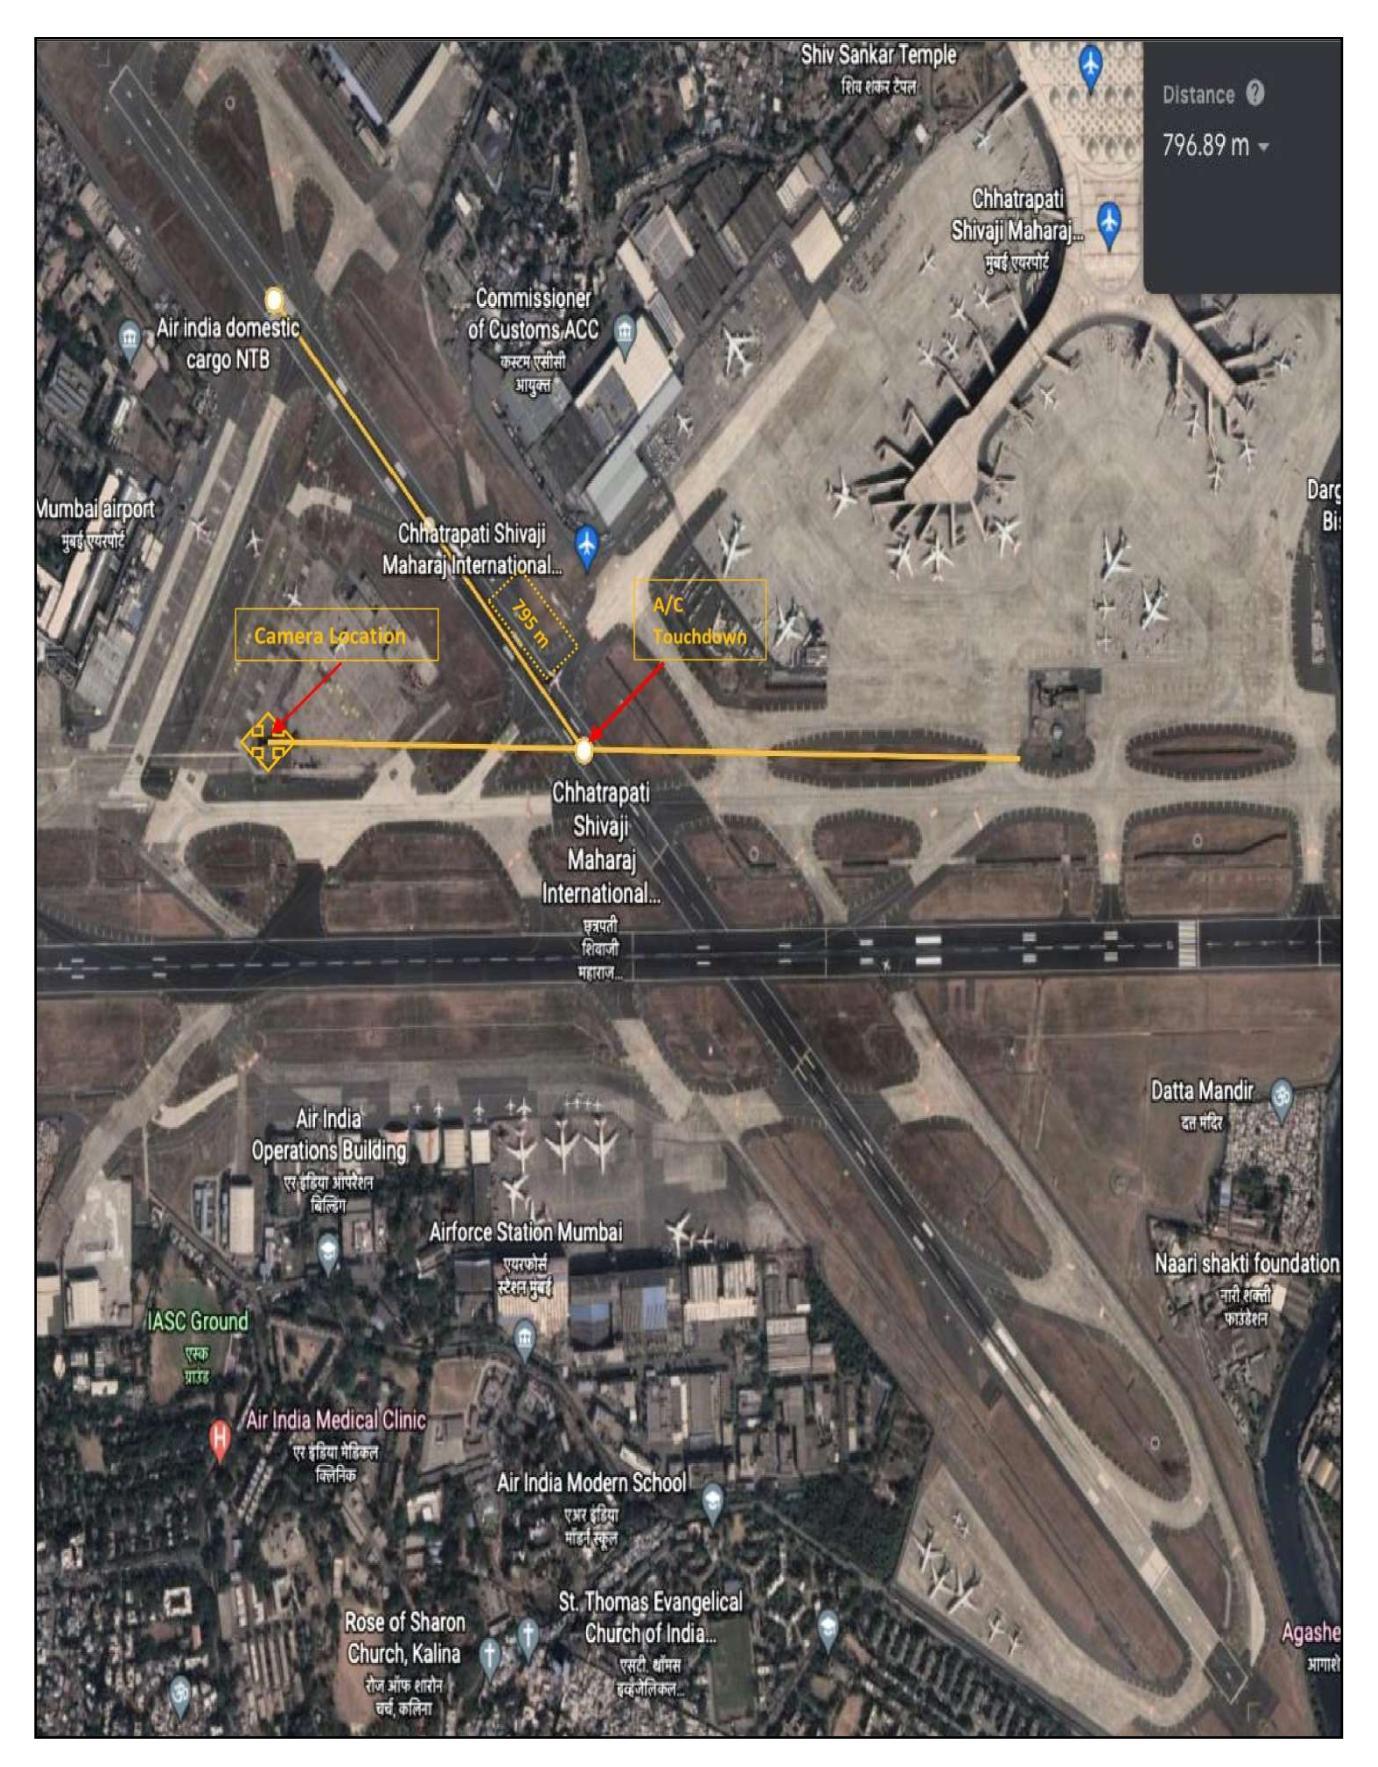
Fig-14 : The Google earth plot (Screenshot) showing the location of the aircraft Main Landing Gear touchdown (Reference CCTV Image). The nose wheel has not yet touched down and the spoilers have yet to deploy

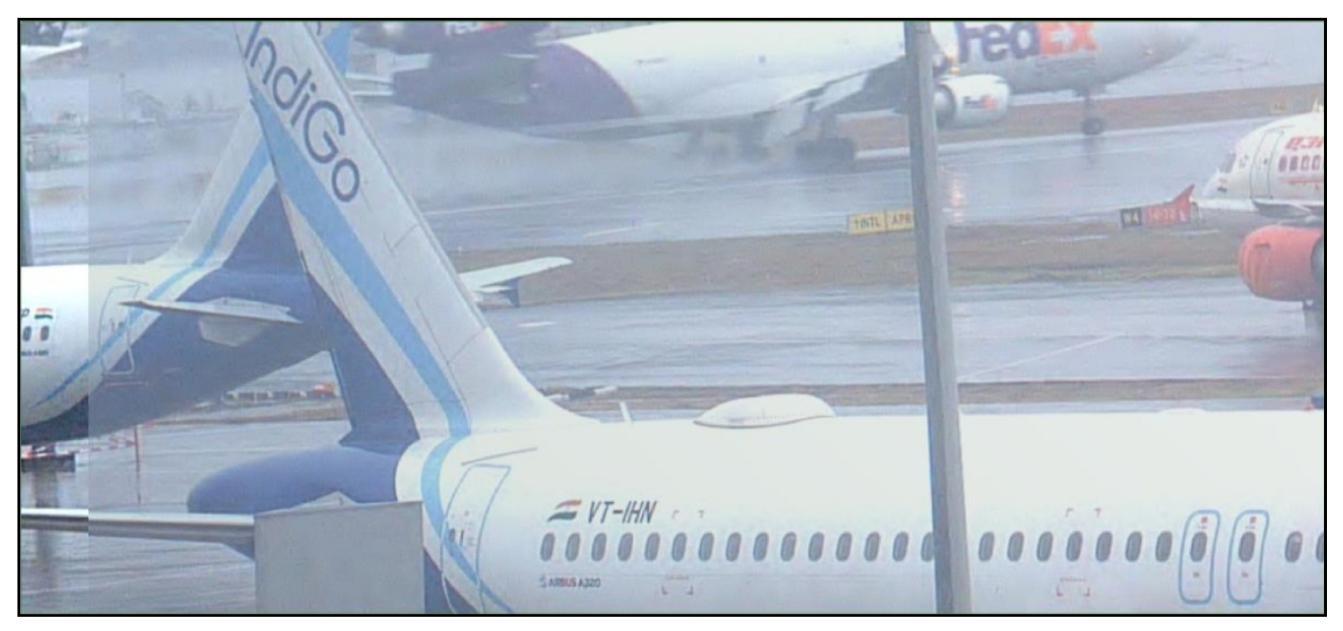
Fig-20: (CCTV 1 Image 5) Shows All main landing gear having contacted the runway surface. The nose wheel has still not contacted the runway. There is no spoiler deployment over the wings at this point.

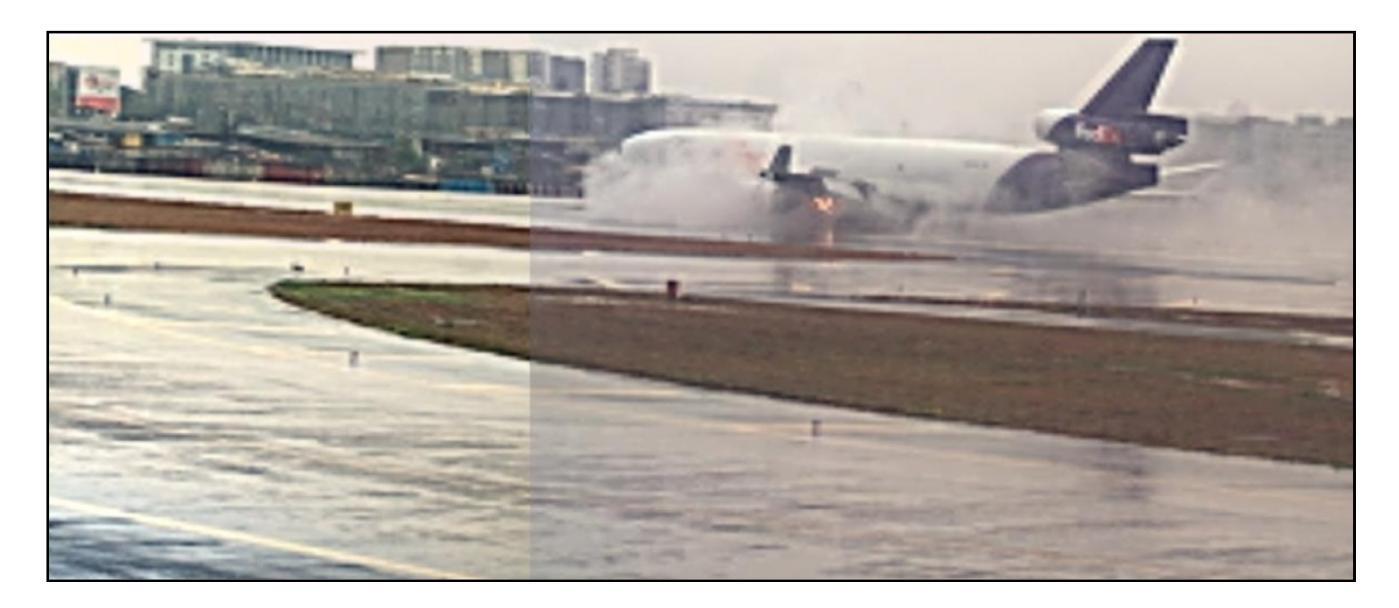
Fig-21: (CCTV 2 Image 1) The CCTV on the south eastern end of the runway shows the aircraft number 1 engine having a small flame in the exhaust section.

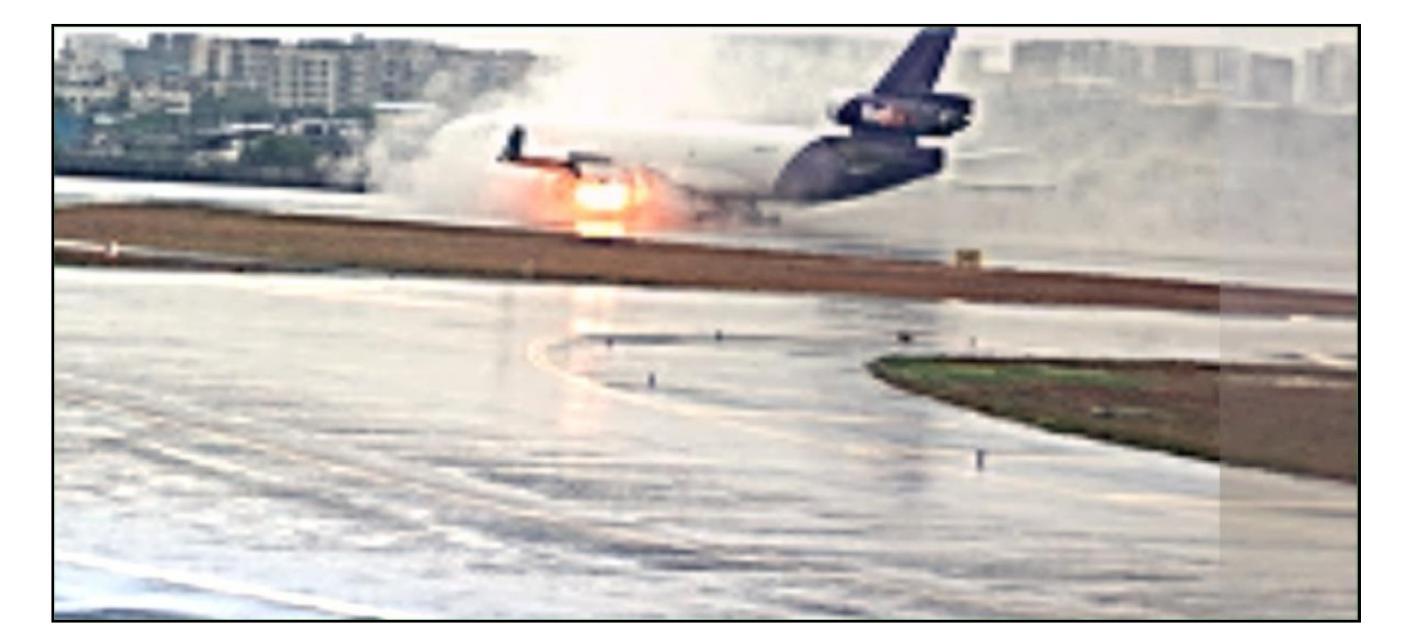
Fig-23: (CCTV 2 Image 2) shows a second and more prominent flame from the number 1 engine.

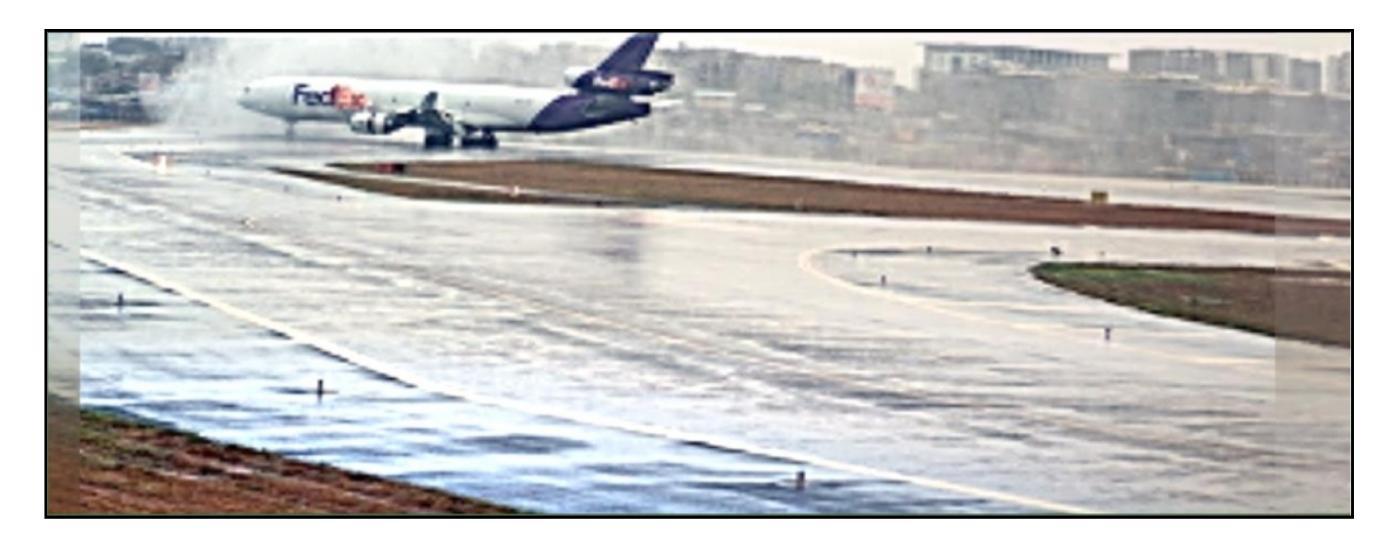
Fig-25: (CCTV 2 Image 3): Aircraft stopped facing 26[°] left of centerline

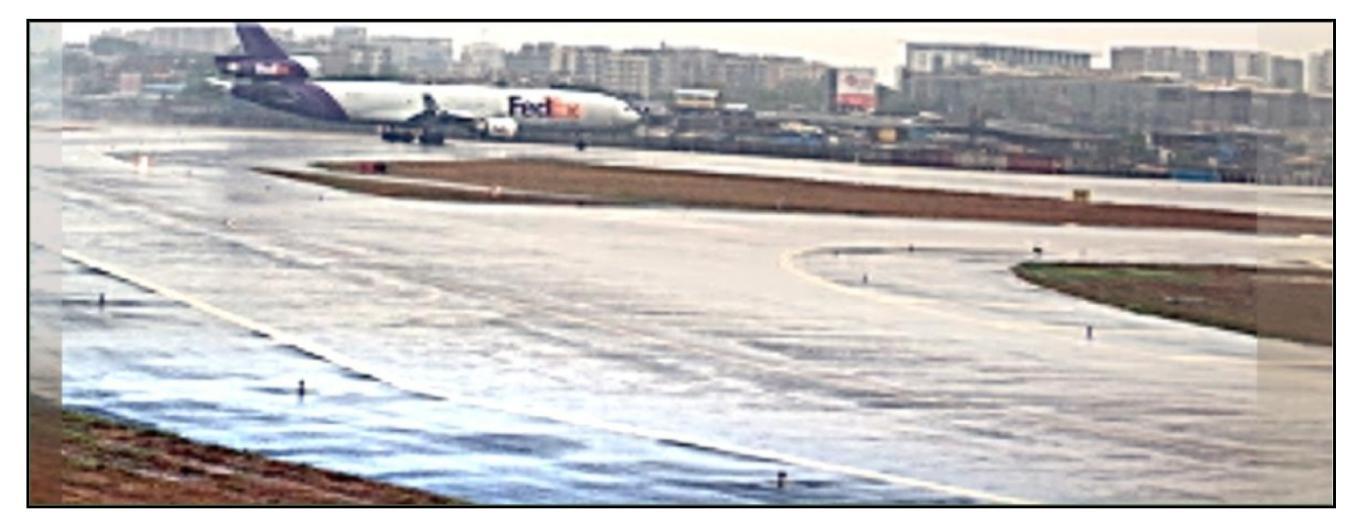
Fig-26: (CCTV 2 Image 4): Aircraft position at final stop, perpendicular to the runway after attempting a right turn to vacate the runway. This was the final position of the aircraft.

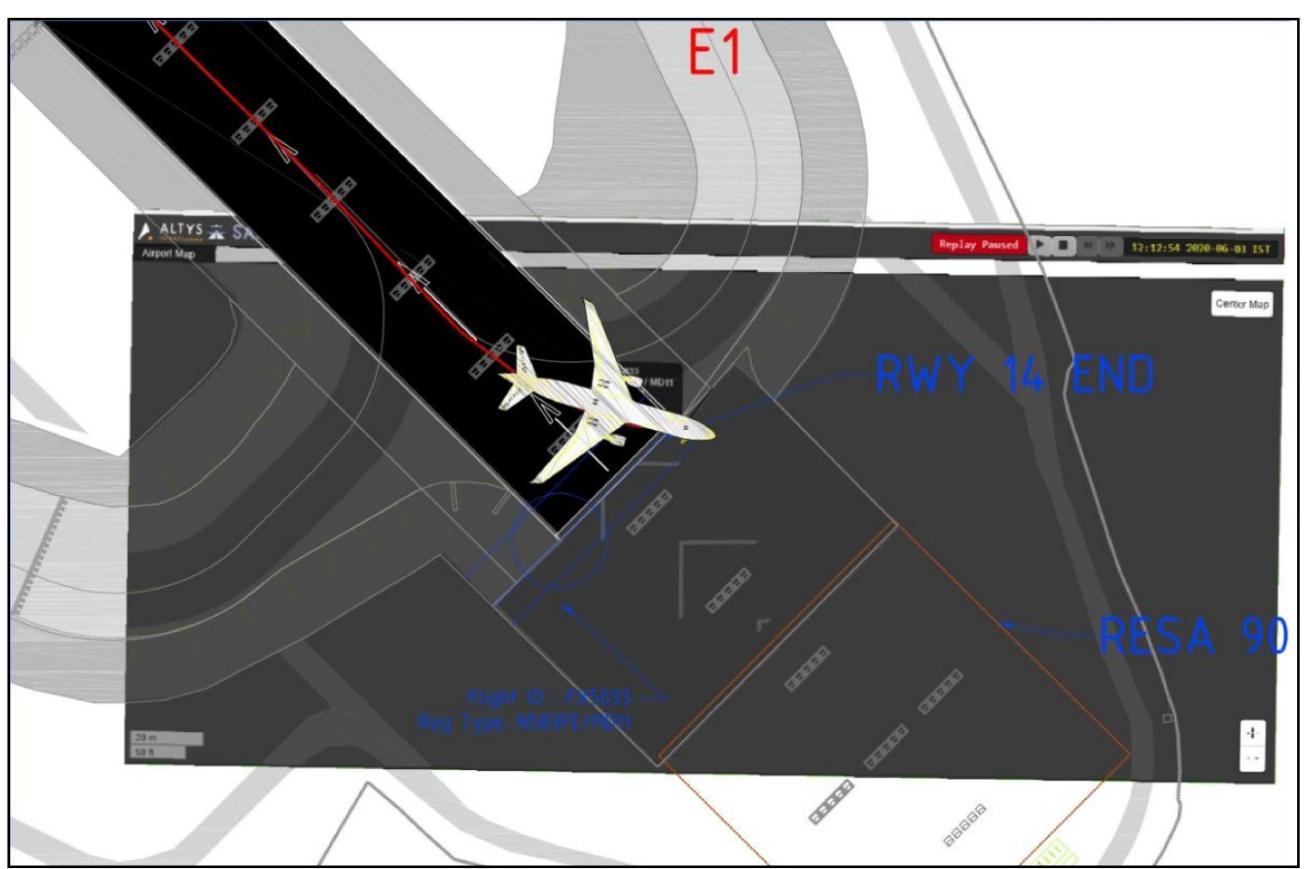
The figure 28 & 29 below has been obtained from the aerodrome radar plot and updated with the aircraft dimensions while the aircraft is stationary. The image shows the aircraft nose wheel having crossed the declared runway surface while remaining on the paved surface designed to carry the aircraft weight.

Fig-28: PLAN VIEW of the Aircraft once it comes to a stop after the landing.

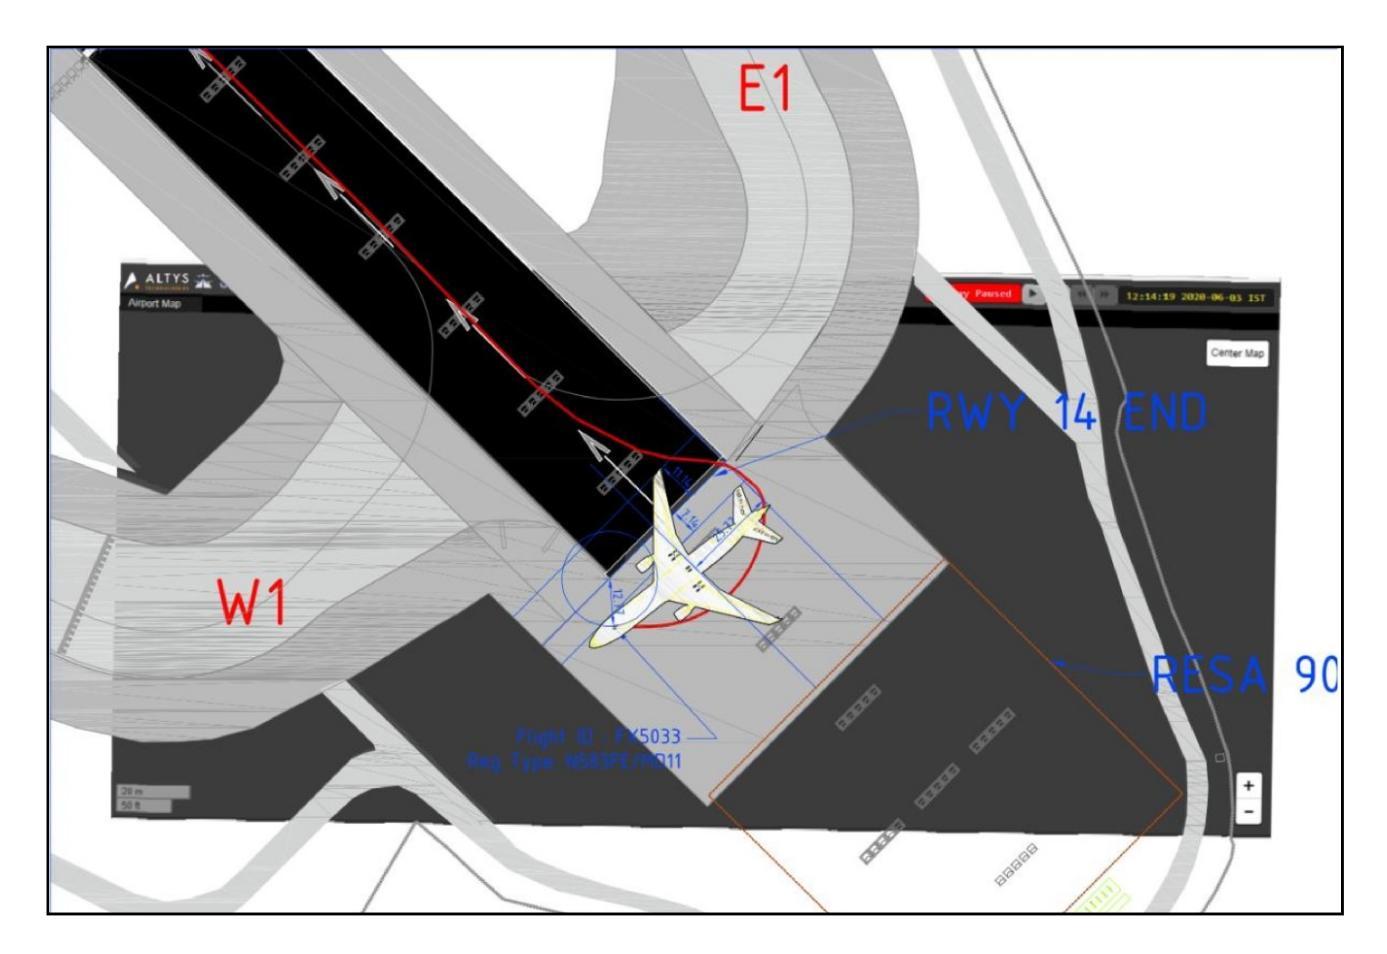
Fig-29: PLAN VIEW of the Aircraft after the crew attempt to steer the aircraft.

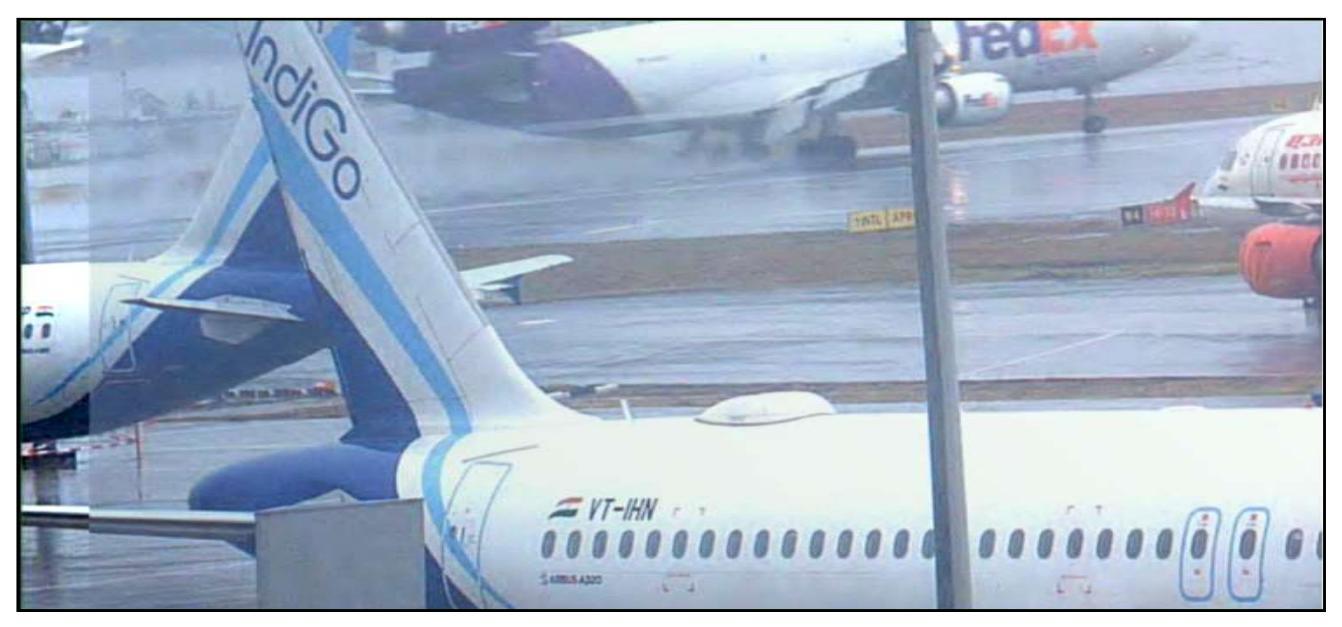
Fig – **30**: (CCTV 1 Image 5) shows All main landing gear having contacted the runway surface. The nose wheel has still not contacted the runway. There is no spoiler deployment over the wings at this point.

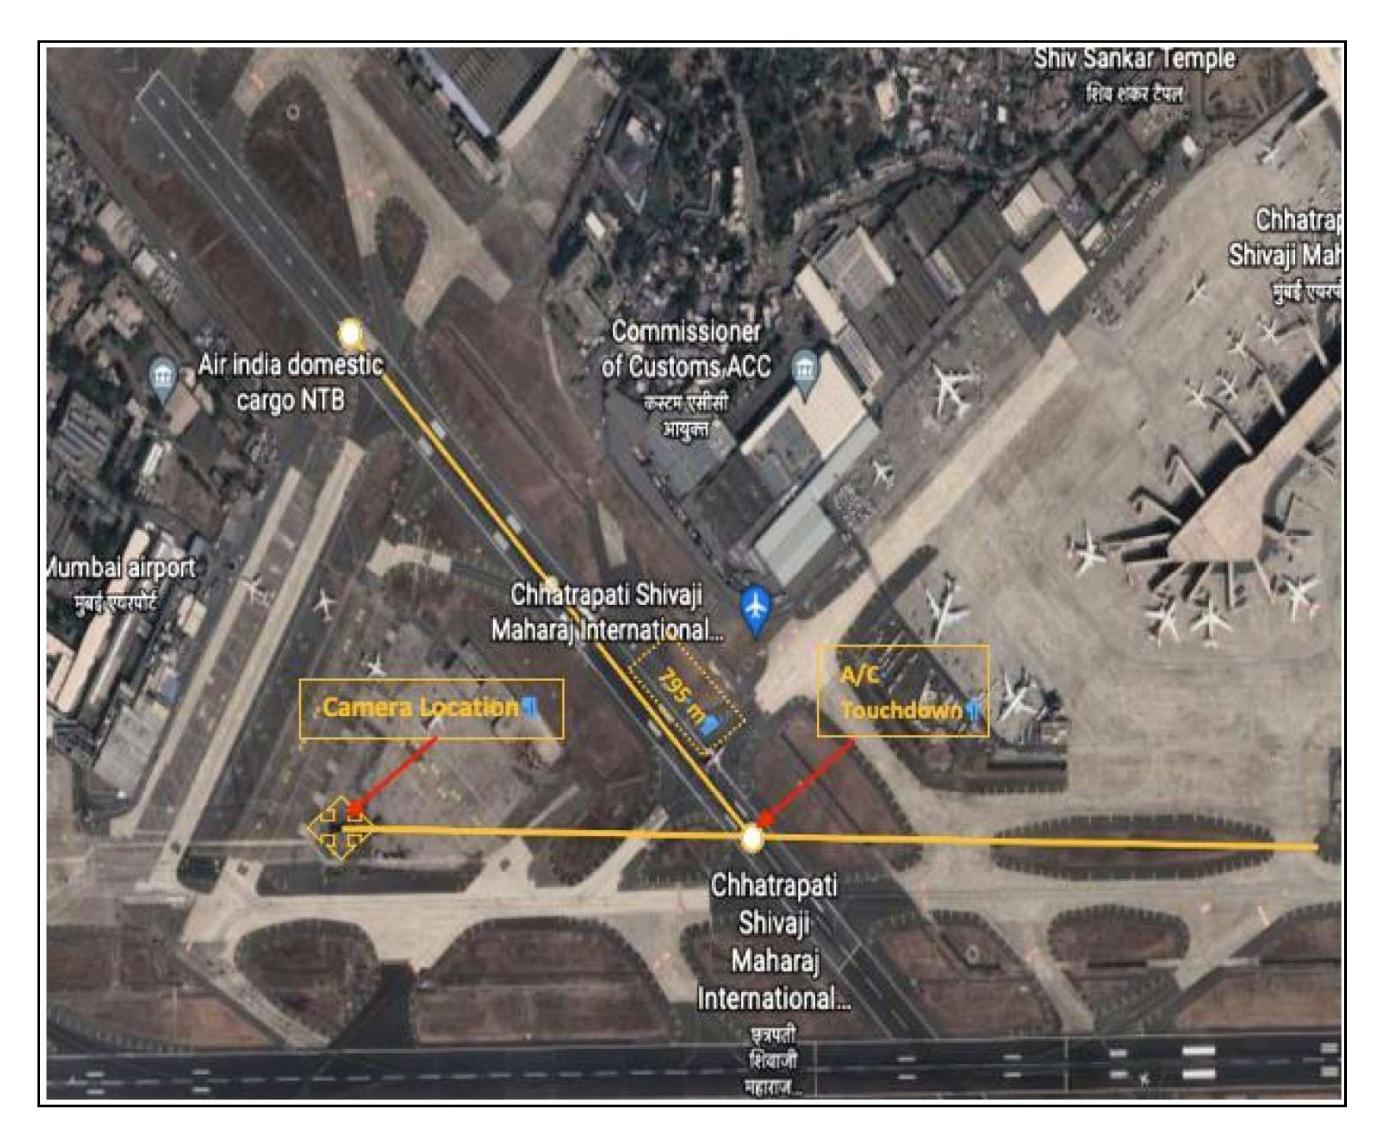
Fig – 31: The Google earth plot (Screenshot): Depicts Touchdown point of FDX5033.

The fig-31 shows approximately 795 meters (2608 feet) being consumed prior to the aircraft having touched down on all main landing gears. There is no visible deployment of wing spoilers or reverse thrust up to this point on the video. Due to the geometric limitation the camera does not cover the aircraft movement much beyond this point and the runway intersection is not captured. The SAGA radar capture and the OEM report (aircraft touchdown) shows the aircraft ground speed of 160 Kts (SAGA) and 165 Kts (OEM Report) which is significantly high considering an extended flare maneuver.
