**Final Investigation Report on Serious  
Incident between M/s Inter-globe A320  
aircraft VT-IEM and M/s Silk Air B737  
aircraft 9VMGH at Kolkata on 11.12.2016**

## **Final Report on Serious Incident between M/s Inter-Globe Ltd A320-232 VT-IEM and M/s Silk Air B737-800 9VMGH at Kolkata Airport on 11.12.2016**

12. Phase of operation : Landing for M/s Silk Air and take off for M/s Inter-globe
13. Type of Occurrence : Serious Incident (Air Proximity)

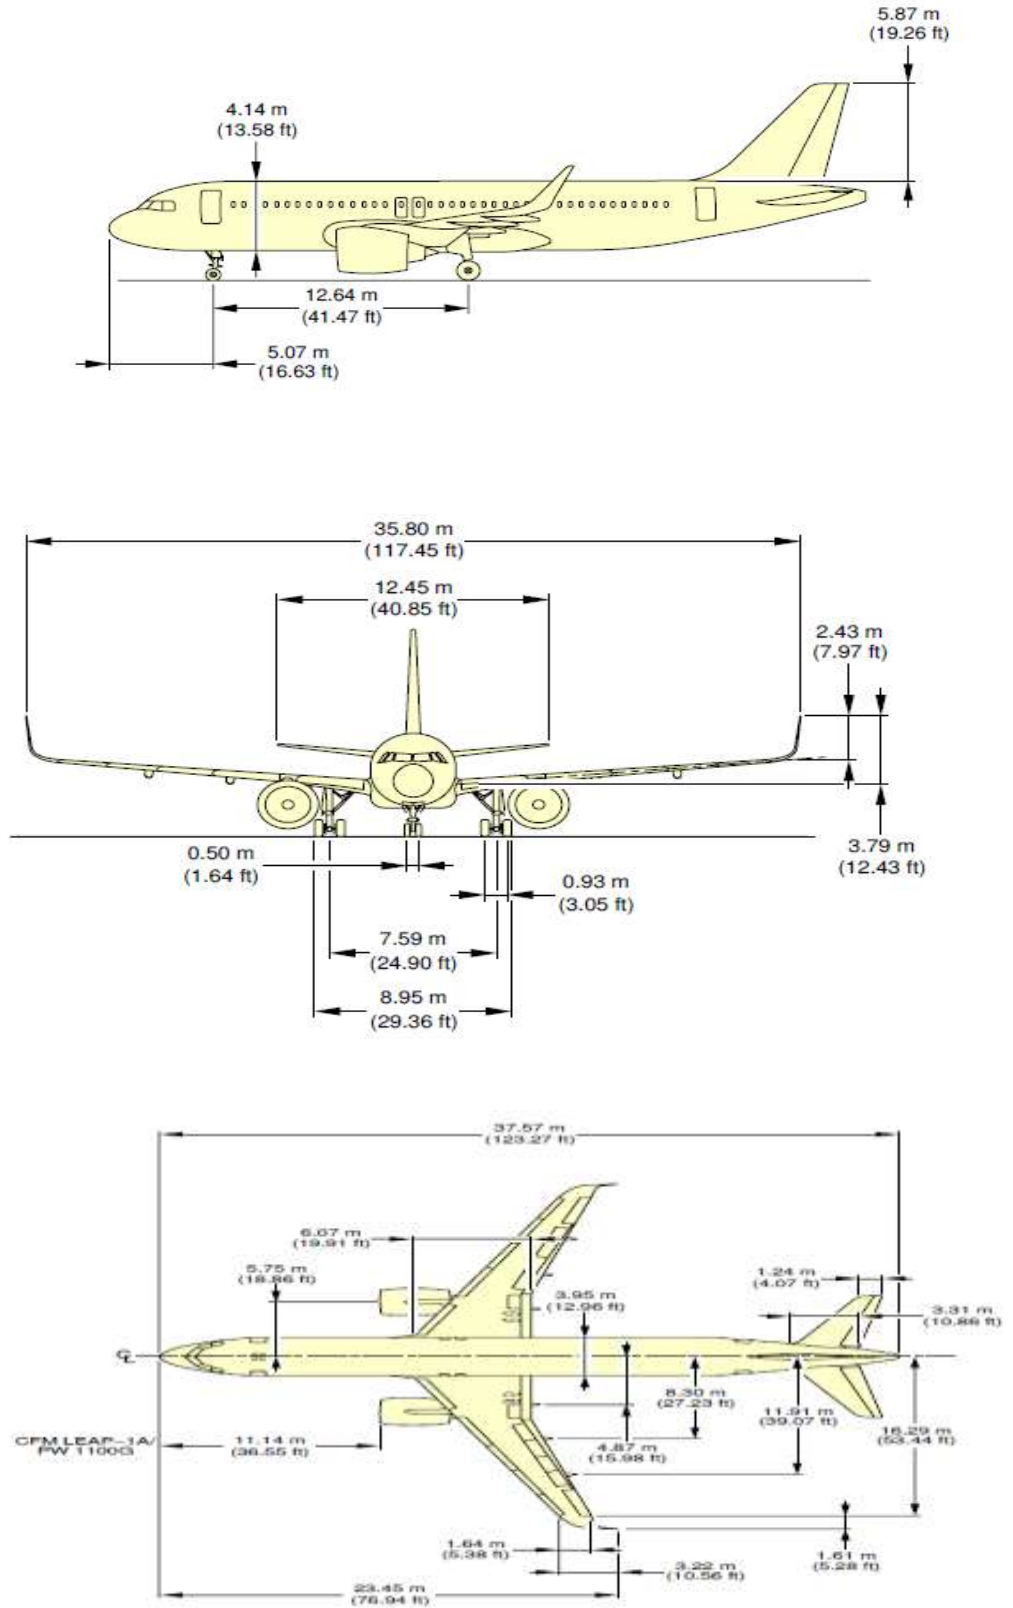
**Figure 1: An A320-232 aircraft**

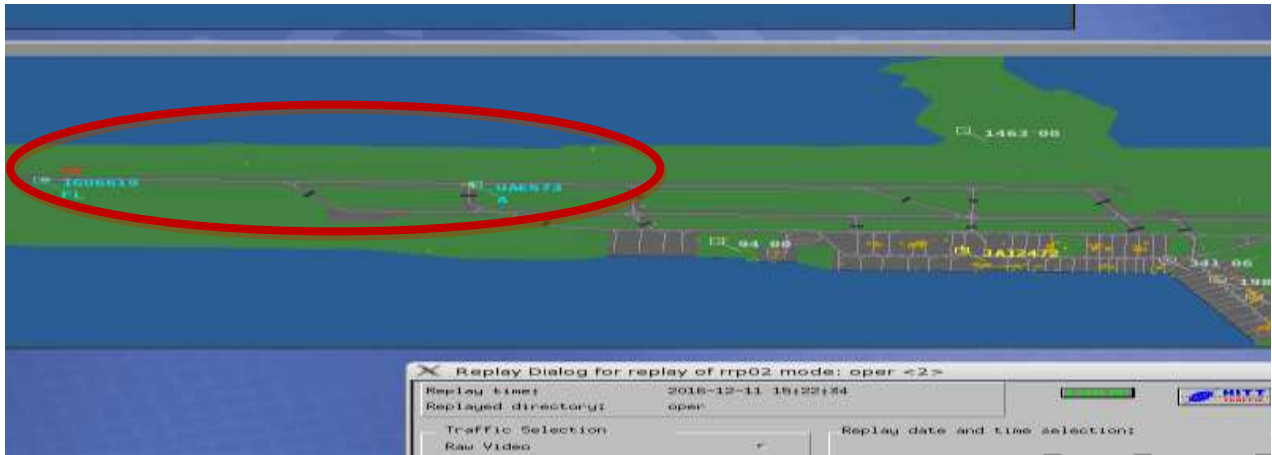
Figure 3: At time 15:22:34, both IGO6619 and UAE573 are lined up simultaneously on RWY 19L

2. Tower Controller confirmed if UAE573 was ready for immediate take-off. After getting confirmation, he asked UAE573 to line up runway 19L abeam “A” intersection at 1522 UTC. SLK488 was 9.5 NM from touchdown maintaining ground speed of 202 Knots and descending 2200 feet. Tower controller asked SLK488 to reduce to minimum approach speed at 1522 UTC and advised her of departure before her arrival.

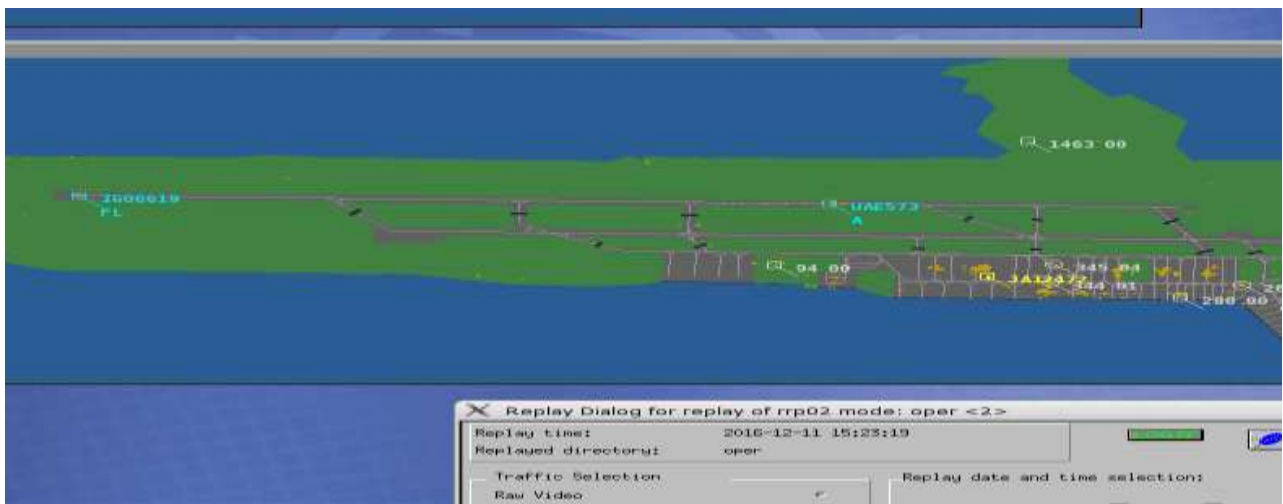
Figure 4: At time 15:23:19, IGO6619 lined up and UAE 573 rolling RWY 19L

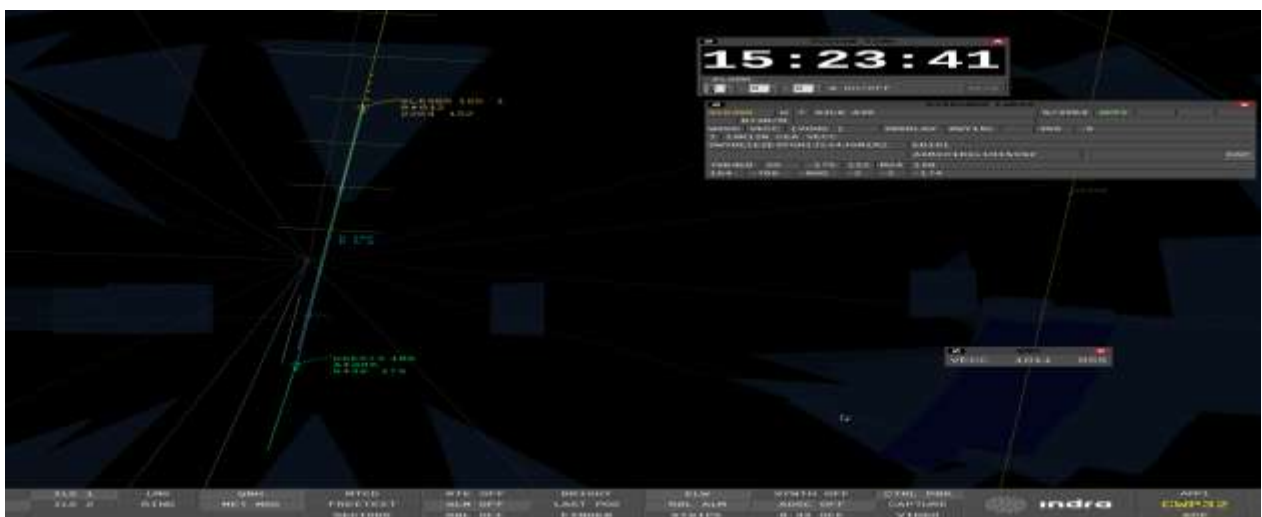
Figure 5: At time 15:23:41, UAE573 was airborne, passing 500feet, the arriving SLK488 was 3.7 NM

3. After departure of UAE573 at 15:23:41 UTC Inter-globe IGO6119 was issued take-off clearance at 15:24 UTC. When UAE573 was rolling, SLK488 was about 06NM to touchdown maintaining 186 Knots and descending passing 1900 feet.

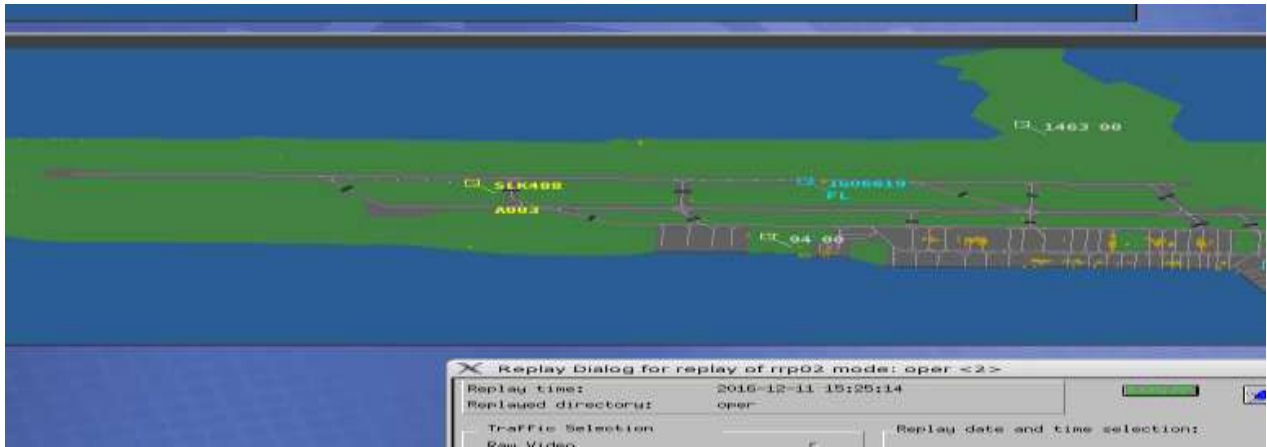
**Figure 10: At time 15:25:14 SLK488 initiated turning right for offset, position is between abeam Twy K and Twy A, whereas IGO6619 rolling RWY19L, position: between abeam Twy B and Twy R**

Inter-globe IGO6619 aircraft A320-232 registration VT-IEM a scheduled flight from Kolkata (VECC) to Shamshabad (VOHS) was given line up and backtrack Runway 19L from Taxiway K by the tower Controller (full length departure). At that time, UAE572 B77W scheduled flight from Kolkata (VECC) to Dubai (OMDB) had crossed Runway 19R and was on Taxiway A and approaching holding point Runway 19L. The tower controller, in order to expedite two departures before the arriving Silk Air SLK488 asked UAE573 if she is ready for immediate departure. On getting confirmation from UAE573, the tower controller asked UAE573 to line up runway 19L abeam taxiway "A" for intersection departure and immediately cleared UAE573 for takeoff at time 15:21:36 UTC when the arriving aircraft Silk Air SLK488 was approximately 09 Nm. The UAE573 which was a heavy aircraft, started rolling at time 15:22:56, when tower controller asked UAE573 "Cleared for take-off, wind calm" i.e. after an elapse of 01 minute 20 seconds from the first take off clearance. By this time, the arriving Silk Air SLK488 was less than 6 NM from touchdown. The Tower Controller who wanted to expedite the second departure ignored the wake turbulence constraints and released the second departure Inter-globe IGO6619 at 15:24:06 i.e. just after 01 minute 10 seconds after the preceding heavy aircraft started rolling. UAE573 was airborne and released to approach radar on 127.9 MHz at time 15:23:41. It is pertinent to mention here that before UAE573 started take-off roll at time 15:22:56, the succeeding departure Inter-globe IGO6619 was ready for departure at time 15:22:40. When IGO6619 started takeoff roll at time 15:24:17, the arriving aircraft, SLK488 was over threshold of Runway 19L. **The lateral separation was reduced to just 0.6 NM.** As per Para 7.9.1 (Separation of the landing aircraft and preceding landing aircraft and departing aircraft using the same runway) of ICAO DOC-4444 (Air Traffic Management (PANS-ATM)) which inter-alia states that "**Except as provided in 7.10 and Chapter 5, Section 5.8, a landing aircraft will not normally be permitted to cross the runway threshold on its final approach until the preceding departing aircraft has crossed the end of the runway in use,** or has started a turn or until all the preceding landing aircraft are clear of the runway- in-use." The arriving SLK488 started turning right for offset after crossing abeam Twy K at time 15:25:14 UTC.

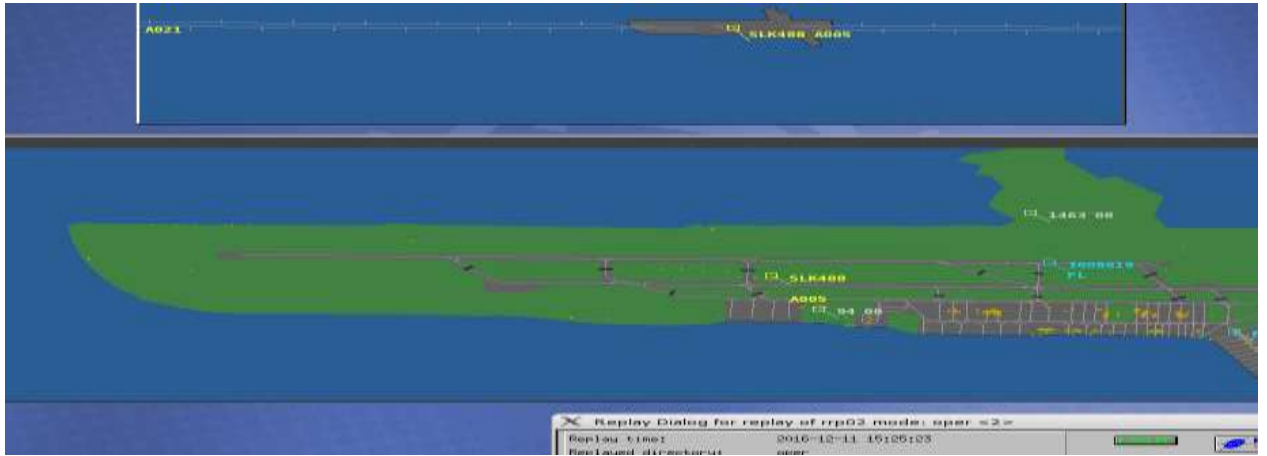
**Figure 11: At time 15:25:23, SLK488 going around, passing 500 feet, offset to right, position abeam Twy B whereas IGO6619 airborne, position abeam Twy C**

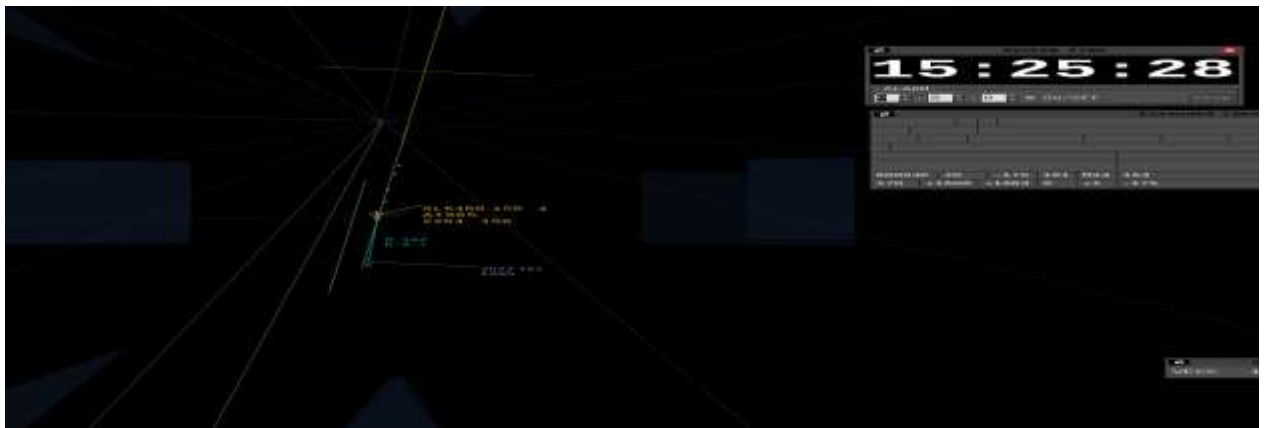
**Figure 12: At time 15:25:28 SLK488 going around, passing 500 feet, offset to right, position abeam Twy B whereas IGO6619 airborne, position abeam Twy C**
