**Final Report**  
**on**  
**Serious Incident**  
**between**  
**M/s British airways Ltd., B787-9**  
**&**  
**M/s Thai Airways Ltd., B777-300**  
**at**  
**Delhi**  
**on**  
**07.10.2017.**

# **Final Report on Serious Incident between M/s British Airways Ltd. B787-9 & M/s Thai Airways Ltd. B777-300 at Delhi on 07.10.2017.**

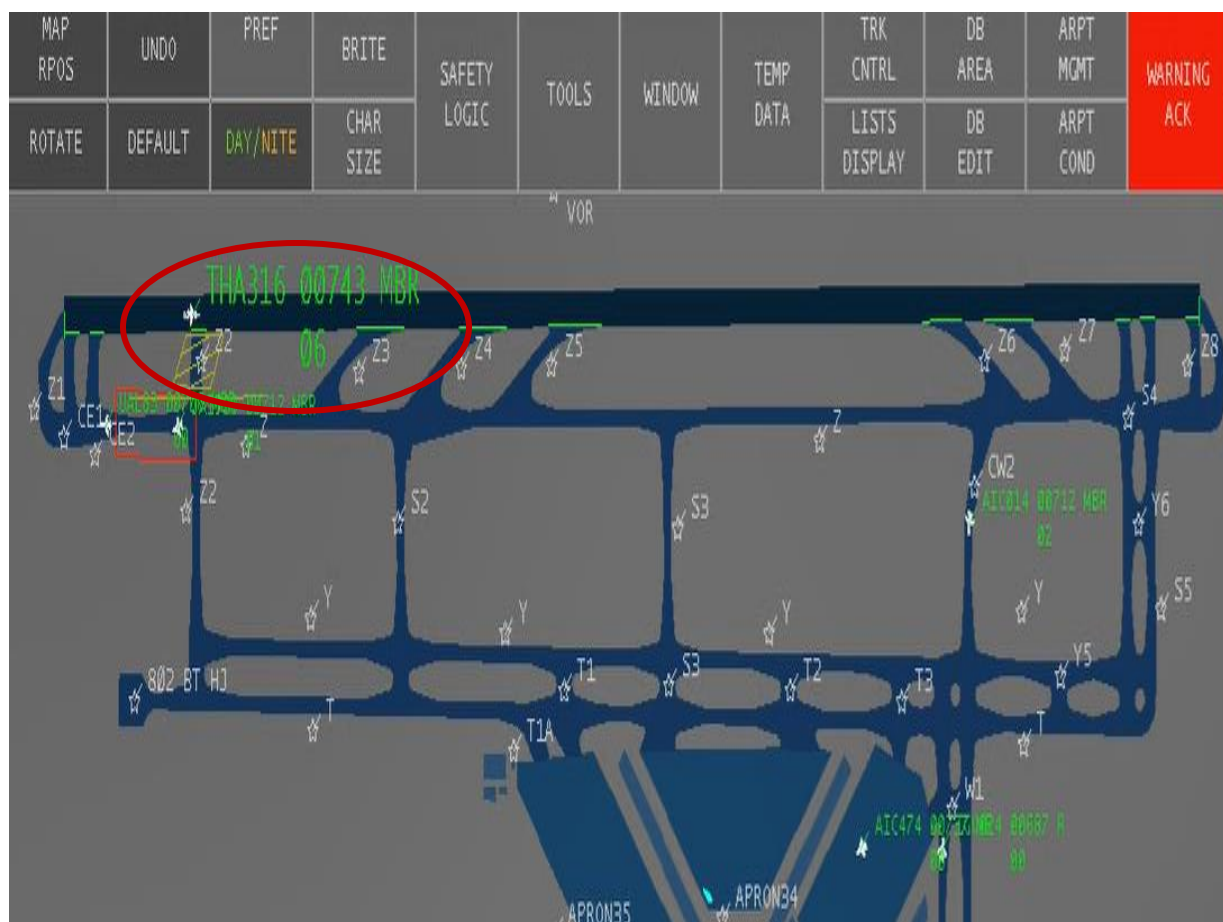
**Figure 7: THA316 rolling RWY29 position abeam Twy Z2 at time 18:24:02**

6. The departing THA316 was observed to be taking some time on the runway before starting takeoff roll. Though the Crew of THA316 have stated “*After received clearance to line up on runway 29, pilots carried out the standard operation procedure (SOP) as normal. After received takeoff clearance from ATC and Checklist had been completed, pilot took off as normal without delay*”, yet the crew of THA316 appears to not followed the standard provisions vide Para 1.5 and 1.6 of ARRIVAL, DEPARTURE PROCEDURE AND RUNWAY CAPACITY ENHANCEMENT MEASURES at Section 5.2 (III) (1) of VIDP AD 2.22 of AIP India at Page AD 2 VIDP-34 and 35.
7. The Tower Controller did not take into consideration the developing dynamic situation and didn’t cancel takeoff clearance Thai Airways.. The Tower Controller did not follow the provisions of Para 1.8 of ARRIVAL, DEPARTURE PROCEDURE AND RUNWAY

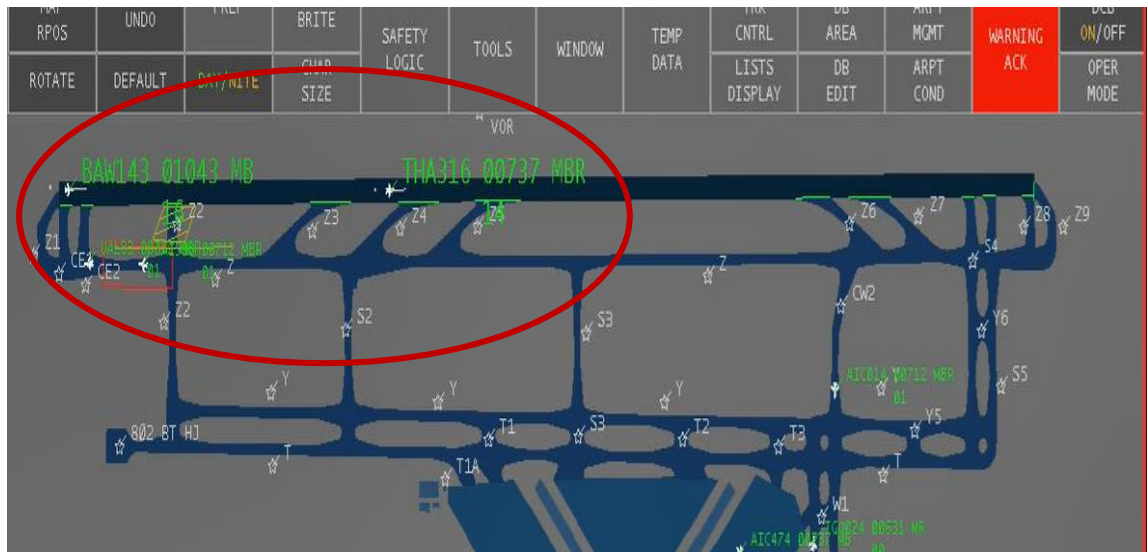
**Figure 8: BAW143 at the beginning of RWY29 (Abeam CE1) (0.7 NM from touchdown) speed 160kts and THA316 rolling (abeam Twy Z4) speed 140 kts at time 18:24:21**

8. The Approach Radar Controller did not follow the provisions of Para 29.1.3.6.2 and Para 29.1.8.3 of MATS-part 2 Page 29-3 and Page 29-7.
9. *The speed differential between the preceding and succeeding arrival was high and it was continuously above 30 kts and sometimes more than 50 kts.*
10. The required standard separation as enunciated by Para 7.10.1.1 of MATS-part1 page 7-15 and depicted vide Figure 4 A: Separation between departing and arriving aircraft was not followed by Tower Controller and crew of BAW 143. In the instant case, the arriving BAW143 had crossed the threshold of RWY29 when the departing THA316 was still rolling on RWY29 abeam Twy Z4. (Figure 8).
