Government of India
Ministry of Civil Aviation
Aircraft Accident Investigation Bureau

Preliminary Report: Accident involving M/s Mahalaxmi Aviation Pvt Ltd.'s BELL 407 helicopter, VT-MPU at Mahad Helipad on 03 May 2024

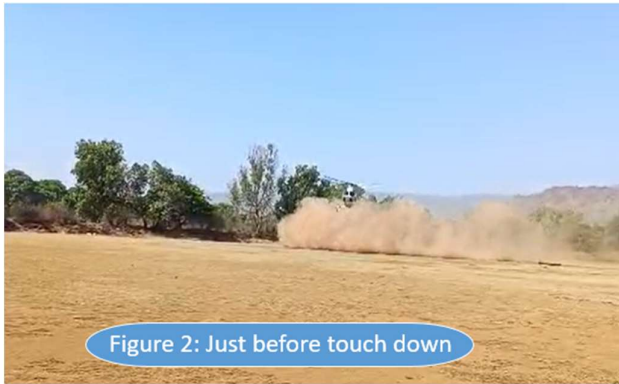
Figure 2: Just before touch down

The flight was uneventful till the helicopter approaches Mahad helipad. While landing, helicopter descended in a right side slant forward motion. As soon the helicopter came closer to the ground, the dust kicked up and surrounded the helicopter. Subsequently, the helicopter hit the ground and toppled to the right side. Consequently, helicopter main rotor blade came in contact with the ground and got damaged. The helicopter came to rest on its starboard side fuselage.

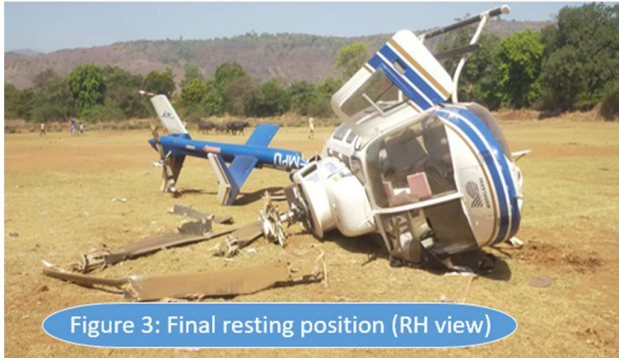
Figure 3: Final resting position (RH view)

As the starboard door of the helicopter was blocked by ground, hence, the company operation staff, first came out of the helicopter from port side door. Subsequently, the pilot also came out of the helicopter from the port side door. Nil injury was reported, whereas the helicopter sustained substantial damages.
