Final Report

Serious Incident of Airprox

between M/s TATA SIA Airlines Ltd (Vistara) flight VTI946 (Reg. VT-TQL, Type of aircraft A320-251N) and M/s Ethiopian Airlines flight ETH689, (Reg. ET-ATL, Type of aircraft B787-800)

near IGI Airport, New Delhi on 10 Nov 2023

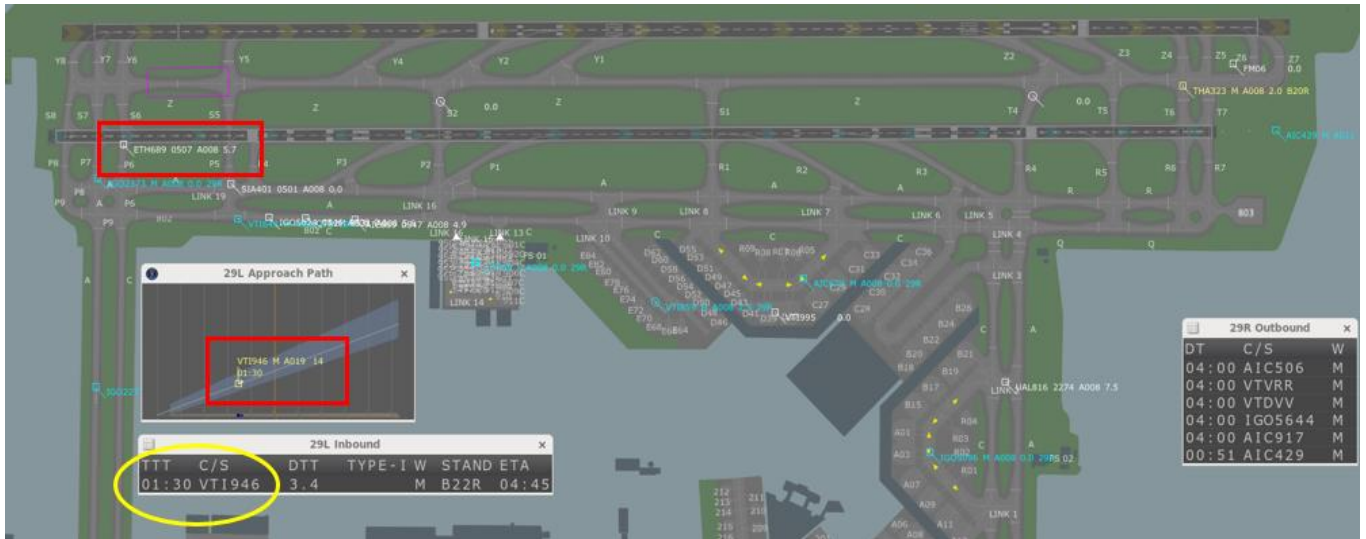
Fig 5: VTI946's TTT when ETH689 was entering on runway

An A320 aircraft registration VT-TQL belonging to M/s Tata Singapore Airlines Ltd. operating as a scheduled passenger flight VTI964 under IFR regulations departed from Sardar Vallabhbhai Patel International Airport, Ahmedabad, at 0337 (ATD). Once the aircraft came in contact with the Approach Final Director (APFD) controller, VTI964 was radar-vectorred for an ILS approach to Runway 29L at IGIA. Further, the aircraft was informed about wind shear encountered by a preceding landing aircraft. Thereafter, flight crew anticipated possible wind shear on final approach to Runway 29L. At 044400, when Ethiopian flight ETH689 was about to enter Runway 29R, the time-to-touchdown (TTT) for VTI946 was 1 minute and 30 seconds (see Fig. 5 below).

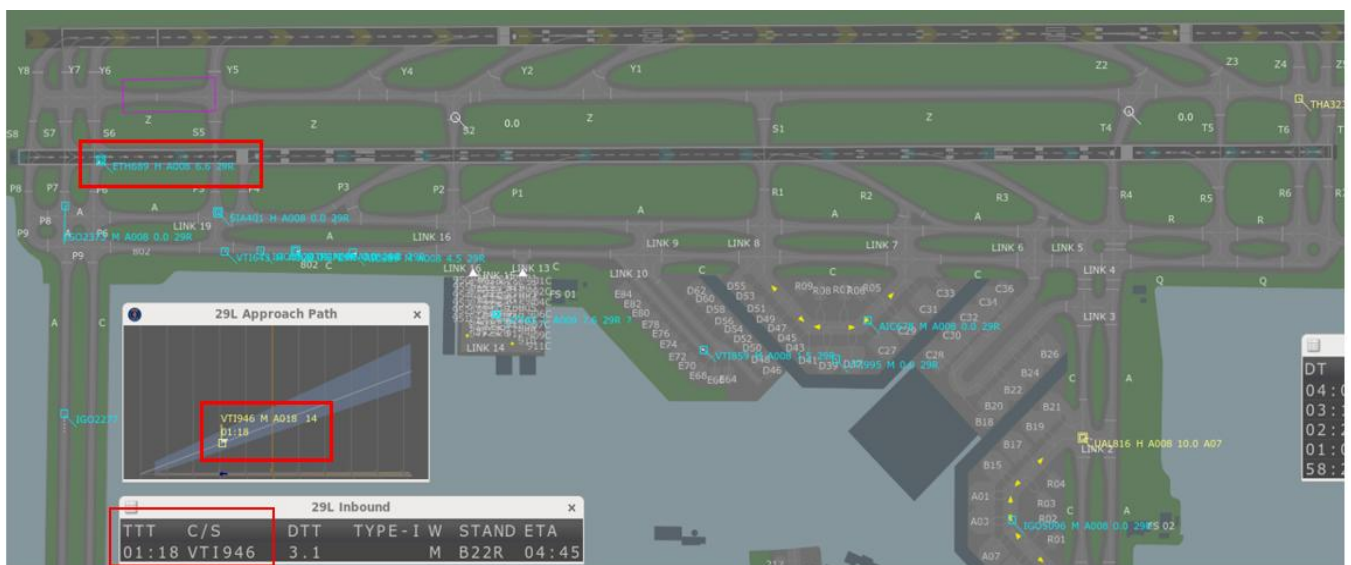
Fig 6: ETH689 position in respect of VTI946's TTT

ETH689 lined up for take-off on Runway 29R at 04:44:09, and the time-to-touchdown (TTT) left for VTI946, approaching Runway 29L, was 1 minute and 18 seconds (see Fig. 6 below).

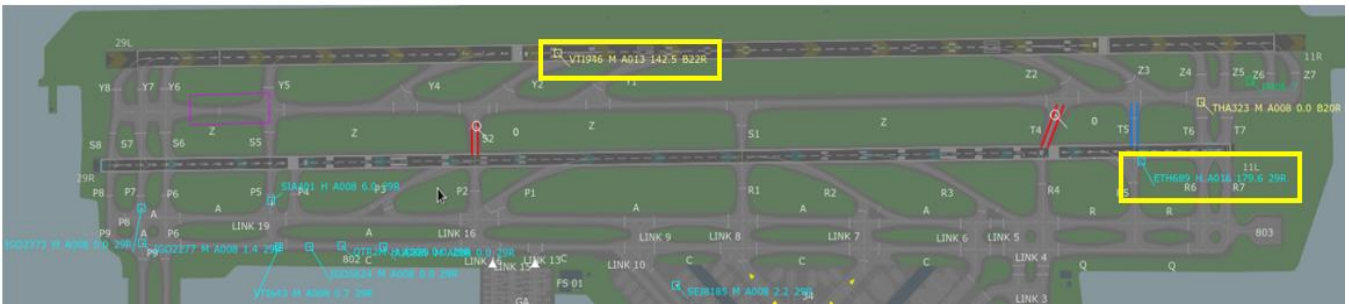
Fig 7: Go around carried by VTI946 while ETH689 tookoff from parallel runway 29R

Within a few seconds of ETH689 becoming airborne, at 044526, VTI946 informed the ADC-S1 controller that due to unstabilised approach they have decided to go around.

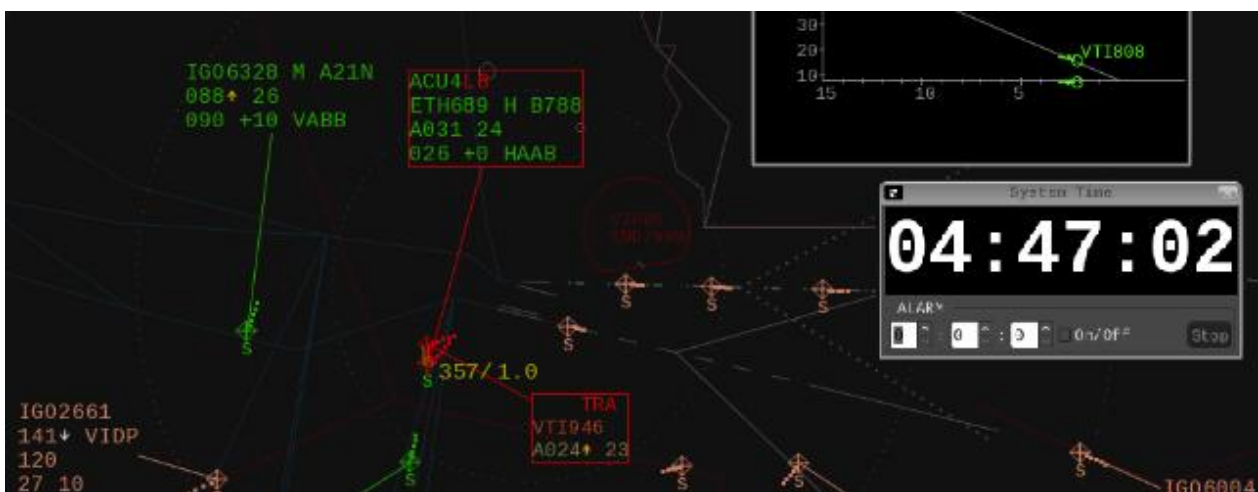
Fig 11: Second time TA/RA displayed on the data block

At 04:47:02, ETH689 had reached 3,100 feet, while VTI946 was passing 2,400 feet. A TCAS RA alert (TRA) appeared in data block of VTI946, showing the aircraft was climbing to 2,600 feet, while ETH689 continued its right turn. The lateral spacing between the two aircraft began to reduce again (see Fig. 11). At 044721, the APAD controller instructed ETH689 to climb to FL70, and subsequently it was acknowledged by ETH689.

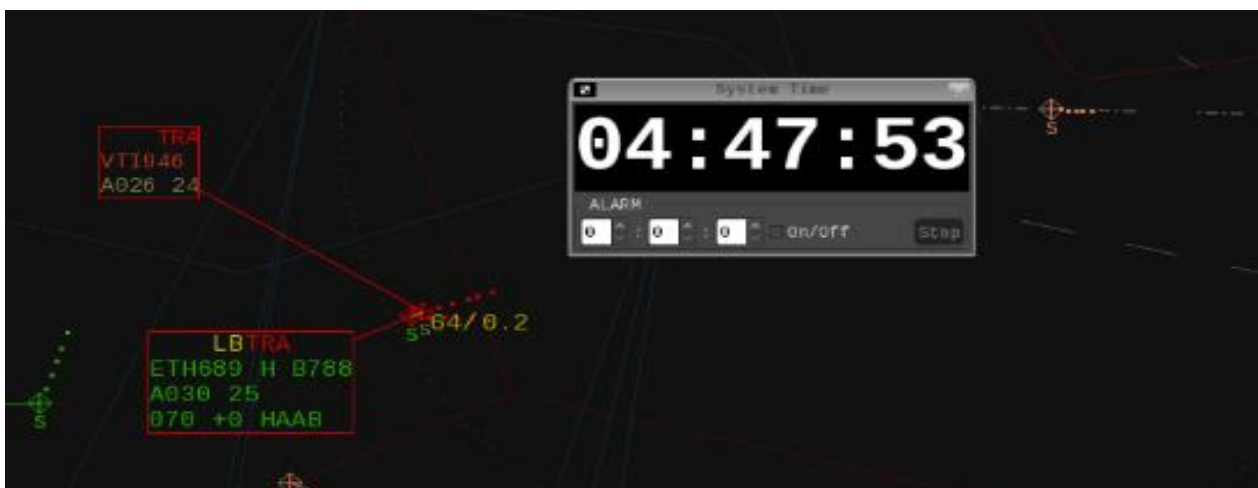
Fig 12: Minimum separation recorded between the aircraft

30. At 044753, TCAS Alert (TRA) triggered for both the aircraft on the radar display and the minimum separation recorded between the two aircraft was 0.2 NM horizontal and 400 feet vertical. (Ref Fig. 12).

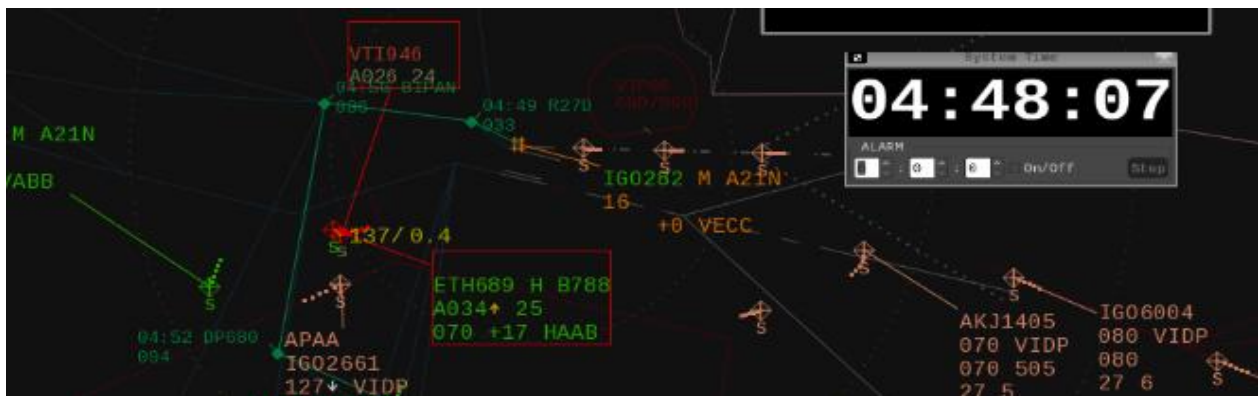
Fig 13: VTI946 reported clear of traffic

31. At 044800, the APAD controller acknowledged and instructed VTI946 to report clear of traffic. VTI946 then confirmed being clear of the conflict and maintaining 2,600 feet (see Fig. 13).

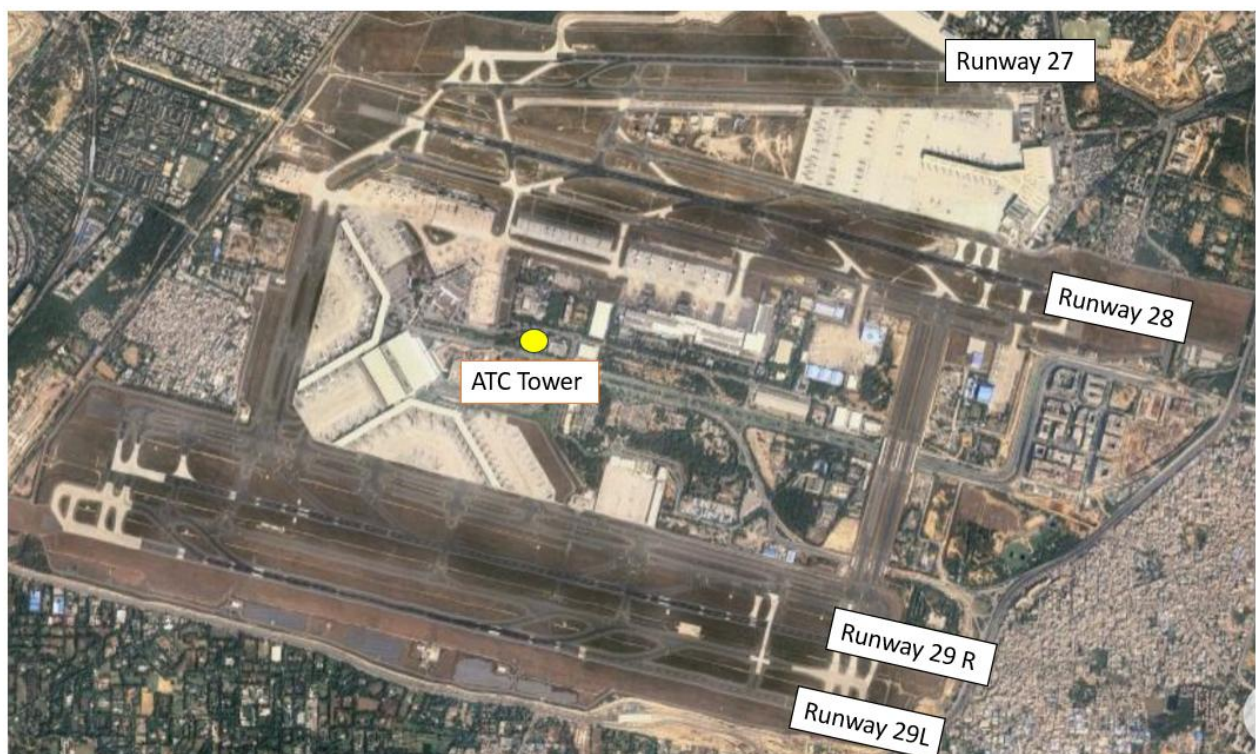
Fig 15: Runway positions at IGI Airport

A new runway, 29R/11L, was operationalized at 0431 UTC on July 14, 2023, and the existing runway 29/11 was renamed 29L/11R. Runways 29L/11R and 29R/11L are parallel, separated by only 360 meters. These runways did not meet the criteria for parallel instrument runways for simultaneous use, as specified in para 3.1.12 of DGCA CAR Section 4, Series B, Part 1, Issue II. Therefore, both runways were operated in Segregated Dependent Mode, with Runway 29L designated exclusively for arrivals and Runway 29R for departures.

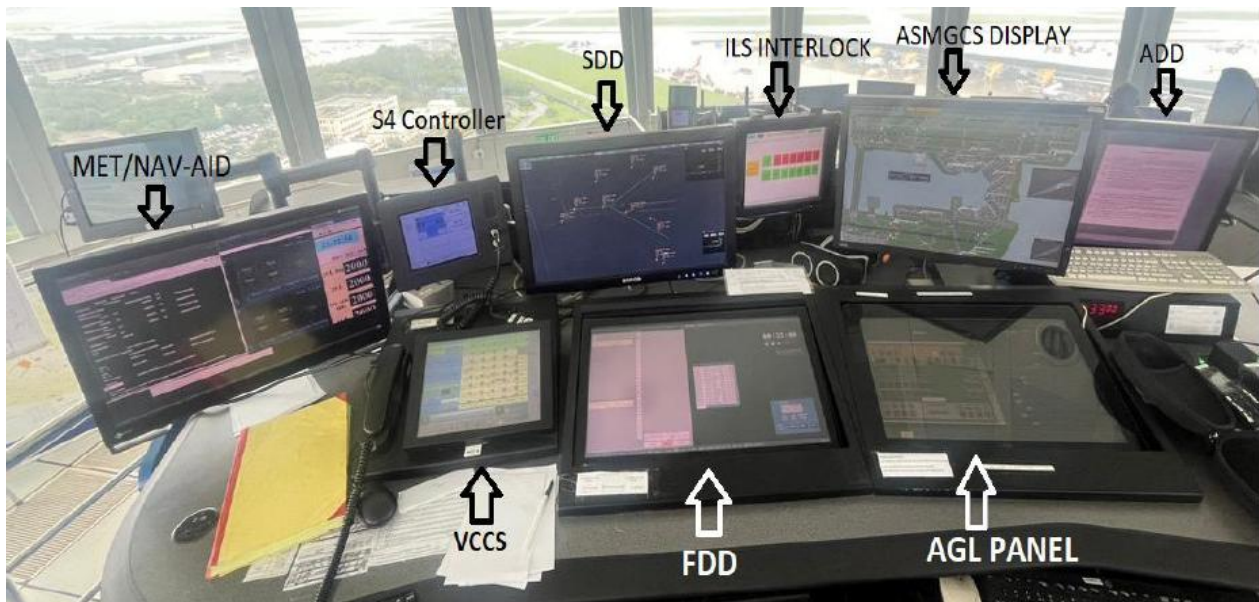
Fig 17: Layout of ADC-S1 workstation

The workstation was set up with a number of displays to help both ADC-S1 and ADC-S2 controllers to monitor and direct the movement of aircraft, manage communications and gather information to assist pilots.
