## Preliminary Report:

***Serious incident of Landing on unassigned Runway by Ariana Afghan airlines flight AFG311, at Delhi (VIDP) on 23.11.2025, 0636 UTC.***

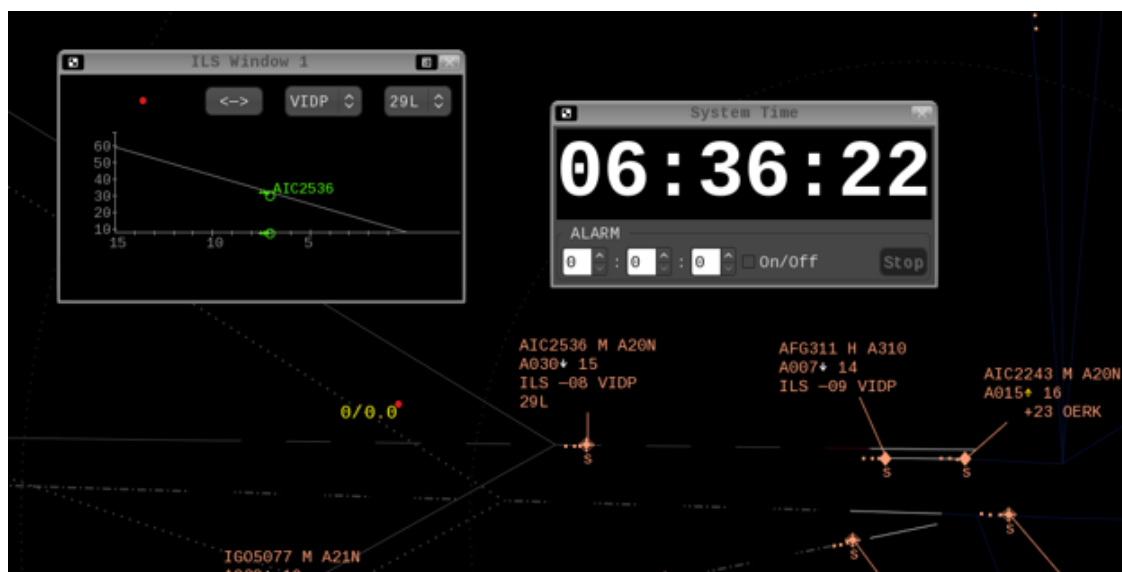
AFG311 reported established on Localizer RWY 29L at 18 NM to touchdown and came into contact of Tower at 10 NM to touchdown on Localizer RWY 29L. Tower Controller instructed AFG311 to continue approach RWY 29L which was read back correctly. At 2NM to touchdown the tower controller gave landing clearance to AFG311 for RWY 29L while AIC2243, was departing from RWY 29R. AFG311 landed on an unassigned RWY 29R at 063622 UTC despite receiving clearance for RWY 29L.

**SS-8 AFG311 landed RWY 29R**

After landing on Runway 29R, the aircraft vacated via Taxiway R and informed Tower on enquiring that they had lost ILS at 4 NM from touchdown and due to poor visibility, were unable to differentiate between Runway RWY29L and RWY29R. As per prevailing mode of operations, RWY 29R was not configured for landings and its approach lights, ILS and PAPI were not switched ON since it was being used in 'Departure ONLY mode'. The aircraft operated its next flight AFG 312 to Kabul at 1012 UTC from Runway 28 on the same day.
