Preliminary Report: Accident involving M/s Red Bird Flight Training Academy Tecnam P2008 JC Aircraft VT-RBC at near Baramati Airport on 19.10.2023

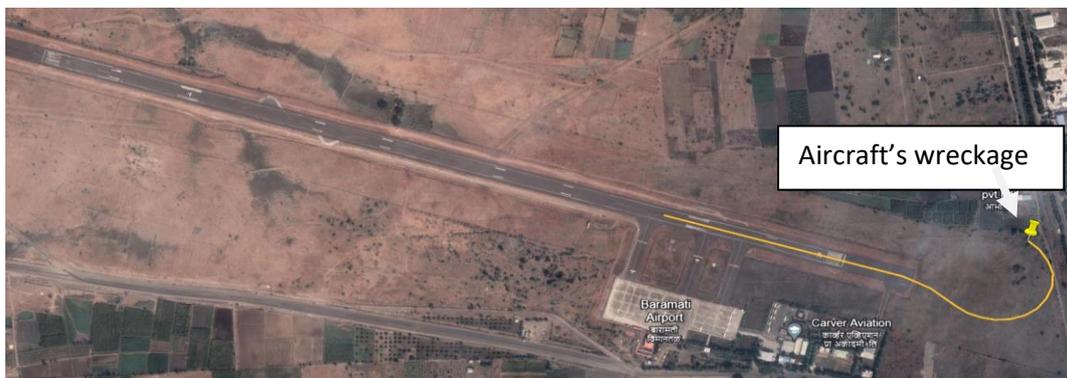
Figure 1: Aircraft trajectory from take off

As per the CFI's statement, he performed flapless take off to check the sluggish operation of the aircraft brakes and abnormal noise in the aircraft. The aircraft got airborne and at around 100 feet height, the CFI stated to have experienced engine power loss. The aircraft banked to the right then turned abruptly to the left followed by loss of altitude resulting in aircraft crashing just outside the Baramati airport fencing approximately 395 m from the RWY 29 threshold.

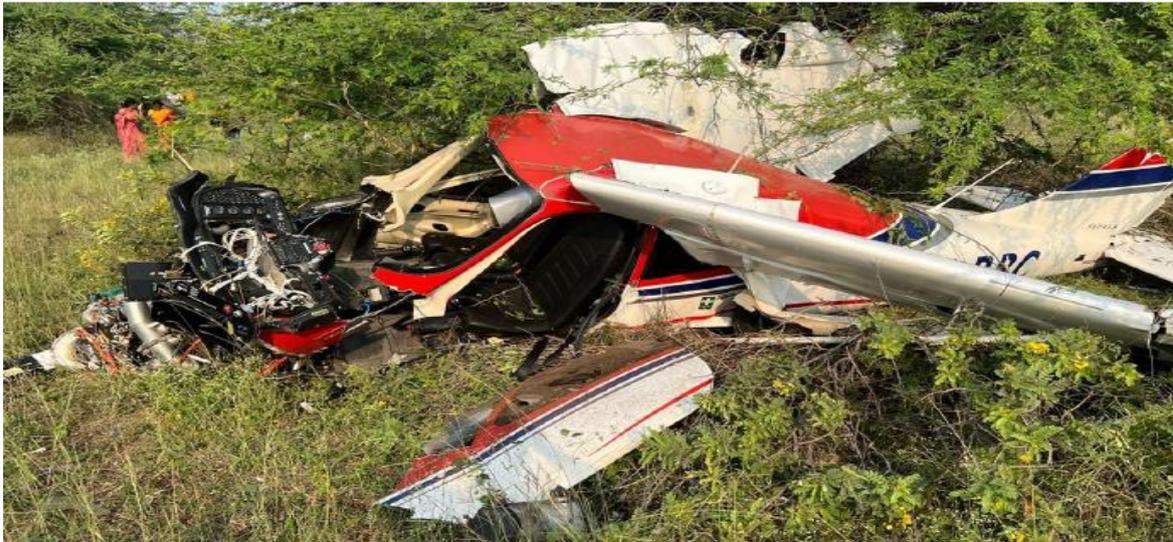
Figure 2: Aircraft's Main Wreckage

Inspection of the aircraft post-accident showed severe damage to its structure. Both the wings and engine were found detached from the mountings and the propeller was found broken. Nose undercarriage got detached from its mounting post impact into the ground. The cockpit area was severely damaged. However, CFI sustained only minor injuries.
