**Preliminary Report: Serious Incident involving M/s Red Bird Flight Training Academy Tecnam P2008 JC Aircraft VT-RBT at near Baramati Airport on 22.10.2023**

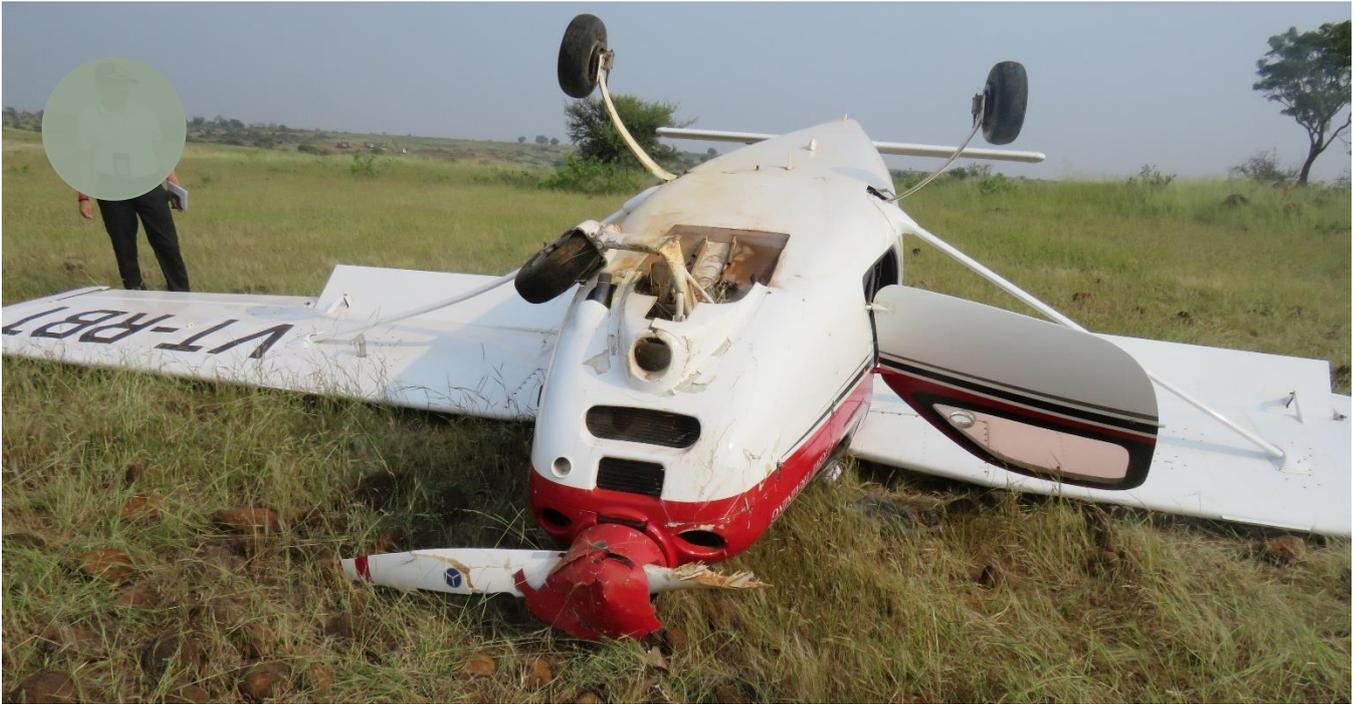
During the onsite inspection, the aircraft was found in an inverted position. Aircraft made an emergency landing with the main landing gear making the initial contact and subsequently nose landing gear touched the ground. The impact with the boulder caused damage to the nose landing gear, resulting in the aircraft toppling and coming to a complete stop.

Further, damage was observed in the vertical fin, rudder and RH main landing gear. Propeller got broken. Dent was observed on leading edge and root of the both wings.

*Figure 1: Aircraft's Main Wreckage*
