Government of India
Ministry of Civil Aviation
Aircraft Accident Investigation Bureau

Preliminary Report: Accident involving M/s Vision Flying Training Institute Tecnam 2008JC aircraft bearing reg. VT-VDF, near Amreli Airport on 22 April 2025

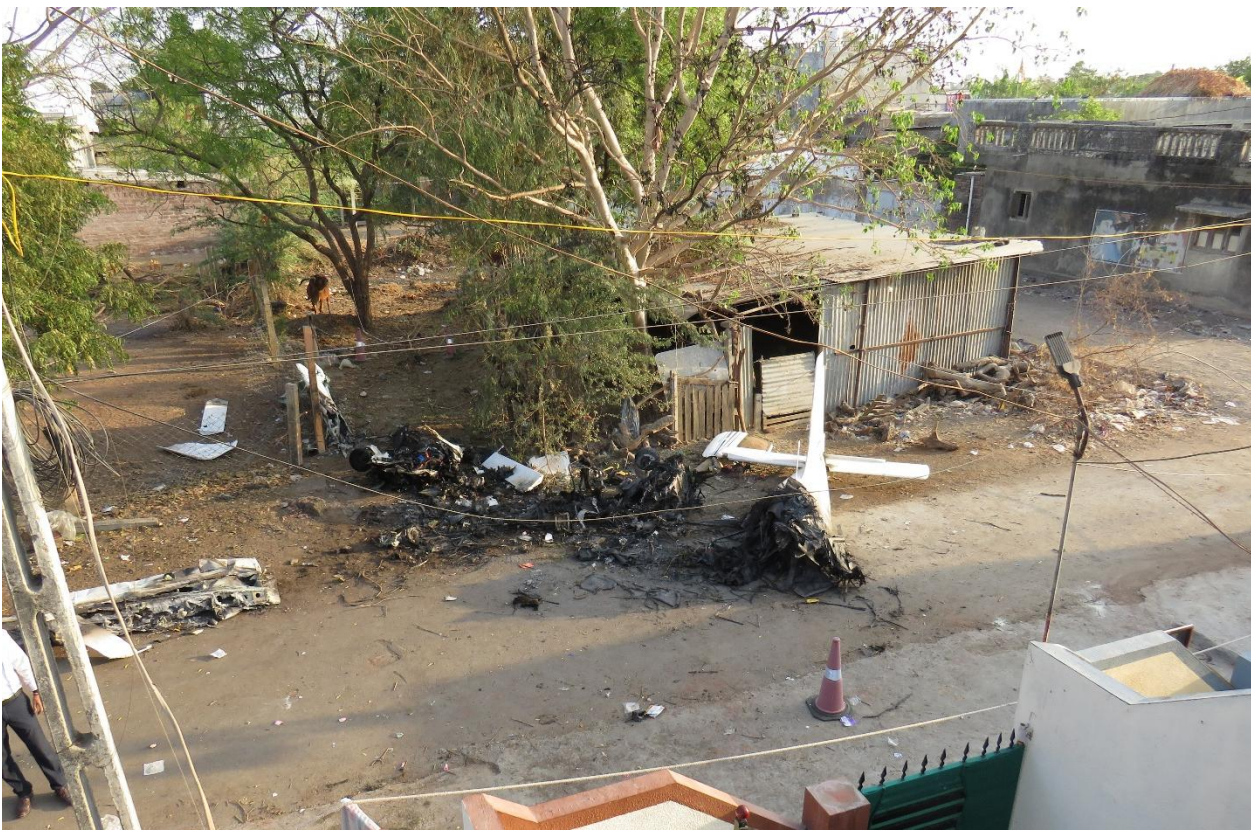
The aircraft crashed in a village adjacent to Amreli airfield, at 3 O'clock position w.r.t runway orientation. The aerial distance between runway edge and the crash site was approximately 920 metres. After impacting a road inside the village, the aircraft caught fire. As the aircraft collided with the ground in nose down position, the overall wreckage was confined to a small area, and no damage was reported to any nearby property. The aircraft was destroyed in the accident. The coordinates of the accident site are Latitude: 21° 37' 28.3" N & Longitudes 71° 13' 31.8 "E.

Fig: Wreckage at Accident Site
