**Aircraft Accident Investigation Bureau**  
**Government of India**  
**Ministry of Civil Aviation**

**Preliminary Report:**

**Accident involving India One Air, Cessna Caravan 208B EX aircraft VT-KSS, near Jalda, Rourkela Odisha on 10th January 2026.**

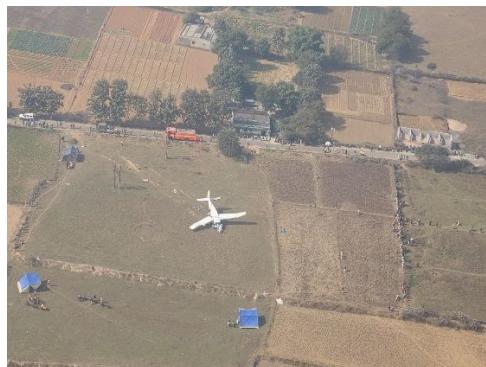
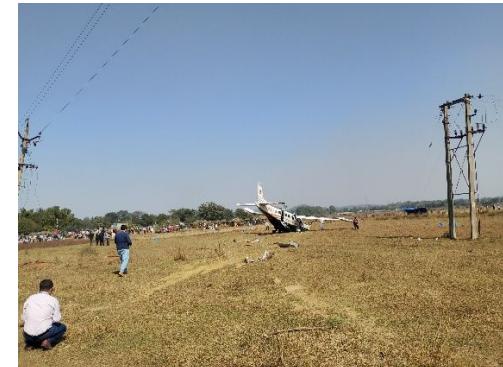
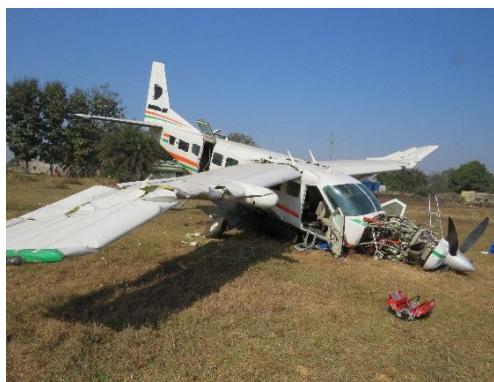
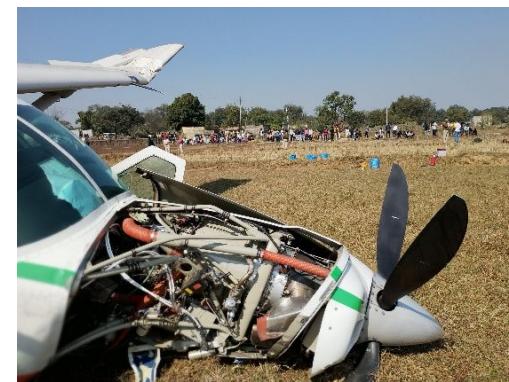
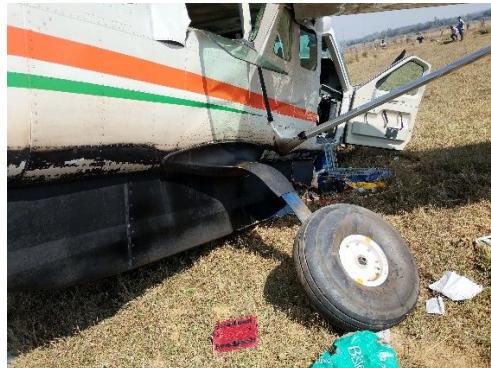
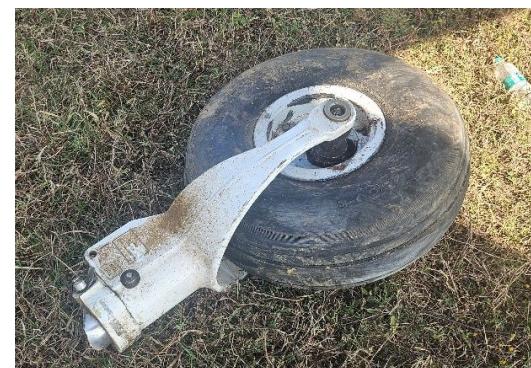
### **Pictures of Crashed Aircraft VT-KSS**

- (a) There was substantial damage to the airframe structure.

- (b) The nose landing gear was separated from the aircraft due to the impact and the main landing gear was deformed.
- (c) Engine propellor blades were damaged.
- (d) The forward section of the fuselage was fragmented with complete structural break, crushing the left- and right-wing controls.
- (e) The vertical stabilizer, the LH stabilizer and trim tab had deep cut due to the impact with the HT cable wire, a part of which got stuck in the stabilizer.
- (f) The cockpit control column and cockpit instruments were significantly damaged.
- (g) Signs of oil stains were found from the fuselage belly area spreading till tail end.
- (h) The aircraft was found with engine touching the ground and tail up with widespread debris at the wreckage site.
- (j) No fire/ smoke was observed.

An High Tension cable joining two adjacent electric poles was hit by the aircraft just before the crash.
