**FINAL INVESTIGATION REPORT OF ACCIDENT TO PAWAN
HANS LTD. DAUPHIN AS 365 N3 HELICOPTER VT-PHZ AT
HARSIL HELIPAD UTTARAKHAND ON 28/06/2013.**

- | | |

| Registration | : VT - PHZ |
| 5. Place of Accident | : Harsil Helipad, Uttarakhand |

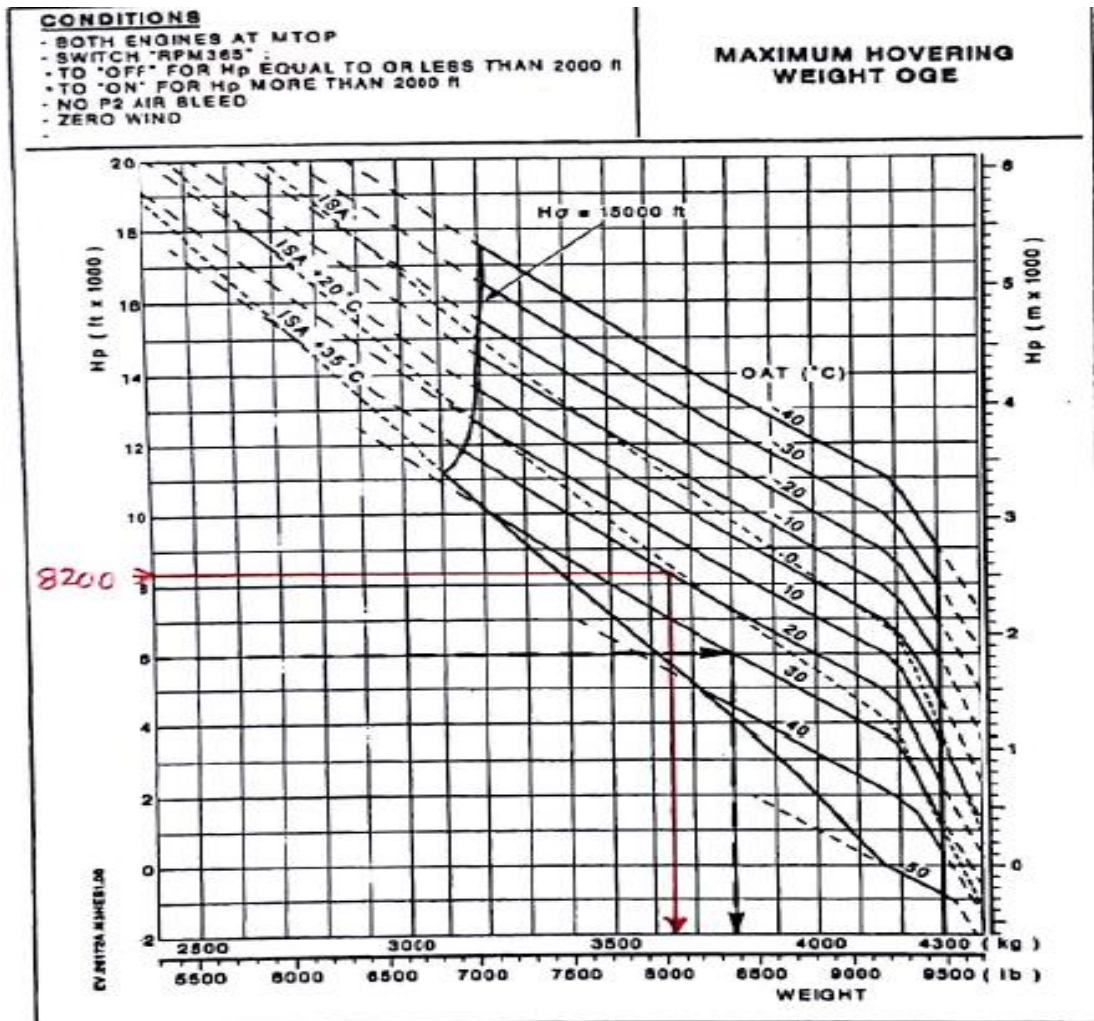
Kgs. The Harsil helipad is at an elevation of 8200 ft and the outside air temperature (OAT) at the time of landing was around 20°C. As per the graph given in the helicopter flight manual the maximum permissible hovering weight at an elevation of 8200 ft. with OAT of 20°C is approximately 3640kgs. Helicopter at the time of landing at Harsil, was very close to its maximum operating weight, as a result, there was less power margin available to the pilots to come up on collective to control the rate of descent.

Graph showing the maximum permissible hovering weight with altitude.

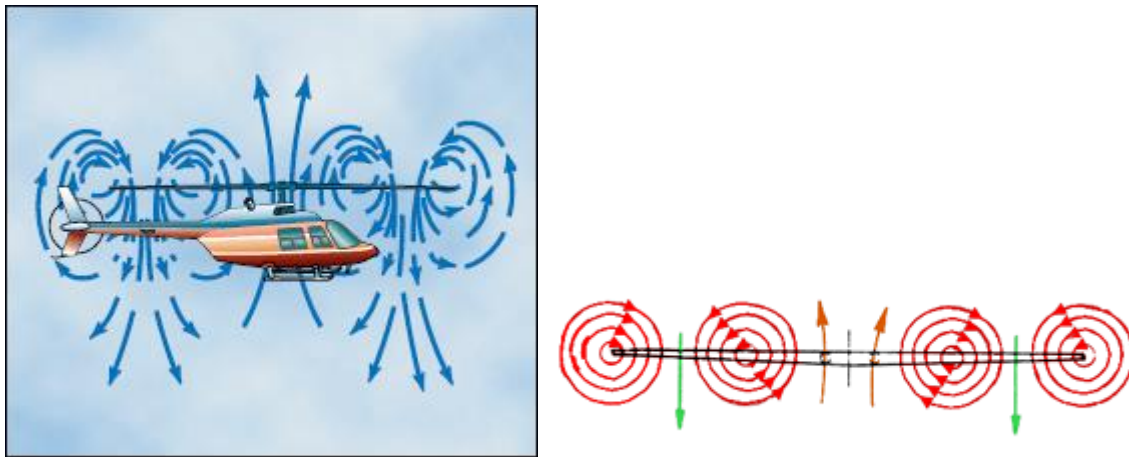
The vortex ring state, also known as "settling with power", is a dangerous condition that may arise in helicopter flight, when a vortex ring system engulfs the rotor causing severe loss of lift. Essentially, the helicopter descends into its own downwash. When the condition arises, increasing the rotor power merely feeds the vortex motion without generating additional lift.

In forward flight, there is no upward flow (upflow) of air in the hub area. As forward airspeed decreases and vertical descent rates increase, an upflow begins because there are no airfoil surfaces in the mast and blade grip area. As volume of upflow increases, the induced flow (air pulled or "induced" down through the rotor system) of the inner blade sections is overcome and the blades begin to stall near the hub. As the inner blade sections stall, a second set of vortices, similar to the rotor tip vortices, form in the center of the rotor system. The inner set of vortices decreases the amount of lift being produced and causes an increase in sink rate. In an accelerated condition, the inner and outer vortices begin to feed each other to the point where any increase in rotor

blade pitch angle increases the interaction between the vortices and increases the rate of descent. In this state, the helicopter is operating in its own downwash, descending through descending air. The failure of a helicopter pilot to recognize and react to the condition can lead to high descent rates and excessive height loss.
