**FINAL INVESTIGATION REPORT ON SERIOUS INCIDENT**  
**TO M/s CATHAY PACIFIC LTD. BOEING B747-400**  
**AIRCRAFT REGISTRATION B-HUL AT IGI AIRPORT**  
**DELHI ON 27.07.2015**

**COMMITTEE OF INQUIRY B-HUL**

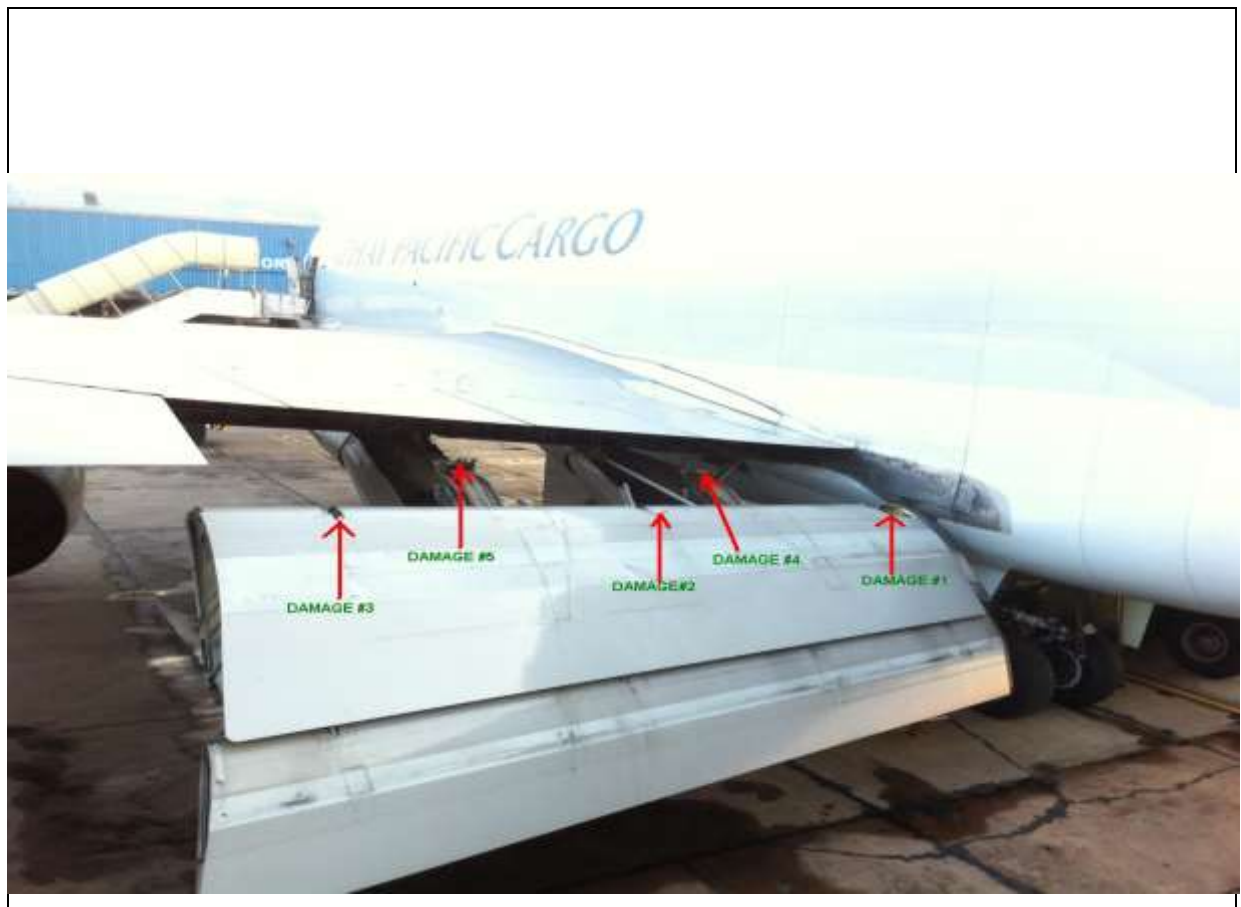
Following main damages were observed on the aircraft structure.

| Damage 1 | Damage 1A | Bull Nose of about 24 Inches from inboard edge was found missing. |
| Damage 1B | | Inboard Mid Flap to foreflap Cut out was found Ripped Off. |

| | Damage<br>1C | 2 Dents Measuring 4" X 1.5" X 3/32" and 18" X 1" X 3/64" were found on the upper surface of the mid flap. |
| | Damage<br>1D | Crease along the AL Skin 9" X 0.5" X 3/32" with skin puncture at outboard side and Honeycomb Visible. |
