**FINAL REPORT OF ACCIDENT  
INVOLVING  
M/s JET AIRWAYS ATR 72-500 AIRCRAFT  
VT-JCX  
AT INDORE  
ON 07<sup>TH</sup> MAY 2016**

**FINAL REPORT ON ACCIDENT TO M/s JETAIRWAYS ATR 72-500**

**AIRCRAFT VT-JCX AT INDORE ON 07/05/2016**

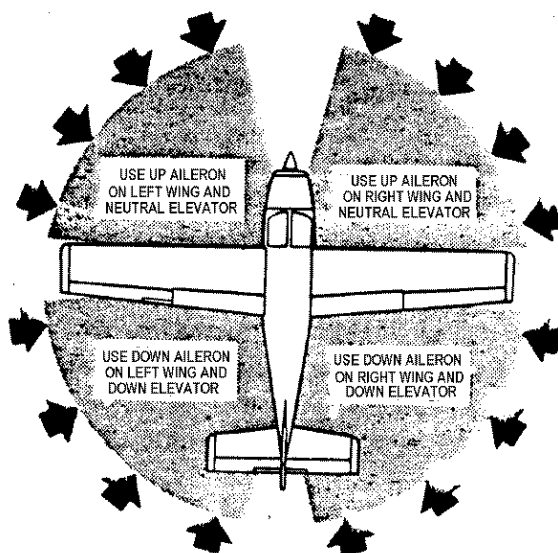
**Fig 12**

At lower speeds the nose down input helps in increasing directional stability by applying higher load on nose wheel if using nose wheel steering. The figure above depicts use of controls in different wind conditions.

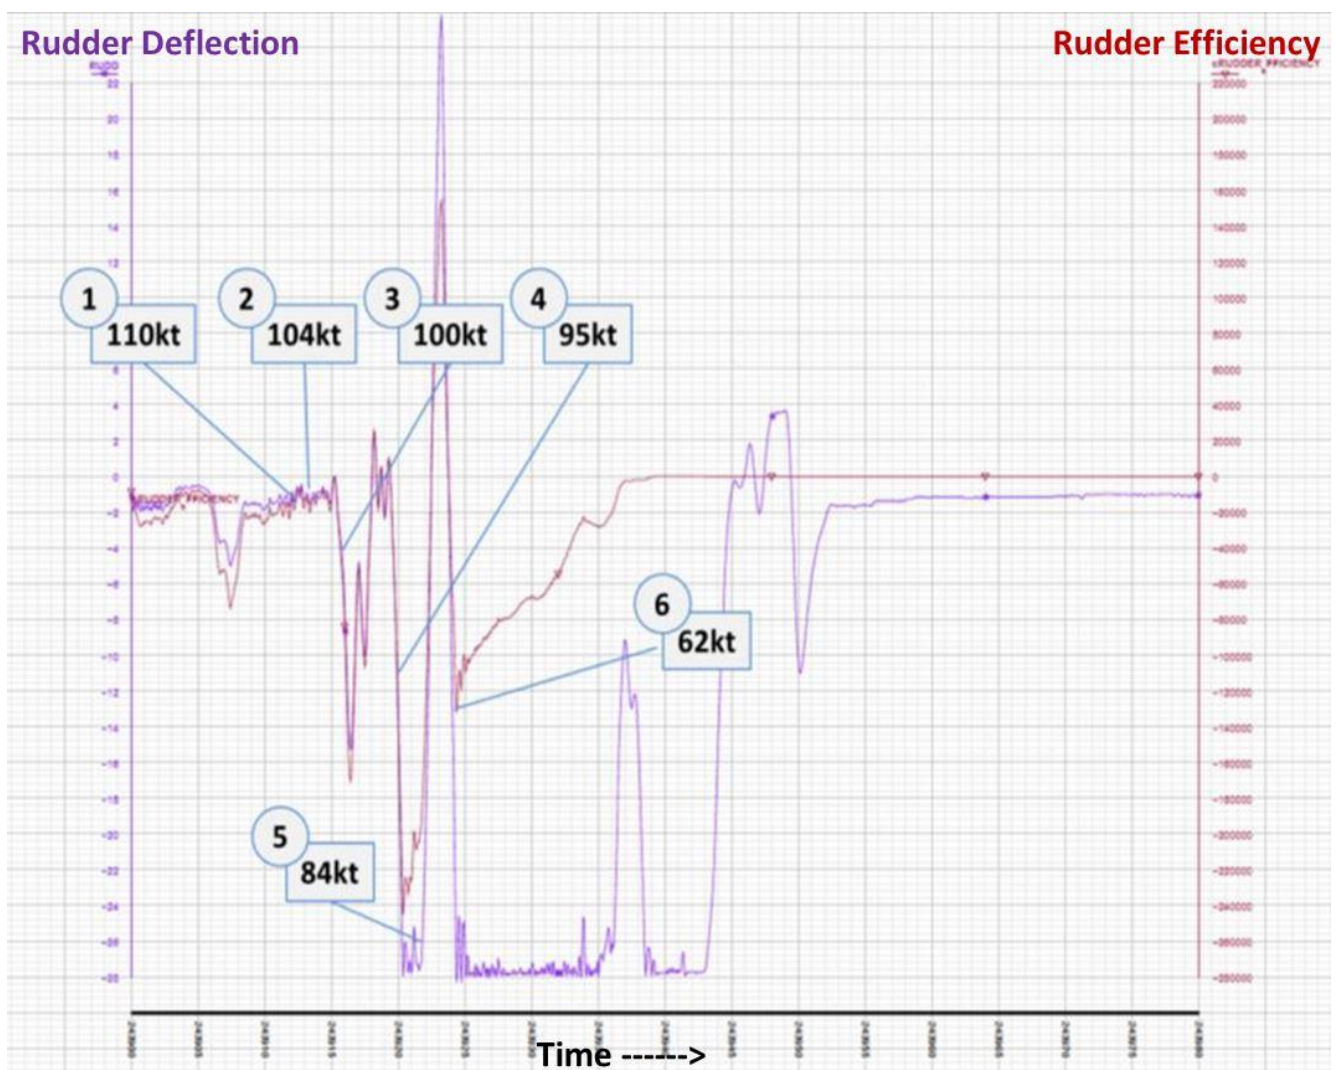
Fig 13

The aerodynamic efficiency of the flight control surfaces such as rudder is related to with square of the speed and proportional to deflection; the graph below is plotted using data from the DFDR and represents the rudder deflections efficiency as a function of time during the event sequence. With the same deflection, the efficiency of the rudder between the first rudder deflection at 95Kt and the second at 62Kt, in 7 seconds, has been reduced by more than half. Below 60Kt the rudder efficiency drops quickly to null efficiency.

In addition, the graph attached also shows the effort applied on the rudder pedals, the diminution of the effort to maintain the mechanical stop of the rudder illustrates the rudder's decreasing effectiveness from the reducing force needed on the rudder pedals.
