# GOVERNMENT OF INDIA MINISTRY OF CIVIL AVIATION AIRCRAFT ACCIDENT INVESTIGATION BUREAU

# FINAL INVESTIGATION REPORT OF ACCIDENT TO B737-800 AIRCRAFT VT-SYK AT MUMBAI ON 01/07/2019

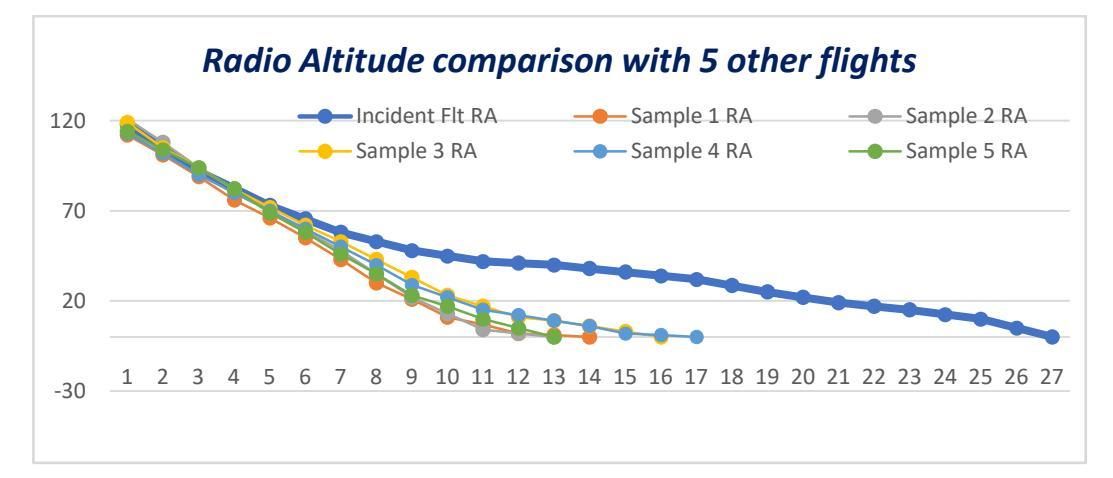
A comparison of rate of descent as in the subject flight was made with 5 other flights of the same aircraft (from DFDR data) having similar landing weight. The graph below shows the comparison of these flights from Radio Altitude of 120 feet to touchdown.

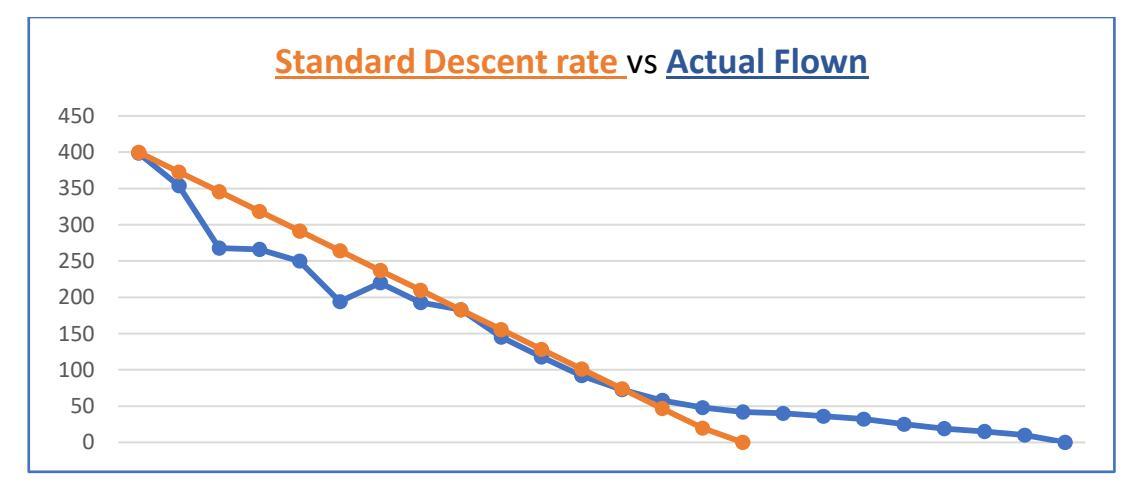
The standard descent rate v/s actual flown by the aircraft is as follows:

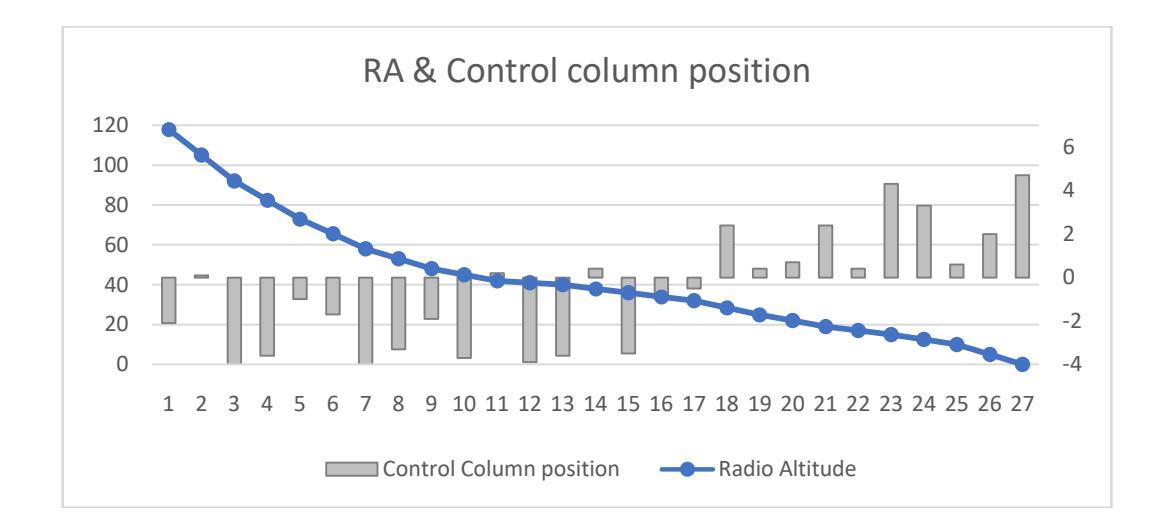
The crew did not factor the effect of the "autopilot trim bias", which gets applied during the approach, on the actual flare technique of the crew carrying out the manual flare and landing. This required the pilot input in the pitch moment to be reduced or even occasionally reversed during the flare in order to achieve the touchdown within the touchdown zone of the runway.

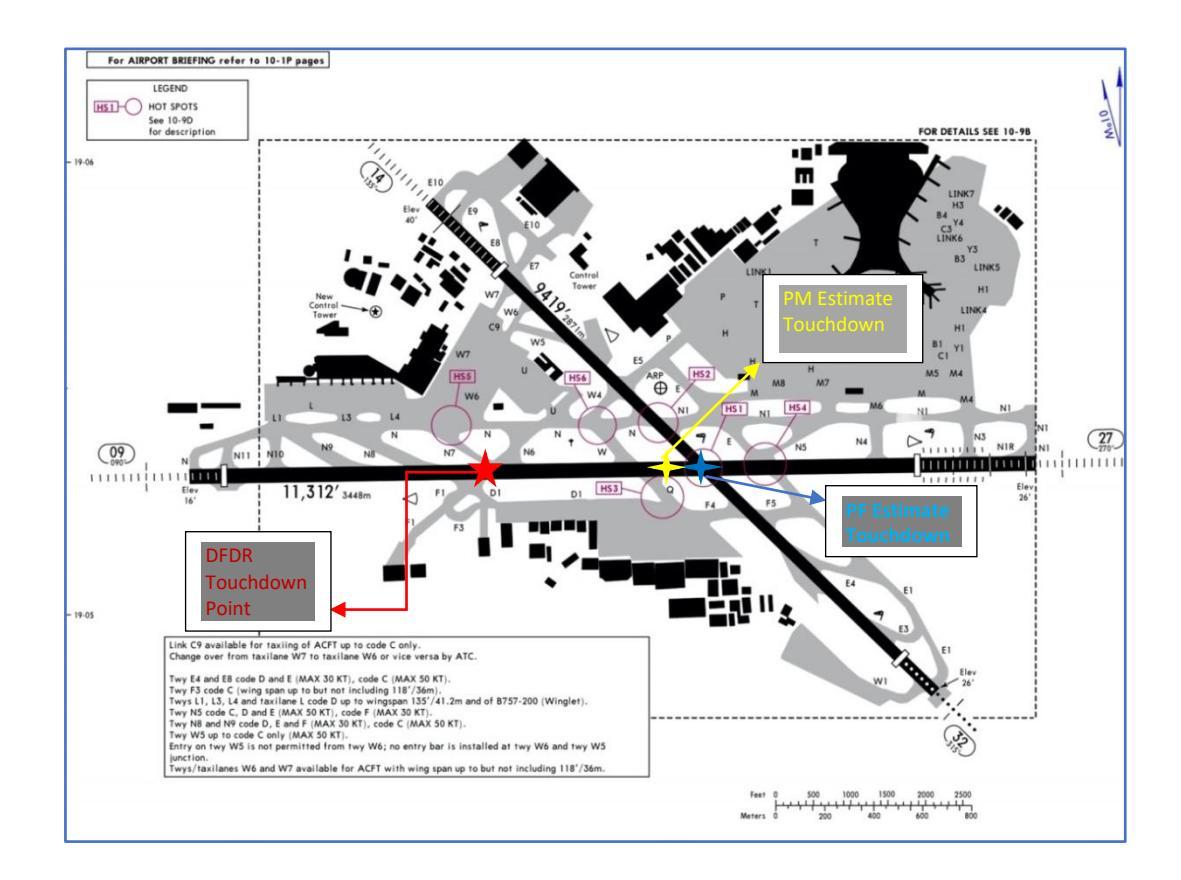
Both pilots have stated that the visibility was such that they could only see the centerline lights which appeared to be blurred due to the refraction from water droplets. Both Pilots have stated that they believed the primary cause of the overrun was the runway surface friction being inadequate and the same not reported to the crew prior to approach and landing. Both crew members' assessment of approximate point of touchdown achieved was inaccurate (marked on the runway). The actual touchdown was outside the touchdown zone.

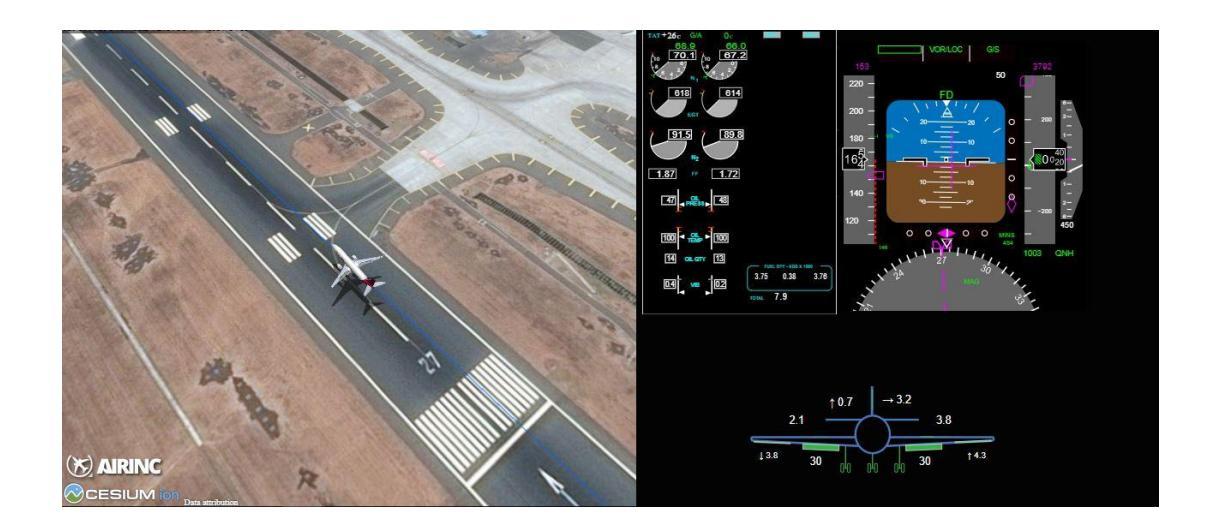
The Image below shows the 50 feet radio altitude position. This was achieved just after crossing the landing threshold at a speed of 165 Kts (12 Kts above Target Approach Speed) and the thrust was (L) 70.1% N1 & (R) 67.2% N1. The auto throttle and Autopilot are both disengaged. The aircraft is on the Localiser and above the Glideslope.

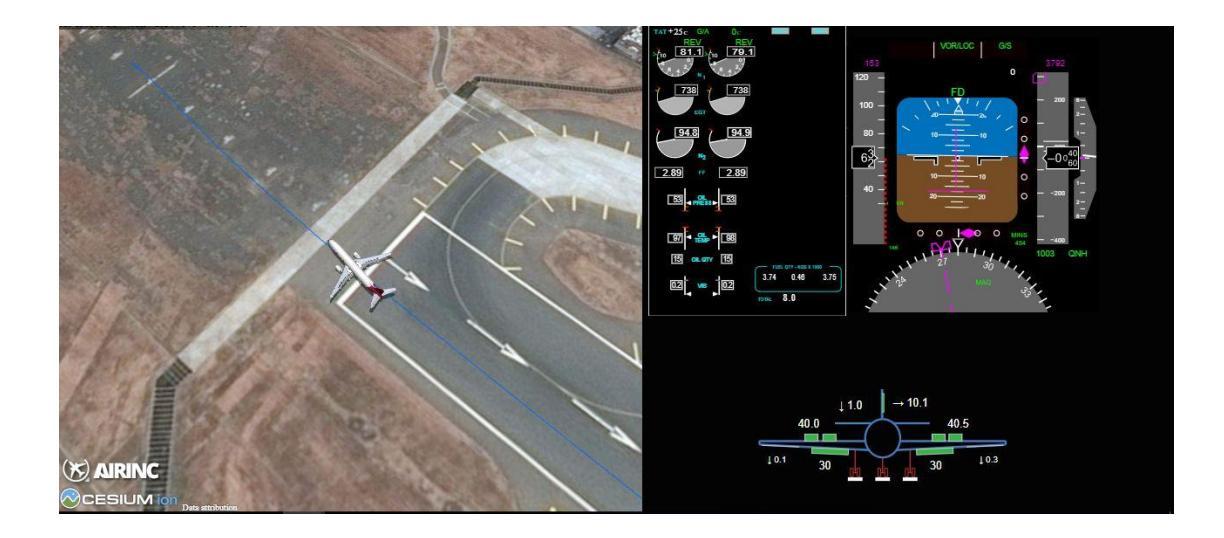
The Image below shows the runway exit from the paved surface at 63 KIAS. The aircraft is to the left of centreline with maximum reverse thrust and maximum brake effort.
