**FINAL REPORT ON SERIOUS INCIDENT TO M/s UZBEKISTAN  
AIRWAYS, A320 AIRCRAFT , UK32022 AND M/s INDIGO, A320  
AIRCRAFT, VT-IHQ IN DELHI AIRSPACE, ON 25/01/2020**

**KUNJ LATA  
INVESTIGATOR-IN-CHARGE**

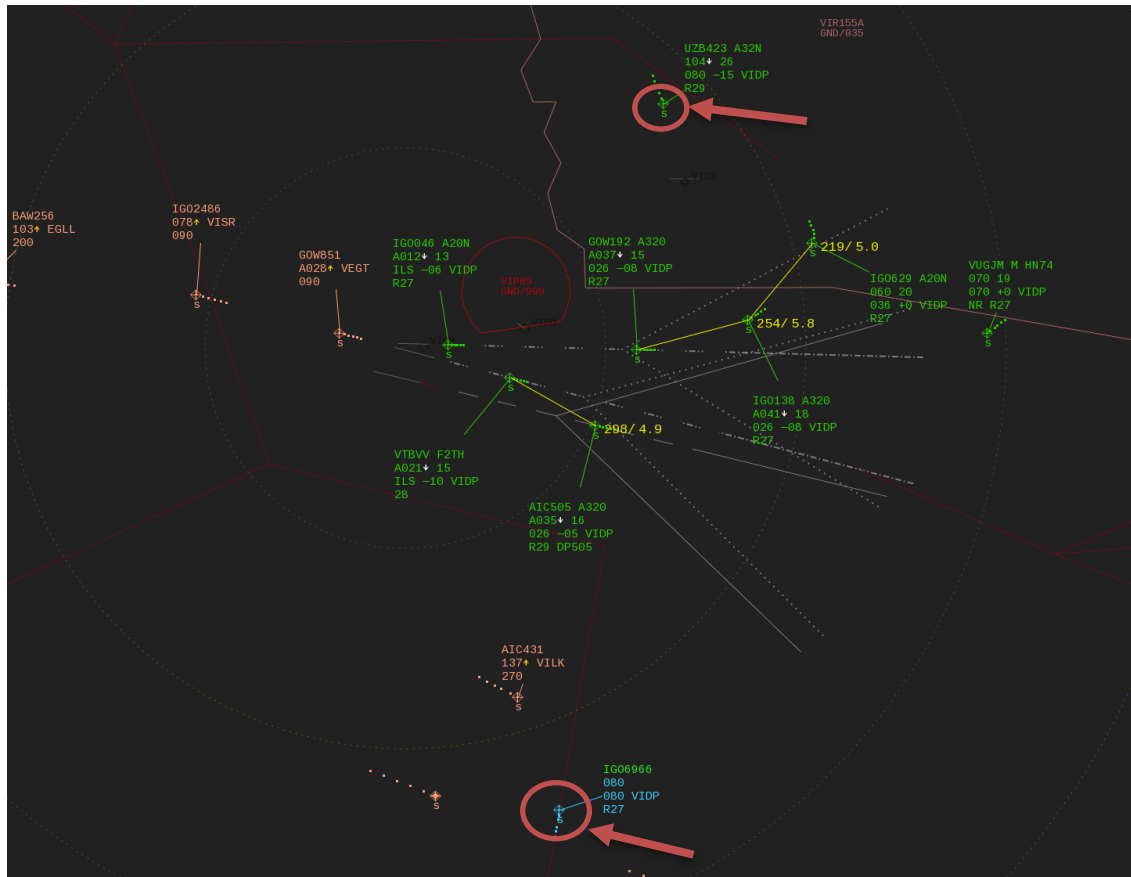
**Figure: Showing initial positions of both aircraft**

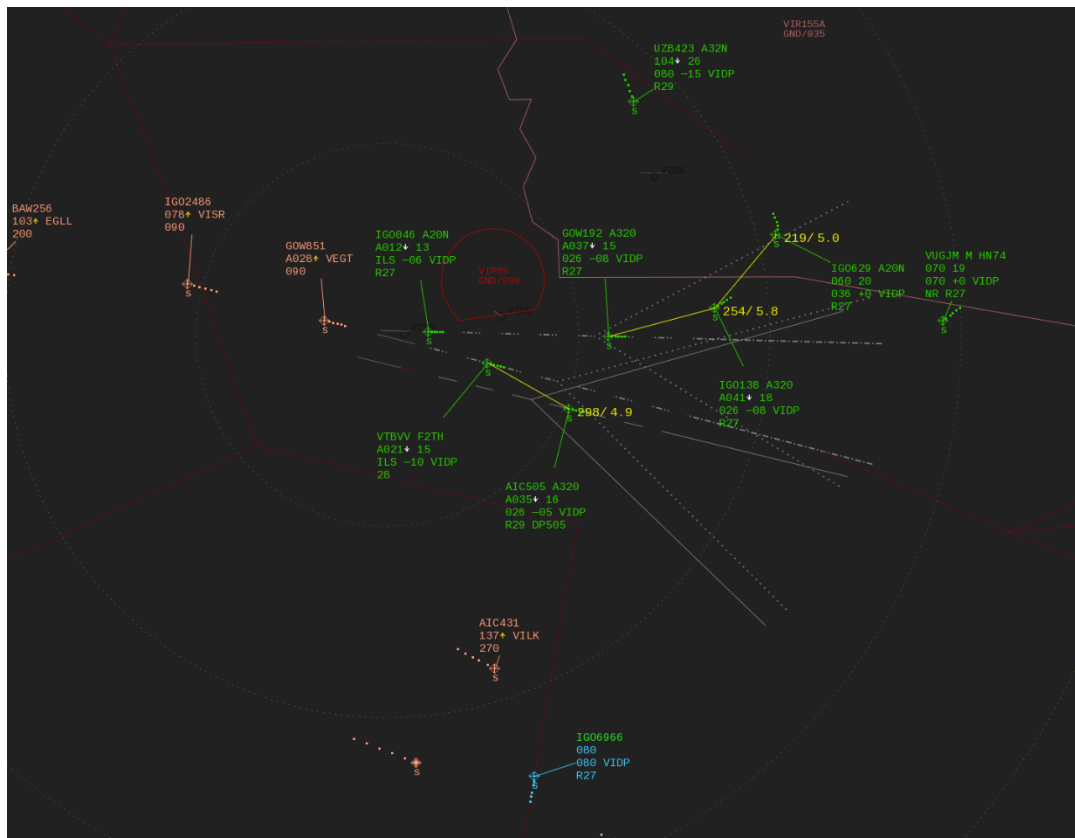
**Figure: At 07:16:41 UTC, IGO6966 maintaining FL80 and UZB423 descending to FL80 (Both the controller are with Approach (AA) Control Unit.**

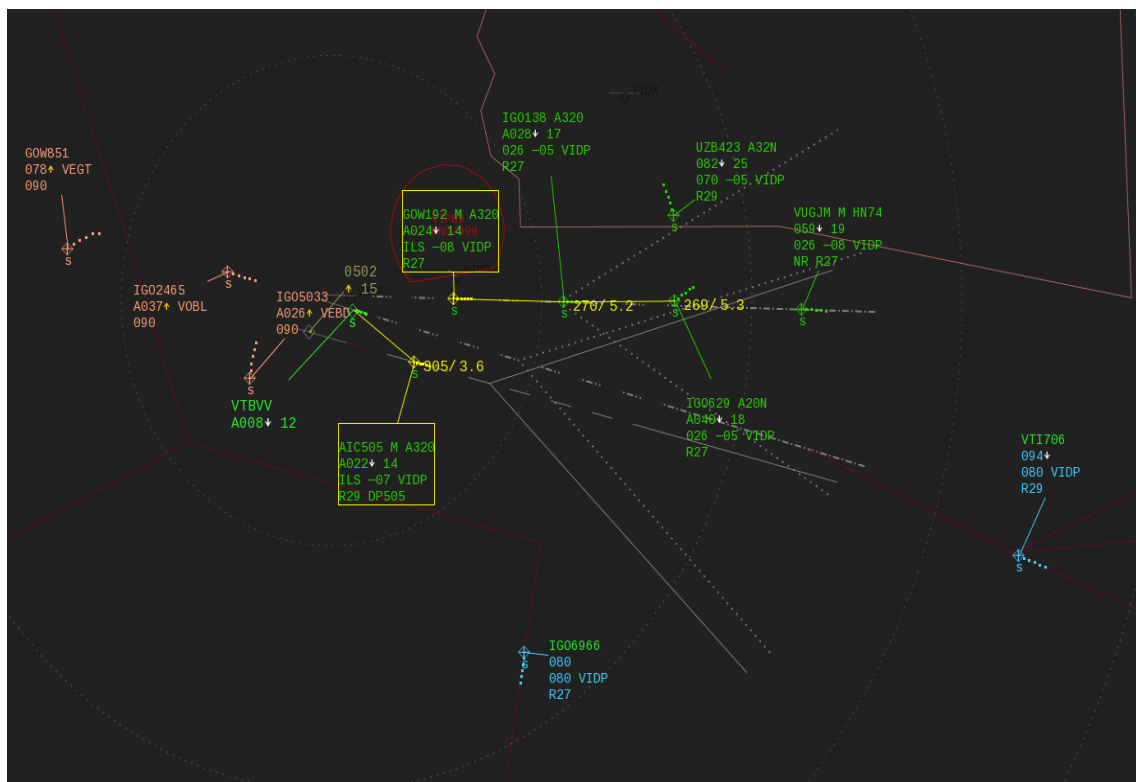
At 0719 UTC, Approach (FA) Controller gave further descent to FL70 and right heading H205. UZB423 was further given descent of FL60. This instruction was read back correctly by UZB423.
